DoD Corrosion Prevention and Control Program

Demonstration and Validation of Materials for Corrosion-Resistant Fencing and Guard Railings in Aggressive Climates

Final Report on Project F09-AR02

October 2015

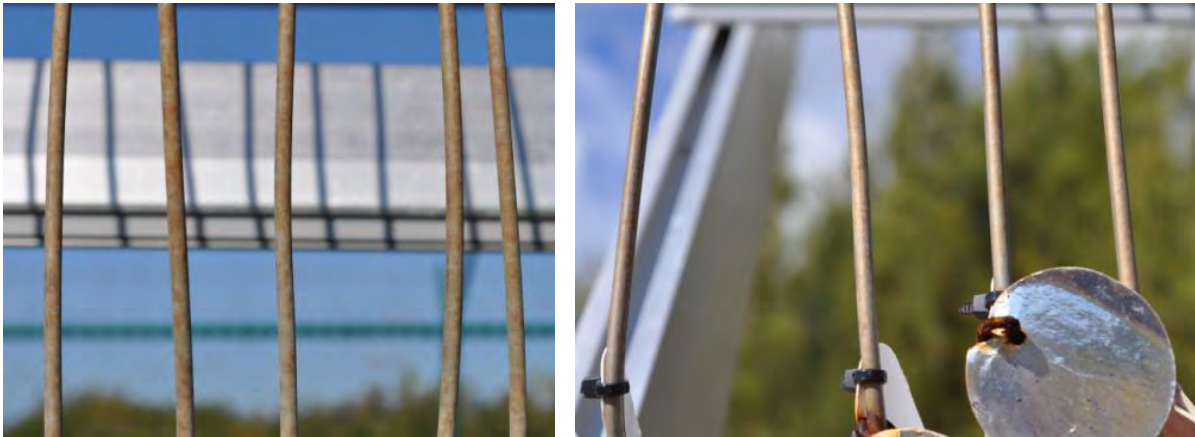
Figure 20. Stainless steel wire coupon at FRF (left) and KTA (right) after 6 months of exposure.

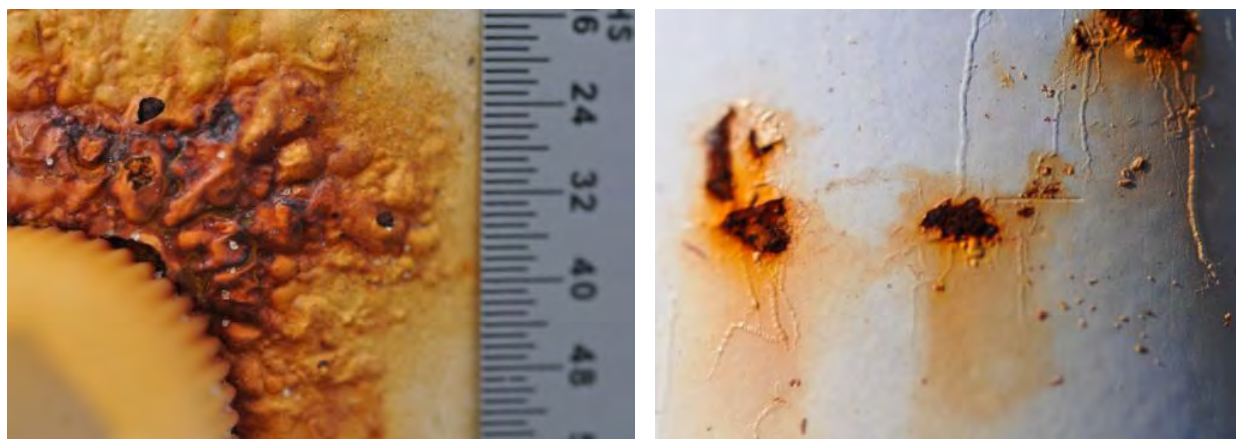
Figure 34. Coated steel railing coupon at FRF (left) and KTA (right) after 12 months of exposure.

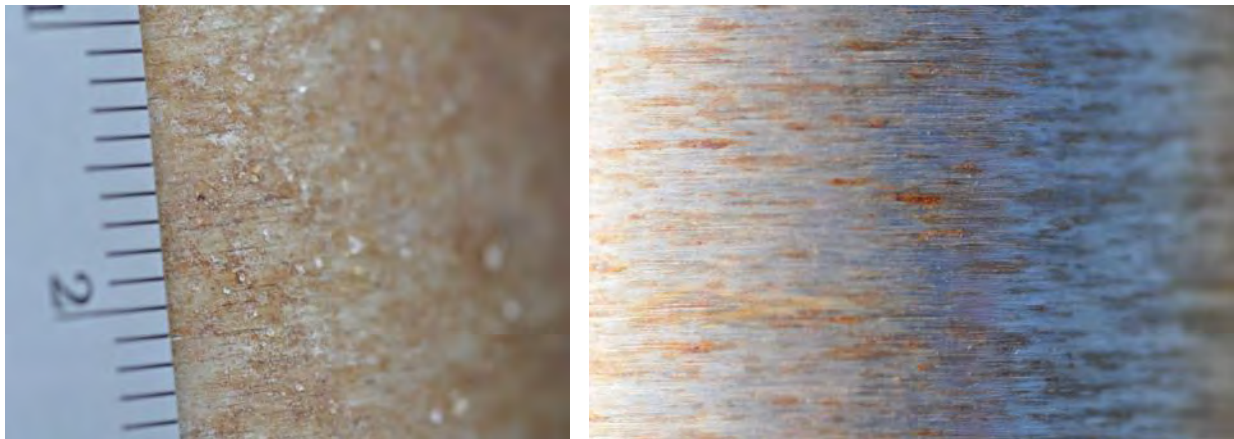
Figure 35. Stainless steel railing coupon at FRF (left) and KTA (right) after 12 months of exposure.

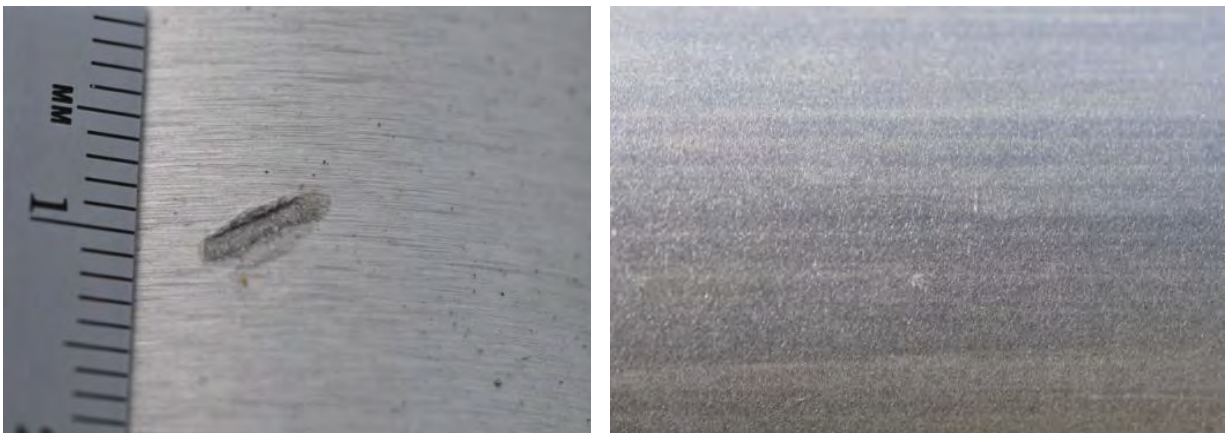
Figure 36. Aluminum railing coupon at FRF (left) and KTA (right) after 12 months of exposure.

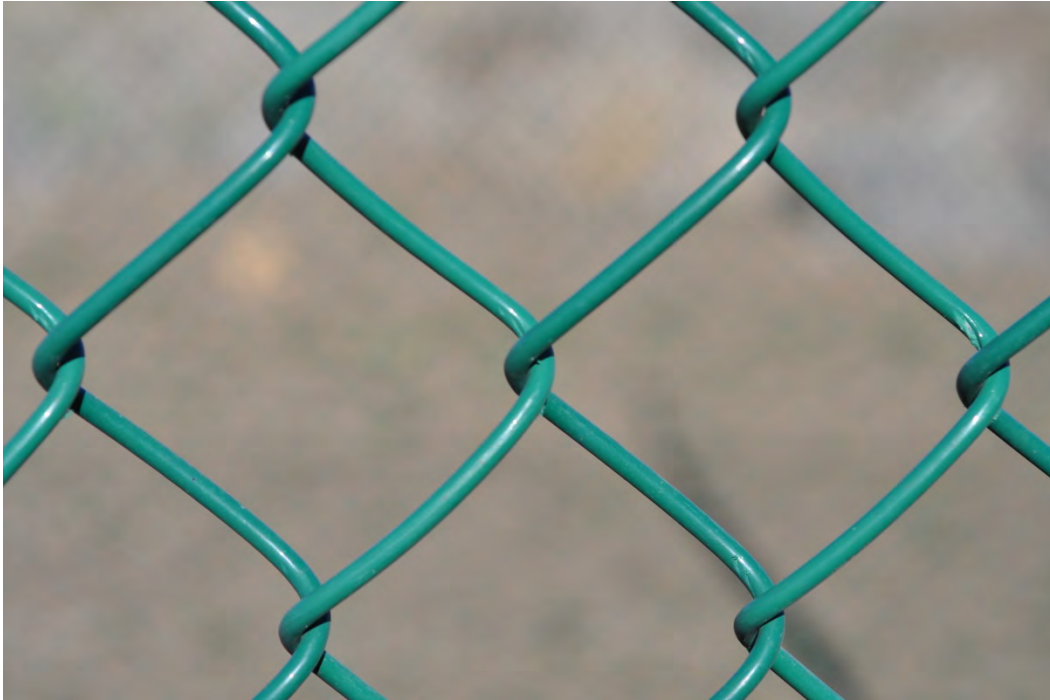
Figure A7. Fuse-bonded PVC after 6 months exposure.

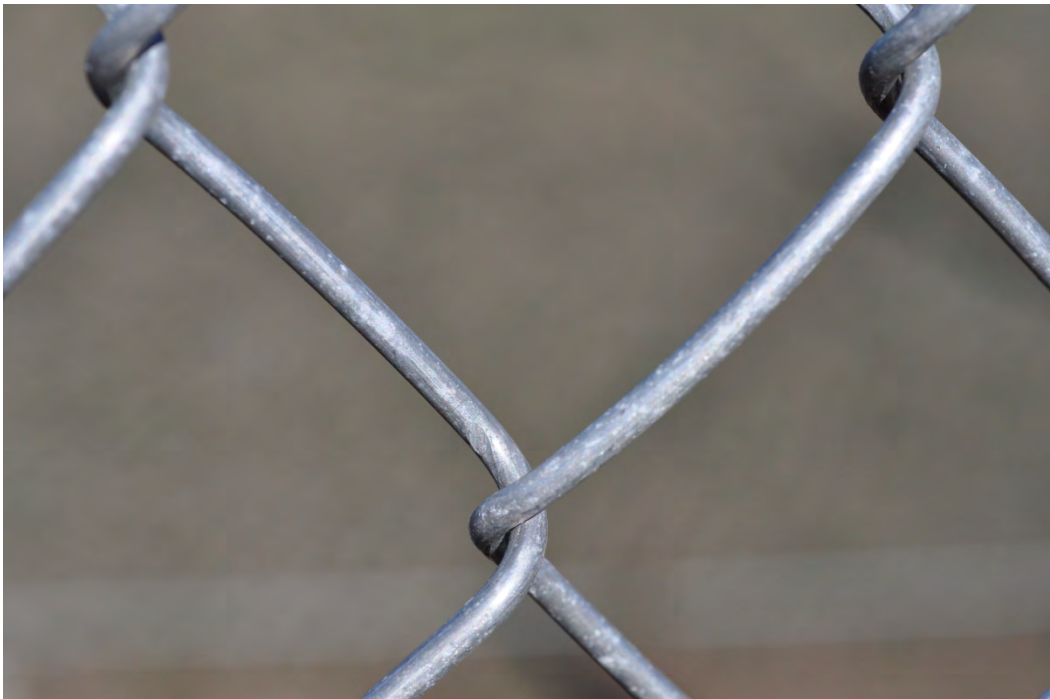
Figure A8. Stainless steel after 6 months exposure.

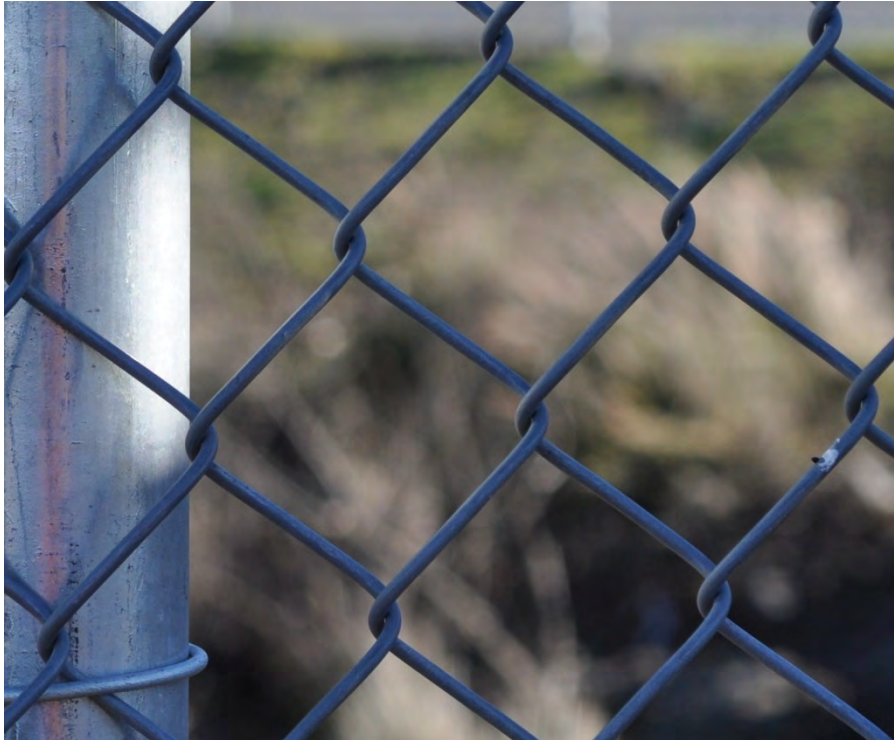
Figure A13. Galvan PVC after 6 months exposure.

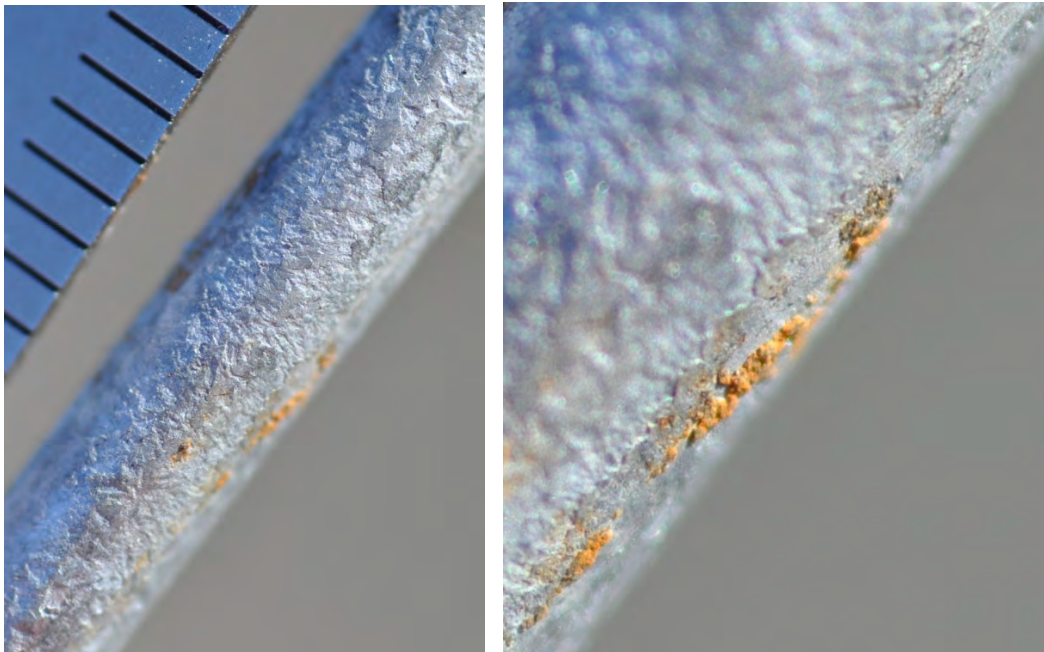
Figure A14. Aluminized after 12 months exposure showing corrosion on less than 5% of the total surface area.

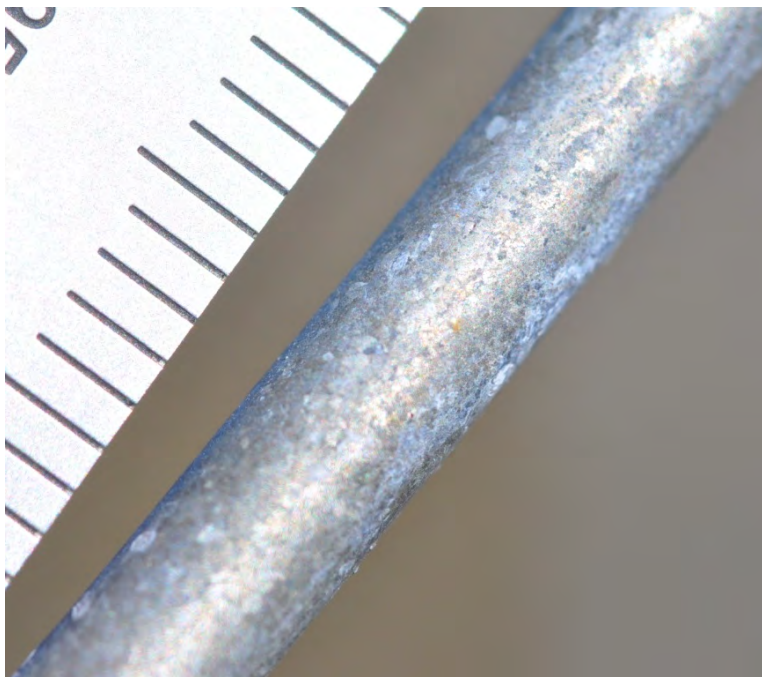
Figure A19. Galvanized after 12 months exposure.

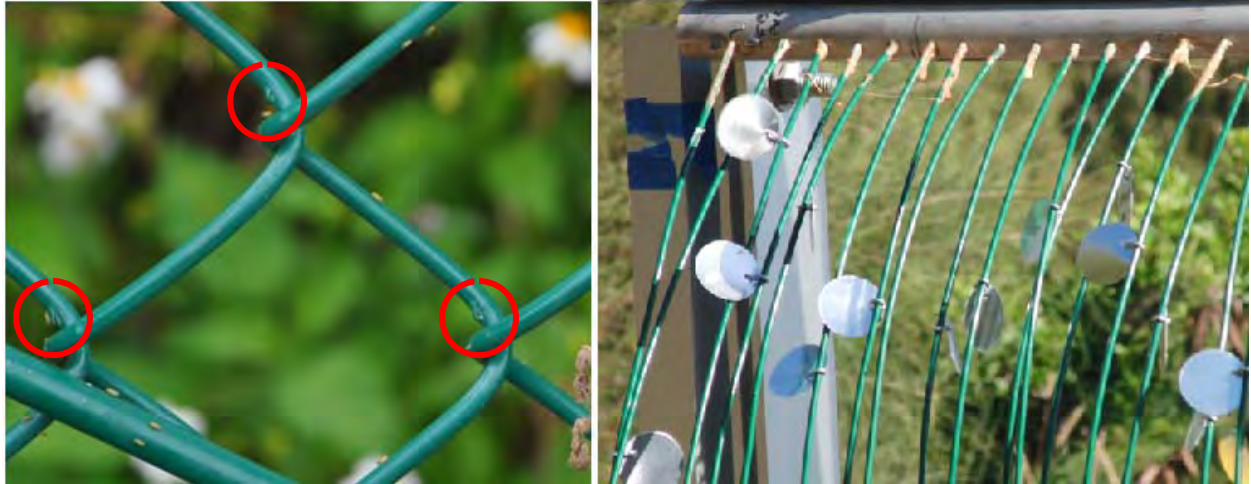
Figure B70. (Left) Stainless steel fence after 3 months exposure.
(Right)Stainless steel wire coupons after 3 months exposure.
