SIO Shipyard Representative Bi-Weekly Progress Report

SIO Shipyard Representative Bi-Weekly Progress Report		
Project: AGOR 28	Contract No.: N00014-12-C-0305	Shipyard: Dakota Creek Industries
Prepared by: Paul D. Bueren Scripps Institution of Oceanography (SIO) 297 Rosecrans St. San Diego, CA 98106	Date: 23 October 2015	Program Officer: Robert (Tim) Schnoor Office of Naval Research 875 Randolph St ONR 321 Arlington, VA 22203-1995
Distribution Statement A: Approved for public release; distribution unlimited.		Report No. A002.086

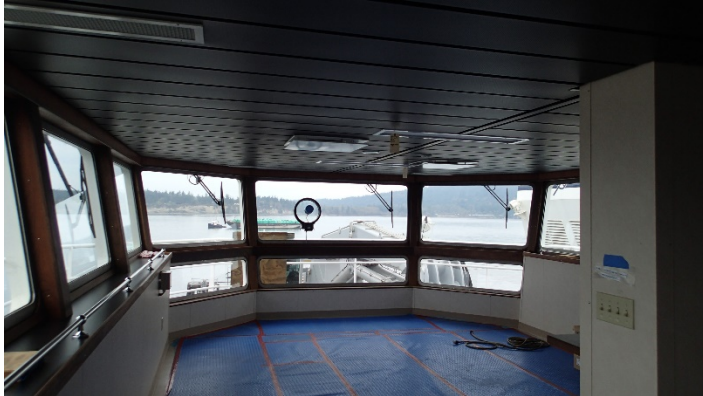
- Hi-PAP - DCI has chosen not to install the HiPAP prior to Phase III.
- Pilot House – The floors are complete. The space is close to 100% complete as far as fit and finish.

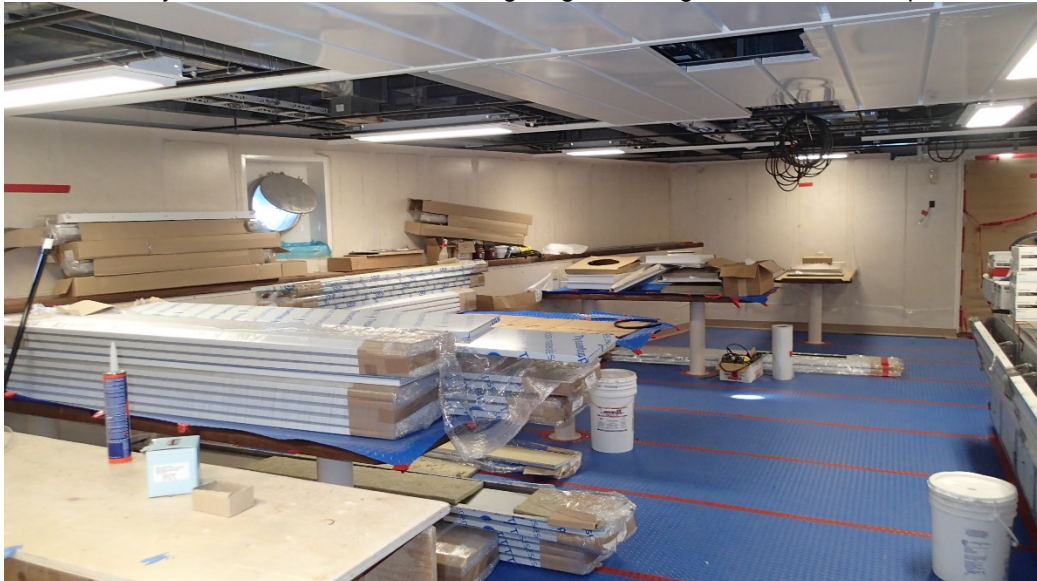
- Galley & Mess – Overheads and lighting are being installed in both spaces.

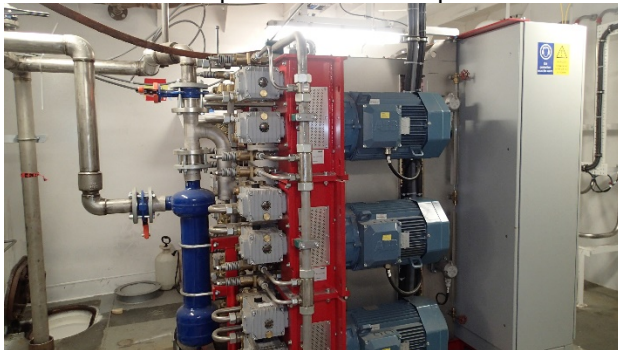
- Deck Machinery – Both the SSHD, CTDHD and Portable Crane were weight tested. The yard was unable to complete the weight tests for both the Stern Frame and Main Crane because both Allied HPU's would not produce the required hydraulic oil pressure needed. The pressure settings for both HPU's have since been corrected by Allied to their specifications. Both the Crane and Stern Frame will be retested.
- Hi-Fog System – The system was commissioned and successfully demonstrated to the USCG, with a couple of minor discrepancies that will be correct when new panel buttons arrive.

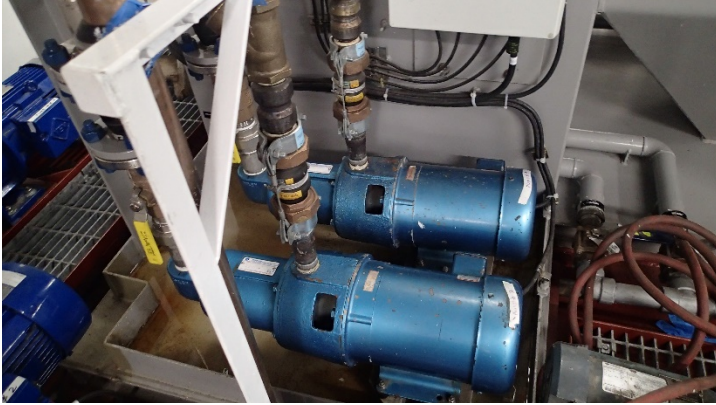
MSD Overboard Discharge Pumps

- Red Fox MSD – Tested and Commissioned by vendor. No operational issues, however both overboarding pumps had cracked housings. Vendor suspects factory defect and is replace with new.

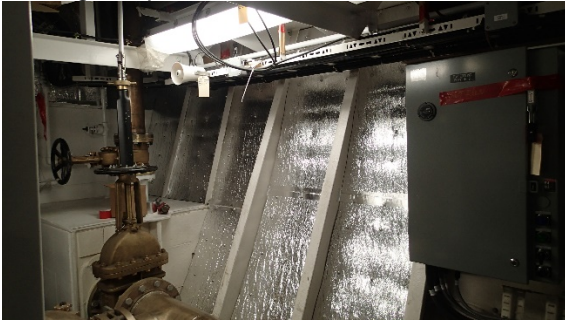
- Sally Ride Quad-Zero MLV – The yard is finishing up the last of the insulation and Quad-zero in the engine space.

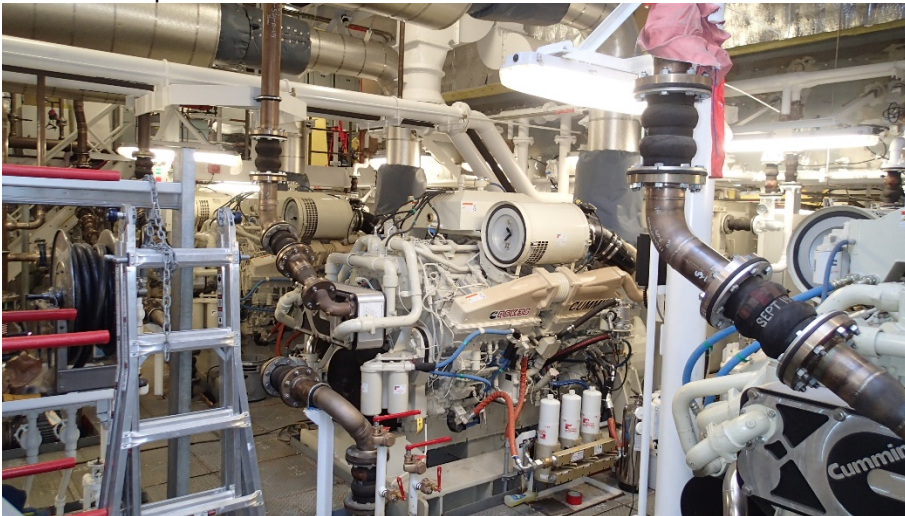
- Main Engine Room – The scaffolding has been removed and the yard is finishing up insulation and painting above the deck plates. Once this is completed, the bilge and deck plating will be cleaned and painted.

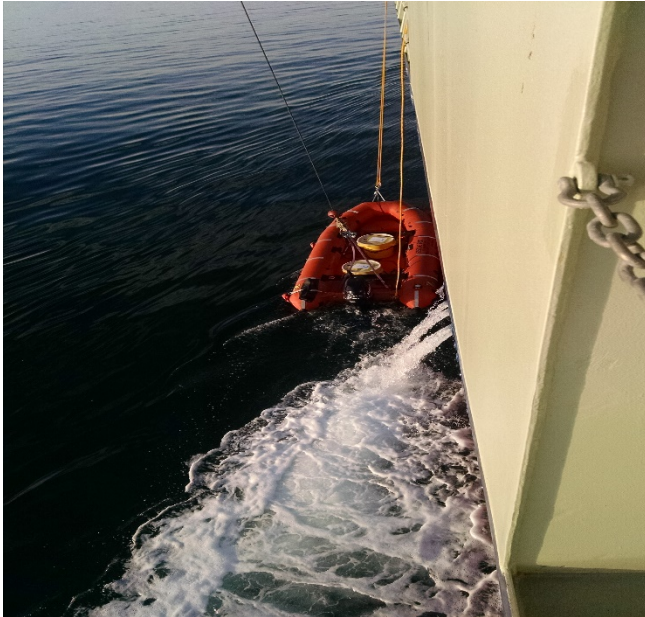
Neil Armstrong got underway to perform emergency drills for Coast Guard. SOLAS rules require rescue boat to be launched while underway. (new one on me) Armstrong's crew did very well on these drills, no

issues. Launched initially with a “simulated” load of two crew members. WHOI used oil spill kit plastic barrels of water for the weight.

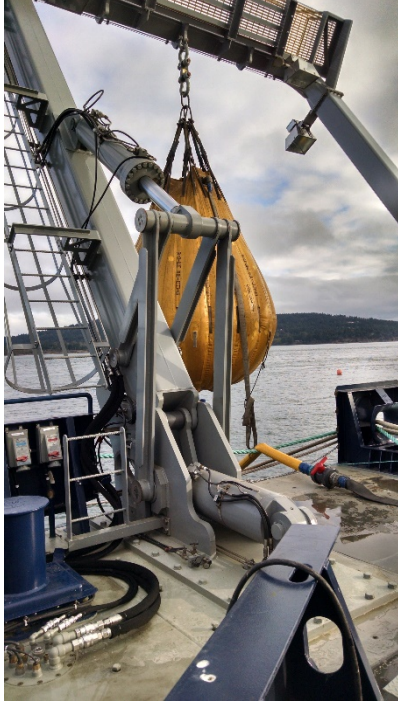
Attempts to weight test A frame unsuccessful. Neither HPU able to achieve necessary pressures to meet the requirements of the test plan. Allied Reps present for test but unable to correct problem. HPU vendor

assistance needed. Allied on it, yard on them. Main crane not tested pending correction of HPU issues.

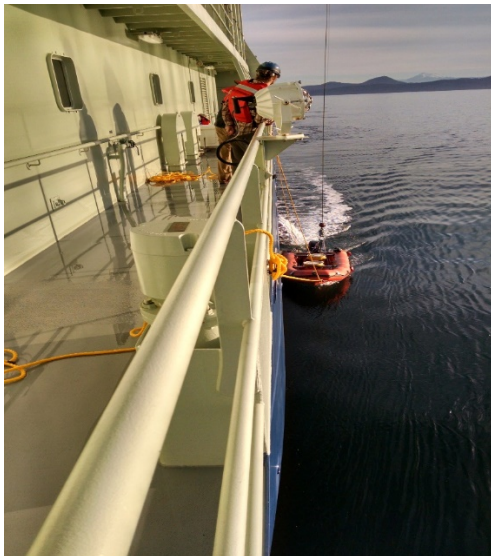
No connection point provided for Rescue Boat Sea Painter, no bitts or cleats provided mid-ships. Armstrong mounted small cleat to fuel tank vent for RB. Sufficient for this drill but not for long term.
