**AN
ENVIRONMENTAL REVIEW
OF THE
PROPOSED RETURN
OF
U.S. AIR FORCE LEASED PROPERTY,
ASCENSION AUXILIARY AIRFIELD
TO
THE BRITISH GOVERNMENT**

Tim deGavre
Computer Sciences Raytheon

March 26, 2004

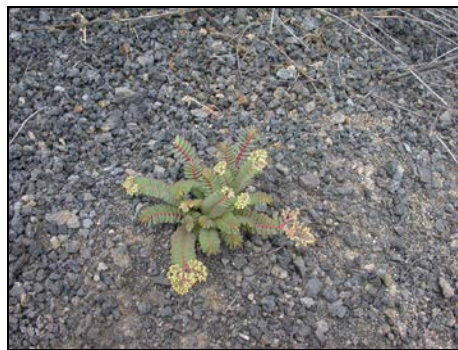
The only threatened and endangered fauna or flora in the area surveyed is the Ascension Spurge plant (*Euphorbia organoides*). Initially listed as Rare in the IUCN (translated: International Conservation Union) list of threatened plants published in 1998, it is now considered to be Critically Endangered with threats to its survival being brought on by introduced plant species, animals (donkies, sheep, and possibly rabbits), and Man.

One of the few remaining sites where the Spurge plant can be found is on Round Hill, the site of the VORTAC Station and the Airfield Control Tower. An inspection of this area revealed that there are several small plants growing, especially on the downwind side of the VORTAC.

5. Endangered Species. It is recommended that, in order to protect the endangered Ascension Spurge plant on Round Hill, invasive alien plants be removed and controlled. The alien plants include the Heliotropium and the Mexican thorn (*Prosopis juliflora*). These should be dug up, removed, and the area monitored to prevent their reoccurrence. In addition, so that PCS and TDY personnel may be made aware of their responsibility to protect the Spurge plant, a sign should be placed near one of the plants that identifies it as being endangered and to treat the plant accordingly.

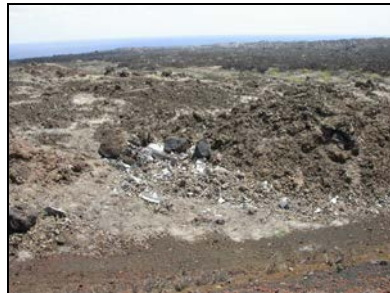
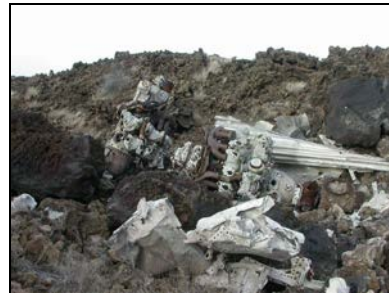
Approximately 200’ beyond the end of the runway at 7° 58.593’ S, 14° 22.869’ W, there are parts of a plane. Though several small pieces of aluminum framing and structure are scattered about, the larger remains consist of two aircraft engines, one with part of its propeller attached. The propellers are four-bladed. The aircraft type is not known, though it is suspected to be of World War II vintage.

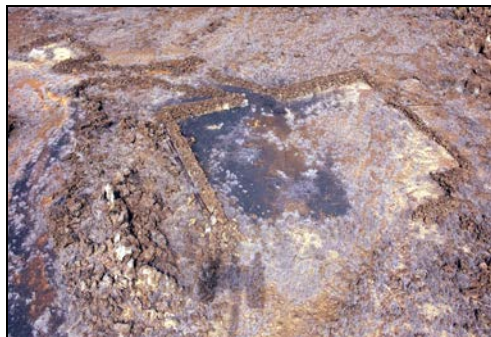
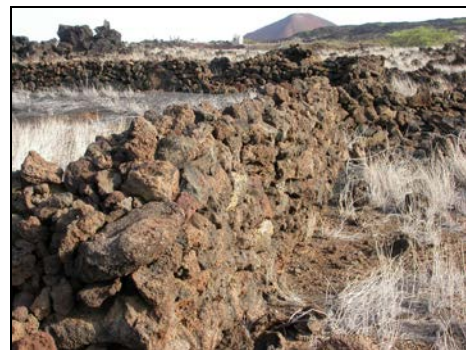
Not mentioned in the SouthArc, Inc, Report are the very old, dry stone walls located about 300 yards behind the Sandblast Facility, inside the fence line. Set among volcanic rocks, these intricately formed walls of lava stone define several large rooms/areas with walled walkways connecting them. It is suspected that this was David Gills original base camp when he came to measure the September opposition of Mars in 1877; this would classify the site as “Significant”.

4. Historical. It is recommended that it be noted that there are two historical structures classified as Significant (the airfield and the runway extension) and a possibly Significant one, the dry stone walls, and that the British Government be so informed. Attempts to determine the history of the dry stone walls should be made. If it turns out that the walled structure is of historic value, as expected, it should be included in the next revision to the Cultural Resources Management Plan; in the meantime, it should be preserved in accordance with paragraph A3.3.1.2.2, Historic Preservation Guide, in the Plan.

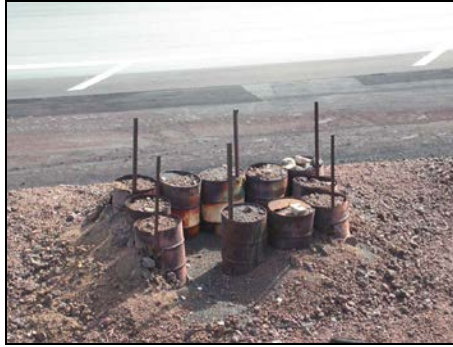
Two sentry posts are located on Round Hill, one on the north side overlooking the runway, and the other on the south. These were constructed and used during the Falklands War and though they do not now meet the qualifications for being listed as “Historical”, they should be preserved.

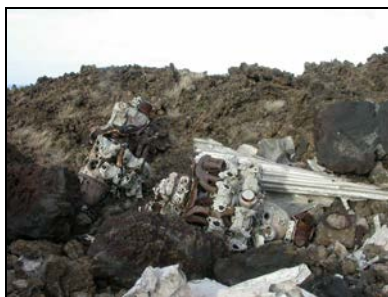
Strips of material, which definitely appear to contain asbestos, were noted on the cowlings of one of the two engines from the aircraft wreck, discussed in Section 3.2.5, Historical and Archeological above.

3. Hazardous Waste. Because runway inspectors or security and maintenance personnel would not normally be anywhere near the telephone poles or the aircraft wreck located among the volcanic rocks along the runway, and because of the lack of any fauna in this inhospitable area, it is highly unlikely that the hazardous substances (the creosote in the pole and the asbestos in the aircraft wreck) would cause harm to human or animal life; consequently, it is recommended that they remain in situ. However the aircraft wreck, being classified as an historical site which may prompt the curious to examine it, should

be appropriately marked as containing asbestos materials to warn the visitors of this hazard.

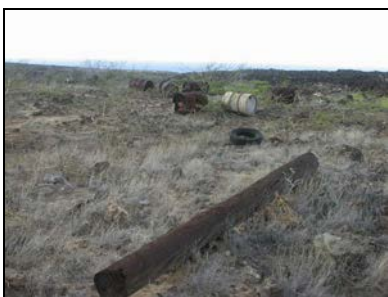
Three abandoned telephone poles, one on the north side of the runway in a gully at approximately the 8,500-foot point, along with several rusted drums, and two poles on the opposite side in a ravine at approximately the 9,500 foot point, have been impregnated with creosote.

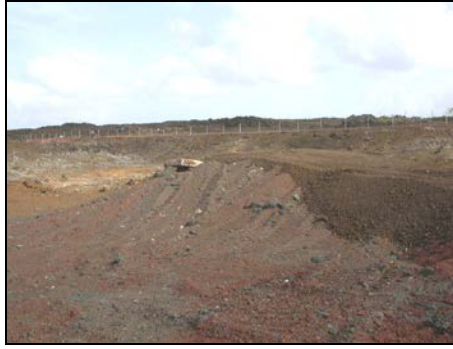
There are two 25,000 gallon and one 10,000 gallon asphalt-filled tanks buried at 7° 57.775' S, 14° 24. 206' W. These were buried in 1997 because the asphalt had hardened, making it unusable and the tanks too heavy to lift to transport.

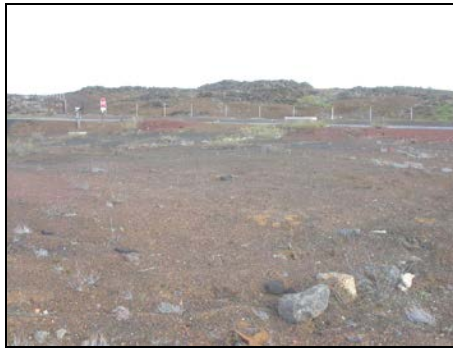
There are also two abandoned 10,000 gallon tanks from World War II buried at 7° 57.765' S, 14° 24. 276' W; they were partially filled with asphalt when they were buried.

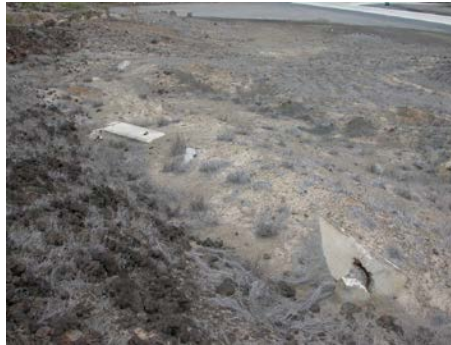
- a. At the base of the small hill near the 6,500 foot point on the north side of the runway are several very large concrete blocks, possibly bases for antennas.

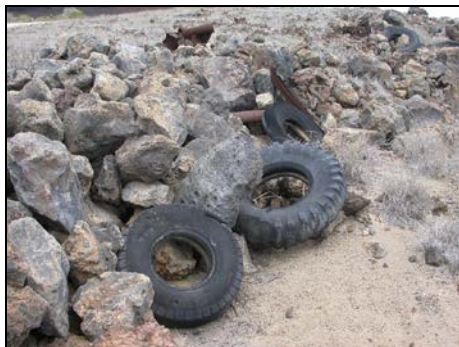
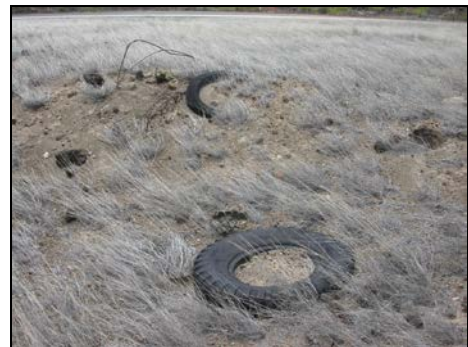
- b. In the center of the High Speed Turn-around, there is a dump that contains:
- several large tires
 - parts of motors and vehicles
 - crushed drums

1. Solid Waste. It is recommended that the debris (rusty drums, tires, machinery, etc.), among the volcanic rocks along the runway remain where it is and that the British Government be advised as to its location and condition. The USAF may consider, simply for aesthetic reasons, removing the tires from the center of the High Speed Turn-around.

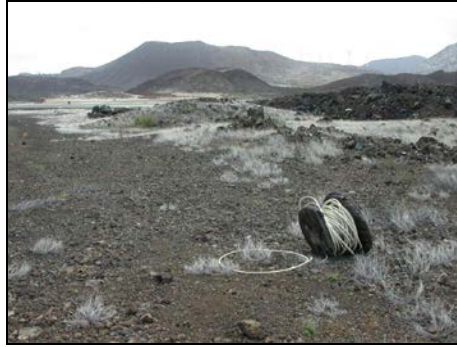
- c. Near the 7,800 foot point and at the base of South Gannet Hill, there is a medium-sized cable reel with several feet of electrical cable on it. Because the reel is in poor condition, it is suspected that it may have rolled down the hill during construction of the Telemetry Site.

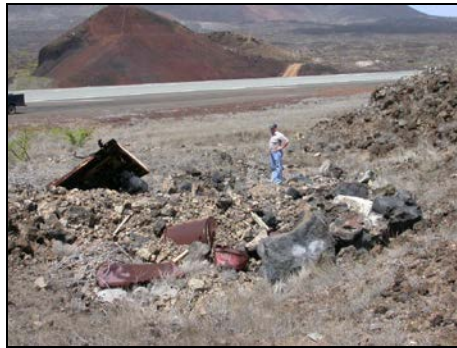
- d. At approximately the 8,000 foot marker on the south side of the runway, there is a large flat metal base and assorted machinery parts. They are well-rusted and have been there for some time.

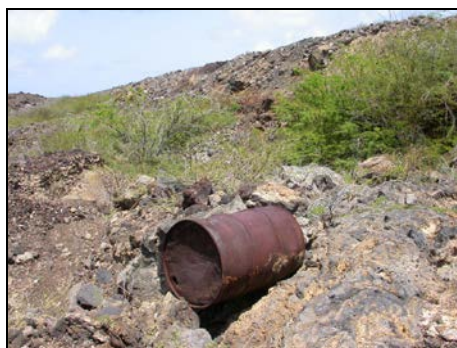
- e. Also near the 8,000 foot marker but on the north side of the runway and close to the fence, are a few very rusted drums (some crushed) and numerous parts of motors and machinery. They appear to have been at one time a part of a large dump located just outside the fenceline. This

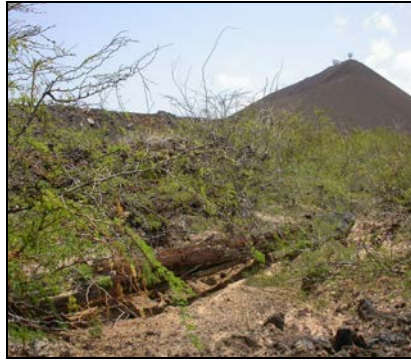
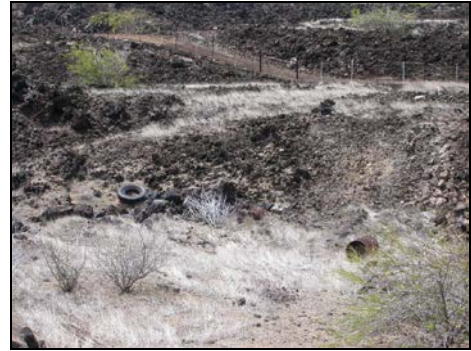
- f. In a ravine at the 8,500 foot point on the north side of the runway is a large creosoted telephone pole and half a dozen rusted, empty 55 gallon drums.

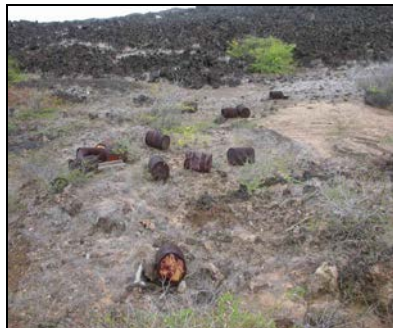
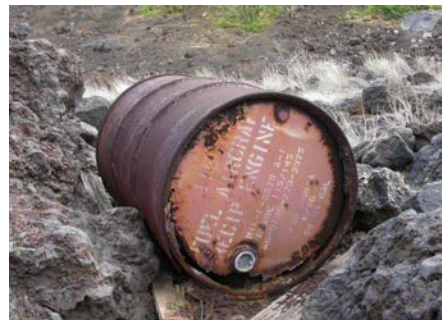
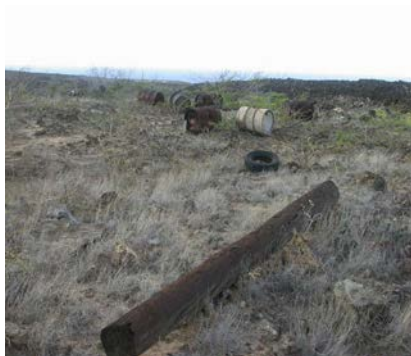
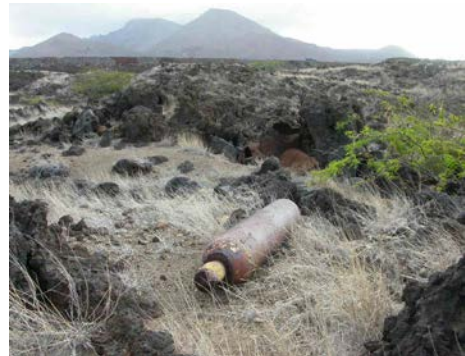
- g. At approximately the 9,500 foot point on the south side of the runway, there are two ravines, one downstream from the culvert and the other about 200 feet to the west of it, that contain:
- approximately 100 55-gallon drums
These drums are empty and very rusted. Some appear to have contained asphalt while others are so rusted it is impossible to ascertain what they may have held. Though it is suspected they may have been left over from the World War II construction of the runway, there was one drum that indicated it was filled in 1956 with aircraft fuel for a reciprocating engine.
 - a few tires
 - two gas cylinder tanks
 - some aluminum aircraft parts
 - telephone poles, noted in Section 3.3.2, page 23
- h. Approximately 200 feet beyond the end of the runway is an aircraft wreck, previously discussed in Section 3.2.5, page 21

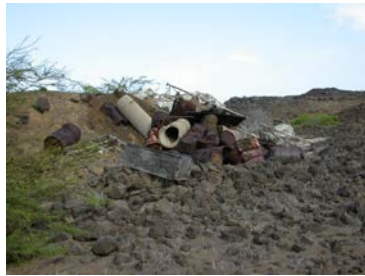
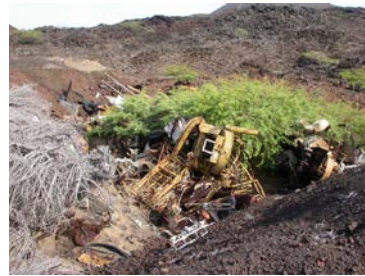
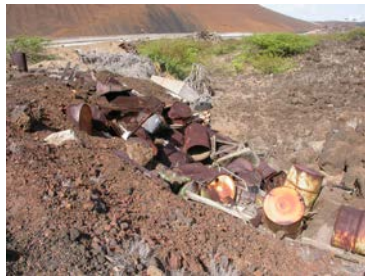
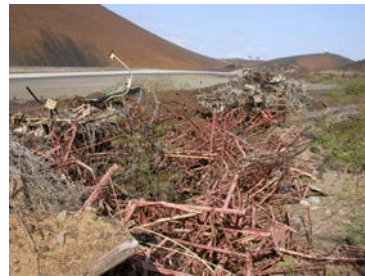
Outside the fence line near the end of the runway, there is an extensive dump containing an old rock-crusher, vehicles, equipment, antenna towers, etc. It is known as the South Africa Dump.
