ACCELERATED MISSION TEST EVALUATION OF TF33 ENGINE COMPONENTS COATED WITH HIGH VELOCITY OXY-FUEL (HVOF) THERMAL SPRAY COATINGS IN LIEU OF HARD CHROME

**Gary C. Shubert / Melvin Freling
Program Managers
Pratt & Whitney**

HCAT Program Review Meeting - April 2003
San Diego, CA

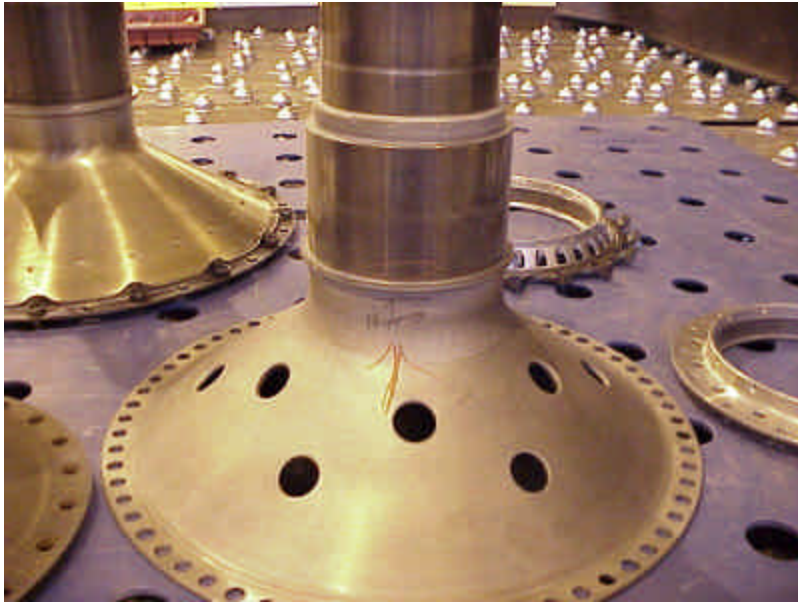
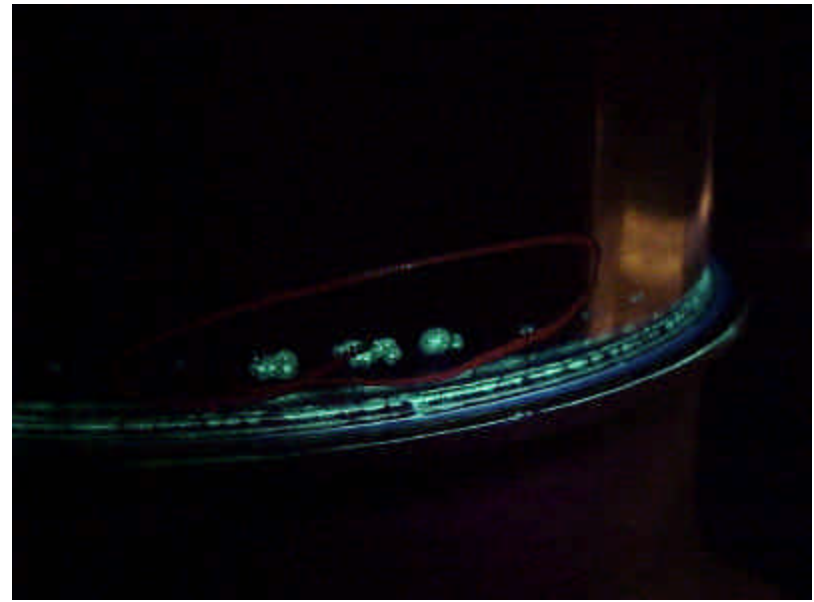
- FPI Inspection (Normal & High Sensitivity)
 - Various indications identified
- Dimensional Inspection
 - Coated areas changed in dimension by a maximum of ± 0.0002 "
 - All coated components met the dimensional requirements for continued engine service
- Metallographic Evaluation
 - Verified acceptable coating structures
 - Confirmed FPI indications
 - Indications due to coating finish grind

No. 2 Bearing Journal FPI Indications Attributed to Coating Grind

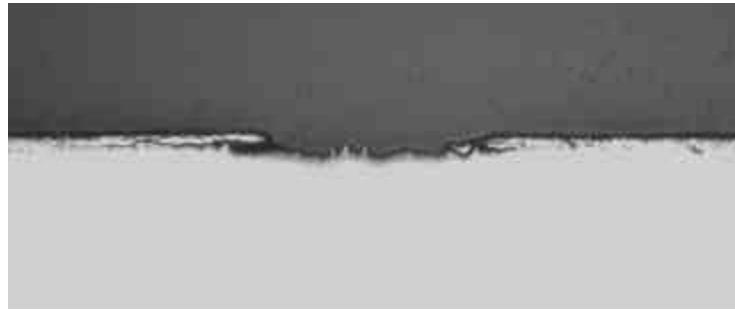
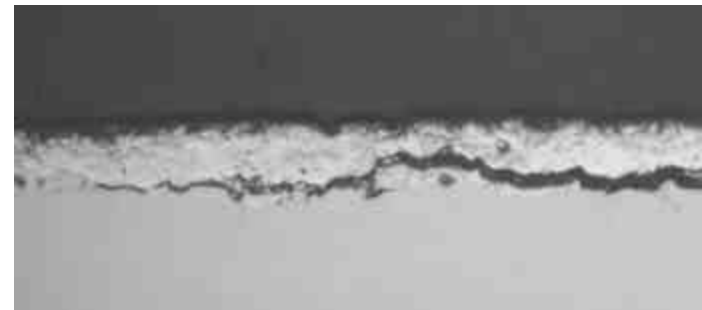
Indications Attributed to Variations In As Ground Coating Thickness

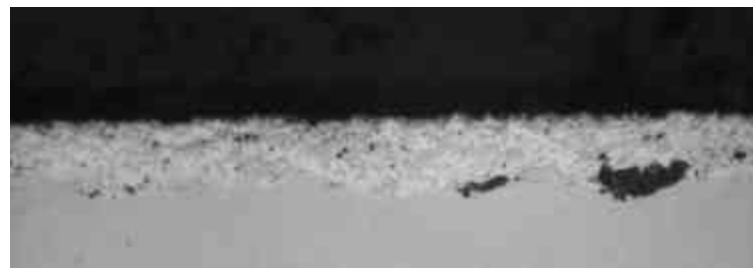
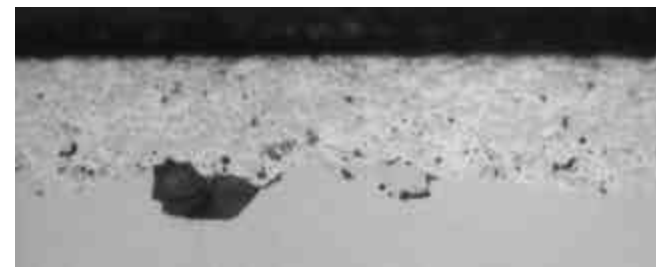
Front Compressor Rear Hub Showing Loss of Coating at FPI Indication (left) and Disbonded Coating Adjacent to Indication (right)

Front Compressor Rear Hub Showing Coating ~0.8 mils in Chatter Region (left) and ~1.8 Mils in Non Chatter Region (right)

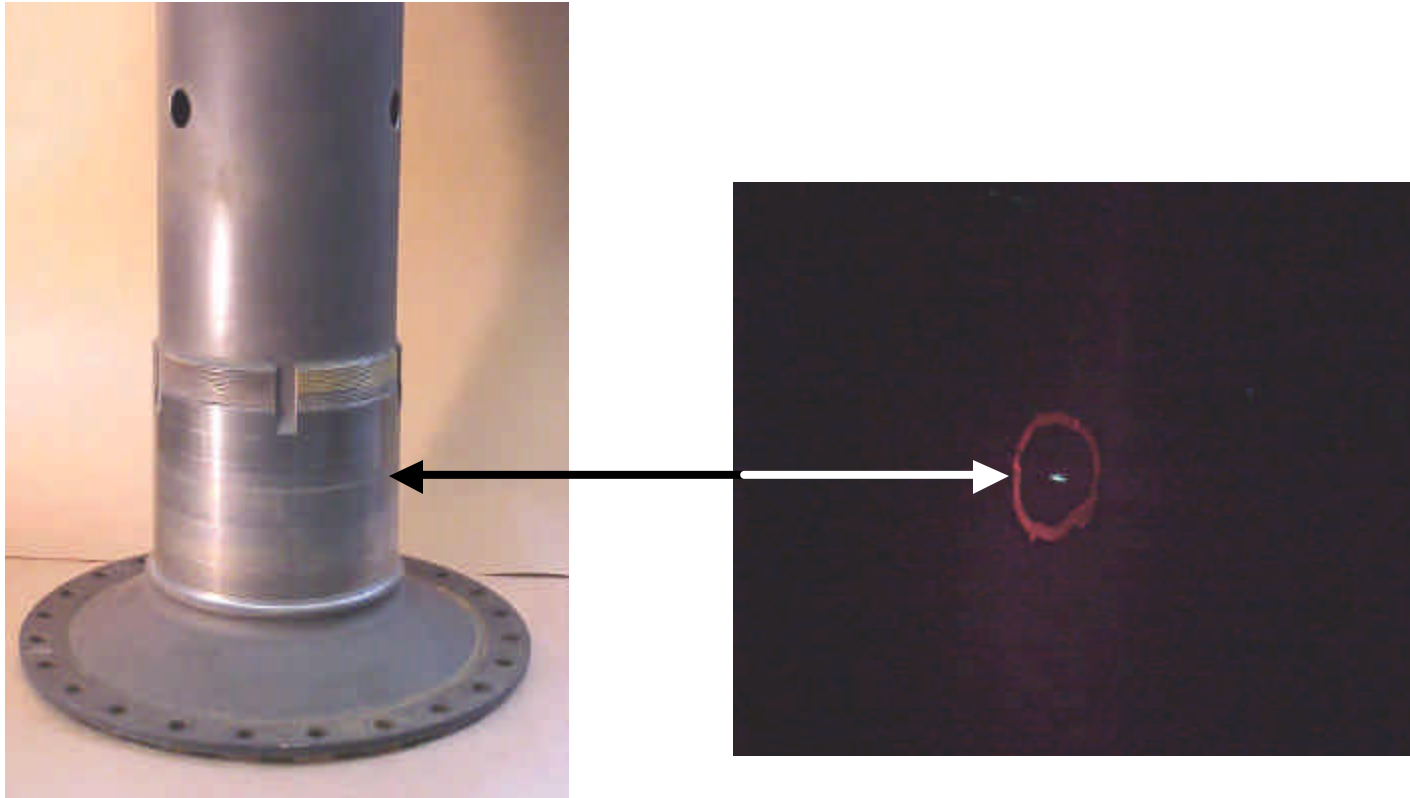
FPI Coating Indication on the No.5 Bearing Journal

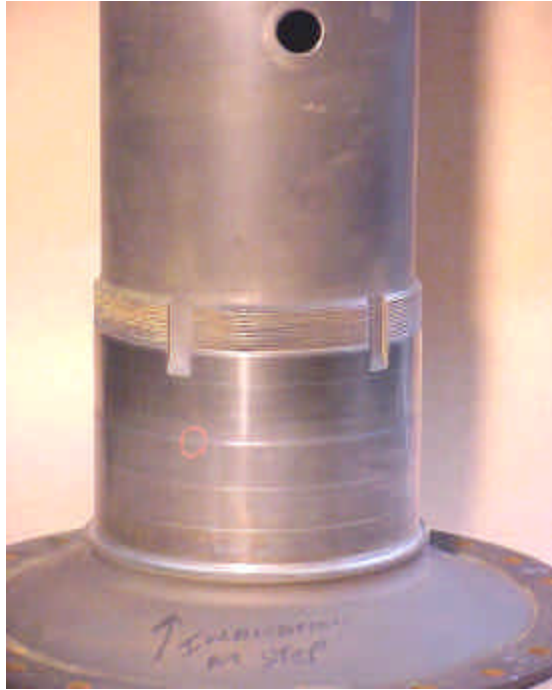
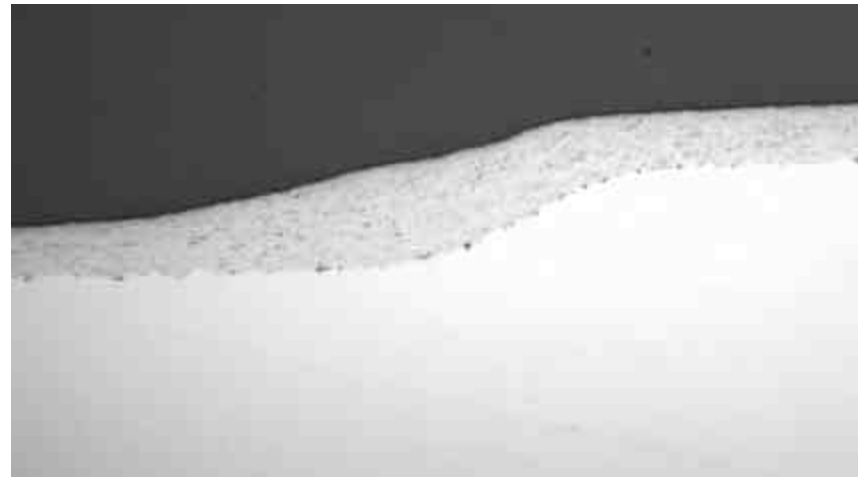
Metallographic Cross-Section of No.5 Bearing Journal FPI Indication

No Defect Found
