Report No. 313/26
Watertown Arsenal
(Problem B-28)

October 28, 1942

GUN FORGINGS

Metallurgical examination of section
from 37 mm. gun forged by Struthers
~~Wells-Ebeneville Corporation~~, and
machined by National ^B ~~Enamatic Company~~.

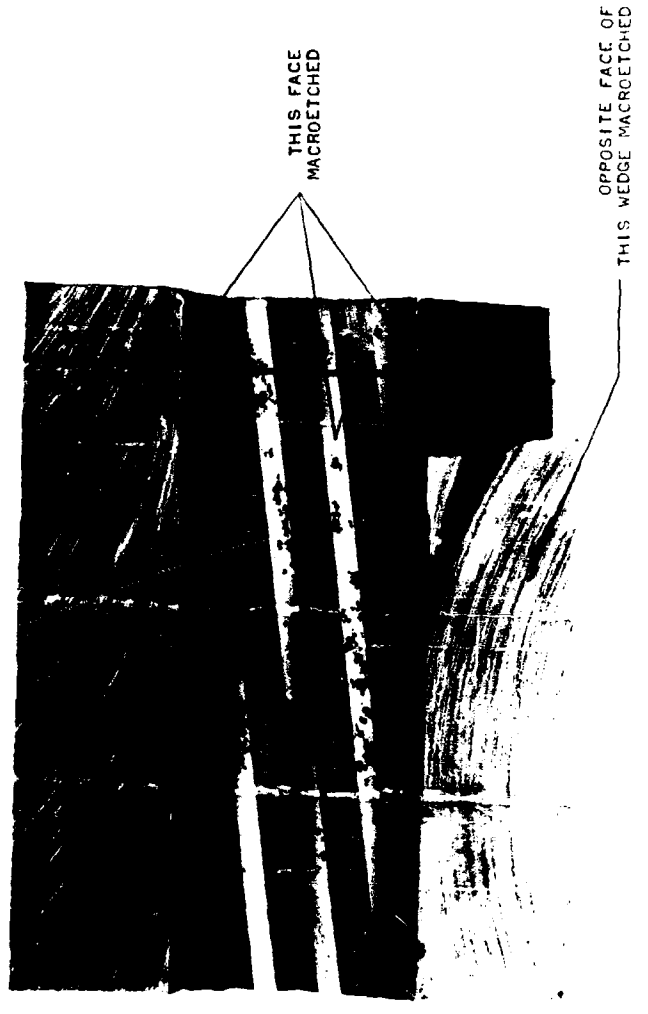
Fig. 1

The defects in question were pitted areas which were scattered on the lands (Figures 1, 2, and 3). By examination of the pits with a binocular microscope, they were seen to contain a greasy, black substance which could be removed with a sharp pointed needle. The greatest depth of pitting was estimated to be about .01 inches. Figure 3 shows pits in a group whose appearance is typical of a corrosion pattern.

Sulphur prints of the transverse and longitudinal specimens, cut as indicated in Figure 1, were made before macroetching. Neither the macroetched specimens nor the sulphur prints gave any indication of defects or irregularities which would tend to cause the pits observed on the land surfaces. (Photomacrographs are reproduced as Figure 4. Sulphur prints are on file at the Watertown Arsenal Laboratory).

FIG. 1
"A" SECTION OF 37MM GUN TUBE FORGING
FORGED BY S... AND MACHINED BY...
"B"

SHOWING
DEFECTS ON LANDS AND LOCATION OF MACROETCH SPECIMENS
MAGNIFICATION X1

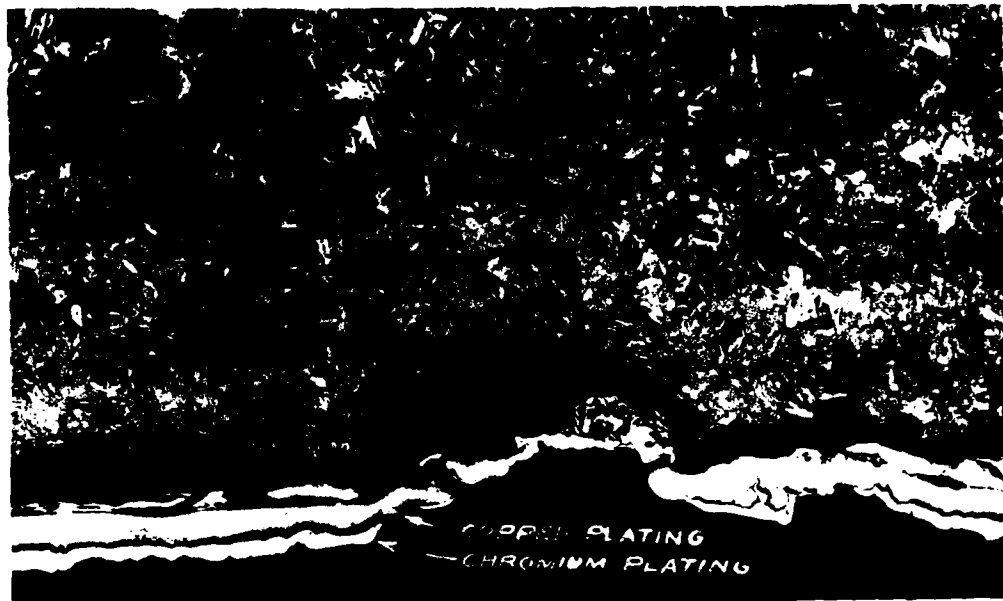
A nital etch did not reveal decarburization near the pits or any nonuniformities other than a slight degree of banding and

micro segregation (Figure 6). Structural distortion which would result from poor machining technique, was not observed.

FIG.
PHOTO-MICROGRAPHS OF 30MM GUN FORGING
SHOWING
TYPICAL PITS ON LAMDS AND MICRO SEGREGATION.
NITAL ETCH X100
