Watertown Arsenal Labs. MA

Rept. No. 312/63

January 3, 1936

Pitted Pawls, Fuse Setter M5

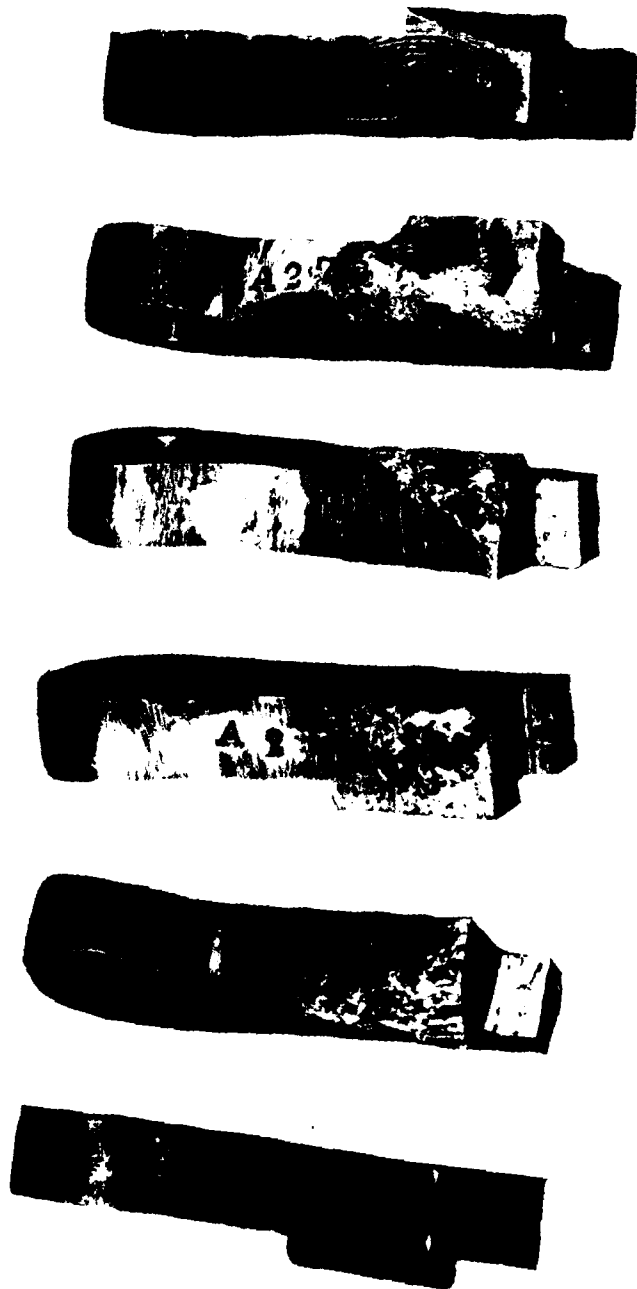
1. The pitting and markings of the unserviceable pawls indicated corrosion, probably the result of improper cleaning after use or insufficient protection while not in use.
2. The steel was of good quality, commercially well forged and heat treated.
3. The hardness probably varied somewhat from piece to piece as the micro structure of the various pawls showed variations in the amounts of martensite and troostite. However, the structure of each pawl was the same throughout.

Figure 1, is a photograph showing the pitted condition of the unserviceable pawls, together with new ones.

Figure 1
Photograph showing pitted
condition of the unservice-
able pawls, together with
new ones.
