**WATERTOWN ARSENAL
LABORATORY**

NO. WAL 316/39

2 3/8" ROUND "RESISTAL" KA2 18-8 STAINLESS STEEL BARS.

P.O. 2975 CRUCIBLE STEEL CO.

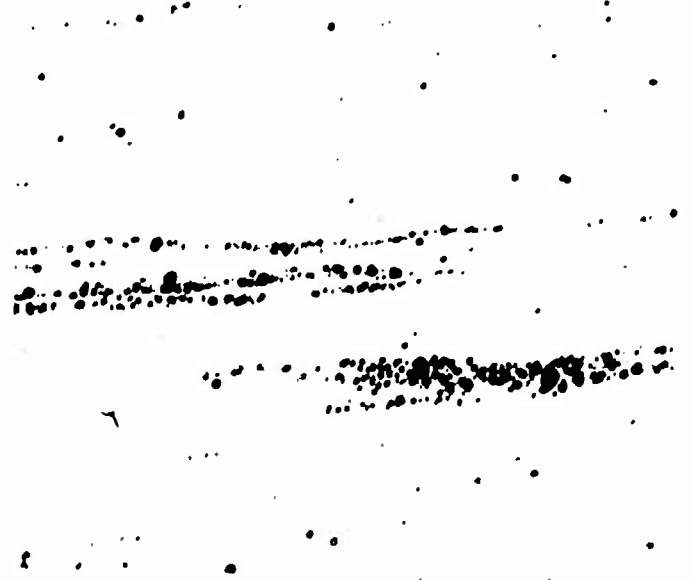
Fig. 2.

Fig. 2 shows at X100 a bad chain like segregation near the surface in the longitudinal section of No.1 bar. C68-3

X100 Unetched No. 1 Bar, Long Section. Showing a bad chain segregation of inclusions which are mostly Zirconium Nitride.

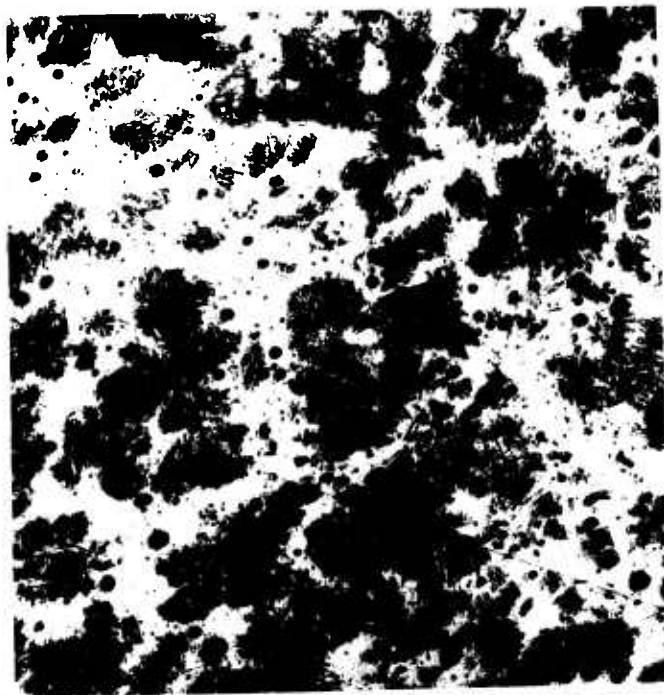
Fig. 5.

Fig. 5 shows at X100 the segregated condition of the steel of No.1 bar. C68-8

X100 FeCl_3 etched No. 1 Bar, Transverse Section. Showing segregated condition. Note small round black dots are pits resulting from attack on inclusions of several etchings and light polishing necessary to overcome the amorphous flow of the metal during polishing.

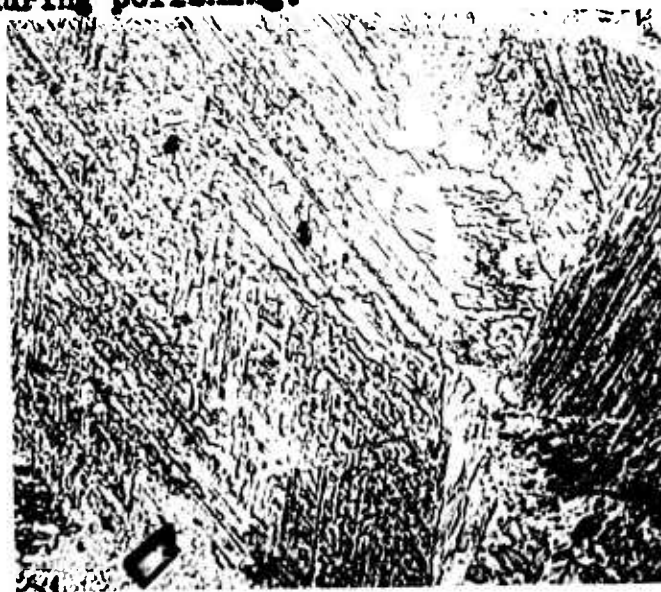
Fig. 6.

5. Whether the carbide precipitation was normally brought about by cold working and soaking at 300°C or whether the steel was unusually sensitive to cold work and 300°C strain relieving is unknown.

Fig. 6 shows at X1000 the slip planes in No. 1 Bar. Precipitate carbides make the sides of these planes "saw-toothed". C68-9

X1000 FeCl_3 etching No. 1 Bar, Transverse Section. Showing slip planes in which are precipitated carbides.

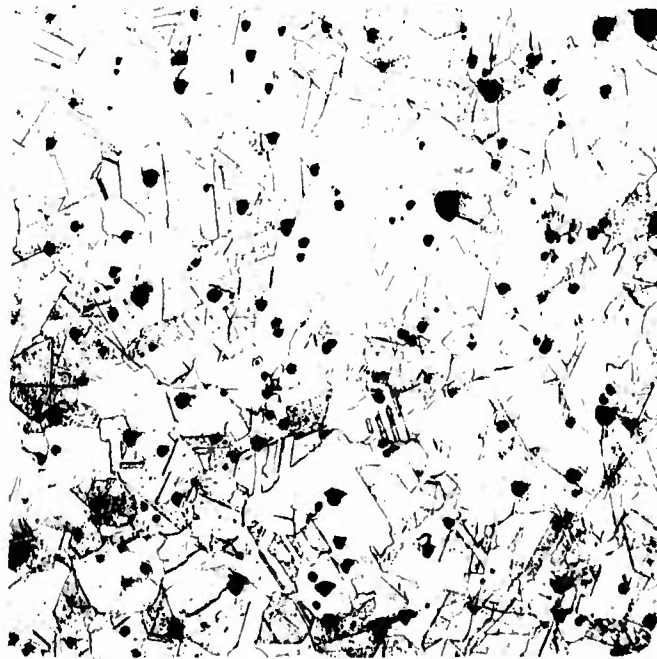
Fig. 8.

2. The structure had medium sized grains/^{of} twinned austenite.

Fig. 8 shows at X100 the medium sized grains of twinned austenite of No. 2 bar. C68-12

X100 FeCl₃ etched No. 2 Bar, Transverse Section. Medium sized twinned austenite containing a few slip planes. Note small round black dots are pits resulting from attack on inclusions of several etchings and light polishing necessary to overcome the amorphous flow of the metal during polishing. C68-12

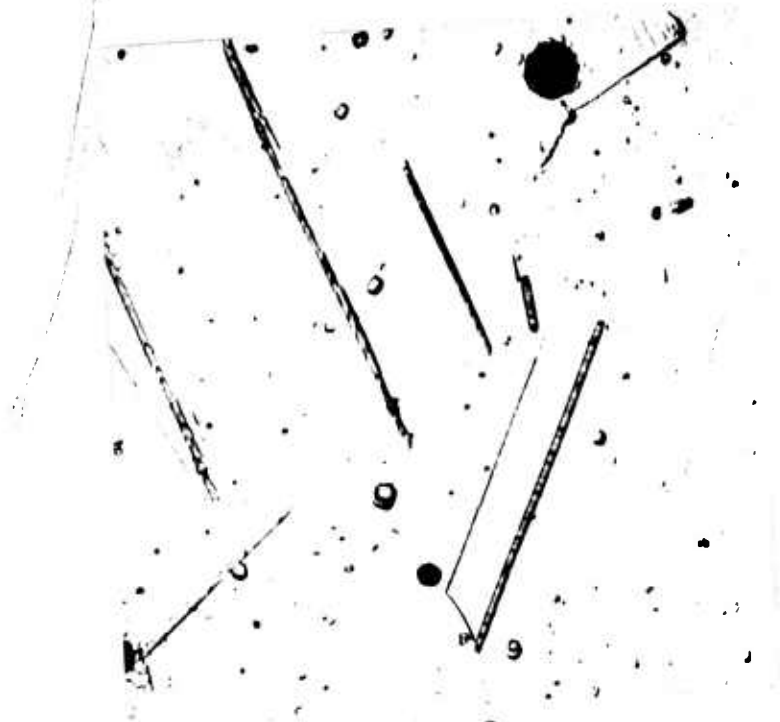
Fig. 9.

4. The slip planes were generally straight sided showing that carbide precipitation had not been great.

Fig. 9 shows at X1000 slip planes in No. 2 bar. The sides of these planes are straight showing that the precipitation of carbides has not been great. C68-13

X1000 FeCl₃ etched No. 2 Bar, Transverse Section showing slip planes in twinned austenite. Only a small amount of precipitated carbides are seen. CCB-13
