File No. 316/14
Watertown Arsenal

December 14, 1932

2 3/8" Round "Resistal" KA2 18-8 Stainless Steel Bars.

P.O.2975 Crucible Steel Co.

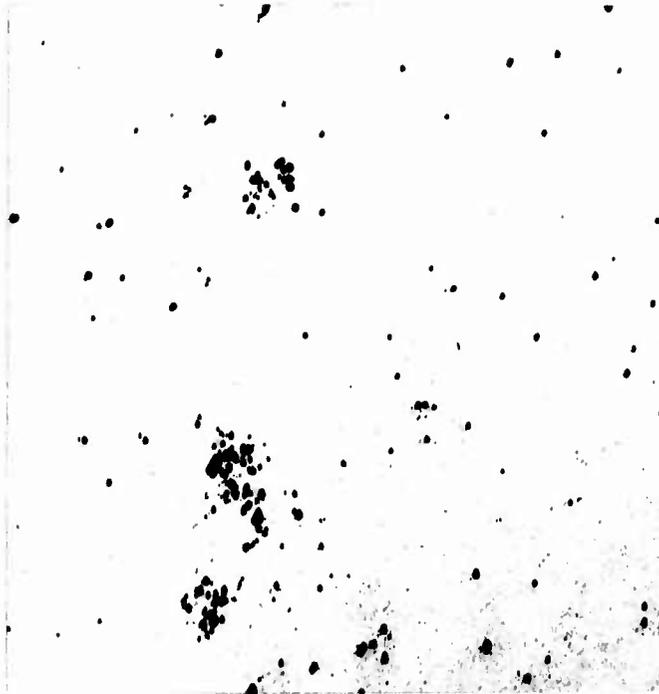
Fig. 1.

1. This bar apparently contained very many minute yellow cubic crystals of Zirconium Nitride which were generally distributed and also segregated in short very closely packed chains.
2. It was segregated throughout and banded for about 1/2" from the outside forming concentric rings.
3. Due to the 16% cold work very many slip planes appeared principally in what probably were at one time the dendrites.
4. These slip planes were not smooth edged but "saw-toothed". This irregularity of the edges was caused by the precipitation of carbides.

Fig. 1 shows at X100 a typical segregation of inclusions in the transverse section of No. 1 bar. C68-2

X100 Unetched No. 1 Bar, Transverse Section. Showing typical segregated areas of inclusions which are mostly Zirconium Nitride. C68-2

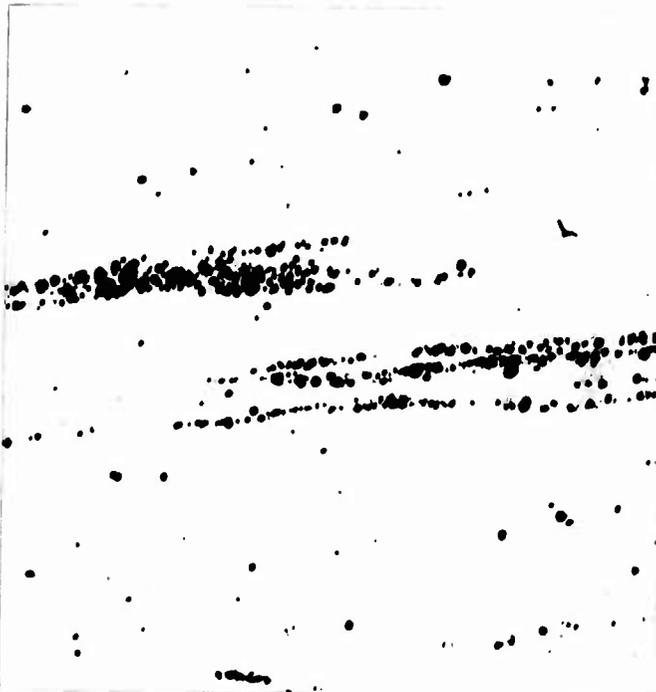
Fig. 2.

6. The surface cracking appearing during cold work and after subsequent machining was undoubtedly due to the chains of cubic crystals of Zirconium Nitride and to the segregated and banded condition of the steel.

Fig. 2 shows at X100 a bad chain like segregation near the surface in the longitudinal section of No.1 bar. C68-3

X100 Unetched No. 1 Bar, Long Section. Showing a bad chain segregation of inclusions which are mostly Zirconium Nitride. C68-3

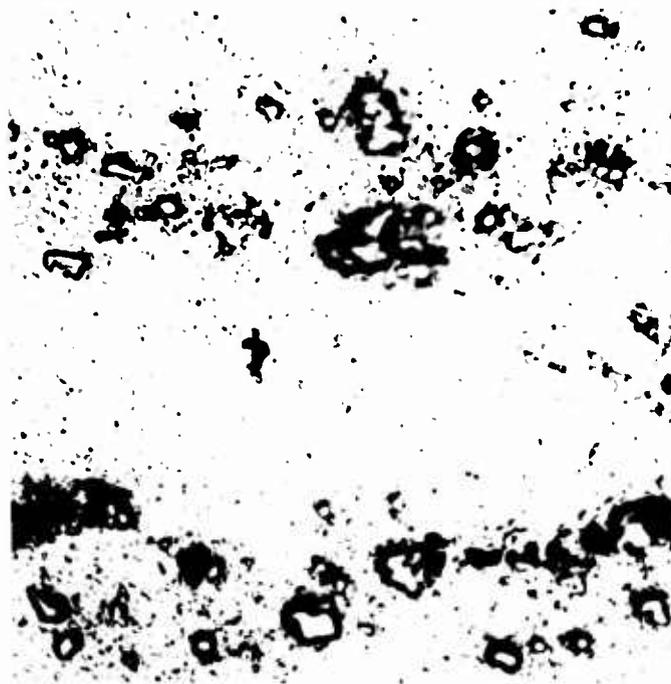
Fig. 3.

Figs. 3 and 4 show at X1000 the cubic crystals before and after 10 minute boiling in 50% Potassium Hydroxide. The cubic crystals are Zirconium Nitride, the gray inclusions are unidentified sulphides in No. 1 bar. C68-6-7

X1000 Unetched No. 1 Bar, Long Section. Part of Fig.2.
Cubic crystals yellow in color are Zirconium Nitrides, gray
inclusions are sulphides (unidentified). C68-6

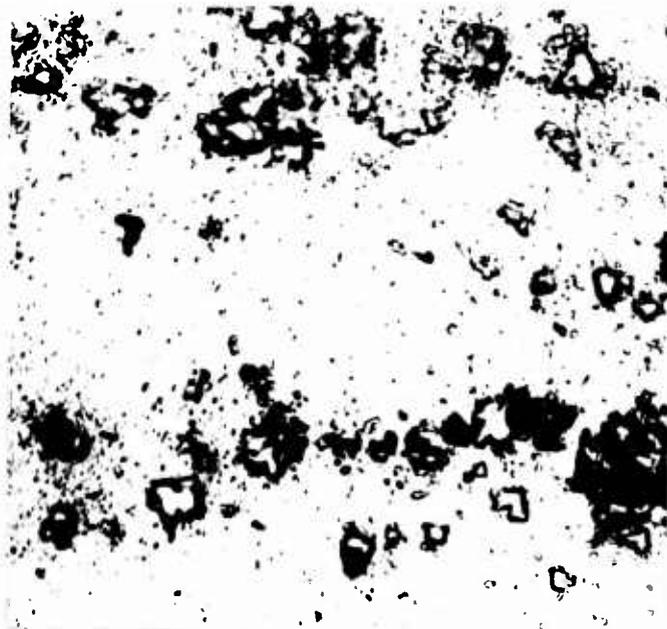
Fig. 4.

X1000 10 Minute boiling 50% KOH etching No. 1 bar, Long Section.
Same area as Fig. 3. Cubic crystals are not attacked. Proving
them to be Zirconium Nitride. C68-7

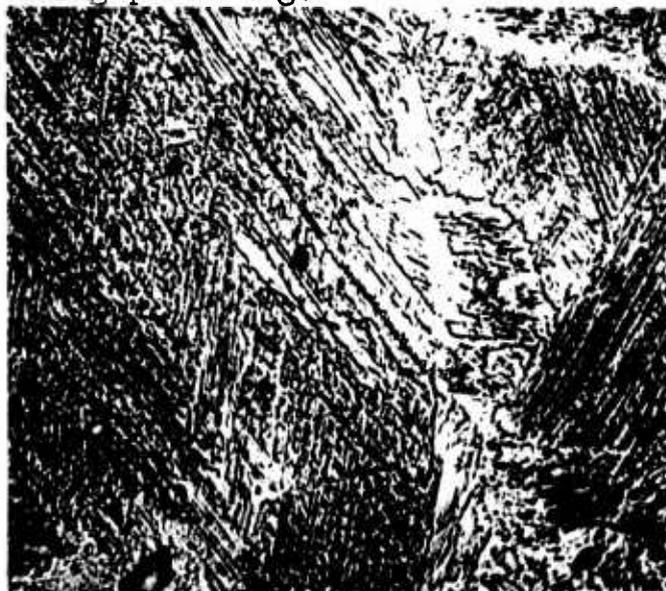
Fig. 6.

5. Whether the carbide precipitation was normally brought about by cold working and soaking at 300°C or whether the steel was unusually sensitive to cold work and 300°C strain relieving is unknown.

Fig. 6 shows at X1000 the slip planes in No. 1 Bar. Precipitate carbides make the sides of these planes "saw-toothed". C68-9

X1000 FeCl_3 etching No. 1 Bar, Transverse Section. Showing slip planes³ in which are precipitated carbides. C68-9

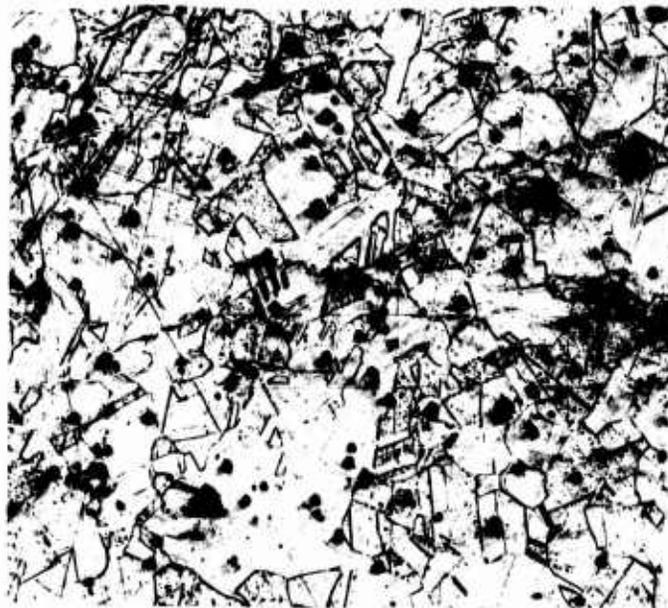
Fig. 8.

2. The structure had medium sized grains ^{of} twinned austenite.

Fig. 8 shows at X100 the medium sized grains of twinned austenite of No. 2 bar. C68-12

X100 FeCl₃ etched No. 2 Bar, Transverse Section. Medium sized twinned austenite containing a few slip planes. Note small round black dots are pits resulting from attack on inclusions of several etchings and light polishing necessary to overcome the amorphous flow of the metal during polishing. C68-12

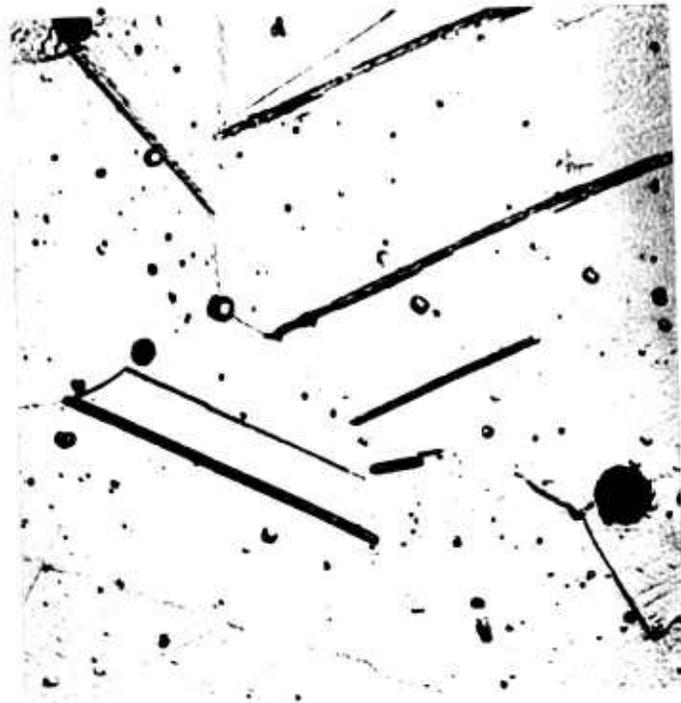
Fig. 9.

4. The slip planes were generally straight sided showing that carbide precipitation had not been great.

Fig. 9 shows at X1000 slip planes in No. 2 bar. The sides of these planes are straight showing that the precipitation of carbides has not been great. C68-13

X1000 FeCl_3 etched No. 2 Bar, Transverse Section showing slip planes in twinned austenite. Only a small amount of precipitated carbides are seen. C68-13
