SHOCK TESTING OF FT4A GAS TURBINE ENGINE
GAS GENERATOR ON THE FLOATING SHOCK
PLATFORM - PHASE I

STRUCTURAL MECHANICS LABORATORY
UNDERWATER EXPLOSIONS RESEARCH DIVISION
PORTSMOUTH, VIRGINIA

August 1963

Report 1783

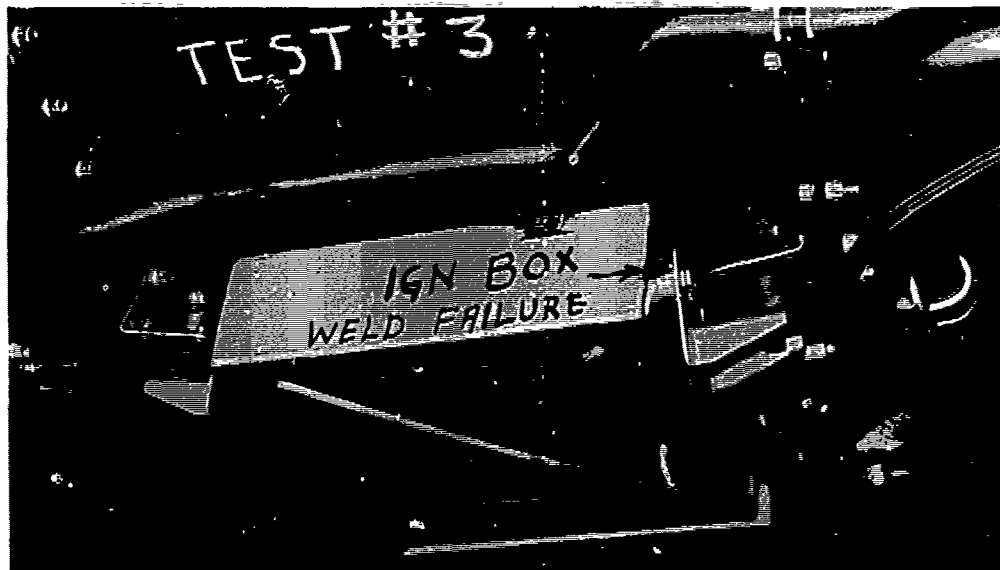
The engine was shut down immediately after the test; no rubbing or associated damage was detected during the rundown. The rotors were turned by hand prior to restarting and again no rubbing was evident. The engine was started and brought up to speed; no defects were observed. The breather lines were pressurized; no drop in pressure was noted (Table 4). Partial failures occurred in all weldments attaching the supporting studs of the ignition box (Figure 7).

Figure 7 - Ignition Box Weld Failure

The engine was started and brought up to speed; no rubbing or other damage was detected. The breather lines were pressurized and no leaks were found (Table 4). The igniter box stud-weld failures experienced on Test 3 increased. On the port side, the ignition lead fitting failed at its connection to the composite box. The top oil tank strap failed and the bottom strap was stretched.

The rear mount suspension bar port side was interchanged with the starboard bar and all bolts were replaced with bolts of same size and strength. An elastic shock cord was placed around the ignition boxes to retain them in position in the event the stud weld should fail completely.

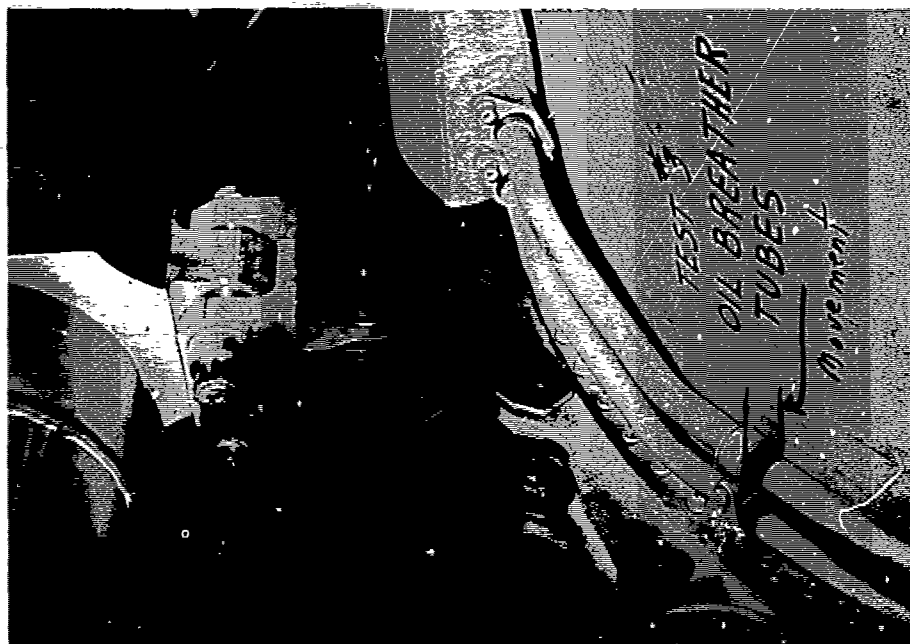
The oil tank breather tubes moved at tube clips on starboard side (Figure 8). The anti-icing line also showed evidence of some axial movement at inlet case fitting.

Figure 8 - Movement of Oil Breather Tubes

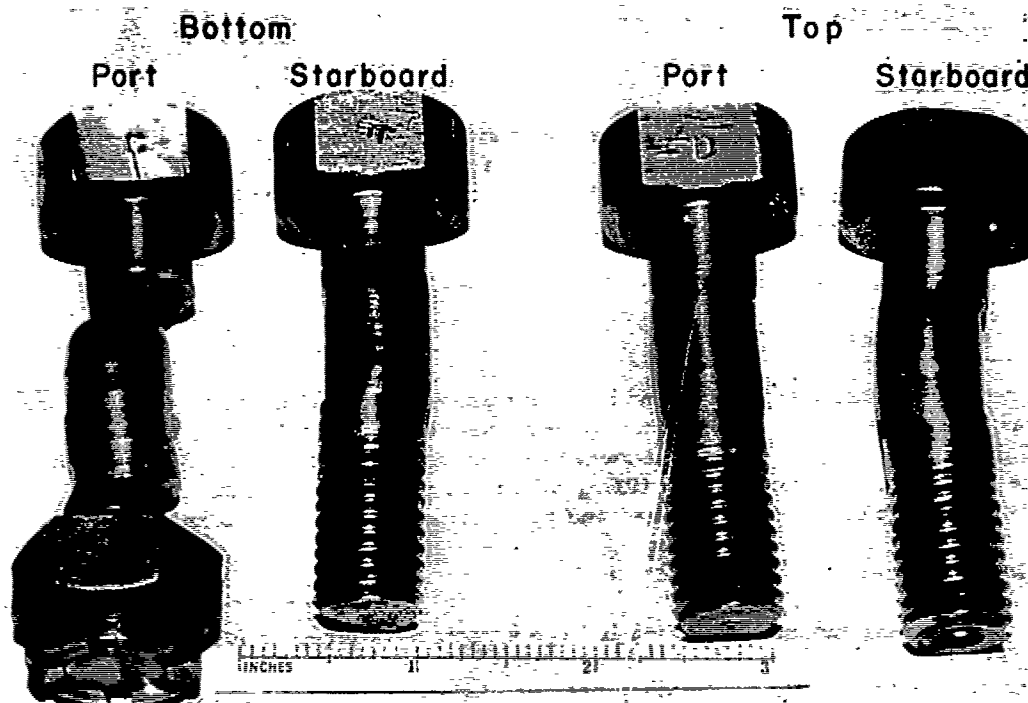
The bottom bolt on the port side suspension bar was sheared and the remaining bolts showed severe shear indentations. The sheared bolt failure is shown in Figures 10 and 11. The other damaged bolts are also shown in Figure 11.

Figure 11 - Damaged Suspension Bar Bolts

The oil tank straps were removed and new straps (same strength) were installed. The suspension bars on rear mount were cold straightened. The lower bolt hole section on the port side was replaced. All bolts for the suspension and athwartship bars were replaced with bolts of equal strength. The athwartship bar was replaced with a bar of equal strength. The port and starboard mount ring couplings were replaced with ones of equal strength. The engine was operating for this attack on the air starter.

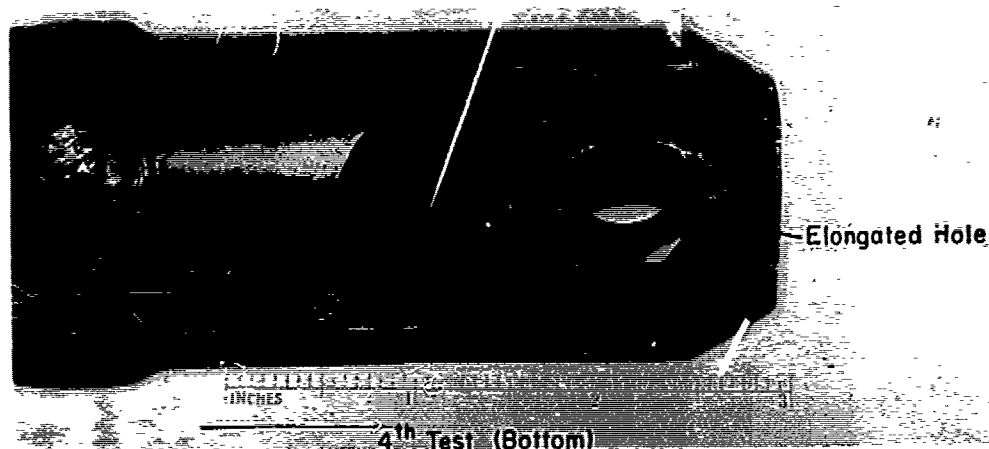
The suspension rod bottom bolt hole was elongated (Figure 12).

Figure 12 - Elongated Hole in Suspension Bar

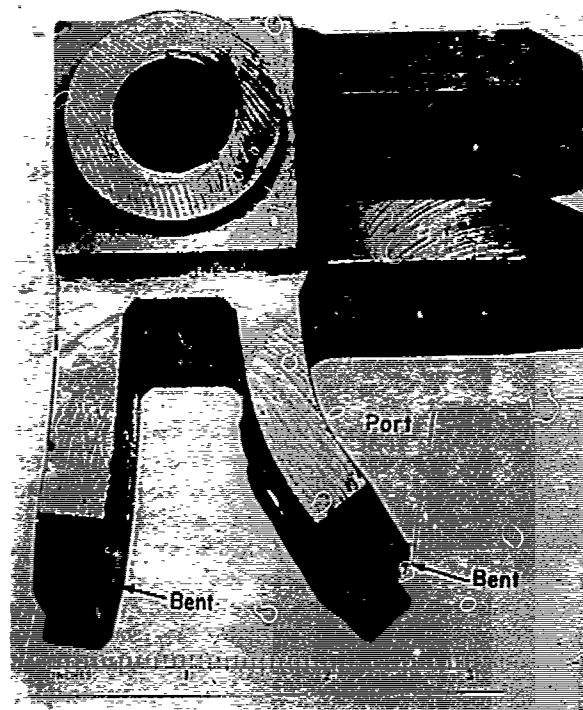
The 90° mount ring coupling port side sustained bending (Figure 13) and an elongation of the bolt hole (Figure 14). (Note indentation of bolt threads inside hole.) The forward mount sustained no visible damage; the linkage bolts were inspected but no shear or bending of the bolts was evident. The flange and holddown mount bolts were checked for torque; no change was noted.

Figure 13 - Damaged 90° Mount Ring Coupling

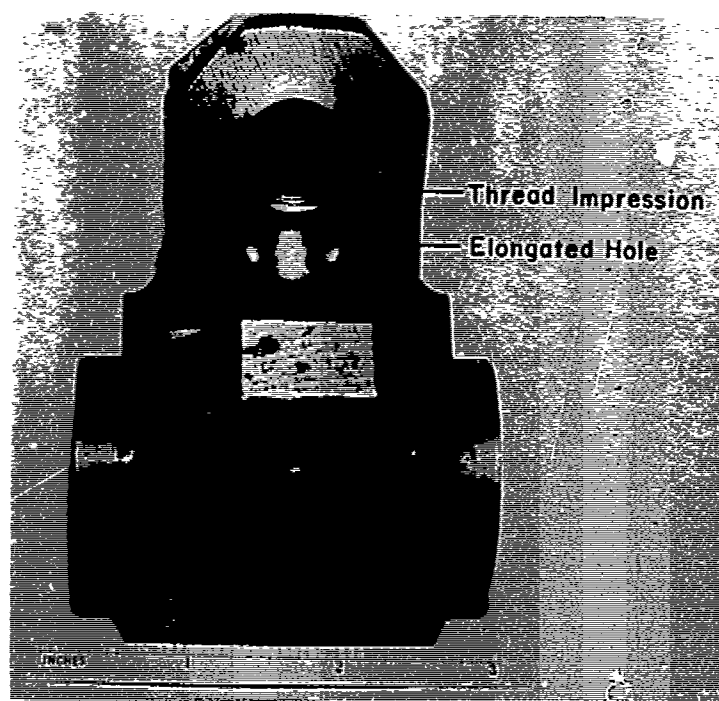
Figure 14 - Elongated Hole in 90° Mount Ring Coupling
