**GUN DIVISION
REPORT NO. WGD -11**

THE MACRO ETCH TEST AS A MEANS OF JUDGING THE ACCEPTABILITY OF MATERIAL FOR THE MANUFACTURE OF CENTRIFUGALLY CAST "COLD WORKED" GUN TUBES

PROGRESS REPORT #1

THE COLD WORKING OF TEST CYLINDERS OF SELECTED MACRO STRUCTURES

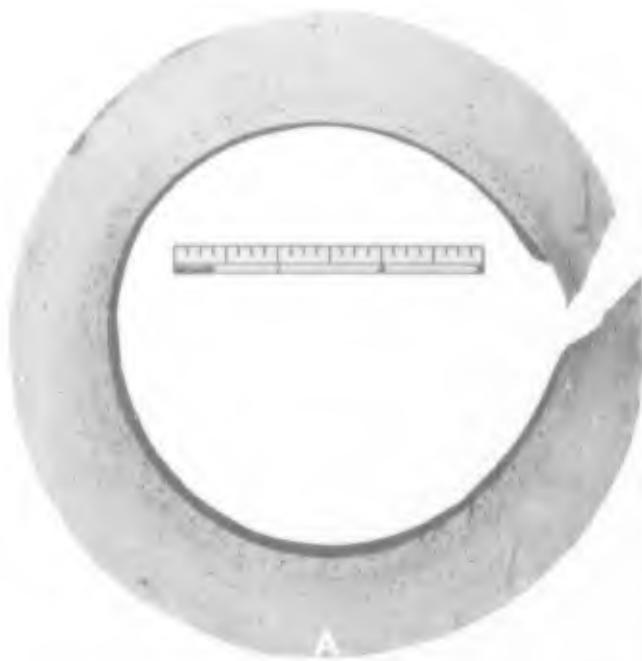
(A) ETCHED DISC FROM ZONE OF GREATEST EXPANSION OF CYLINDER #1 SHOWING MACRO STRUCTURE.

CYLINDER #1 FROM SMALL CROSS SECTION CASTING COLD WORKED TO DESTRUCTION.
CYLINDER BORED ON CENTER. WTN.639-6153

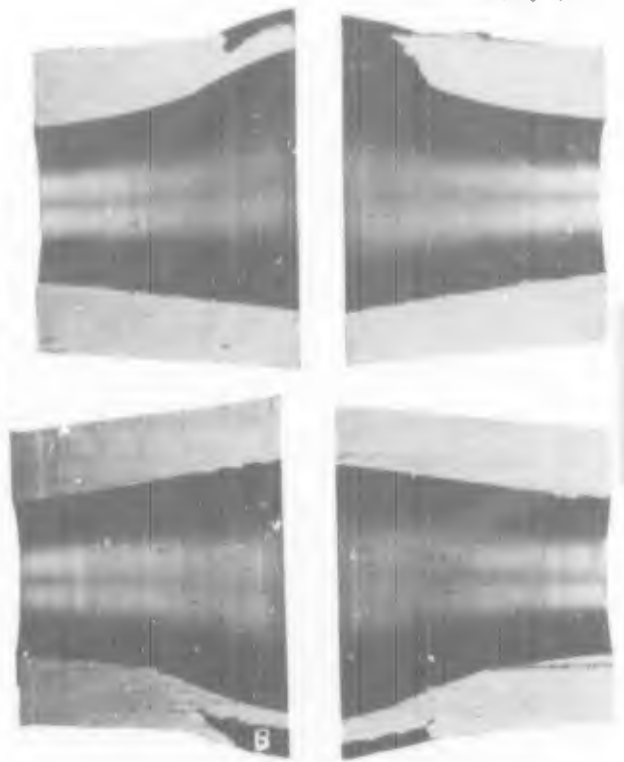
(B) LONGITUDINAL CROSS SECTION SHOWING CHECKS IN BORE.

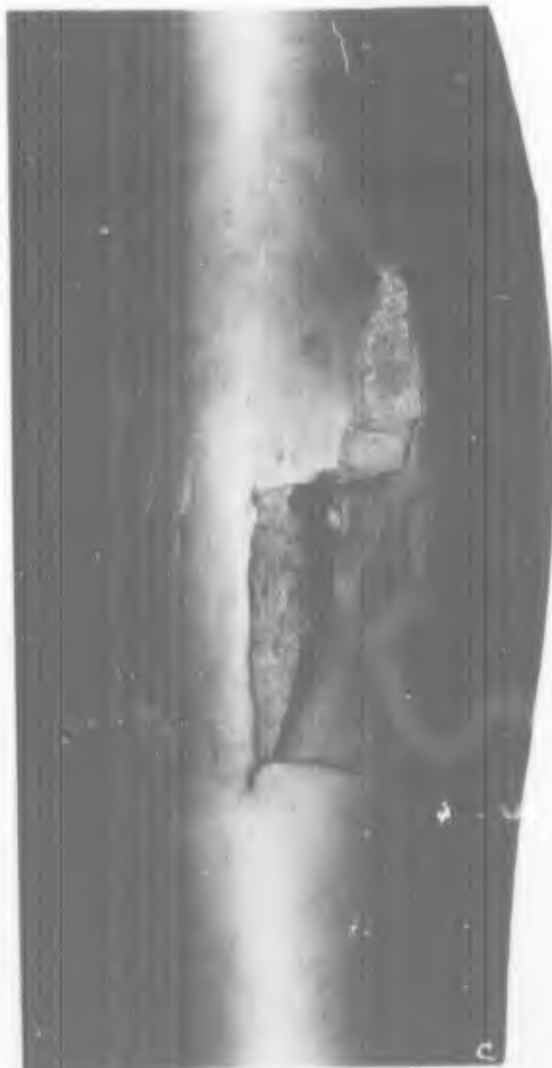
(C) FAILURE NEAR CENTER OF CYLINDER SHOWING TYPE OF FRACTURE.

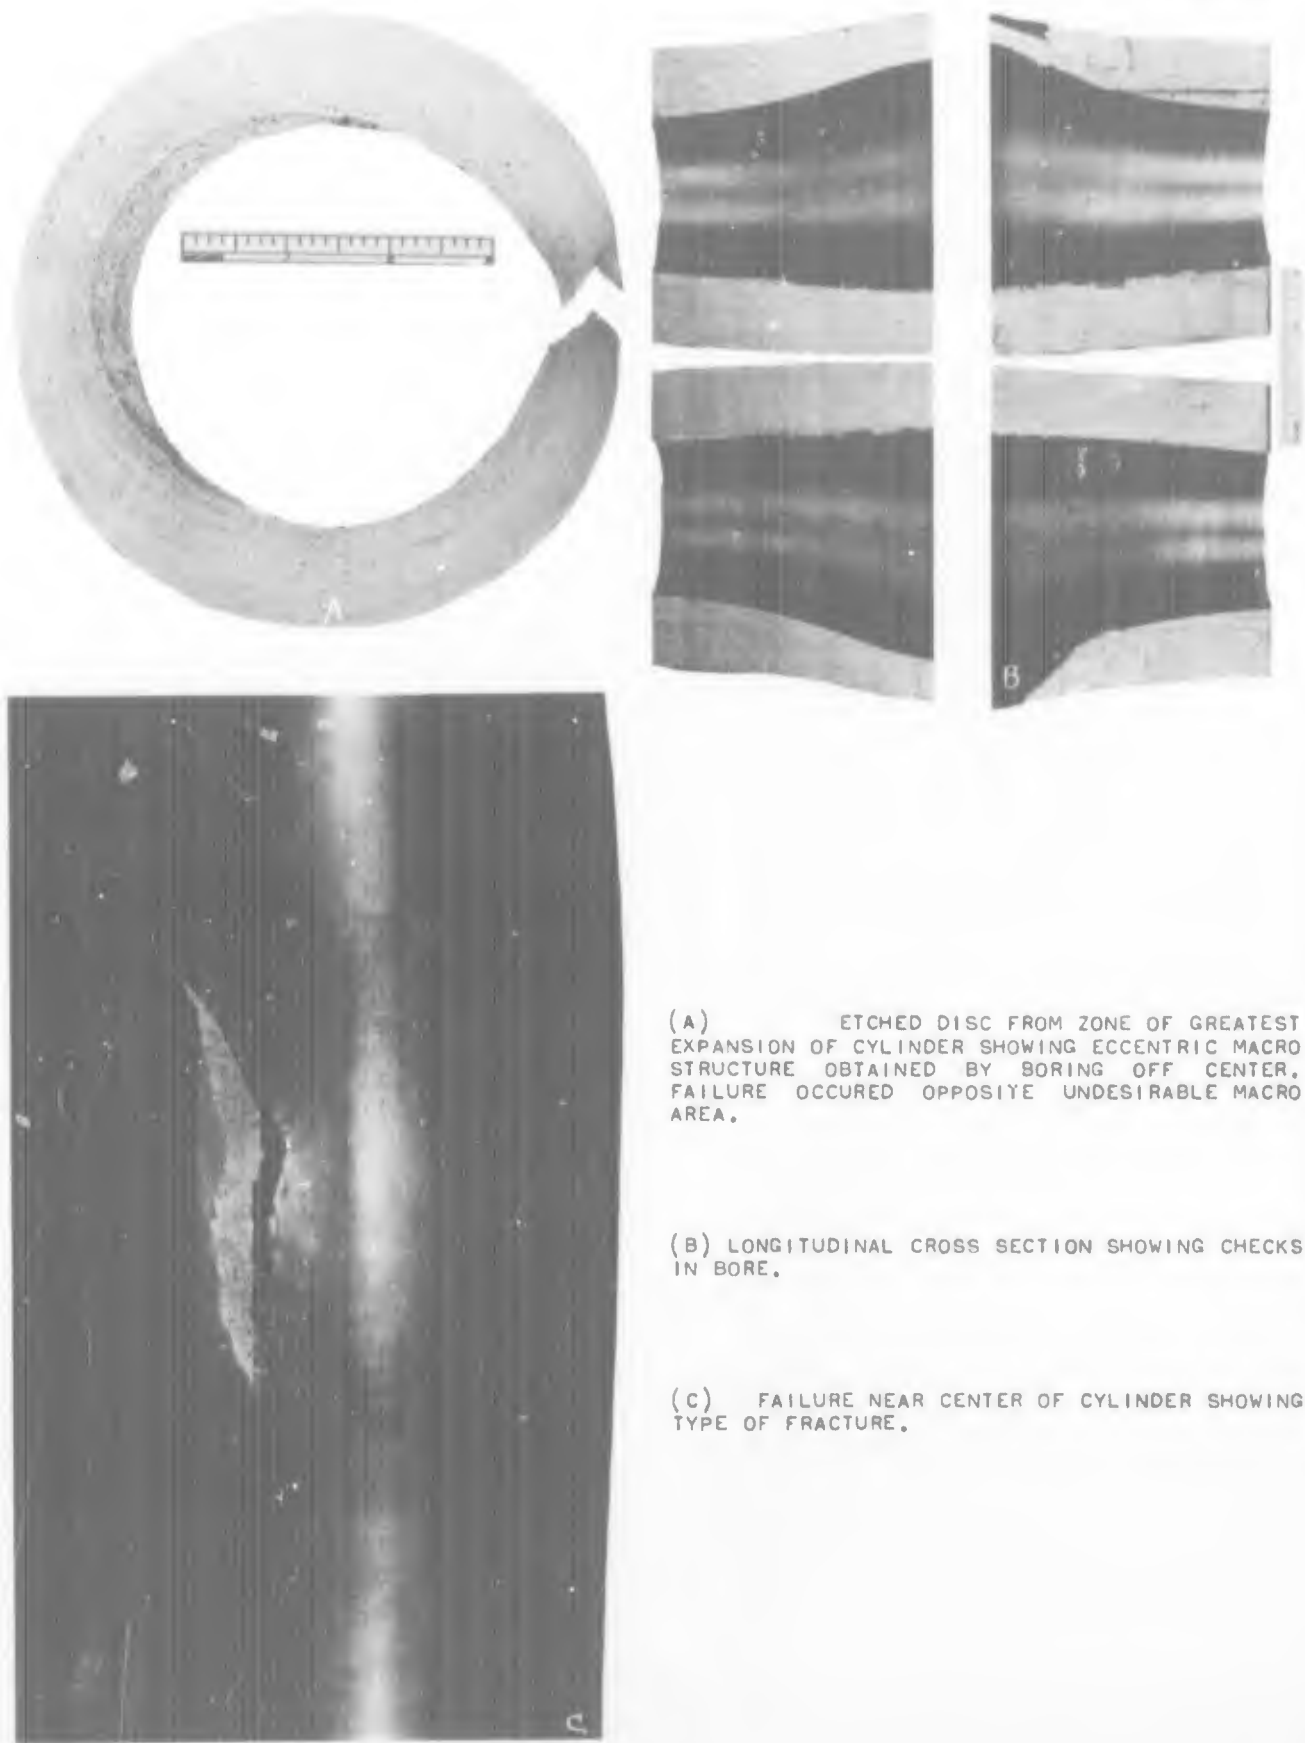
(A) ETCHED DISC FROM ZONE OF GREATEST EXPANSION OF CYLINDER SHOWING ECCENTRIC MACRO STRUCTURE OBTAINED BY BORING OFF CENTER, FAILURE OCCURED OPPOSITE UNDESIRABLE MACRO AREA.

(B) LONGITUDINAL CROSS SECTION SHOWING CHECKS IN BORE.

(C) FAILURE NEAR CENTER OF CYLINDER SHOWING TYPE OF FRACTURE.

CYLINDER #2 FROM SMALL CROSS SECTION CASTING COLD-WORKED TO DESTRUCTION. THIS SECTION WAS STRESS RELIEVED AT 570°F FOR 12 HOURS PRIOR TO THE COLD WORK OPERATION—CYLINDER BORED OFF CENTER WTN.639-6155

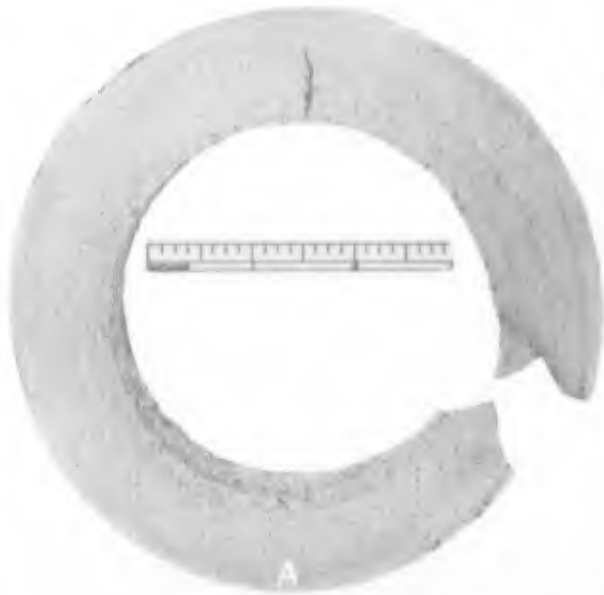
(A) ETCHED DISC FROM ZONE OF GREATEST EXPANSION SHOWING ECCENTRIC MACRO STRUCTURE OBTAINED BY BORING OFF CENTER. FAILURE OCCURED AWAY FROM AREA OF MOST UNDESIRABLE MACRO STRUCTURE.

CYLINDER #3 FROM SMALL CROSS SECTION CASTING—COLD WORKED TO DESTRUCTION. CYLINDER WAS BORED OFF CENTER. WTN.639-6152

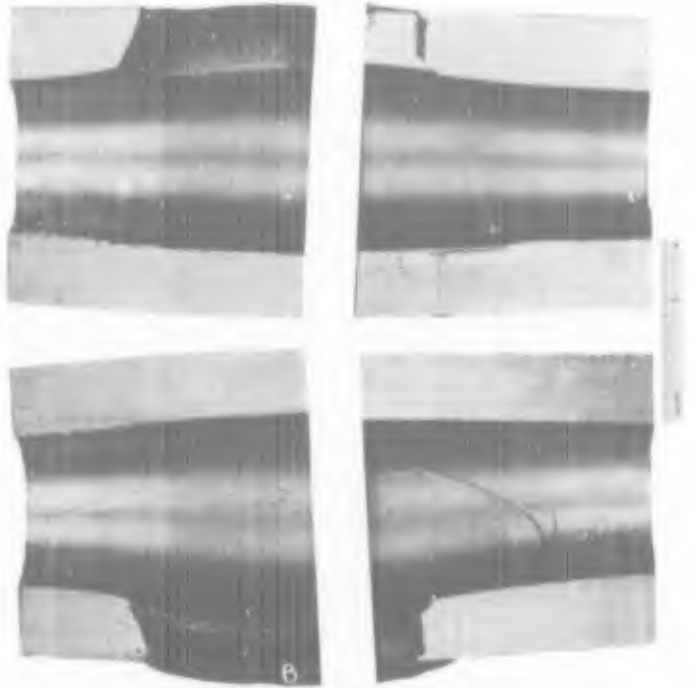
(B) LONGITUDINAL CROSS SECTION SHOWING CHECKS IN BORE AND NATURE OF FAILURE.

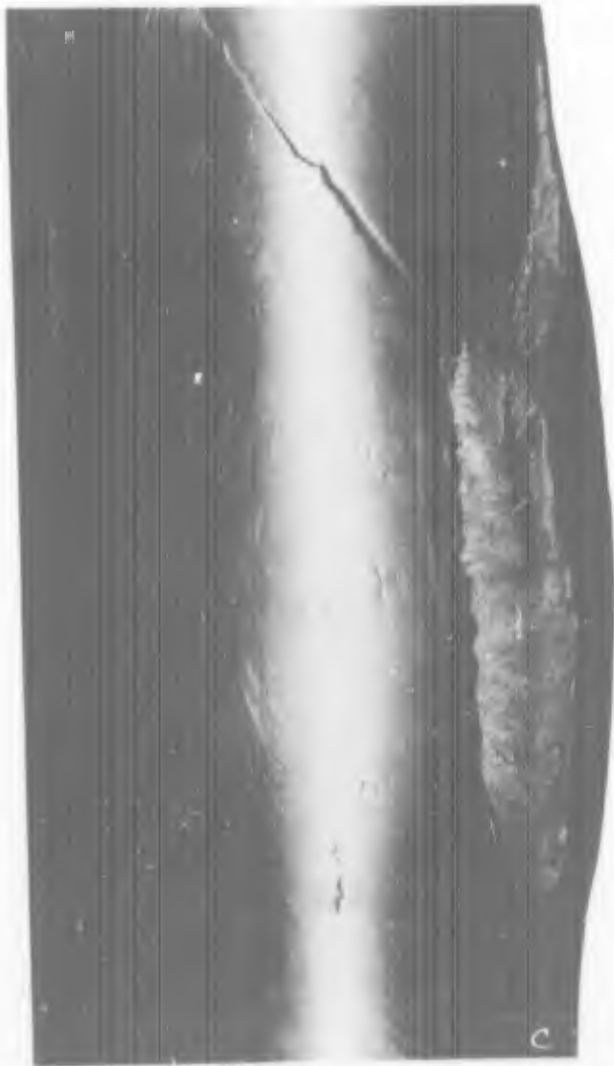
(C) FAILURE NEAR CENTER OF CYLINDER SHOWING TYPE OF FRACTURE. NOTE CHECKS ON OUTSIDE SURFACE.

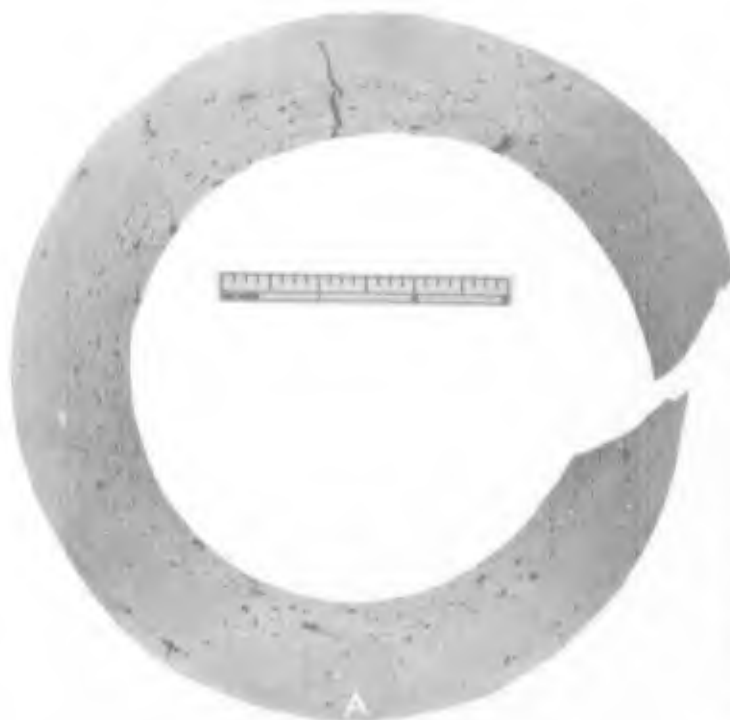
(A) ETCHED DISC FROM ZONE OF GREATEST EXPANSION OF CYLINDER SHOWING PITTED MACRO STRUCTURE.

CYLINDER #1 FROM LARGE CROSS SECTION CASTING. COLD WORKED TO DESTRUCTION. CYLINDER BORED ON CENTER. WTN.639-6151

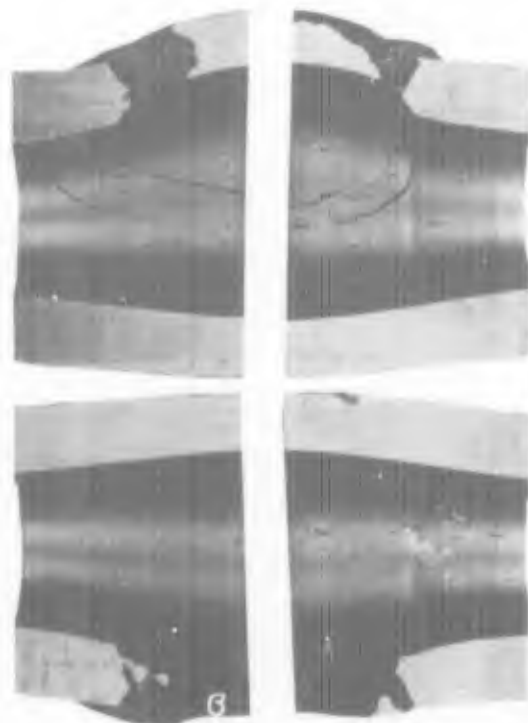
(B) LONGITUDINAL CROSS SECTION SHOWING DETAILS OF FAILURE AND CHECKS IN BORE.

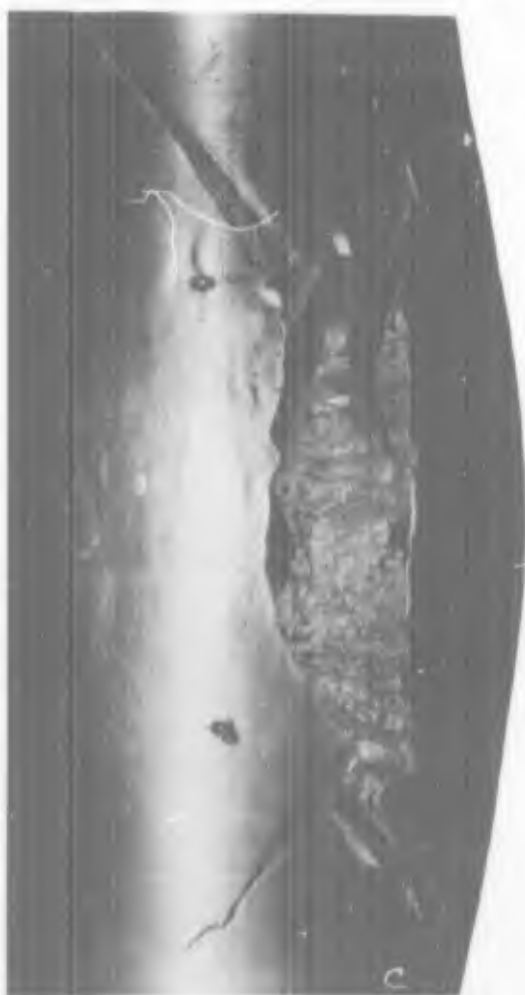
(C) FAILURE NEAR CENTER OF CYLINDER SHOWING TYPE OF FRACTURE.

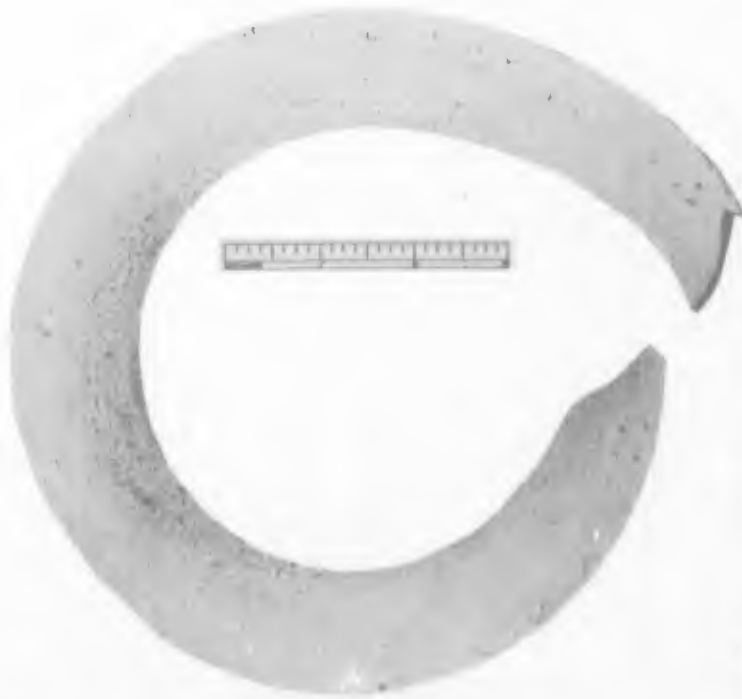
(A) ETCHED DISC FROM ZONE OF GREATEST EXPANSION OF CYLINDER SHOWING ECCENTRIC MACROSTRUCTURE OBTAINED BY BORING OFF CENTER. FAILURE OCCURED OPPOSITE UNDESIRABLE MACRO AREA.

CYLINDER #2 FROM LARGE CROSS SECTIONED CASTING COLD WORKED TO DESTRUCTION. THIS SECTION WAS STRESS RELEASED FOR 12 HOURS PRIOR TO THE COLD WORK OPERATION. CYLINDER WAS BORED OFF CENTER. WTN.639-6150

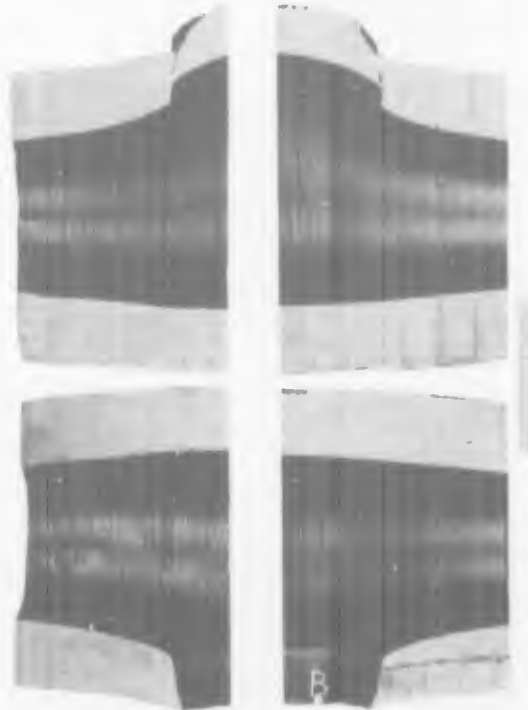
(B) LONGITUDINAL CROSS SECTION SHOWING DETAILS OF FAILURE AND CHECKS IN BORE.

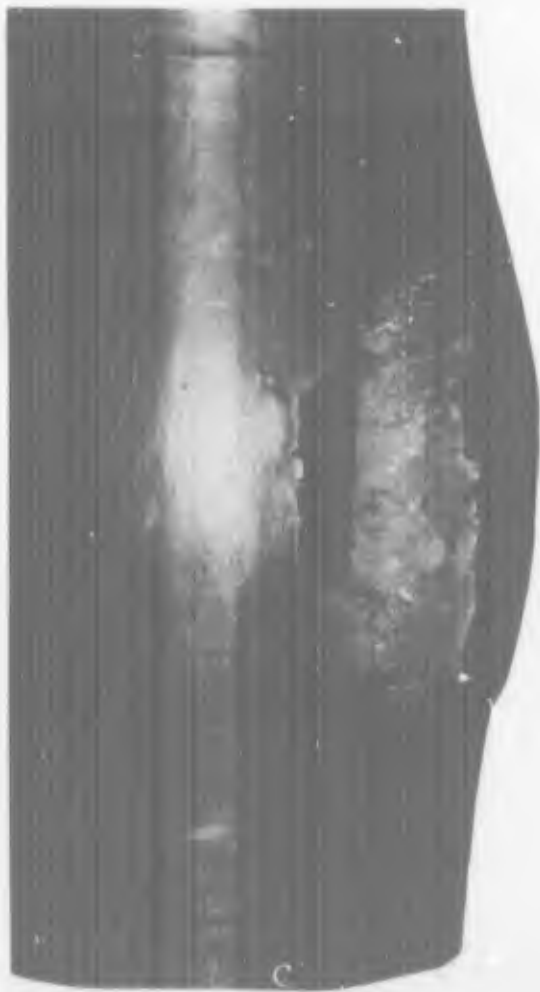
(C) FAILURE NEAR CENTER OF CYLINDER SHOWING TYPE OF FRACTURE. NOTE SLIGHT CHECKS ON OUTSIDE SURFACE.

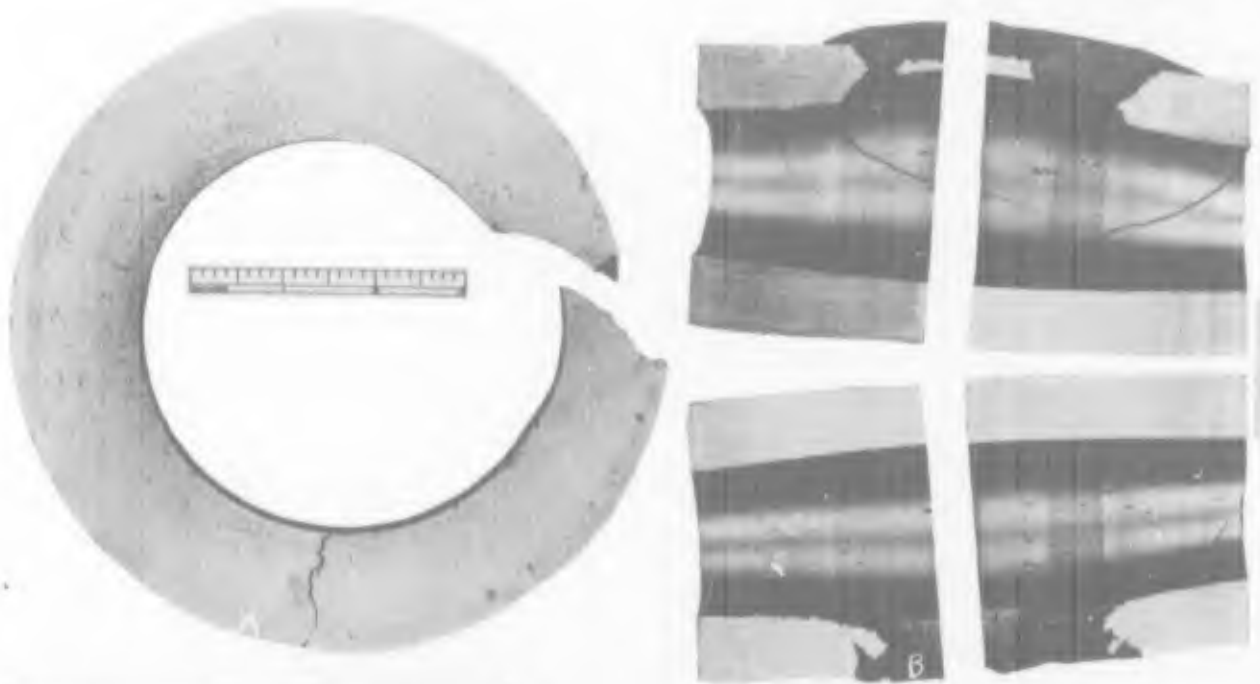
(A) ETCHED DISC FROM ZONE OF GREATEST EXPANSION OF CYLINDER SHOWING ECCENTRIC MACRO STRUCTURE OBTAINED BY OFF CENTER BORING. FAILURE OCCURED OPPOSITE UNDESIRABLE MACRO AREA.

(B) LONGITUDINAL CROSS-SECTION SHOWING DETAILS OF FAILURE AND CHECKS IN BORE.

CYLINDER #3 FROM LARGE CROSS SECTIONED CASTING. COLD WORKED TO DESTRUCTION. CYLINDER BORED OFF CENTER. WTN.639-6154

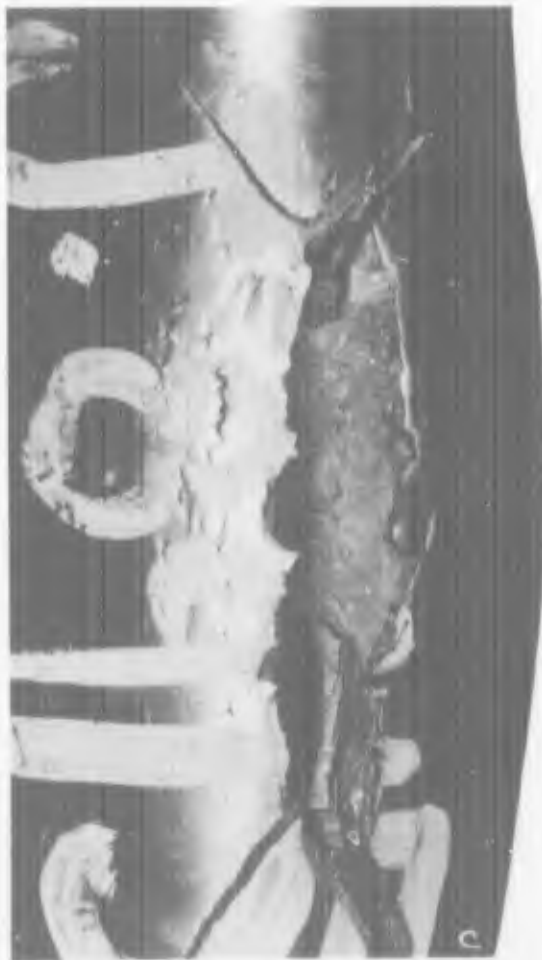
(C) FAILURE NEAR CENTER OF CYLINDER SHOWING TYPE OF FRACTURE. NOTE BAD CHECKS ON OUTSIDE SURFACE.
