MEMORANDUM REPORT

NO. WAL 710/520

Heavy Tank T26M1

Metallurgical Examination of Components Which Failed

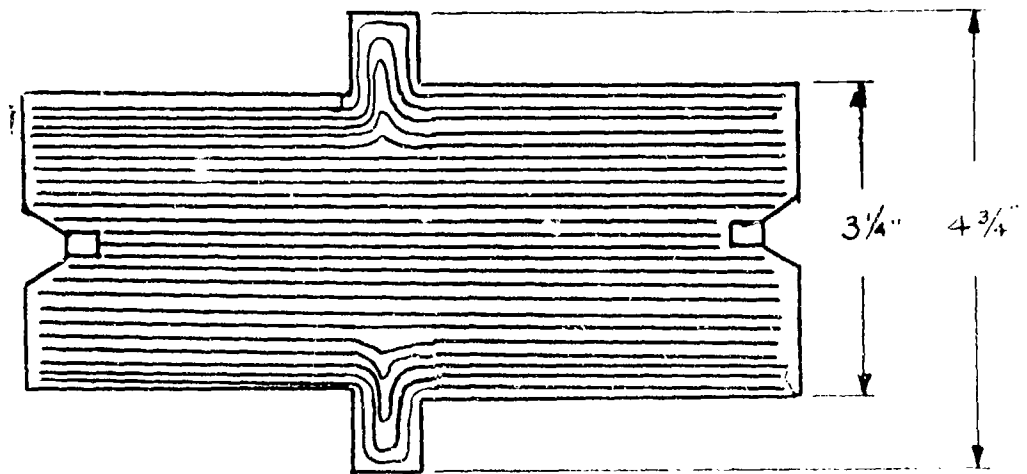
Proposed Design of Trunnion Shaft
Made from Upset Forging

Satisfactory toughness can be attained in the shaft by employing a steel having sufficient hardenability for a $3\frac{1}{4}$ " diameter round when water or oil quenched depending upon which is to be employed by the heat treater. The composition used (SAE 6150) possessed insufficient hardenability when water quenched, whereas the composition specified (SAE 4340) as well as several of the .40% carbon N.E. compositions can be satisfactorily heat treated when water quenched. A probable optimum combination of toughness and resistance to deformation can be obtained by tempering the part to a hardness of 330-360 Brinell. The toughness can be controlled by a V-notch Charpy impact test taken from the center of one shaft from each lot. A satisfactory minimum value at the above hardness level is 30 ft. lbs. at room temperature. There is some danger of the higher alloy steels (over 3% alloy) being susceptible to temper brittleness, and, therefore, it might be advisable to oil quench from the tempering temperature. Considerable saving in metal and machining time could be achieved by using an upset forging rather than the bar stock which was employed, and the shaft would possess better directional properties at the base of the flange where the stress concentrations are greatest.
