NO. WAL 710/591

Metallurgical Examination of Twelve 1 Inch Cast Armor Plates

Furnished by McConway-Torley Corporation

12 February 1944

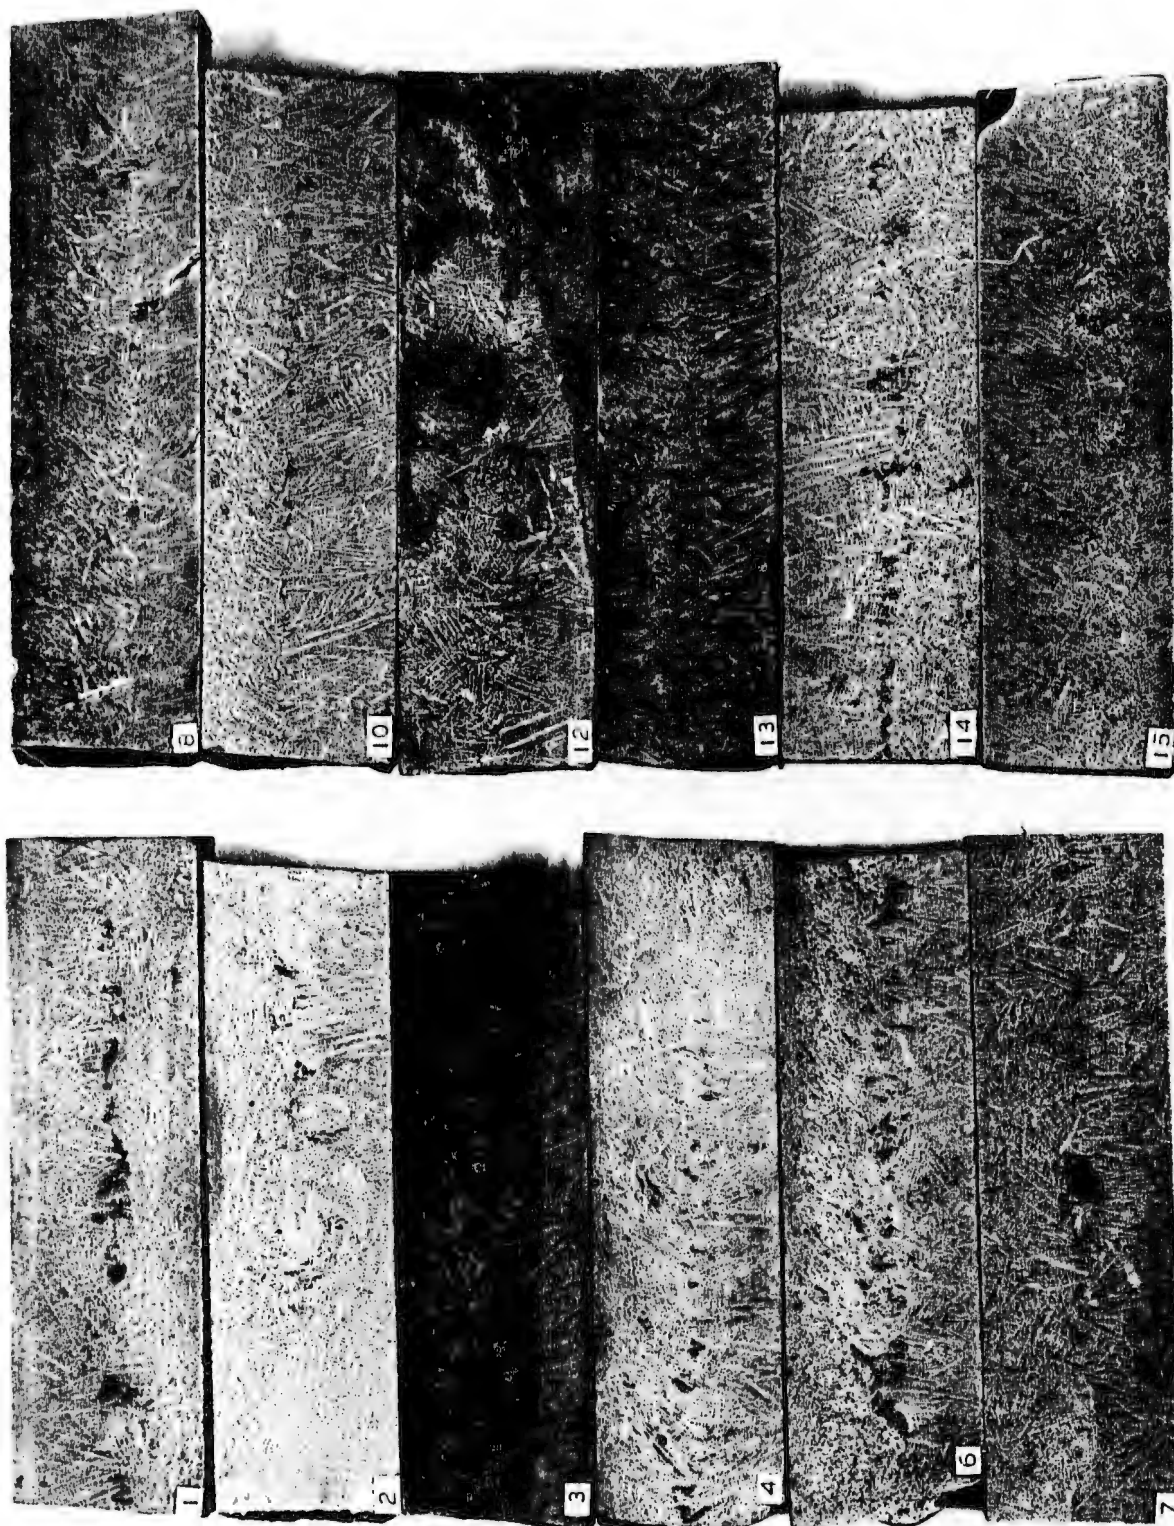
FIGURE 1

Fractures were difficult to interpret because of the presence of porosity, conchoidal areas, and/or a pronounced dendritic condition on all samples. The dendritic and conchoidal aspects undoubtedly have a detrimental effect upon ballistic shock resistance and prevent the obtainment of a completely ductile fracture. It is probable that all plates were satisfactorily heat treated as indicated by the microscopic examination. The inferior fractures, therefore, reflect poor steel making and deoxidation practices.

c. Macroetch tests. Macroetch tests were made on sections from each plate. The results are shown in Figure 1. The pronounced dendritic structure is apparent on all plates. Considerable unsoundness is also indicated on the majority of plates, particularly 1, 6, 7, 12, and 14.

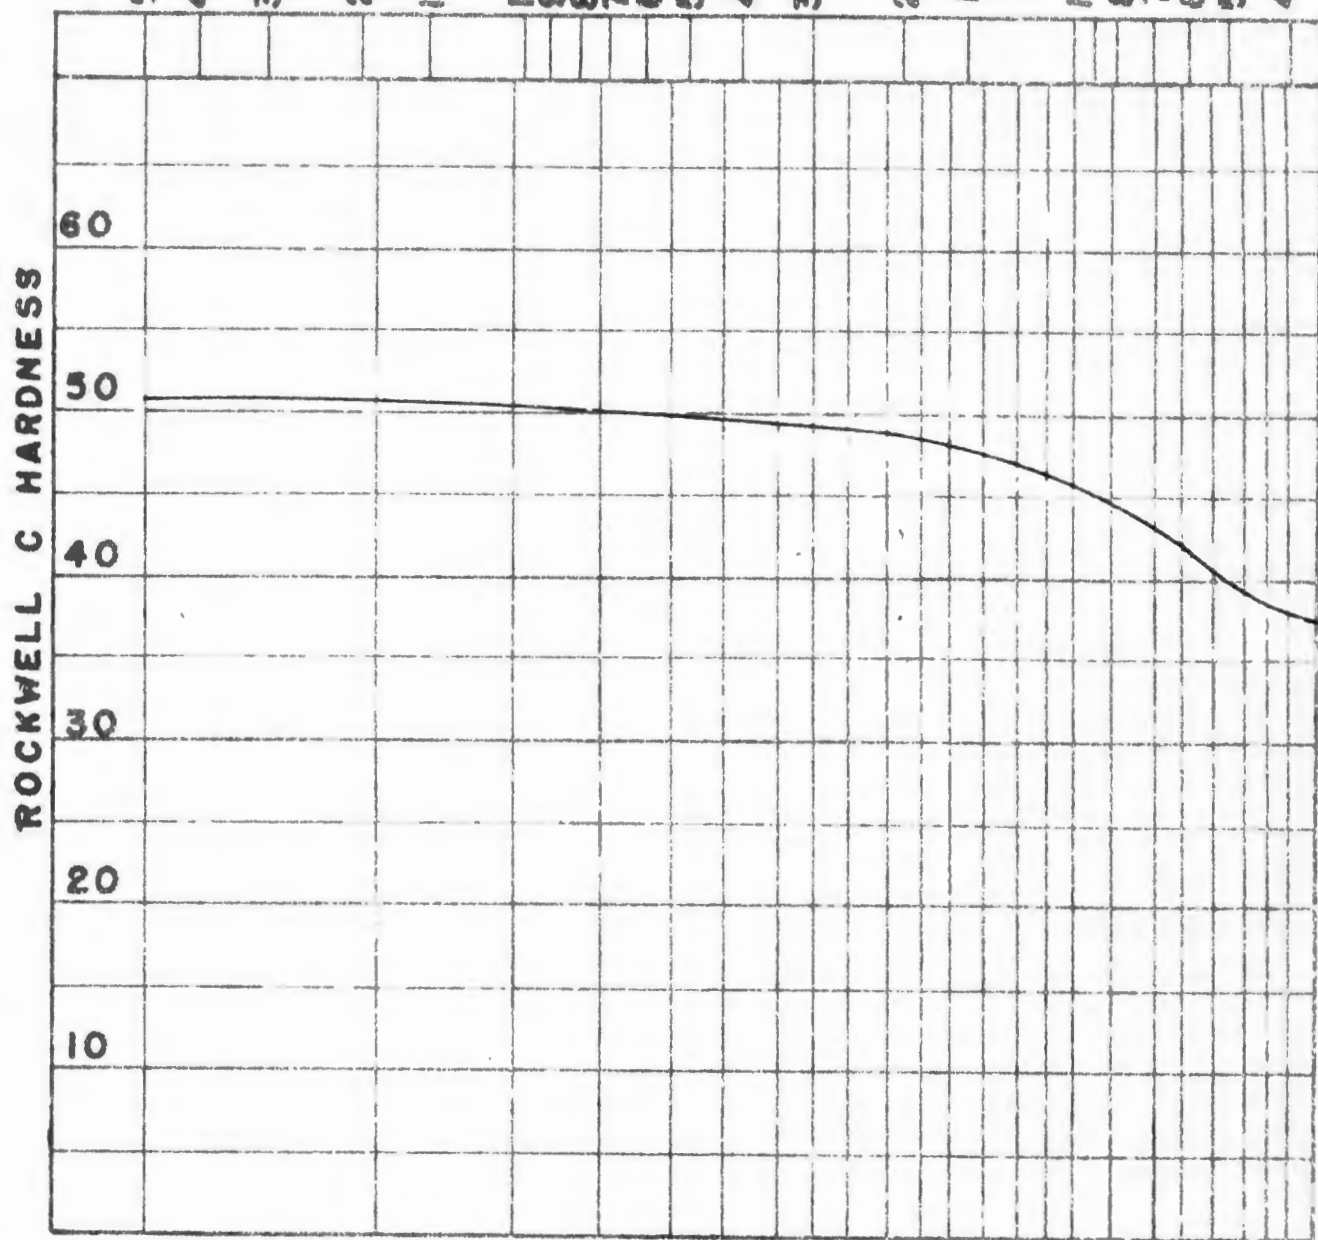
FIGURE 2.

The analysis shows a boron content which correlates with the exceptional hardenability for the analysis. The high residual aluminum content is perhaps one of the factors responsible for the tendency toward a conchoidal fracture condition. Work at Battelle Memorial Institute has shown that the conchoidal fracture may be produced by an aluminum nitride precipitate. High residual aluminum and high nitrogen contents, therefore, tend to promote the conchoidal fracture. It has been shown that the conchoidal condition has an adverse effect upon impact properties.

The exceptional hardenability considering the analysis can only be explained by the observed boron content. No boron additions are reported by the manufacturer. The hardenability (See Figure 2.) is more than adequate for a 1 inch section and is satisfactory for a 2 inch section as regards the transformation to high temperature products such as ferrite and pearlite.

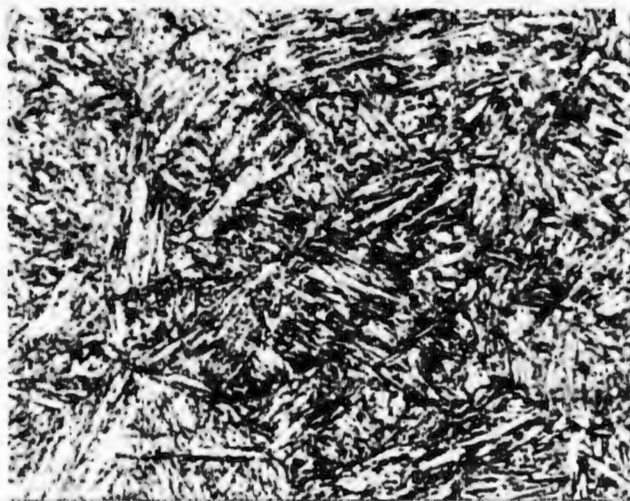
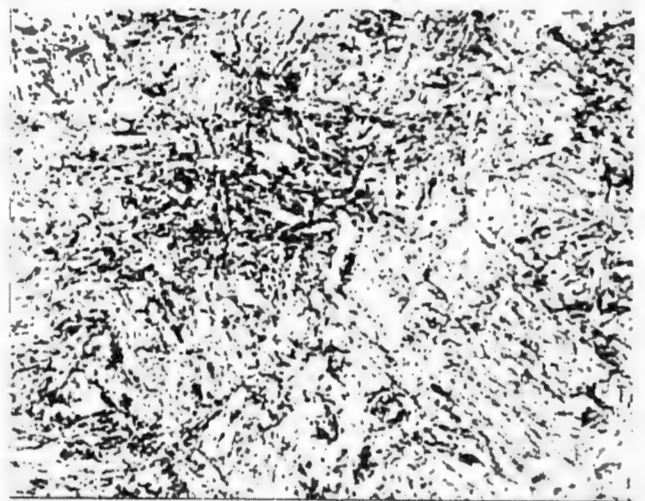
Typical microstructures are illustrated in Figure 3. The microstructures are essentially tempered martensite, with no evidence of high temperature transformation products but with the possibility of partial transformation to bainites as evidenced by the acicular structures shown of plates, numbers 7 and 15. However, the plates tempered to lower hardnesses, as indicated by the photomicrograph of plate 12, display a normal tempered martensitic structure. It is, therefore, believed that the plates have been well heat treated. This evidence is substantiated by that obtained on the impact test values as influenced by temperature.

Picral Etch Plate 7 Plate 15 X1000  
Tempered martensitic structures characteristic of plates 1, 3, 4, 7, 13 14 and 15.

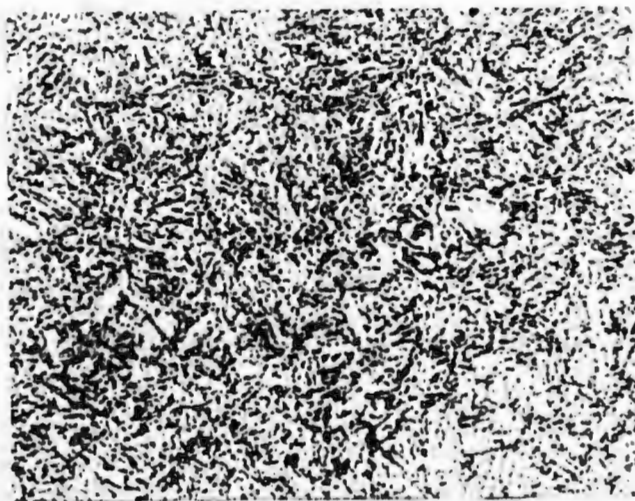
Picral Etch  
Tempered martensitic structure characteristic of plates 2, 6, 8, 10, 12 at the lower hardnesses.
