REPORT NO. 710/395

METALLURGICAL EXAMINATION
OF 1/2" GUNTERBUNK PIVETS

November 2, 1941

WATERTOWN ARSENAL
WATERTOWN, MASS.

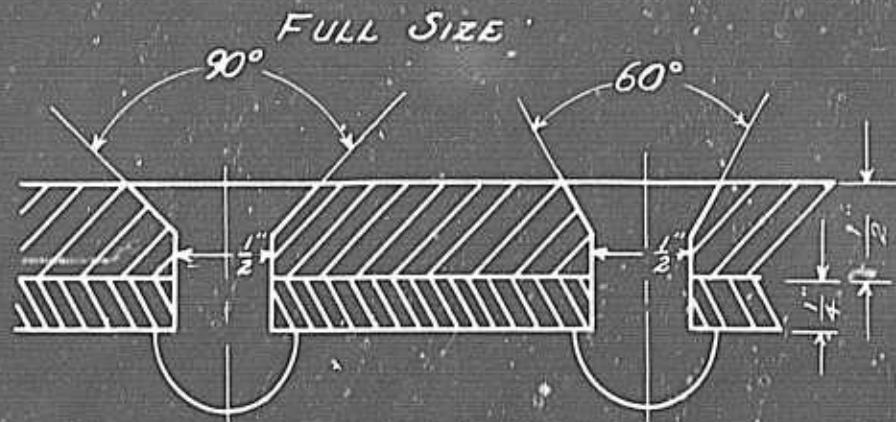
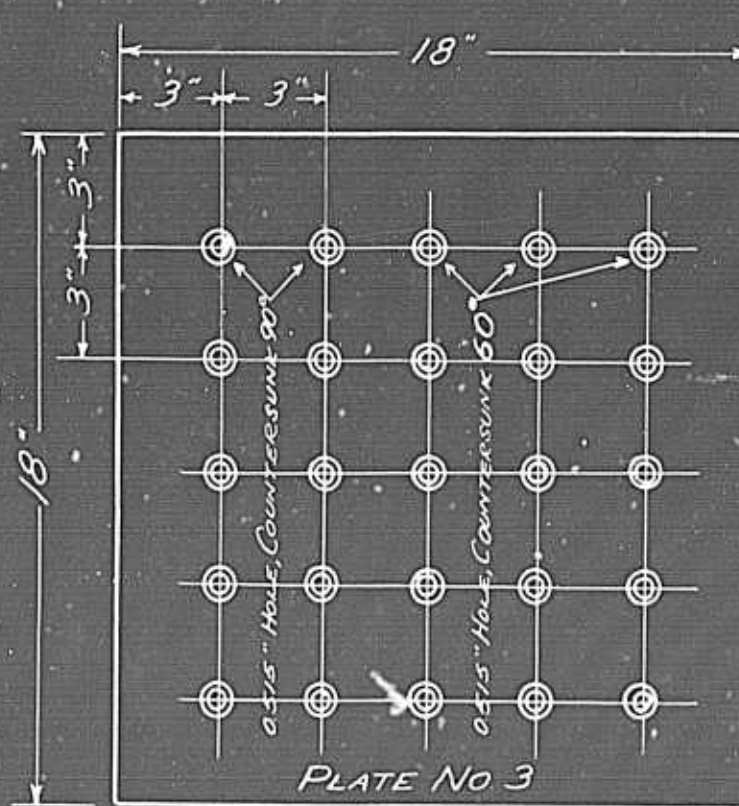
FIG. 1

b. The absence of filleting at the junction of the shanks and button points of the rivets producing stress concentrations. (See Figure 1.)

Test plate No. 3 was made up of an $18 \times 18 \times 1/2$ " face-hardened armor plate riveted to an $18 \times 18 \times 1/4$ " soft iron back plate with 25 half-inch rivets - ten rivets of the 90° countersunk type and fifteen rivets of the 60° countersunk type. The rivets were arranged in five rows of five rivets each. The ten 90° countersunk rivets were placed in two vertical rows at the left of the plate, the fifteen 60° countersunk rivets were placed in three vertical rows to the right. The rivets were evenly spaced on 3" centers. (See Figure 1.) All rivets were made of SAE 2330 nickel steel stock.

To provide for satisfactory shock resistance, some provision, such as, countersinking the rivet holes in the back plate should be made to allow for generous filletting at the junction of the shank and the button point. In this connection reference should be made to the Memorandum Report W.A. 710/373 entitled "Cold Heading versus Hot Heading and Rivet Design", dated July 8, 1941, in which it was recommended that all rivets used in armor fabrication be provided with generous fillets.

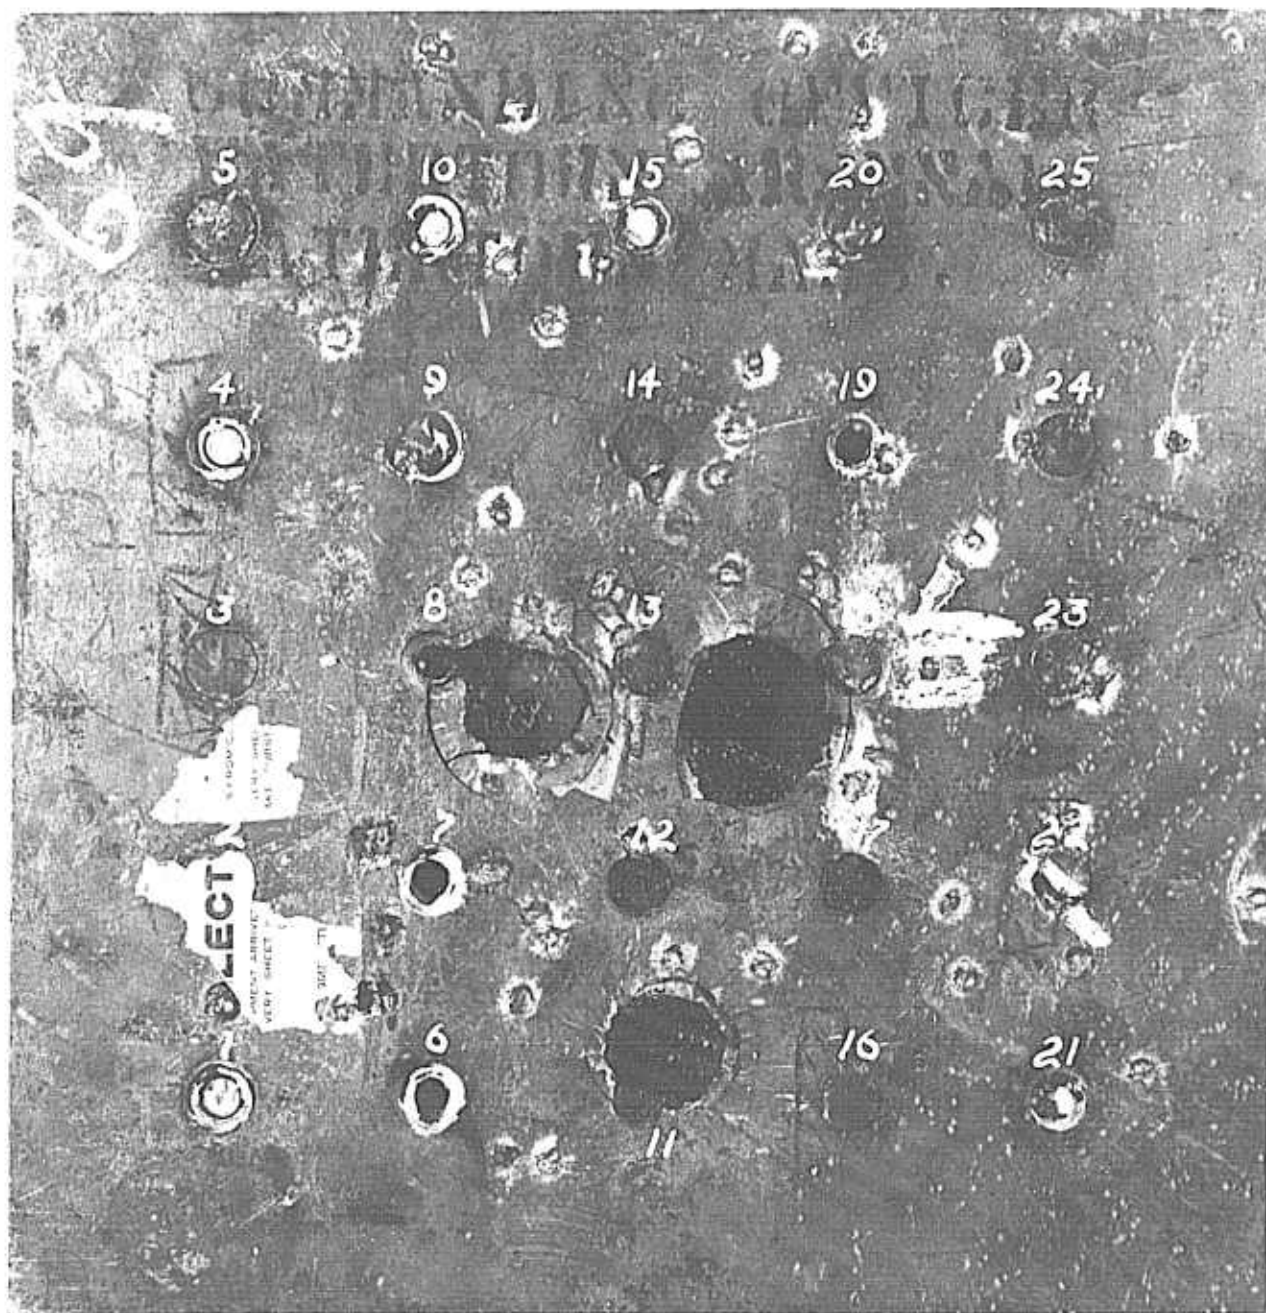
FIG. 2

The individual rivets are numbered, starting at the bottom and to the left as rivet No. 1 and counting to the top. Figure 2 shows the front of the riveted section and Figure 3 the rear after the ballistic tests.

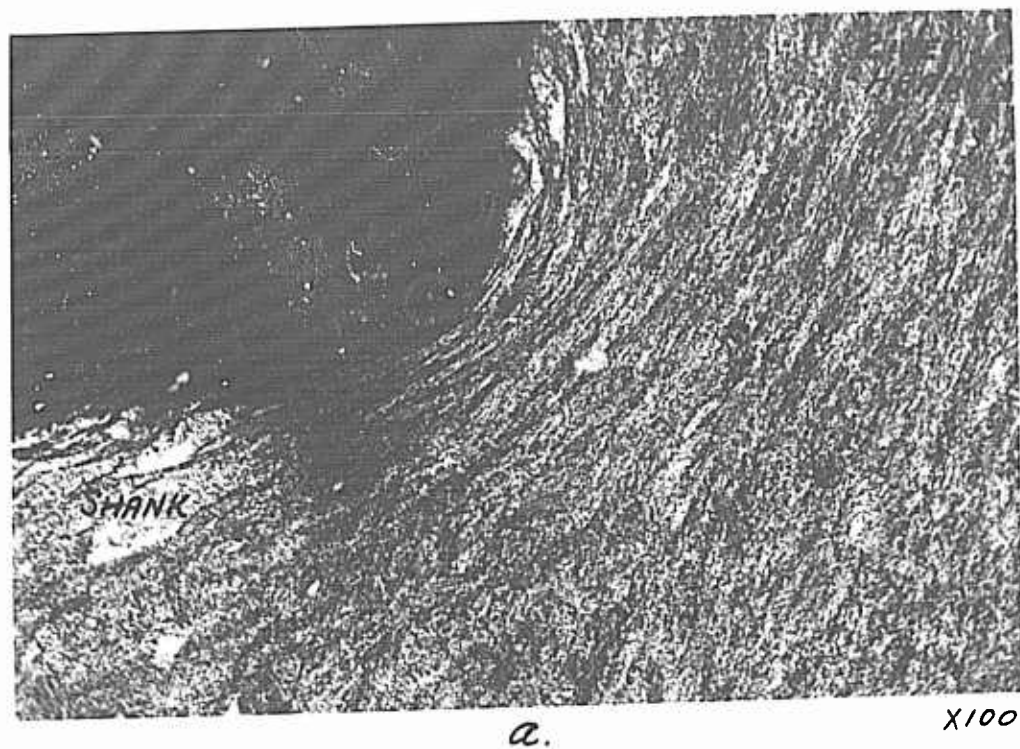
Figure 4.
MICROSTRUCTURE OF RIVETS

The following rivets were examined: #3 and #4, 90° countersunk heads, and #13, #16, and #22, 60° countersunk heads. Both rivets #3 and #4 were fractured at the junction of the countersunk head and the shank, while rivet #16 was fractured at the junction of the button point and the shank. Rivets #13 and #22 were not fractured. No cracks were found in any of the rivets other than the fractured surfaces, and no laps or seams were found under the button points of the rivets examined. No allowance was made for the formation of adequate fillets under the button points and consequently sharp corners were formed which were made more dangerous from the standpoint of stress concentration by surface grain boundary oxidation resulting from heating the rivets prior to driving and also by numerous strain lines in the vicinity of the corners. (See Figures 4a and 4b, X100.)

- (a) Junction of shank and rivet head of rivet #1 showing absence of adequate fillet.

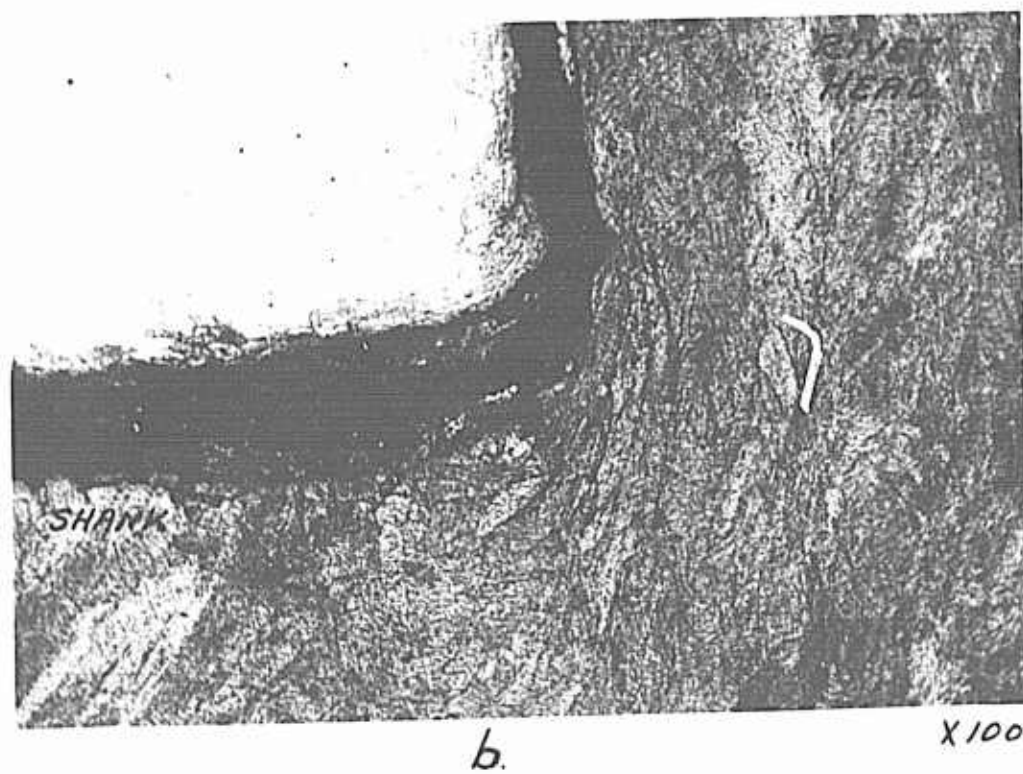
- (b) Junction of shank and rivet head of rivet #22 showing absence of adequate fillet. Grain boundary oxidation at rivet surface intensifies poor stress resisting qualities in this area.

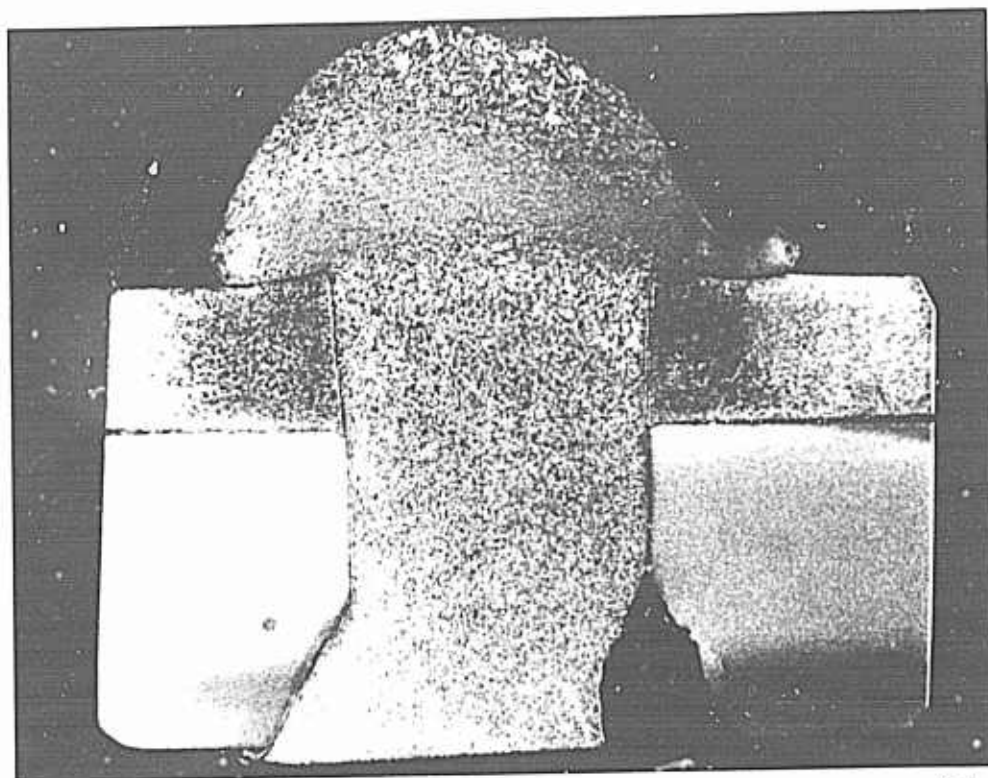
a.

Figures 5a and 5b, X3, illustrate the variation in grain size over the cross-section of the rivets, and also the lack of proper fillets under the button points. The microstructure is decidedly martensitic. Figure 6, X250, shows the relatively coarse martensitic structure of the shank of rivet #13. This martensitic condition is typical of all the rivets examined.

- (a) Rivet #22, showing variation in grain size over the cross-section of the rivet. Note sharp corners at junction of shank and button point caused by lack of allowance for adequate fillets.

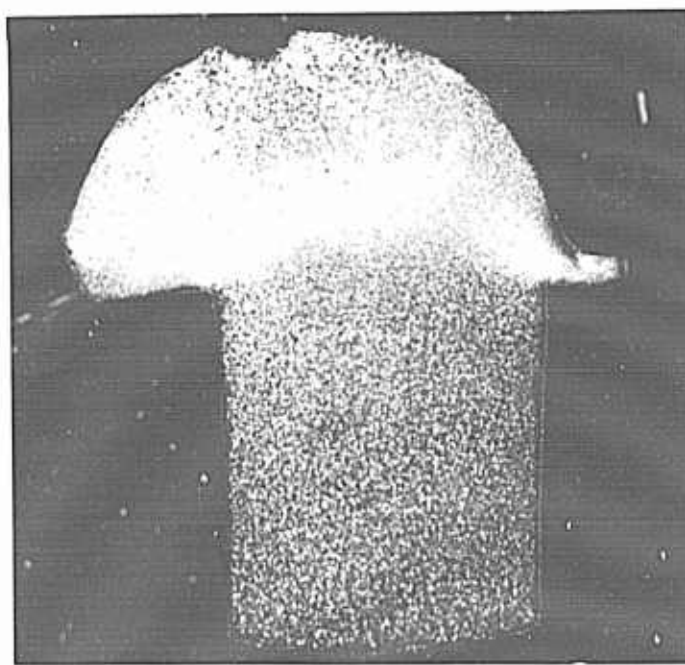
b.

- (b) Rivet #3-1. - The variation in grain size over the cross-section of the rivet is typical of all rivets studied. The outer zone of the button point is very coarse grained, the inner zone of the button point is very fine grained, while the shank and the countersunk head are medium coarse to medium fine grained.

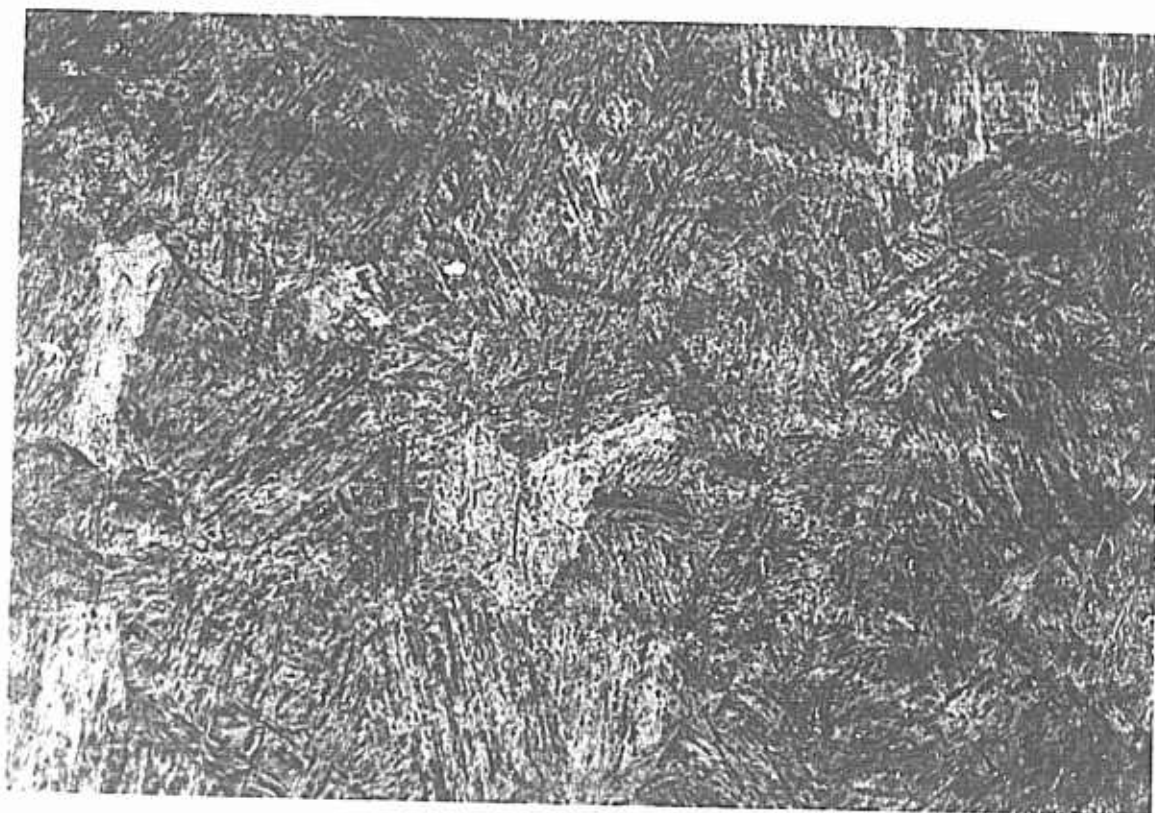
Figure 6.
MICROSTRUCTURE OF RIVETS

Medium coarse martensitic structure in shank of rivet #13. This martensitic structure is typical of the microstructure of all rivets examined.

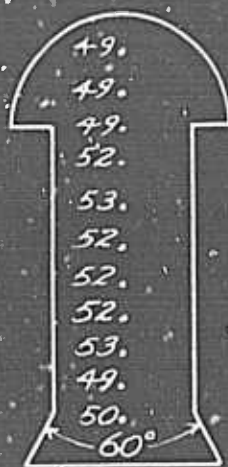
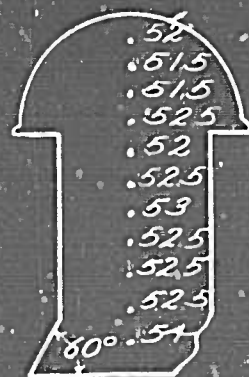
FIG. 7

a. Excessive hardness resulting from the relatively high carbon content (0.34%) in conjunction with the nickel alloy content. (See Figure 7.)

Hardness curves were made along the cross-sections of the five rivets studied using the Superficial Rockwell Hardness Tester with a 30 kg. load and the N-Brale penetrator, and converting the results to their corresponding Rockwell C values. Figure 7 shows that the hardness of the rivets varied from 49 to 56 Rockwell C.

In spite of the fact that the rivet stock was much below the specification for carbon content, the rivets were brittle because of the high hardness resulting from the chilling induced by the plate metal surrounding the rivet as it was being driven. A carbon content

of 0.34% in conjunction with the nickel content is too high for satisfactory ductility under the cooling conditions present.
