MEMORANDUM REPORT

NO. WAL 710/476

A Preliminary Study of the Effect of Shot Blasting Upon
The Ballistic Characteristics of the M1 Steel Helmet

DATE 28 February 1944

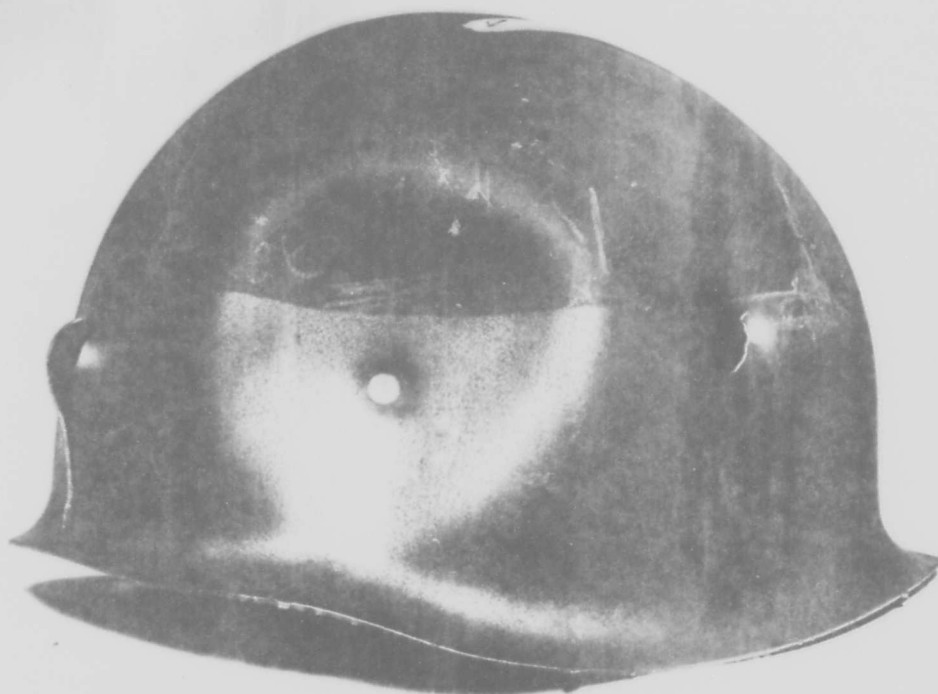
Helmet No. H7. McCord Lot 619B. Carnegie Heat 246861.
Ballistically tested in as-received condition.

Ballistic Limit 774 ft./sec.

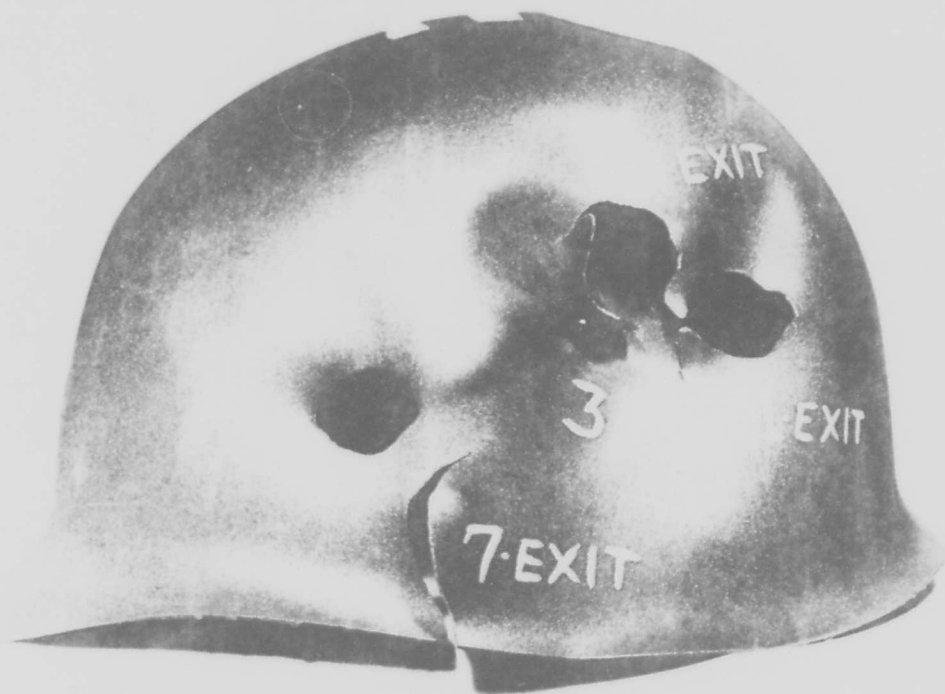
8. Poor ballistic properties and brittle behavior were encountered in both helmets which had been shot blasted on their exterior surfaces, while no deleterious changes occurred in the helmets shot blasted on the interior surface and on both interior and exterior surfaces. It is believed that the stress pattern is to a large extent responsible for the observed ballistic characteristics. In the cold formed condition the interior surface of the helmet shell is in compression and the exterior surface in tension. These residual stresses are so disposed as to resist bullet penetration, because penetration is occasioned by tensile failure of the back surface of the attacked area. The original compression of the rear surface must first be overcome before failure will occur. The high residual stresses induced in Hadfield manganese steel helmets by the cold-forming operation may account for some of the superiority of manganese steel helmets over heat treated magnetic steel helmets of comparable thickness, which, being heat treated after forming, are relatively stress free.

9. Shot blasting the exterior surface of a helmet puts that surface into compression. If the superimposed stresses are sufficiently large, the interior surface of the helmet shell will be put into tension. With this stress distribution, i.e. compression on the outside and tension on the inside, the bullet is aided in its penetration, resulting in a lowering of the ballistic limit. The transition from ductile to brittle behavior may be traceable to the fact that the change in stress pattern is effective in increasing the strain rate. When the inside surface is in tension, the fracture stress will be reached before much deformation has occurred. The bullet speed will not, consequently, have been appreciably lowered, and thus a high strain rate will be maintained to the point of fracture, resulting in brittle failure. With the inside surface in compression, the fracture stress will be reached only after considerable deformation has occurred. The velocity of the bullet will be reduced by the cushioning action of the deforming metal; and when the fracture stress is reached, the strain rate will have been reduced sufficiently to allow ductile failure. Experiments with the shot blasting equipment available at this arsenal indicate that even at the minimum air pressure of 45 pounds per square inch the shot blasting is very severe, and in all probability, too severe for optimum benefit in the helmet application. Apparently, any shot blasting treatment which will result in the interior surface being in tension will have a harmful effect upon the ballistic properties of helmets.

Helmet No. H3. McCord Lot 618B. Carnegie Heat 166839.
Entire exterior surface ballistically tested.

Ballistic Limit - Below 658 ft./sec.

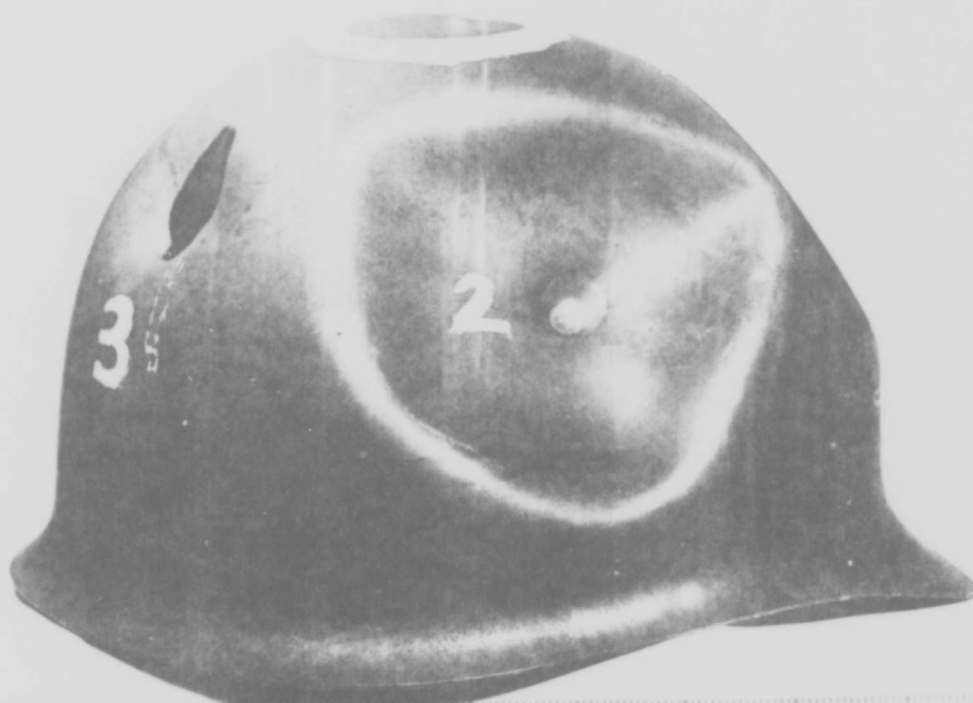
Helmet No. G7.

McCord Lot 621A.

Sharon Heat 72517.

Ballistically tested in as-received condition.

Ballistic Limit 907 ft./sec.

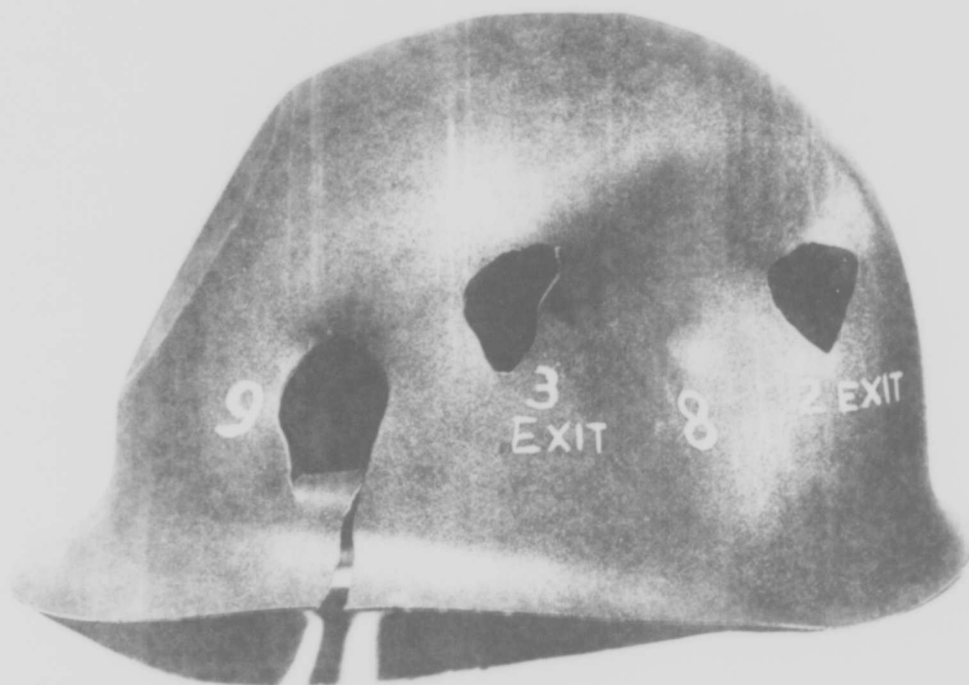
Helmet No. G6.

McCord Lot 621A.

Sharon Heat 72517.

Entire exterior surface shot blasted prior to ballistic test.

Ballistic Limit - Below 847 ft./sec.

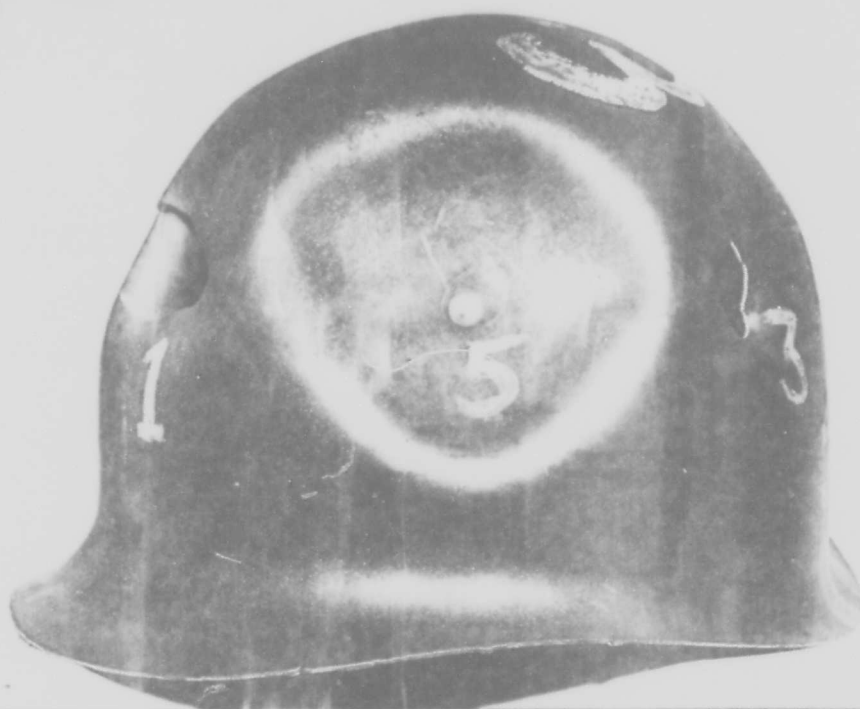
10. Shot blasting the interior surface of the helmet shell produced no appreciable change in the ballistic properties. If any favorable increase in compressive stress occurred it was compensated for by a decrease in the effective fracture strength of the inside surface. Shot blasting both the exterior and interior surfaces also produced no changes in ballistic properties. Both surfaces of the helmet were put into compression and the interior of the sheet into tension. Apparently, as long as the interior remains in compression, the ballistic properties remain satisfactory.

Helmet No. G3. McCord Lot 620A. Sharon Heat 72516.
Entire interior surface shot blasted prior to ballistic test.

Ballistic Limit - 897 ft./sec.

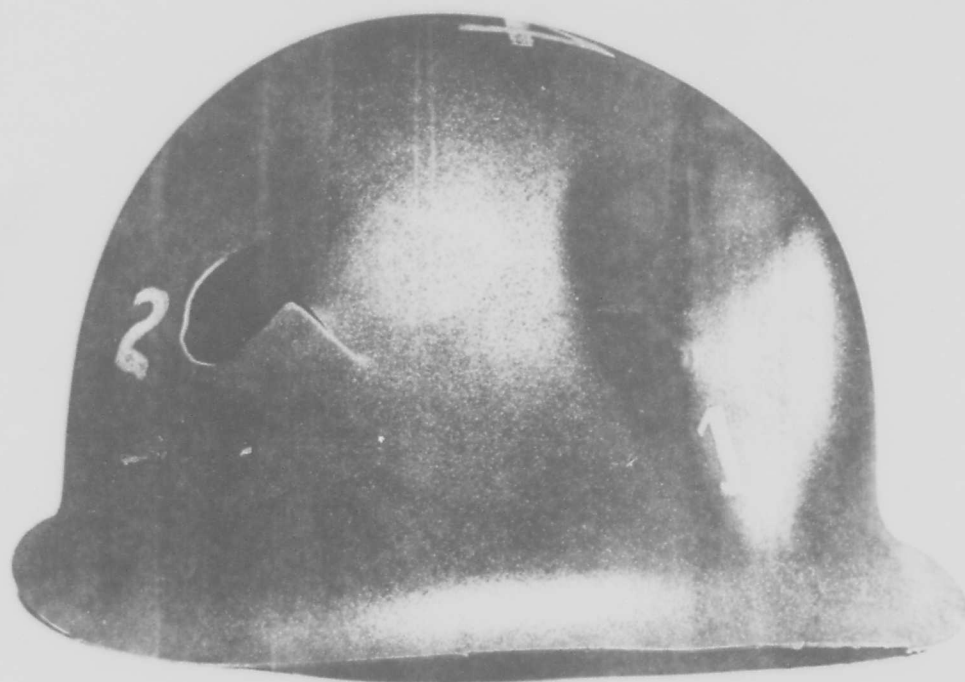
Helmet No. G4. McCord Lot 620A. Sharon Heat 72516.
Both interior and exterior surfaces shot blasted prior to ballistic test.

Ballistic Limit - 882 ft./sec.

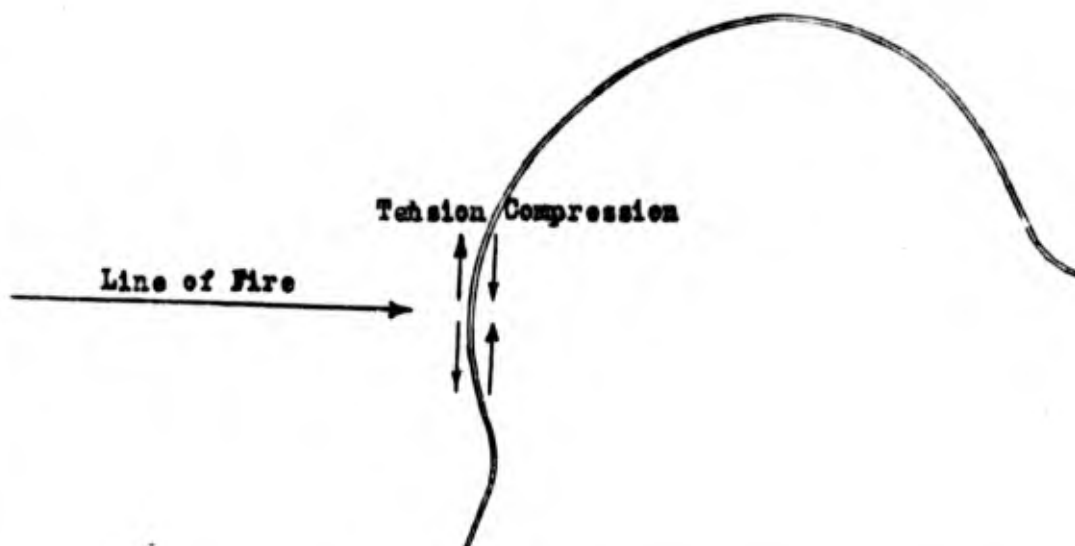
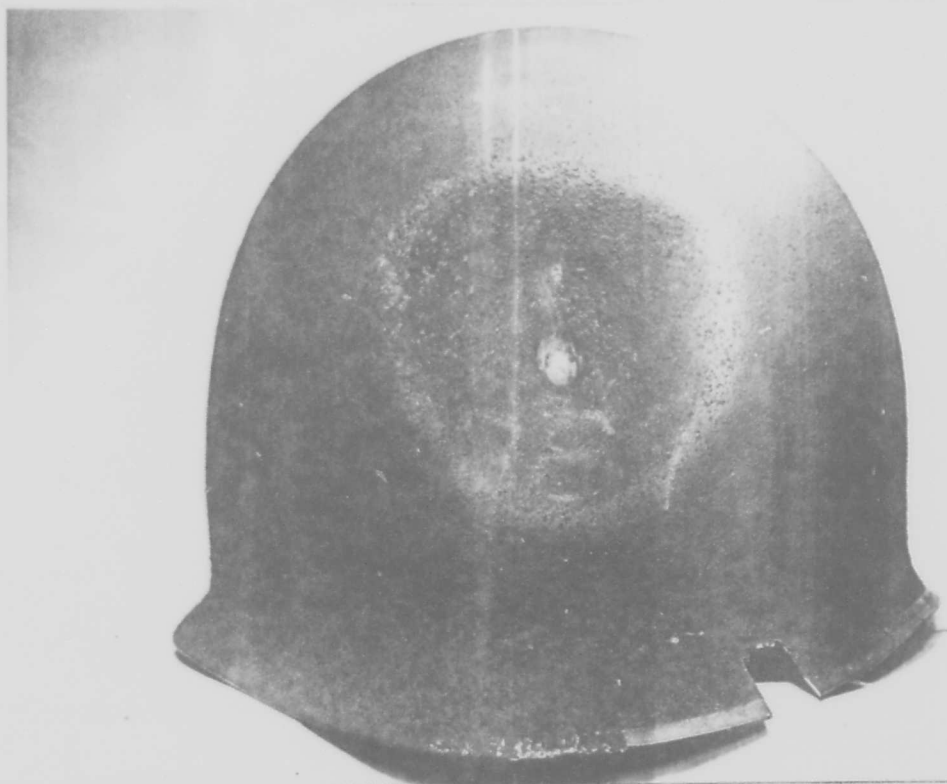
12. Obviously, the above experiment did not involve only a comparison of the effect of stress distribution upon ballistic properties, since the additional factor of differences of curvature exists. When helmet No. 6 was impacted on the outside surface, the deformation was distributed over a large portion of the area adjacent to the impact. This was due to the structural shape of this region of the helmet which permits the bending inwards of a large portion of the arch. In the case of helmet No. 5 which was impacted from the inside, the shape is such that deformation is restricted to a much smaller area than previously, tending to produce failure more readily. The brittle failure of helmet No. 5 is, however, a strong indication of the effect of the stress distribution upon the ballistic characteristics of thin sheets of a material whose ductility has been greatly reduced by cold deformation. When good quality manganese steel helmets are penetrated by caliber .45 ball ammunition, the metal tears and a piece is folded back as the bullet passes through. The complete separation of circular sections much larger than the diameter of the projectile is indicative of brittle behavior.

**Helmet No. 6. Residual Stresses Oppose Penetration.
Partial Penetration at 789 Ft. Per Sec.**

Helmet No. 6. McCord Lot 608A. As-received Condition.
Outside surface of helmet impacted at velocity of 789 ft./sec.
Partial penetration.

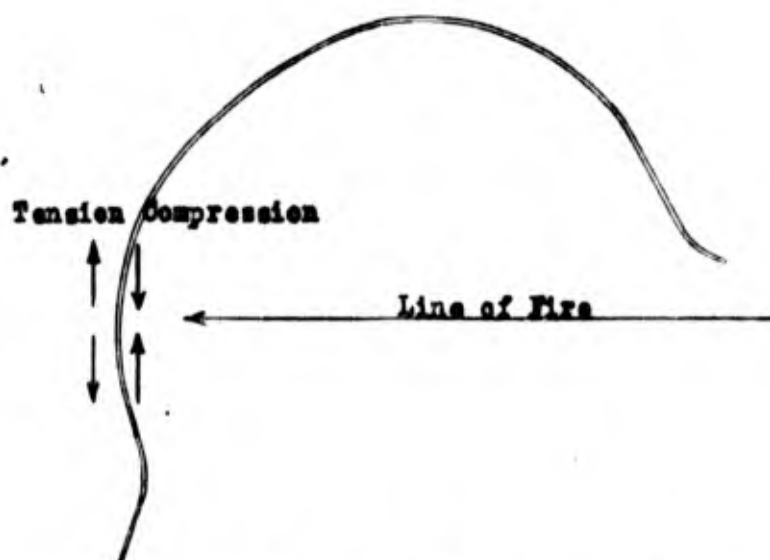
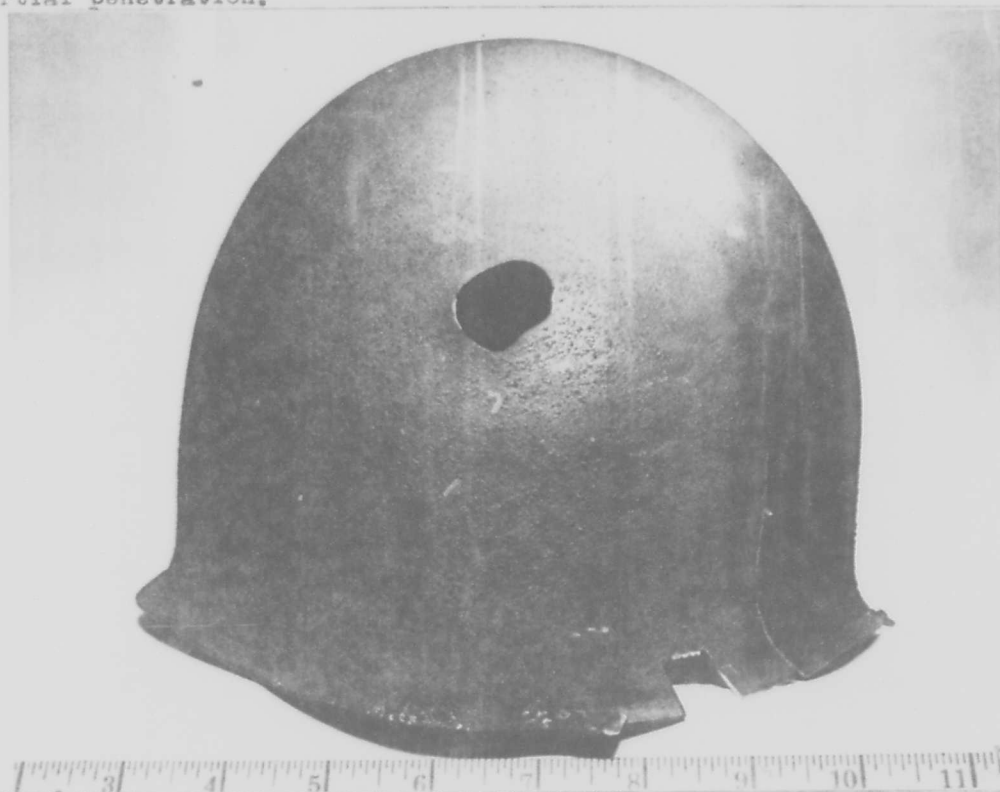
11. To substantiate the contention that the stress distribution plays a prominent part in determining the ballistic properties of Hadfield manganese steel helmets, two finished helmets from McCord Lot 608A were ballistically tested. These helmets were part of a group previously sent to this arsenal for metallurgical examination because of age cracking. The cracking was traced to a combination of highly stressed material and notches existing at a constant position in the visor edges. The steel was free of metallurgical defects. One shot was fired at identical spots on each helmet, using caliber .45 ball ammunition. The powder load, the same for each bullet, was intended to produce a velocity approximately 100 feet per second below the expected ballistic limit of satisfactory quality helmets. Helmet No. 6 was impacted on the outside surface, while helmet No. 5 was fired at so that the bullet struck the same spot on the inside surface of the helmet shell, see Figure 4. A partial penetration was produced in helmet No. 6 whereas a complete penetration, with brittle behavior, resulted in helmet No. 5, see Figure 5.

**Helmet No. 5. Residual Stresses Aid Penetration.
Complete Penetration at Approximately the Same
Velocity as Above.**

Helmet No. 5. McCord Lot 608A. As-received Condition.
Inside surface of helmet impacted at approximately the same
velocity as above. Complete penetration. Brittle behavior.
