**WATERTOWN ARSENAL
LABORATORY**

NO. WAL 710/321

Metallurgical Examination of Two

1/4" Rolled Homogeneous Armor Plates Which Exhibited
Differences in Steel Soundness under Ballistic Tests

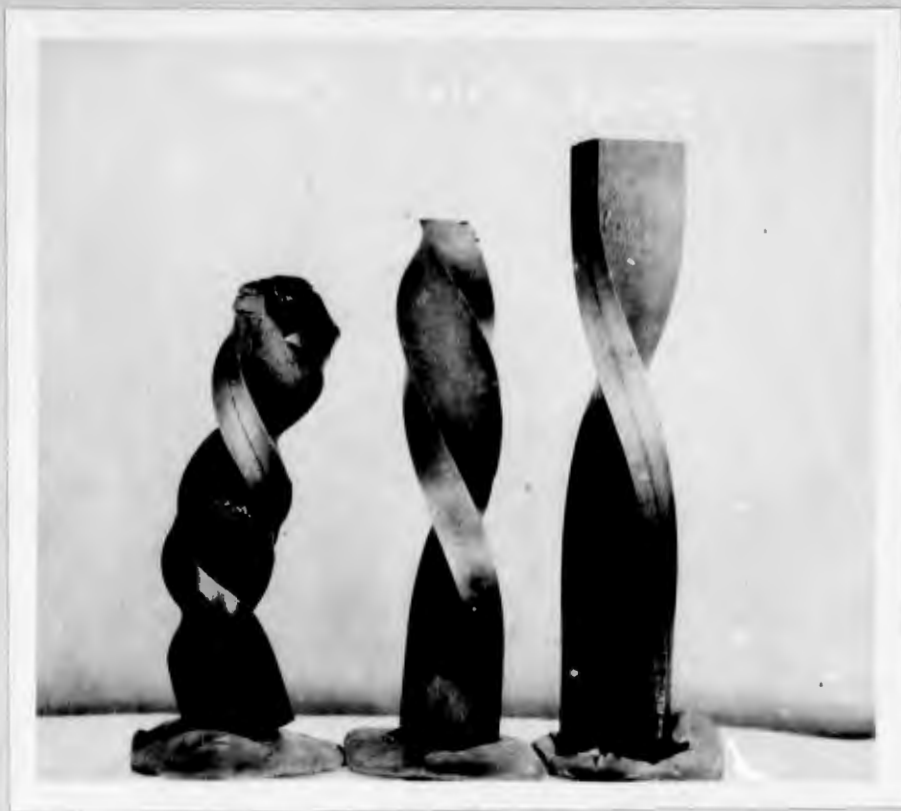
A

e. Torsion Tests. It was learned that a torsion test has been employed at the Naval Proving Center for revealing laminations in steel, and consequently a few tests were conducted on the subject plates to ascertain whether the subject defect could be revealed. Sections $\frac{1}{2}$ " x 3" x T (thickness) were cut adjacent to the macroetch test bar, clamped in a vise, and twisted with a wrench. The deformed bars (Figure 1A) from plate #2 exhibit a continuous lamination in the central plane of the plate extending completely across the bars. Since the first bar tried was twisted over three turns before the lamination was noticed, a second bar was tried, and it was found that $\frac{3}{4}$ of a turn revealed the lamination. For comparison a bar from plate #3 was twisted till the end sheared off yet no laminations were observed.

Comparison of torsion bars from Plates #2 and #3 showing lamination in Plate #2.

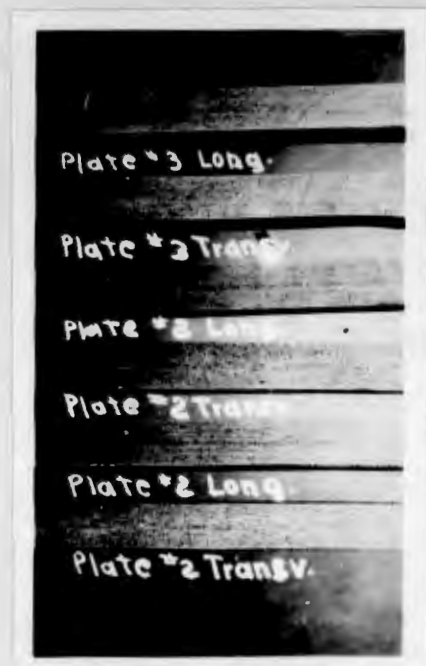
D

d. Macroetch Tests. Longitudinal and transverse sections were cut from an area 1" from the fractures and others 1" away from one of the ballistic penetrations exhibiting a backspall and etched in hot acid. The results are shown in Figure 1D. A faint centerline segregation is visible in the longitudinal direction and a disconnected segregation is observed in the transverse direction of plate #2. Plate #3 appears to be reasonably free from any extensive segregations of nonmetallic inclusions. The segregations observed in Plate #2 were considerably more prominent before the smudge was removed from the etched surface, indicating that the defect though pronounced was probably discontinuous.

Macro-etched sections.

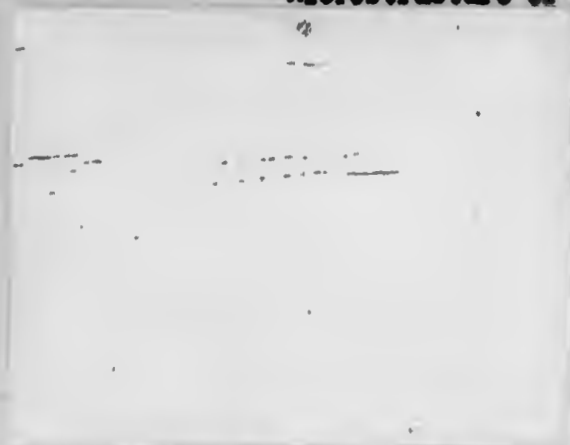
f. Microscopic Examination. An examination of the unetched specimens revealed a preponderance of silicate type stringers at the center of the plate #2, (Figure 2A). The sheared end of a torsion bar from this plate was examined microscopically, and it was observed that silicate type inclusions were present in the crack as well as in the undeformed metal in the same plane as the crack (Figure 2C).

X100 A Unetched
Plate #2 centerline inclusions.

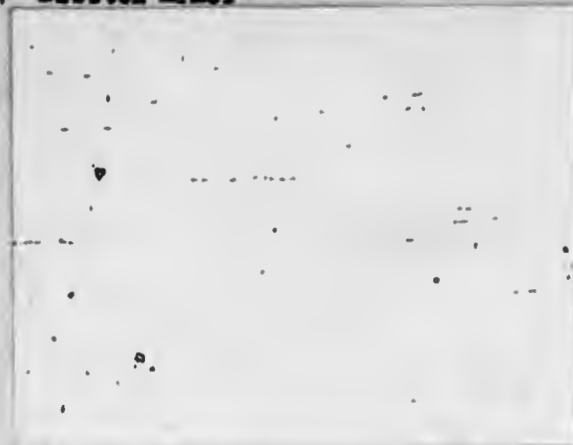
X100 B Unetched
Plate #3 - typical distribution of inclusions.

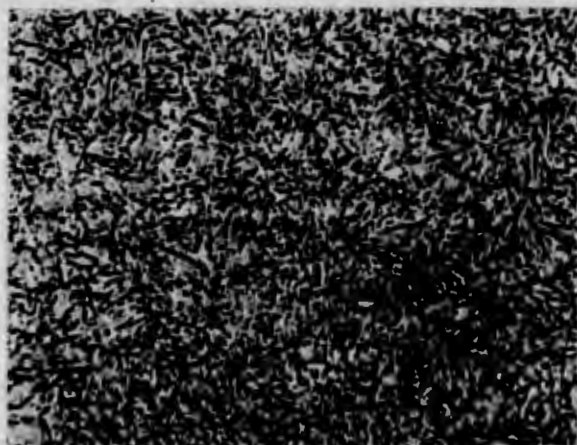
The microstructure in both plates was a homogeneous tempered martensite (Figure 2D and E).

X1000 D Pical
Plate #2 - Tempered Martensite.

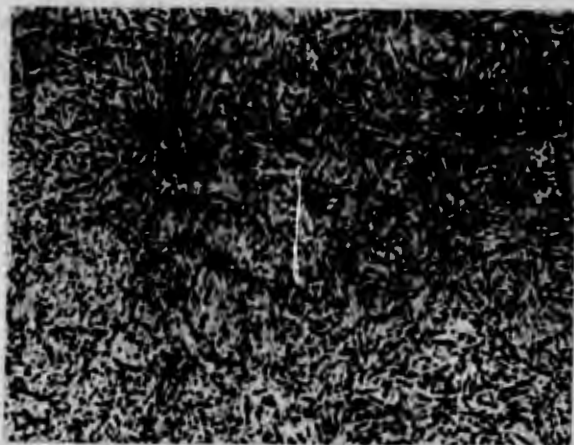
X1000 E Pical
Plate #3 - Tempered Martensite.
