Report No. 710/393
Watertown Arsenal
Restricted

Metallurgical Examination of Punchings from
Cast Turret of British A-12 Infantry Tank

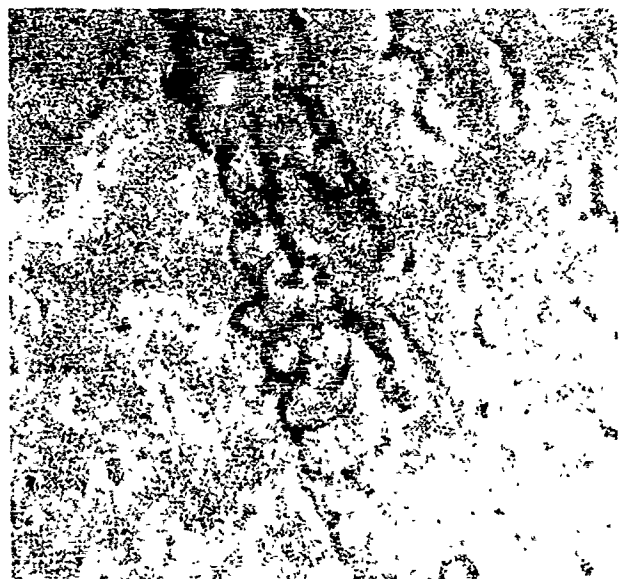
Figure 7 illustrates the typical dendritic structure revealed by the Oberhoffer etch. A crack is visible extending into the cross section from the surface. It was noted that the path of rupture

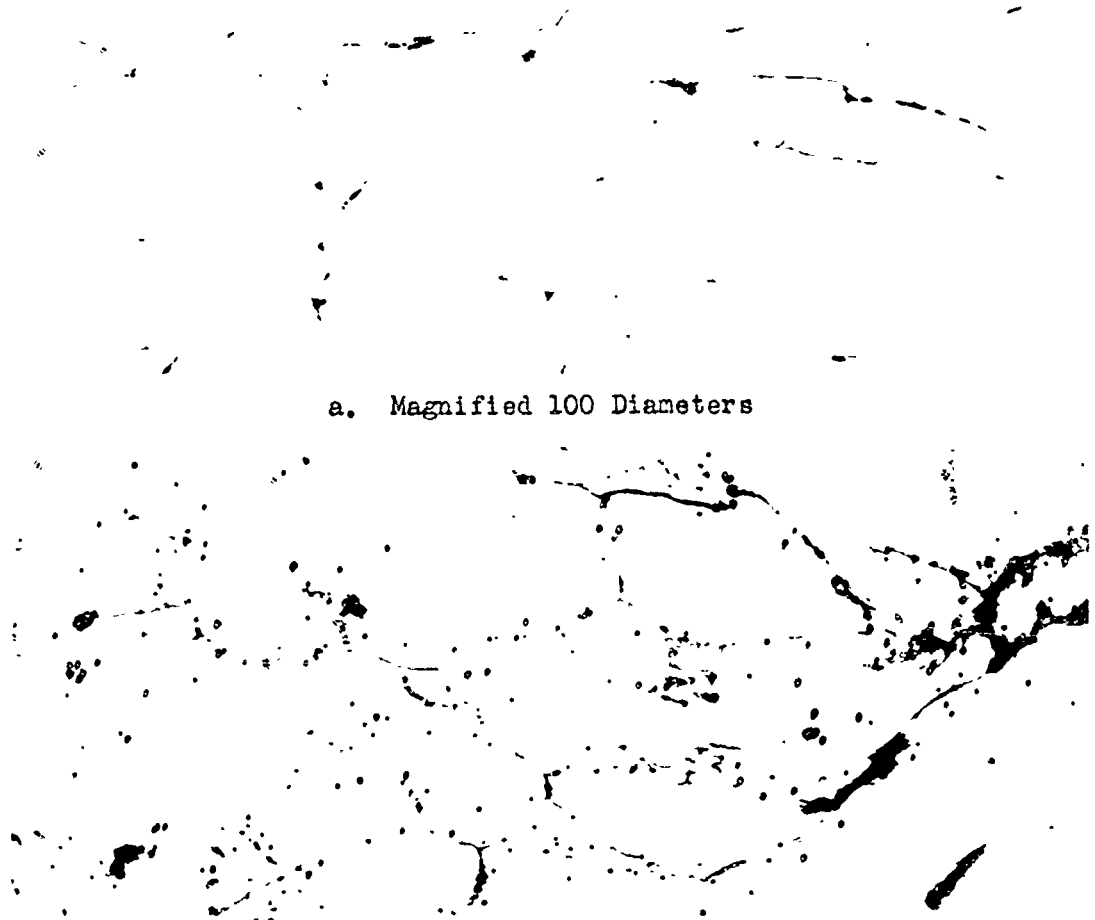
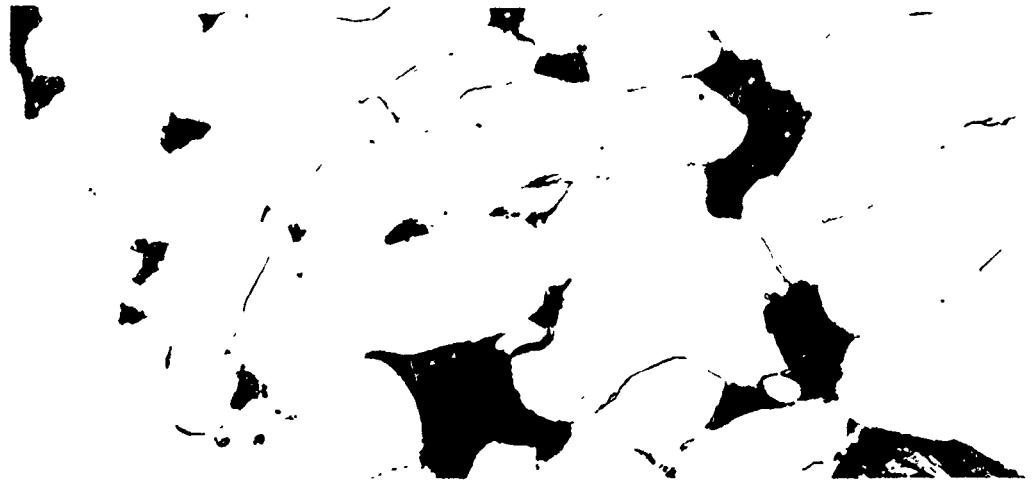
Figure 8

- (a) No. 1-1 - Films around grain boundaries found in isolated region in microspecimen. The hot acid etch shows this condition to be more widespread than expected from an examination of the polished unetched surfaces.

- (b) No. 1-2 - Oxides and oxide films around grains found in a porous region about 1/8"x1/4" in area on specimen.

- (c) No. 1-2 - Porosity and grain boundary cracks found in a porous area about 1/8"x1/4" in extent.

It is believed that the coarse fracture found on the punchings is due to failure extending along defective regions like the above. Although only isolated regions of this type were found in the polished specimens, the hot acid etch revealed a more general occurrence of hairline cracks, and a coarse, open dendritic structure, associated with shrinkage porosity.

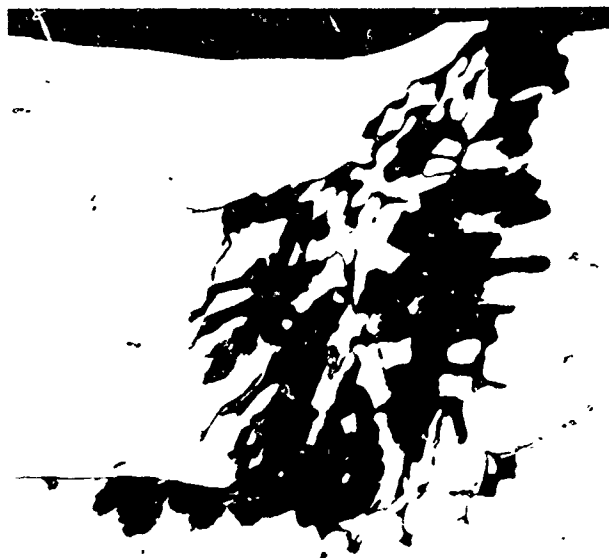
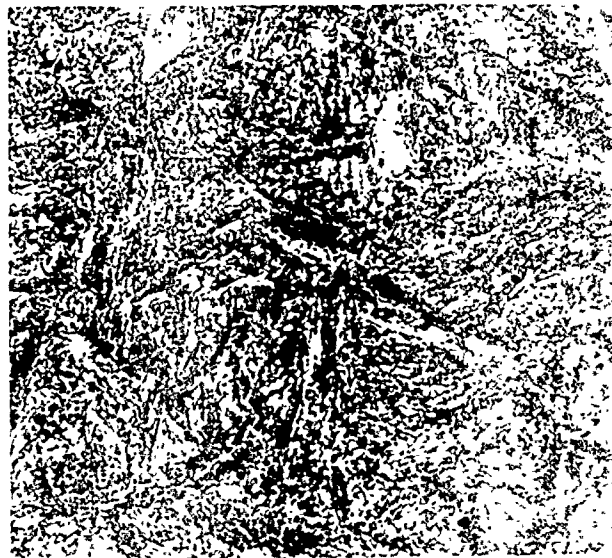
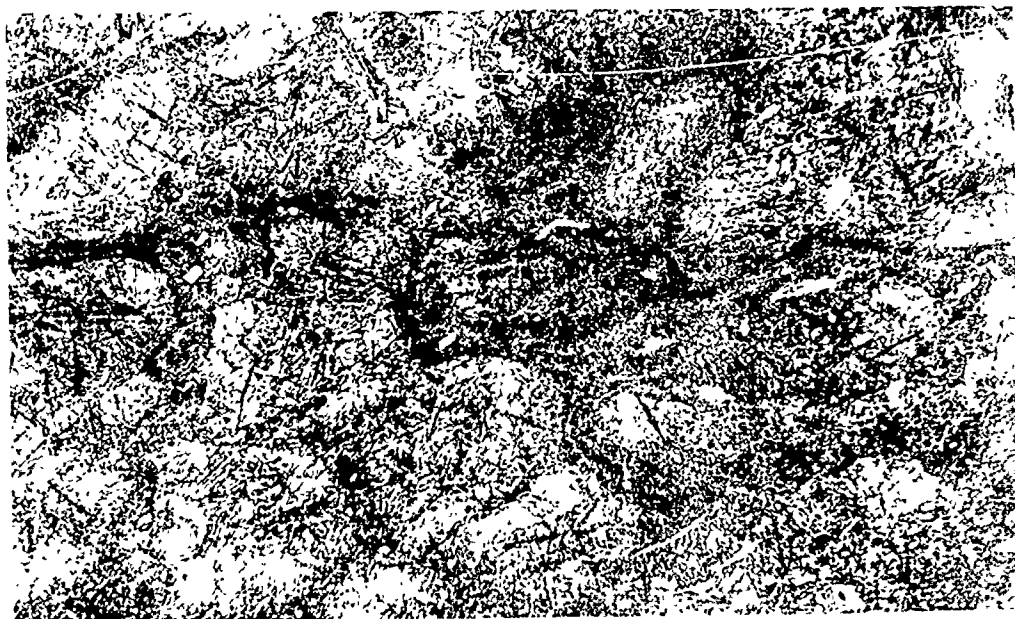
Figure 9MicrostructureUnetched and Etched in 1% Nital

- (a) No. 2-3 - slag-filled shrinkage porosity found at surface of casting. The surface of the casting is marked with many lines and cracks, some of which are found to extend more than 1/2" into the metal. (See MA-3527.) These cracks seem to be hot tears. Some porosity also extends to the casting surface.

- (b) No. 3-2 - There is a band about 1/8" wide extending across this specimen and roughly parallel to the casting surface and 1-1/4" away from the surface that contains heavy segregations of nonmetallics and massive carbides are found associated with the nonmetallic inclusions just as in MA-3529. This region has, in addition, a more segregated microstructure, with the nonmetallics and the carbides usually found in the interdendritic fillings. (This band also extends across specimen No. 3-1.)

- (c) No. 3-2 - Average microstructure of punchings. Spheroidized sorbite arranged in acicular fashion. This microstructure is fairly uniform.

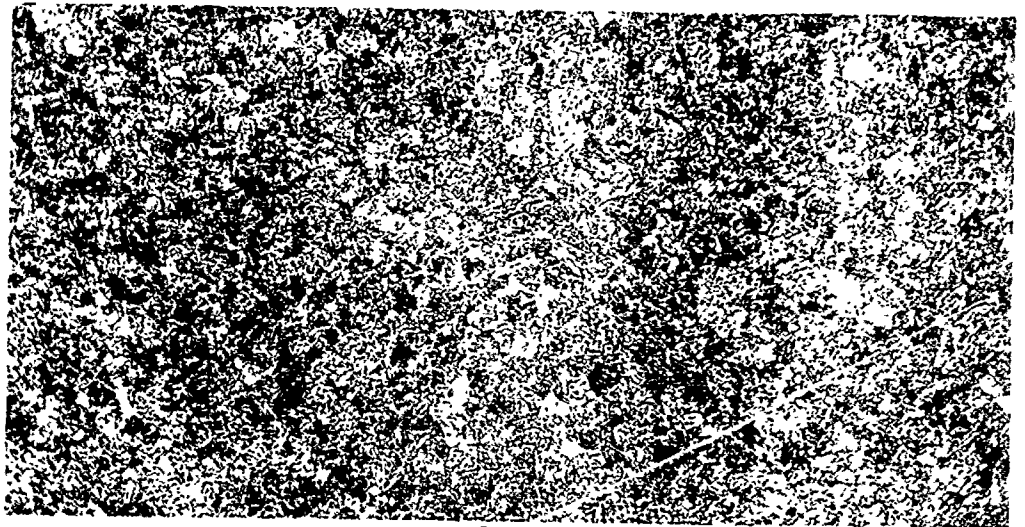
b.

- (b) Microstructure of section of punching No. 3 after the following heat treatment:

The massive carbides were put into solution by this heat treatment.

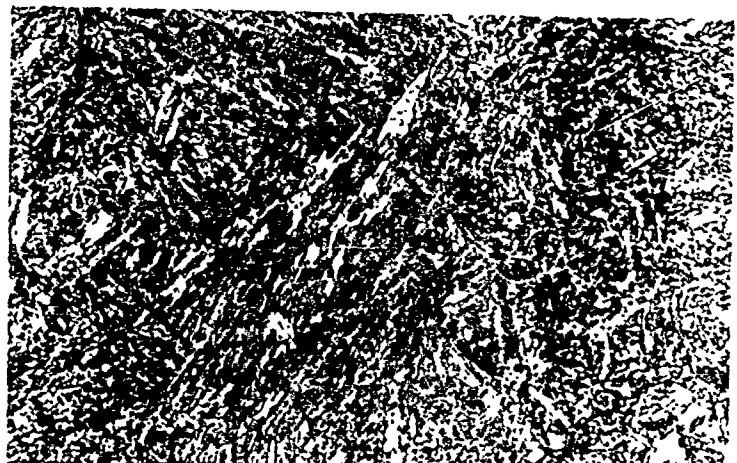
c.

- (c) View at higher magnification of the above specimen. Acicular sorbitic structure with finely spheroidized carbides.

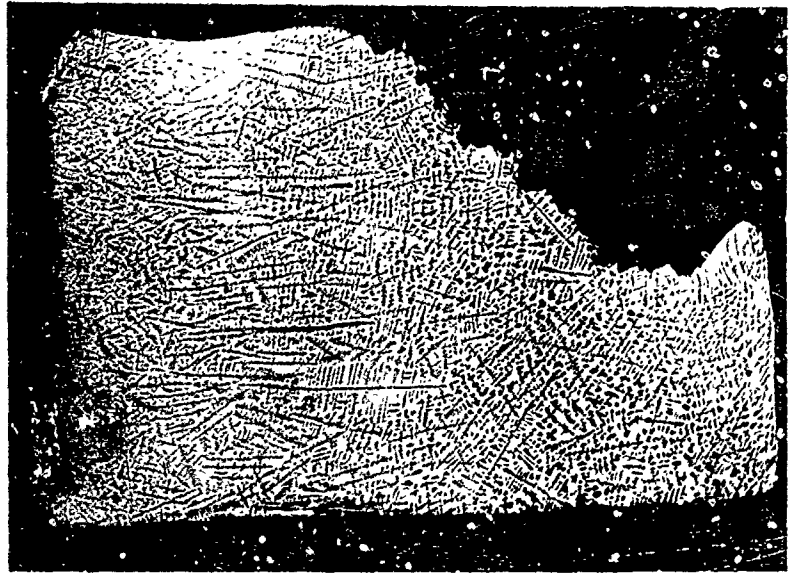
a. X3

followed the dendritic pattern. (See Figure 11a.) Figure 11b shows macrostructure of same punching after Watertown Arsenal heat treatment.

- (a) Macrostructure of specimen No. 2-1 which had a coarse fracture. The fracture follows the outline of the interdendritic filling material in which the impurities and oxide films are segregated.

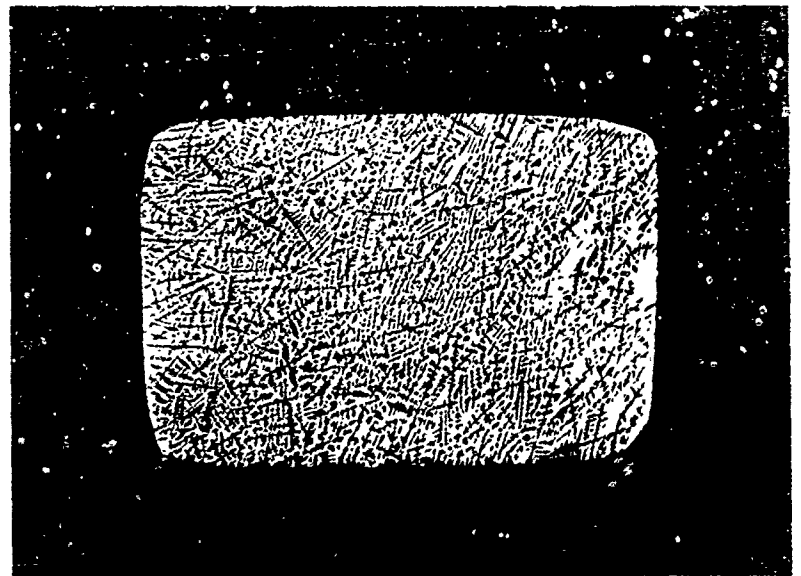
b. X3

- (b) Macrostructure of specimen No. 3 after the homogenizing heat treatment:

No appreciable change in the macrostructure was produced by the treatment.
