MEMORANDUM REPORT

NO. WAL 710/612

A Study of the Seam Welding Process Applied to
Prevent Stress Cracking of the Visor of the M1 Helmet

BY
A. HURLICH
Assoc. Metallurgist

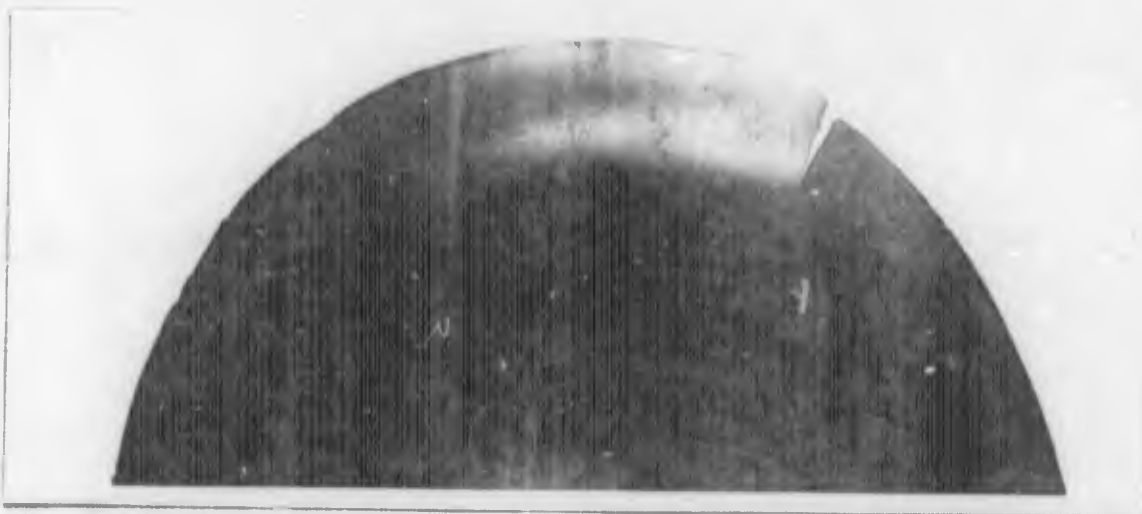
a. Visual examination. Each of the two regular production helmets had one crack located at the 26° position,* one 2.2" and the other 0.43" in length. Both cracks originated at a notch at the edge, see Figure 1A. The two edge annealed helmets also contained visor cracks, both at the 26° position, one 0.12" and the other 0.16" in length, and both originating from edge notches. The significant feature of the visor cracks in the edge-annealed helmets is that the cracks do not extend through the welded zone, terminating in both cases approximately at the beginning of the zone, see Figures 1B and C.

Another significant observation is that the cracks occur in a constant position in all helmets and in every case are associated with notches. This correlates with previous observations that trimming die defects are responsible for the notches, which, being located in highly stressed regions, promote the formation of cracks.

A. Lot 21382. Magnification $X_{1/2}$. Looking down upon visor from top of helmet. 2.2" long crack at 26° position extending from notch at rim.

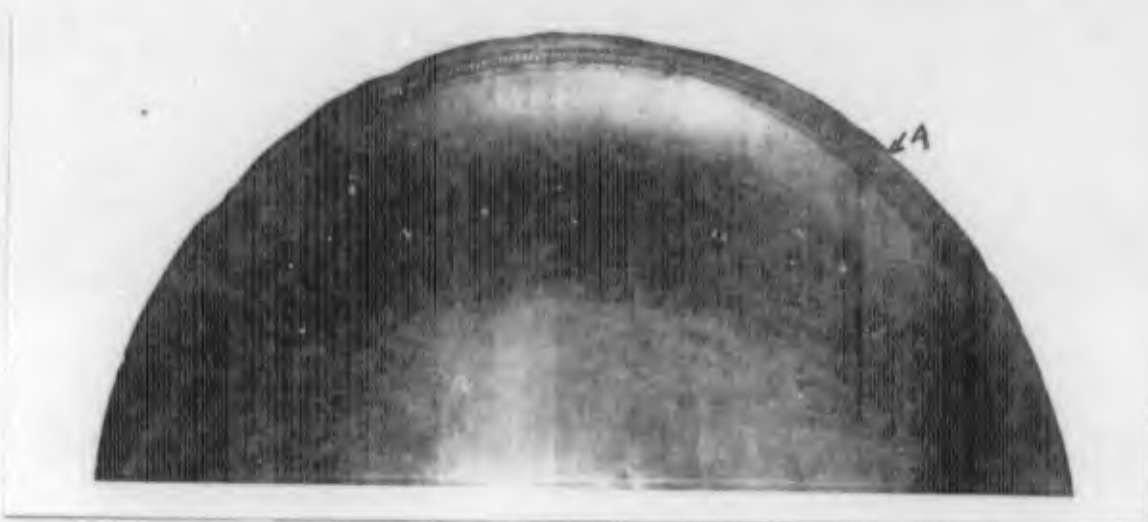
B. Lot 21383. Magnification $X_{1/2}$. Visor seam-welded to anneal cold worked rim. Note small crack at notch at A.

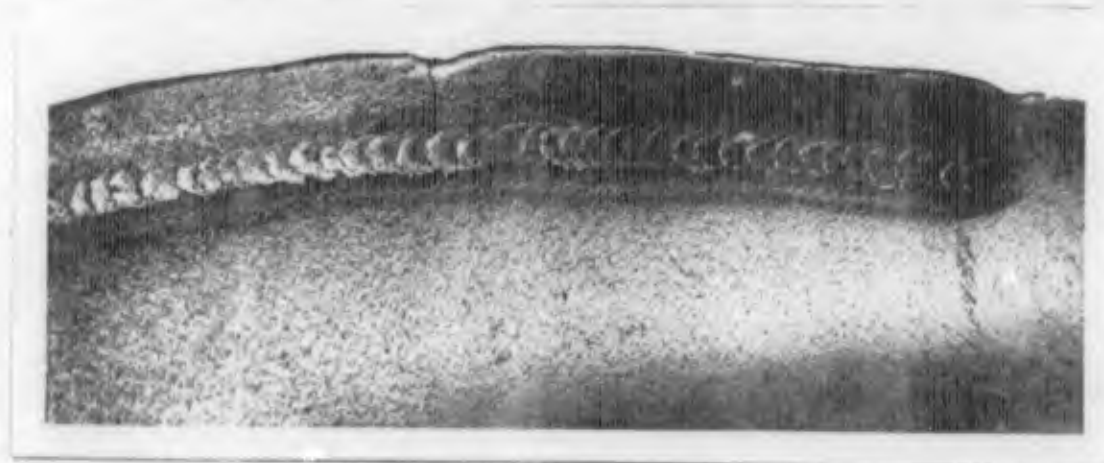
C. Lot 21383. Magnification X_2 . Area at A in above photograph. Note that crack extends to, but not through, seam-welded zone. Length of crack - 0.16".

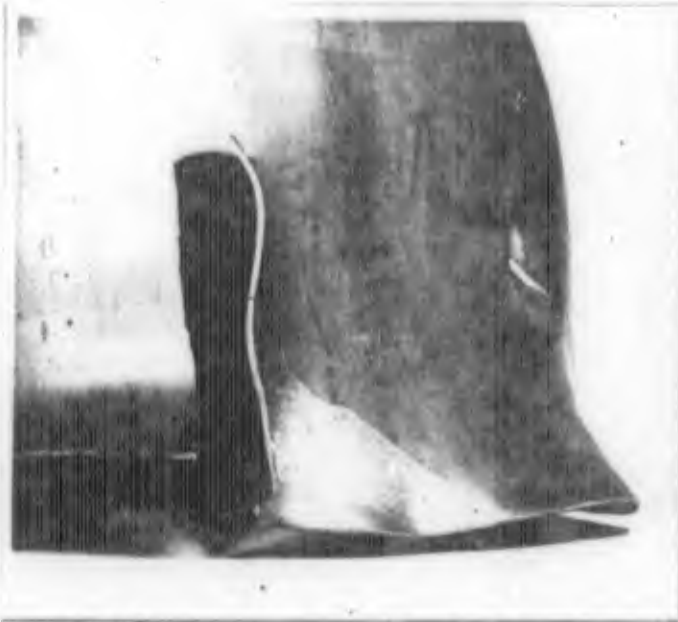
The regular production helmet was impacted with one bullet which struck the edge of the visor approximately two inches away from the 2.2" long crack at 26°. The crack was lengthened to 2.5 inches, and another crack, 0.6" long, developed at 22°, see Figure 2A. The edge-annealed helmet was impacted with four rounds which struck at or near the edge of the visor at a distance of 1 to 3 inches away from the 0.16" long crack at 26°, see Figure 2B. The crack was extended to 1.7" in length but no new cracks were developed. This test, although conducted upon only one helmet, indicates that the edge-annealing process causes no deleterious change in the ballistic properties of the visor.

Lot 2132. -A- X $\frac{1}{2}$
Cracks resulting from impact of Cal. .45
ball upon visor. Velocity approx. 900
ft./sec. Edge of helmet not annealed by
seam-welding. Cracks at 22° and 25°
positions.

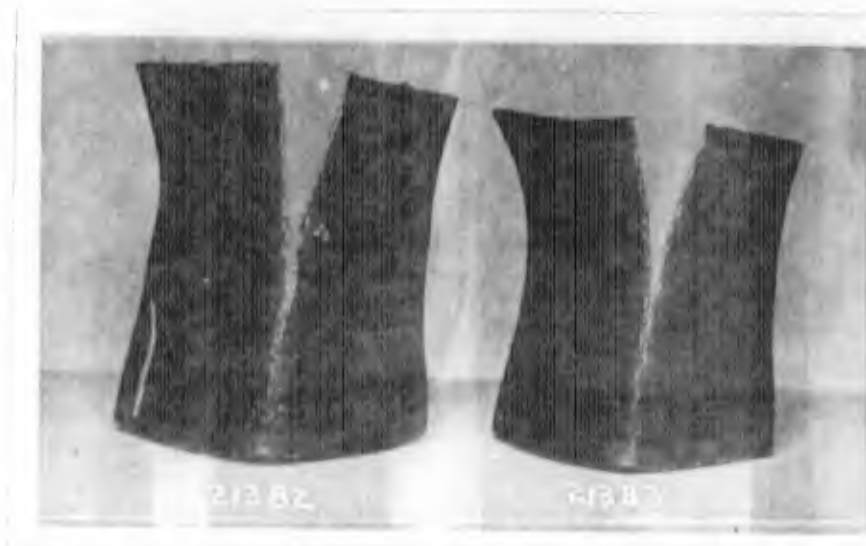
c. 90° bend tests. Approximately two inch square sections were cut from the visors of the four helmets in the region lying between 350° and 10°. The sections were clamped in a vise with approximately one inch protruding, and the projection was hammered down to produce a 90° bend in a direction perpendicular to the edge of the helmet. The sections from the regular production helmets broke completely apart, as did the cold worked region above the weld zone of the edge-annealed helmets. The section from one of the edge-annealed helmets showed no cracking whatsoever from the edge to the far boundary of the weld zone, while the other section showed some slight surface cracking in the cold worked zone between the edge and the weld, see Figure 2C. This test demonstrates the improved ductility imparted to the edge of the visor by the annealing process.

-C- X1
90° bend tests on sections cut from visors of edge
annealed helmets. Similar tests on helmets without
edge-annealing resulted in complete breakage.

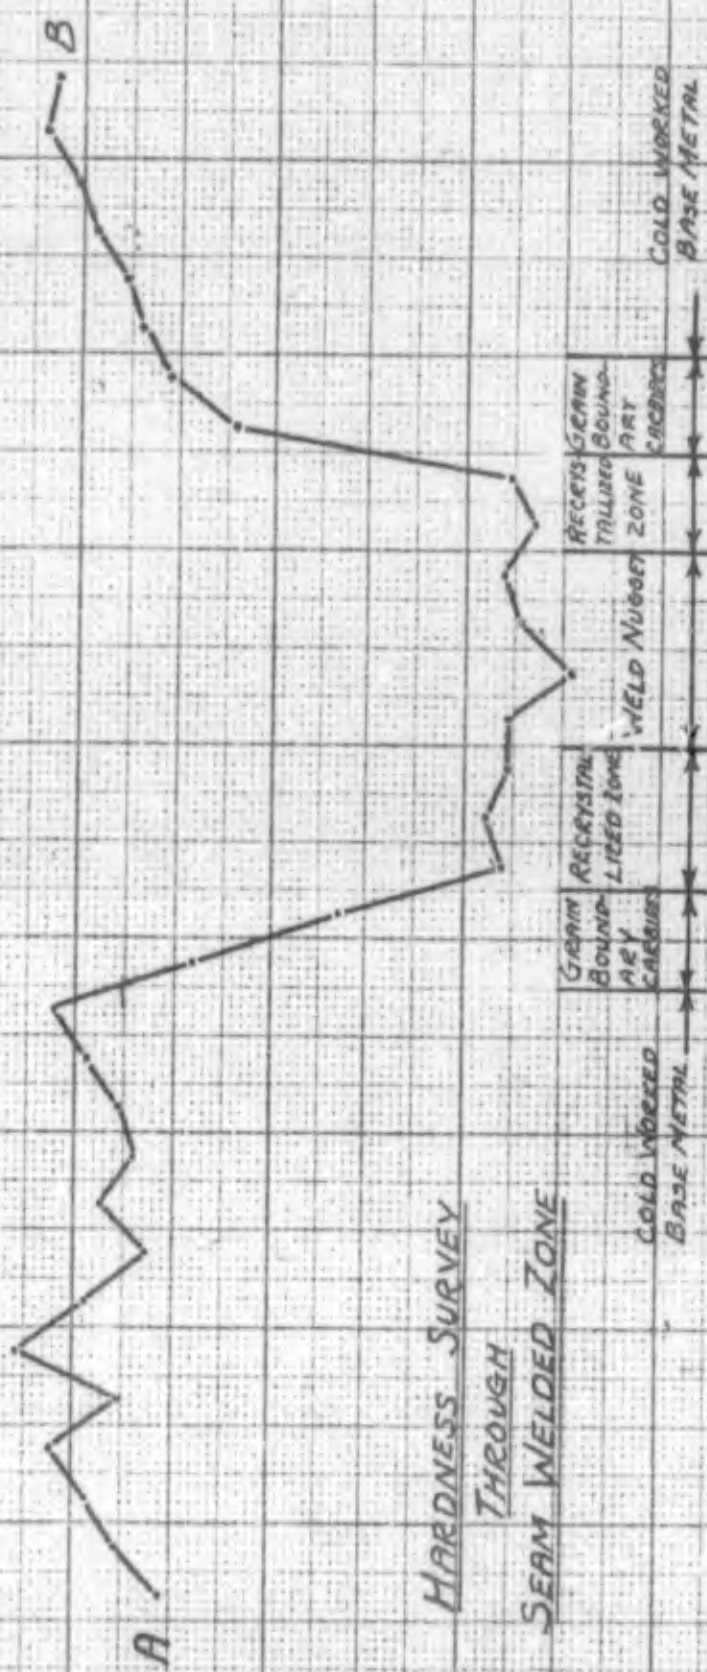
FIGURE 3

d. Hardness Surveys. Sections were cut transversely through the annealed zones, mounted in lucite, and metallographically polished. After etching in nital, Knoop hardness surveys were made through the weld zone and the cold worked base metal. The results of a typical hardness survey are shown in Figure 3. The hardness from the edge to a distance of 0.15" from the edge averages approximately 500 Knoop Hardness Number,* then falls

sharply to approximately 275 KHN through the weld zone which is approximately 0.08" wide, then rises again to the base metal hardness of 500 KHN. A photomicrograph of a portion of a Knoop hardness survey through the weld zone is shown in Figure 4B.

HARDNESS SURVEY
THROUGH
SEAM WELDED ZONE

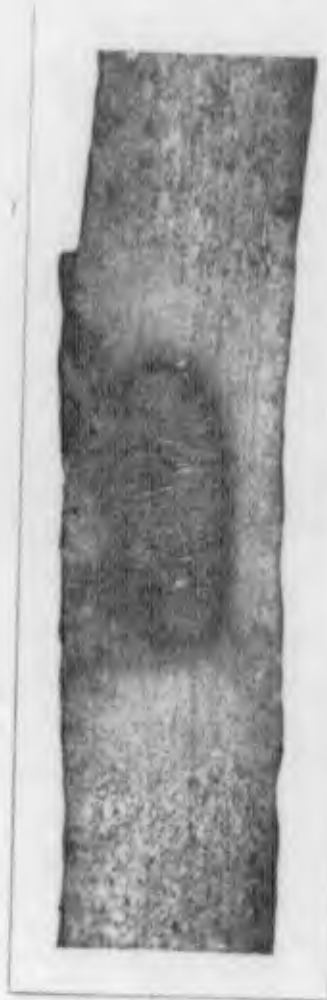
e. Microscopic Examination. The appearance of a cross-section of the edge-annealed zone at low magnification is shown in Figure 4A. The dendritic structure in the oval weld nugget indicates that the melting temperature had been reached in this zone, resulting in the dendritic solidification structure. The weld nugget is surrounded by a very fine grained recrystallized zone in which all traces of cold working have been eliminated. The extremely fine grain size probably resulted from the very short thermal cycle, and accounts for the relatively high hardness of the annealed zone. Normally annealed Hadfield steel, having a grain size of A.S.T.M. #4-5, has an average hardness of Rockwell C 10-11, whereas the annealed zone in the edge-annealed helmets has a hardness equivalent to Rockwell C 27-28.

Lot 213B3
 -A- X25
 Longitudinal section through semi-welded zone. Dendritic structure of weld nugget indicates melting and resolidification.

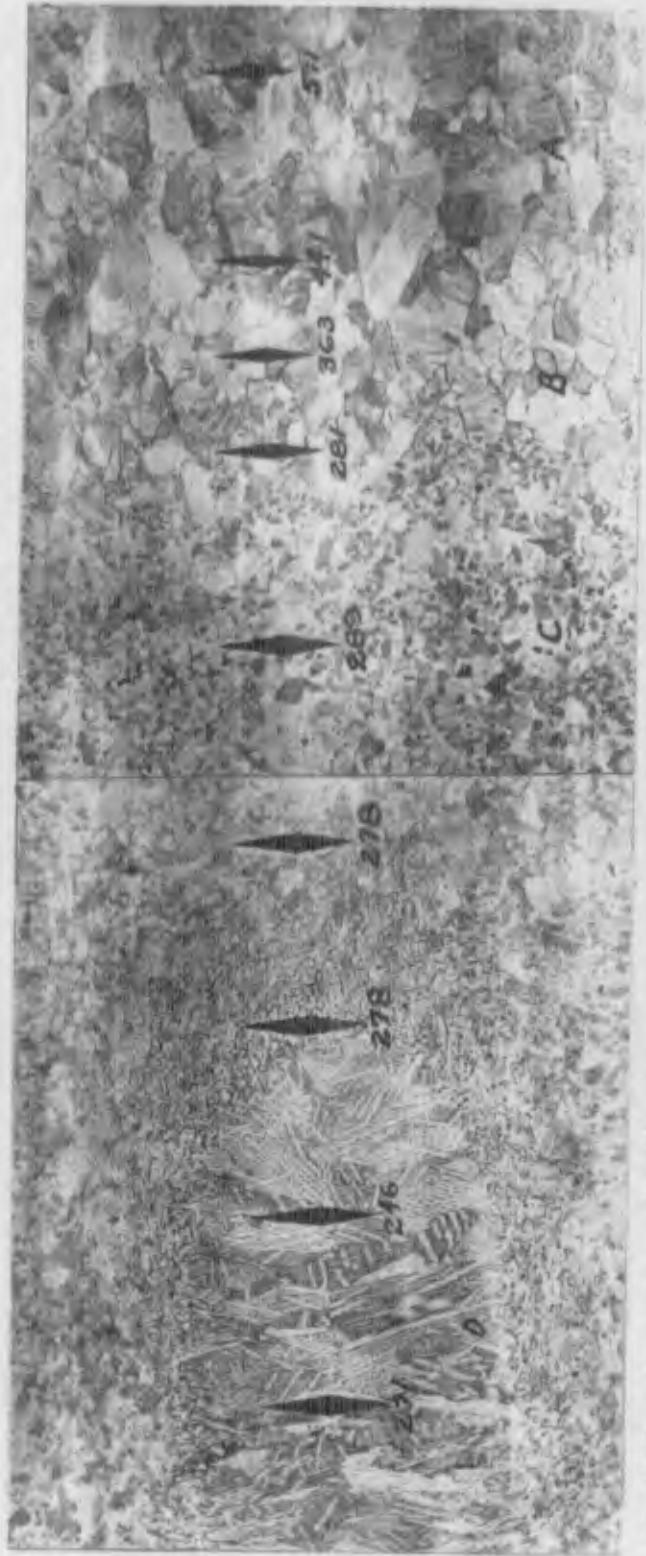
Flanking the annealed zone is a region averaging 0.02" in width in which carbides have been precipitated by heating in a temperature range between approximately 700°F. and the temperature of recrystallization.

Same as above after Knoop Hardness Survey. X100
 -B-
 A is cold worked base metal. B is zone in which carbide precipitation at grain boundaries has occurred. C is zone of recrystallized annealed metal. D is weld nugget showing dendritic structure. Zone D is surrounded by area in which carbide precipitation occurred.
