REPORT NO. 710/14

TEST OF COMPOSITE PLATES FOR  
ARMOR PLATE

Report No. 710/14  
Watertown Arsenal

Test of Composite Plates for Armor Plate

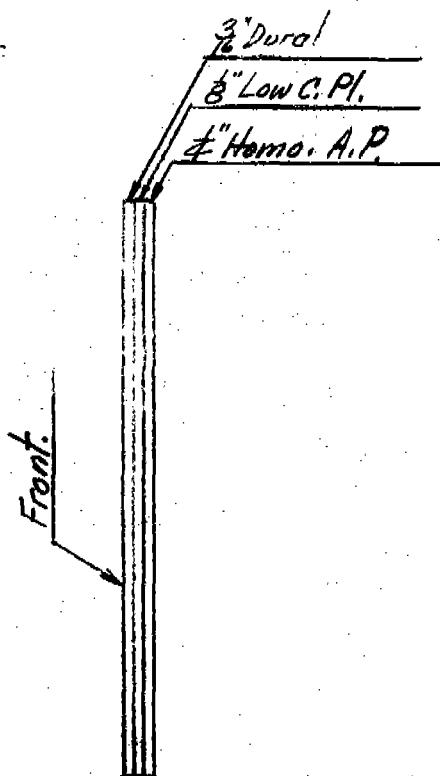
Combination "A"

Rounds 1 to 4 inclusive were fired at front side of plate. Rounds A to C inclusive were fired at back side of plate.

ROUND NO.	STRIKING VELOCITY	REMARKS
1	2460	
2	"	Comp. penetratio
3	"	"
4	"	"
A	2460	"
B	"	Comp. penetratio
C	"	points of core just through and core stayed in plate.

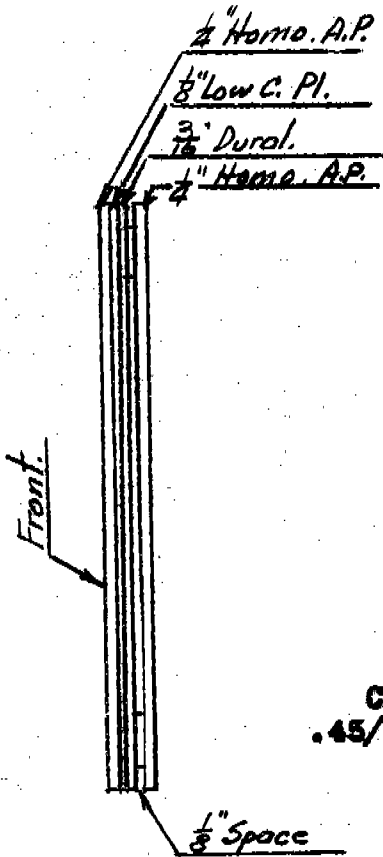
PLATE NO. Combination "B"

This plate was found very good using 2460 f.s. velocity ammunition and Springfield rifle, and plate was sent to Frankford Arsenal for further firing test, the results of which are included within the pages of this report.

ROUND NO.	STRIKING VELOCITY	REMARKS
S, S, & S.	2460	Bulged dural to face of back plate-no damage on back plate.

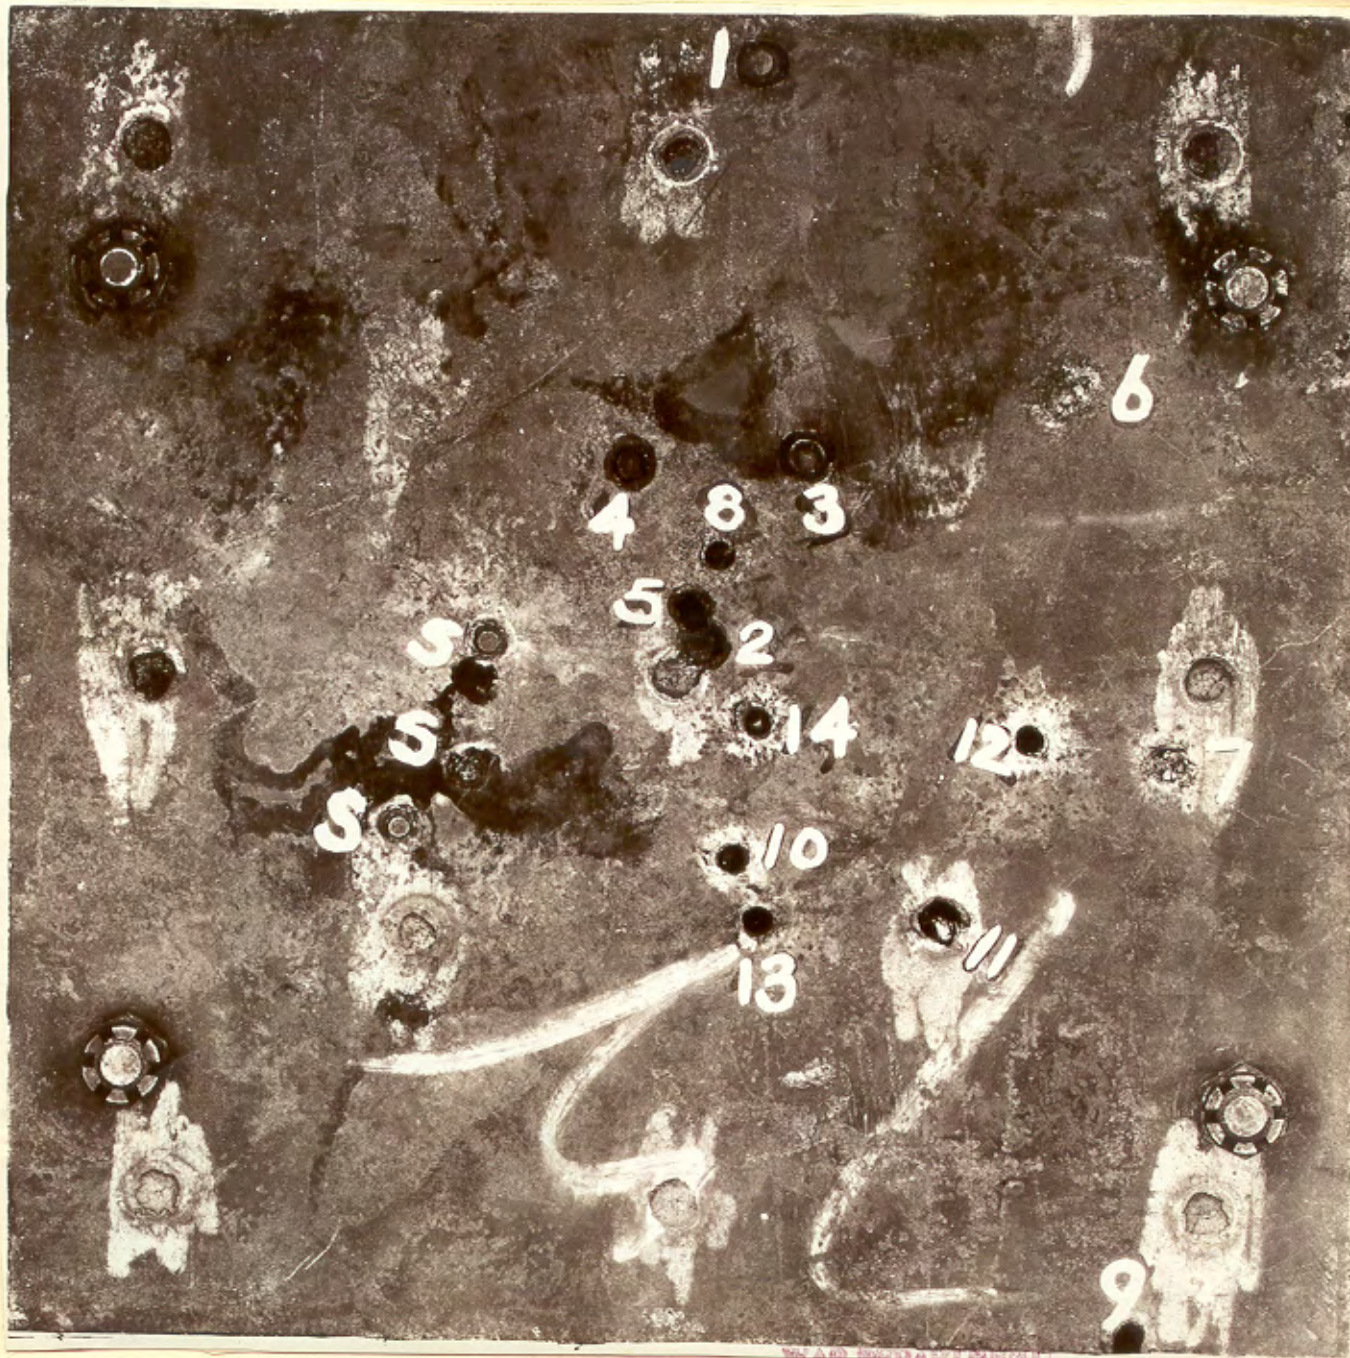
710-25

FRONT  
OF  
FRONT PLATE.

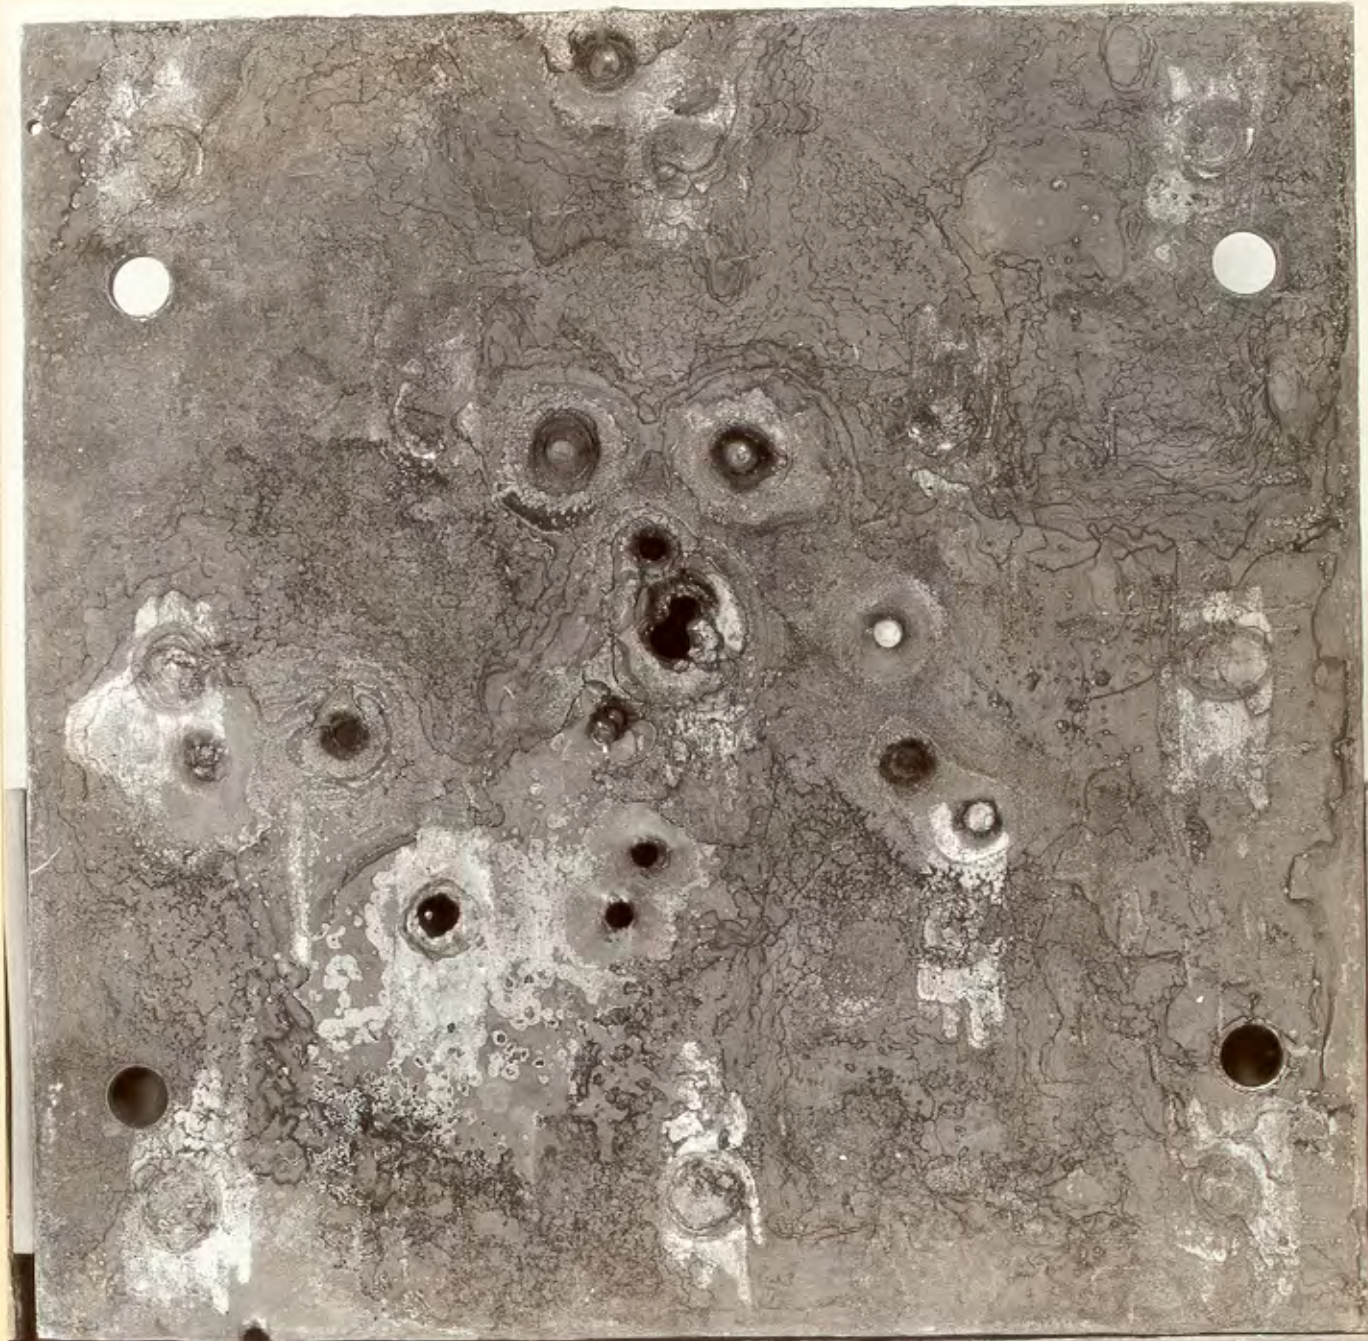
710-26

BACK  
OF  
FRONT PLATE.

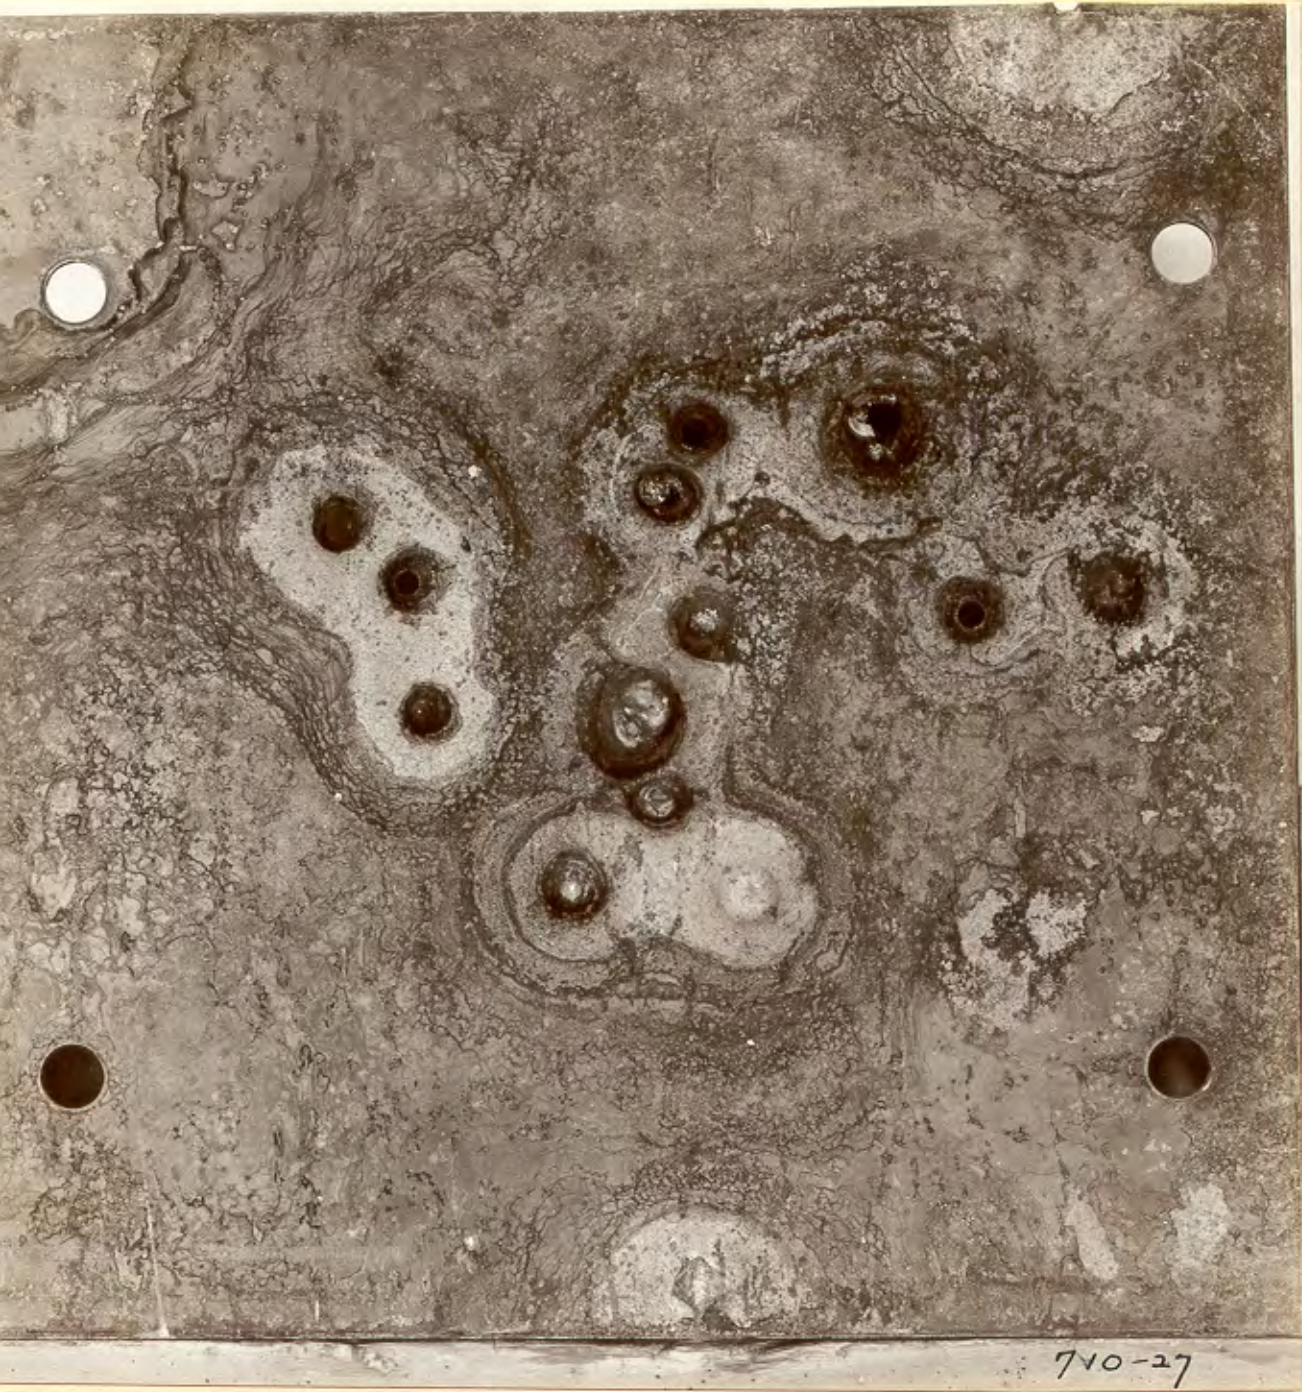
710-27

The photographs at the back of this report should be studied and special attention should be paid to the condition of the low carbon steel 1/8" plate and the dural sheet which gave with the core and flattered against the back plate.

FRONT  
OF  
LOW CARBON PLATE.

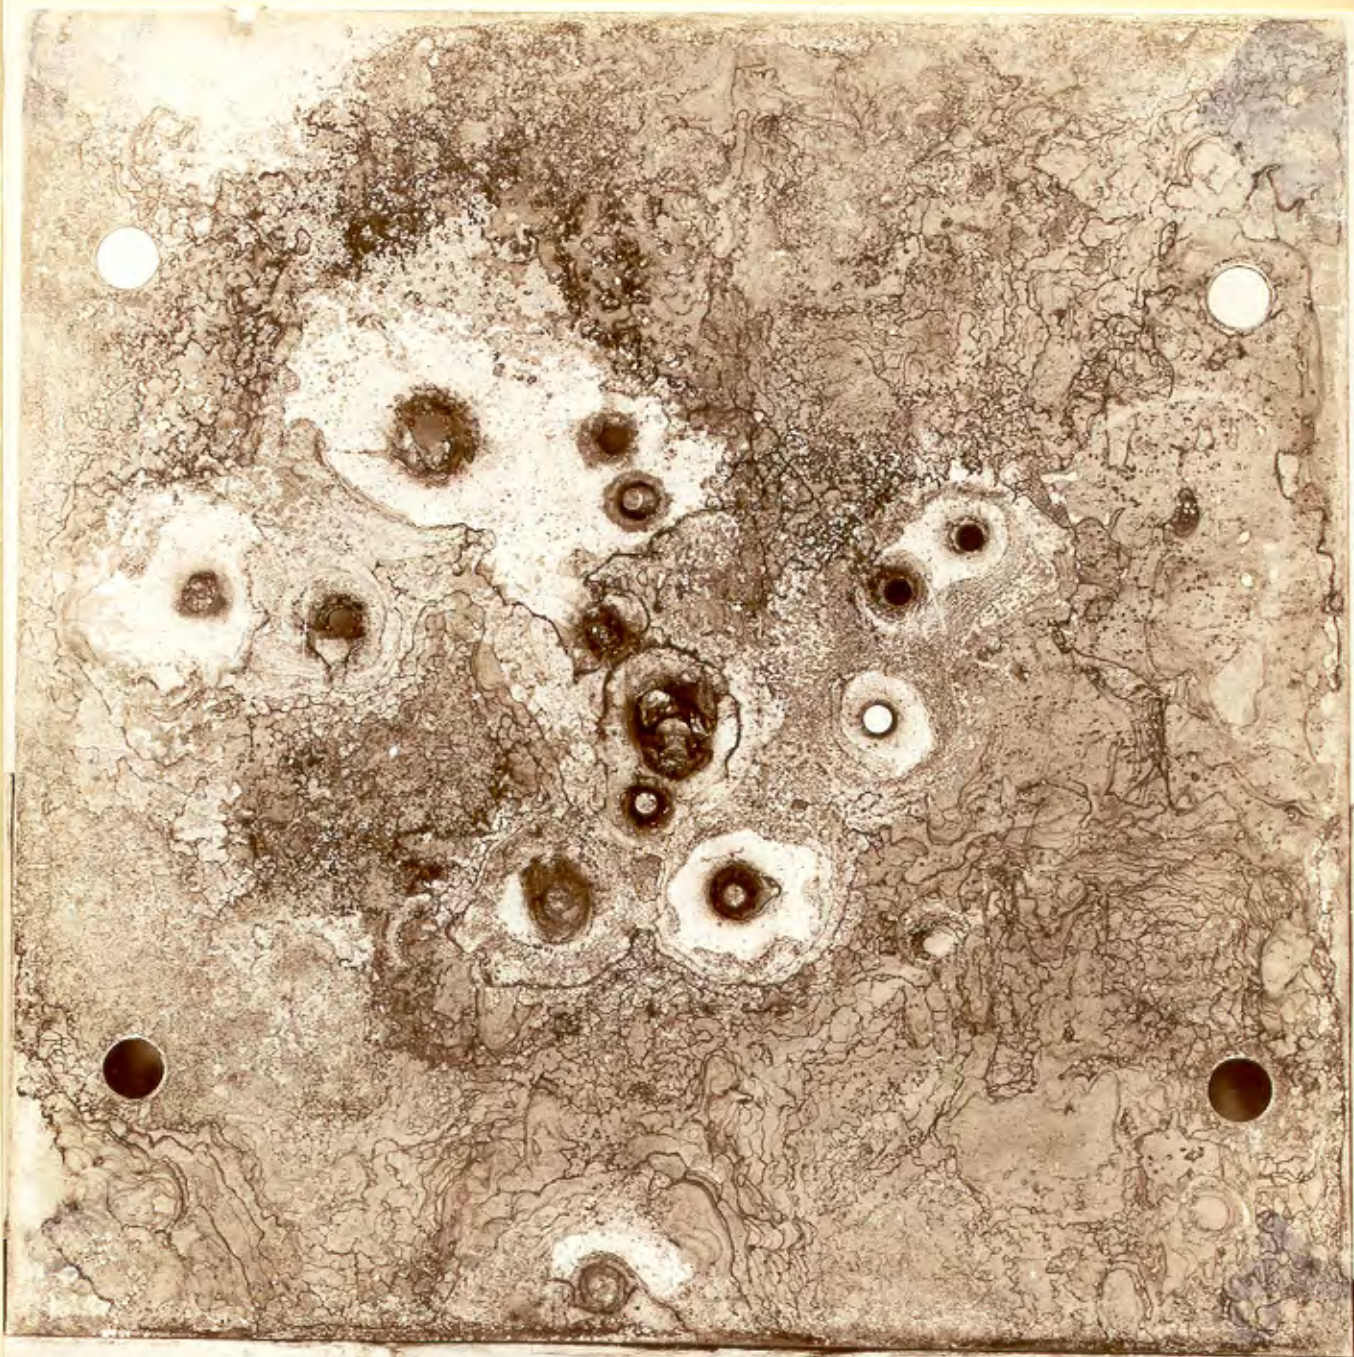
710-2B

BACK  
OF  
LOW CARBON PLATE.

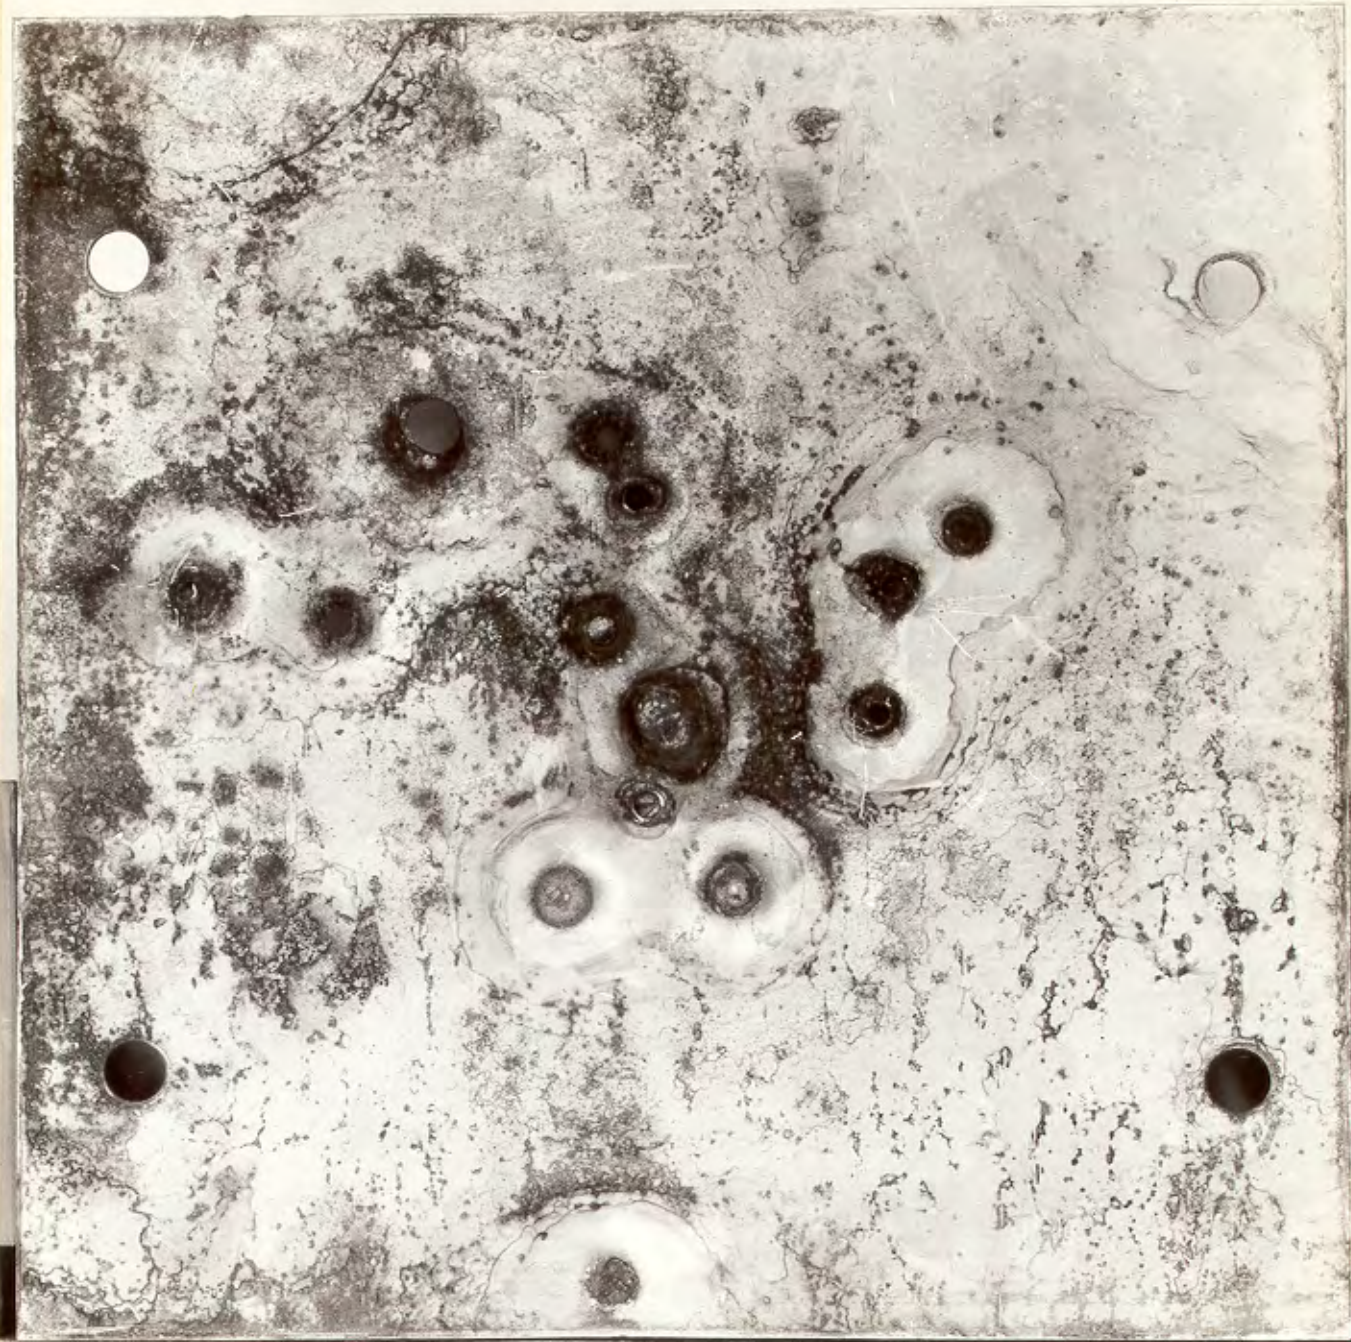
710-29

FRONT  
OF  
DURAL PLATE.

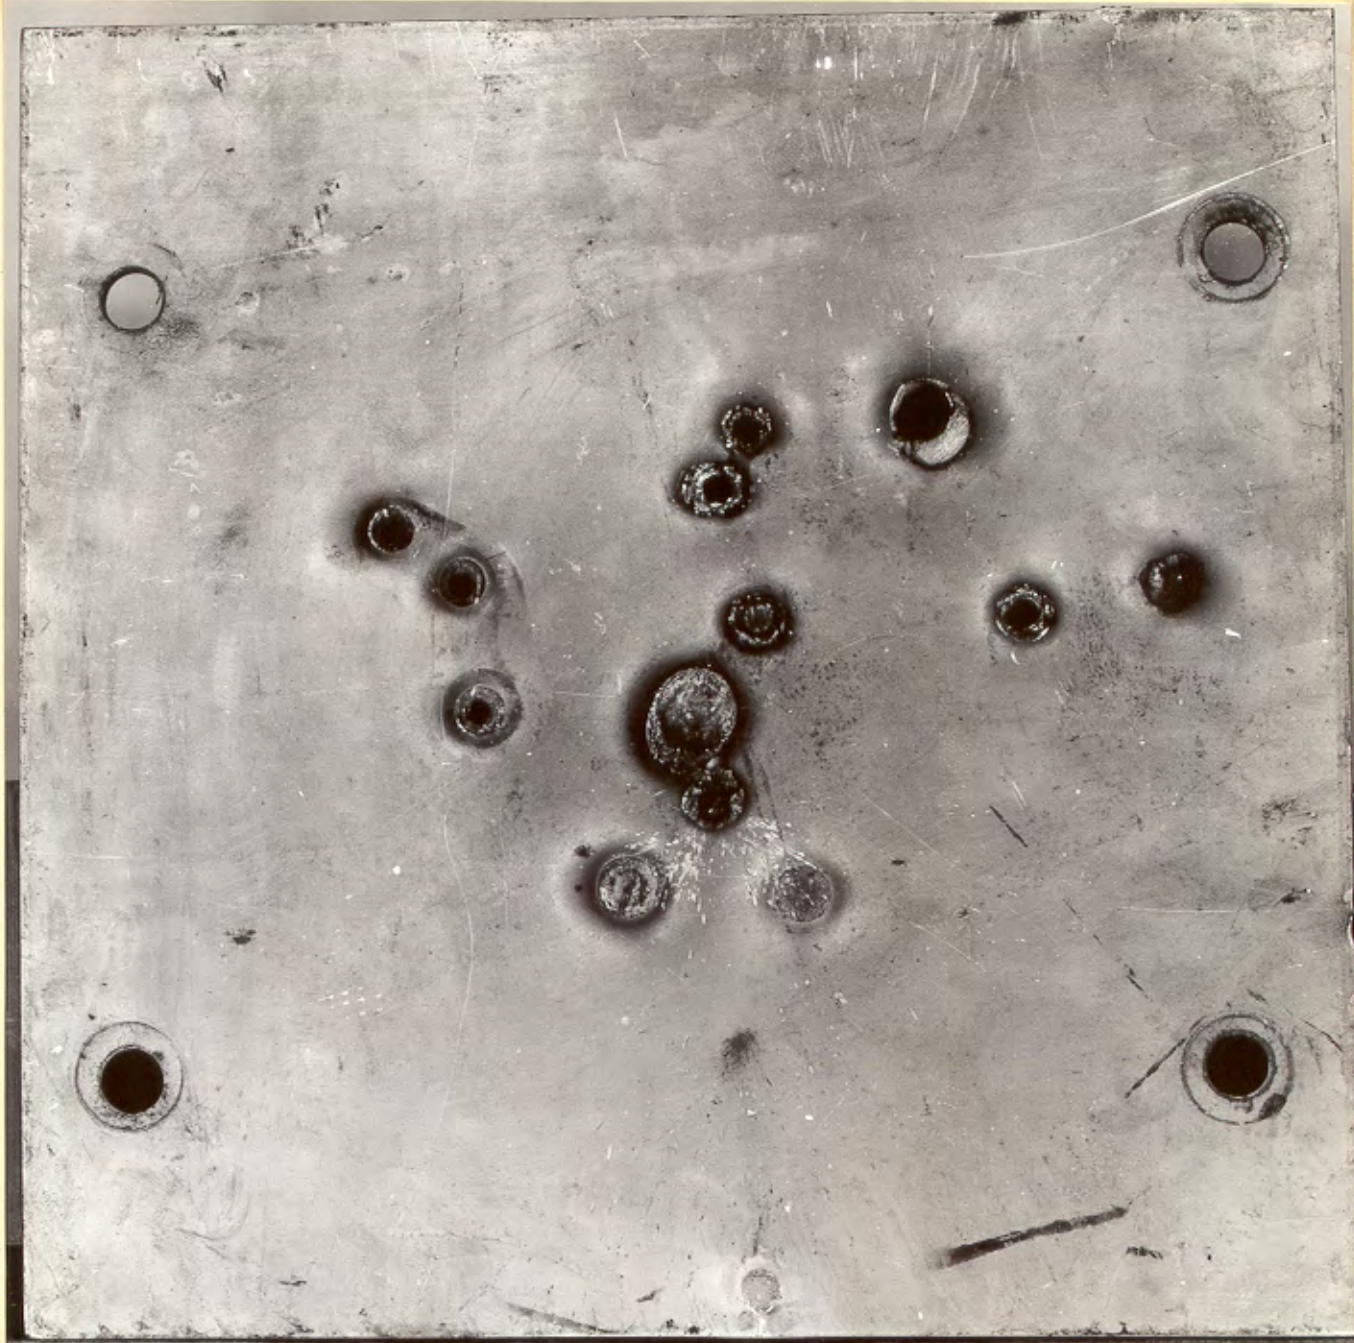
710-30

BACK  
OF  
DURAL PLATE

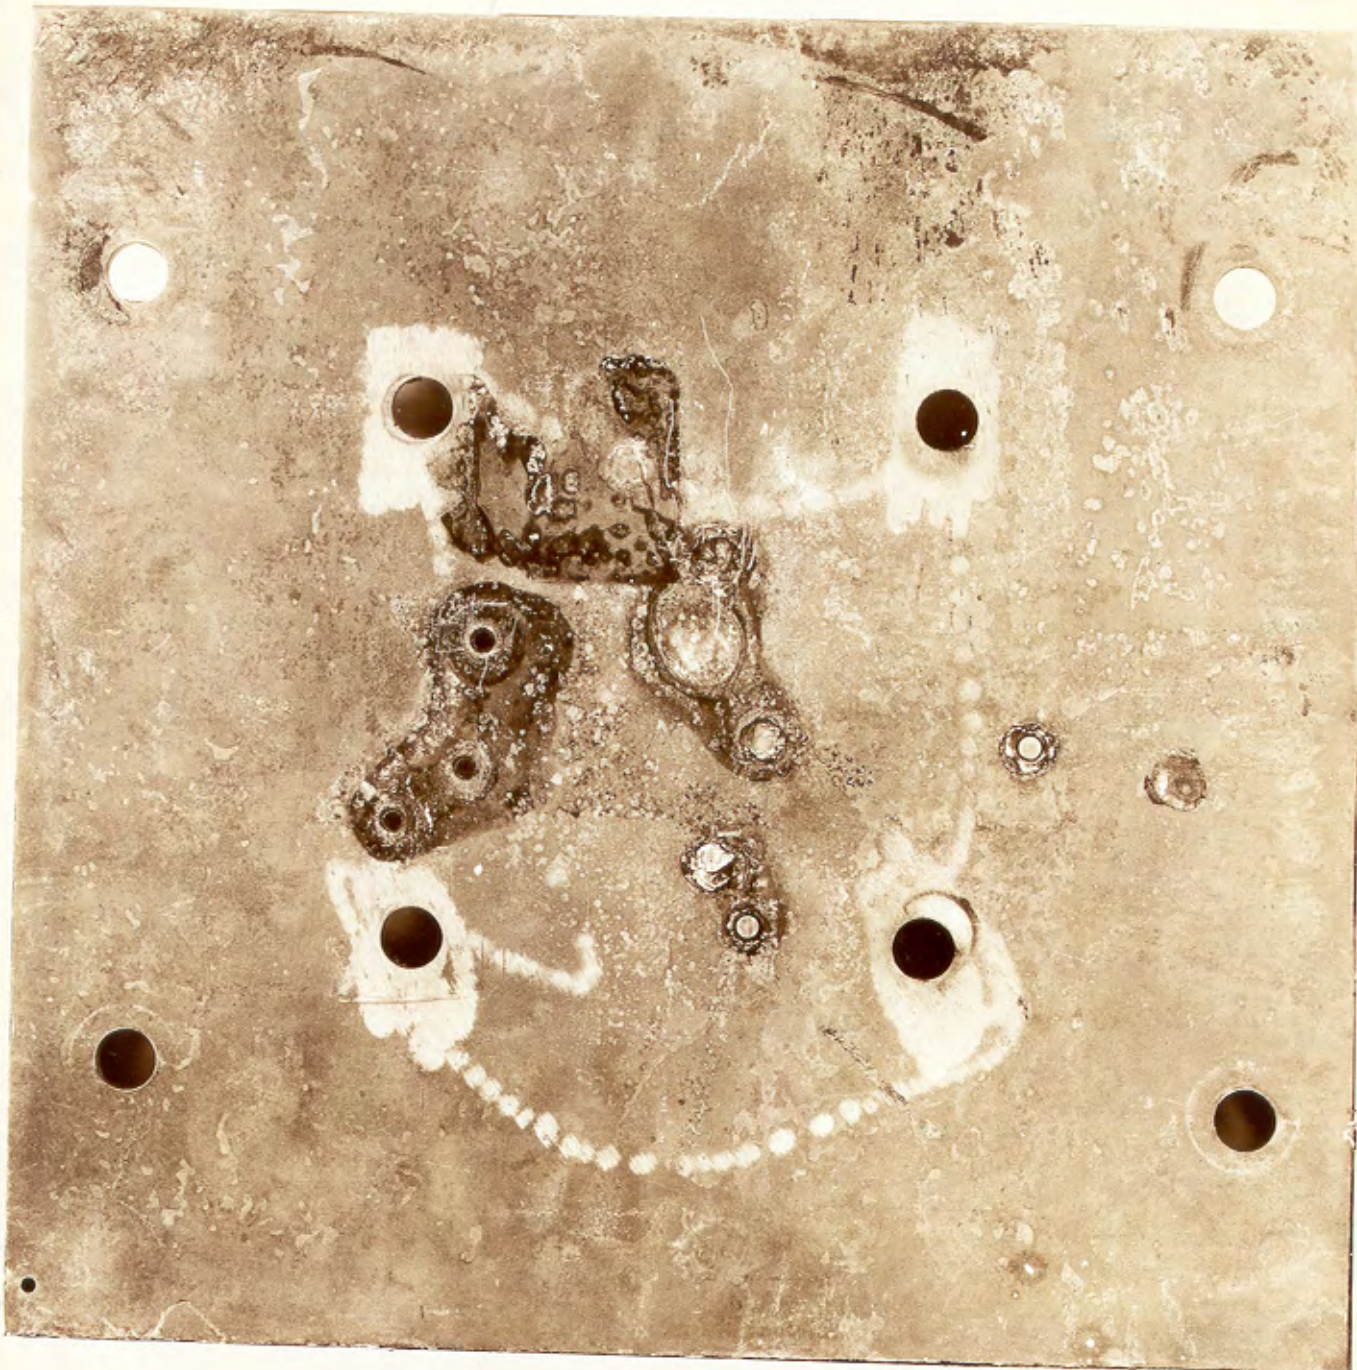
710-31

FRONT  
OF  
REAR PLATE

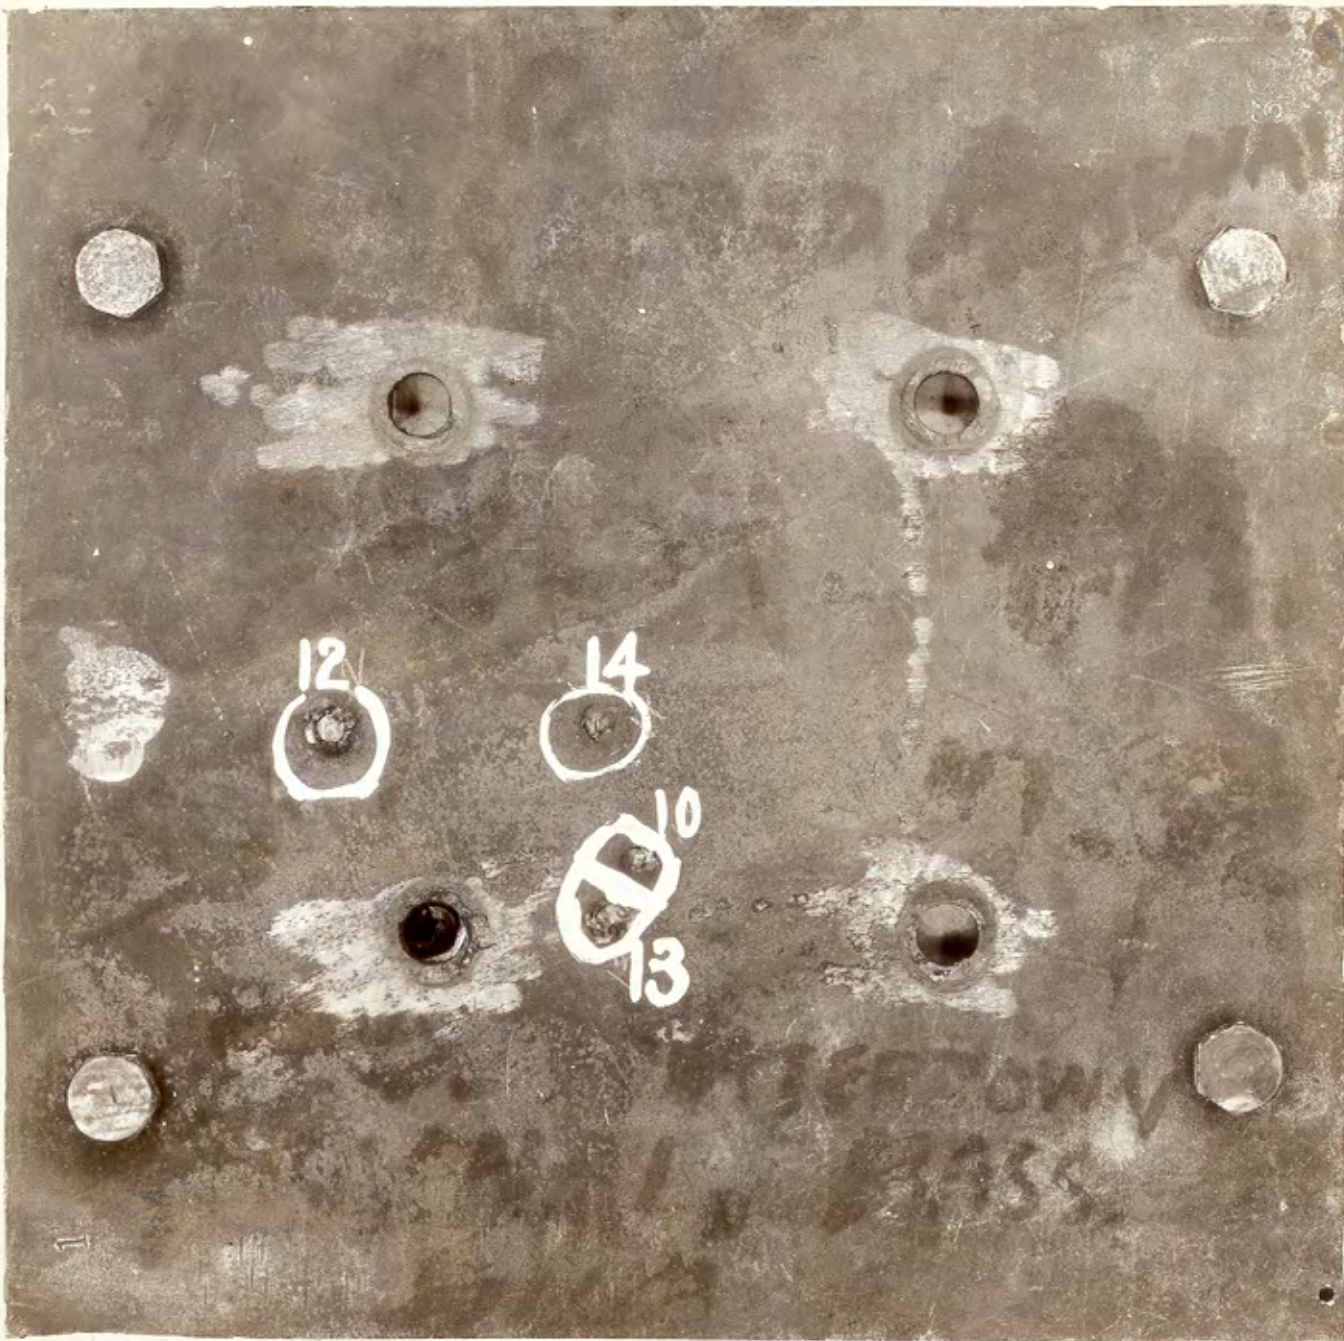
710-24

BACK OF REAR PLATE  
REAR OF COMPOSITE PLATE
