Watertown Arsenal Laboratory  
Report Number WAL 710/414  
Problem No. B-52

6 October 1943

Metallurgical Examination of Cast Turret No. 757 for M4  
Tank, Manufactured by Union Steel Castings Co., Ballistically  
Tested at Subzero Temperatures at Camp Shilo, Canada.

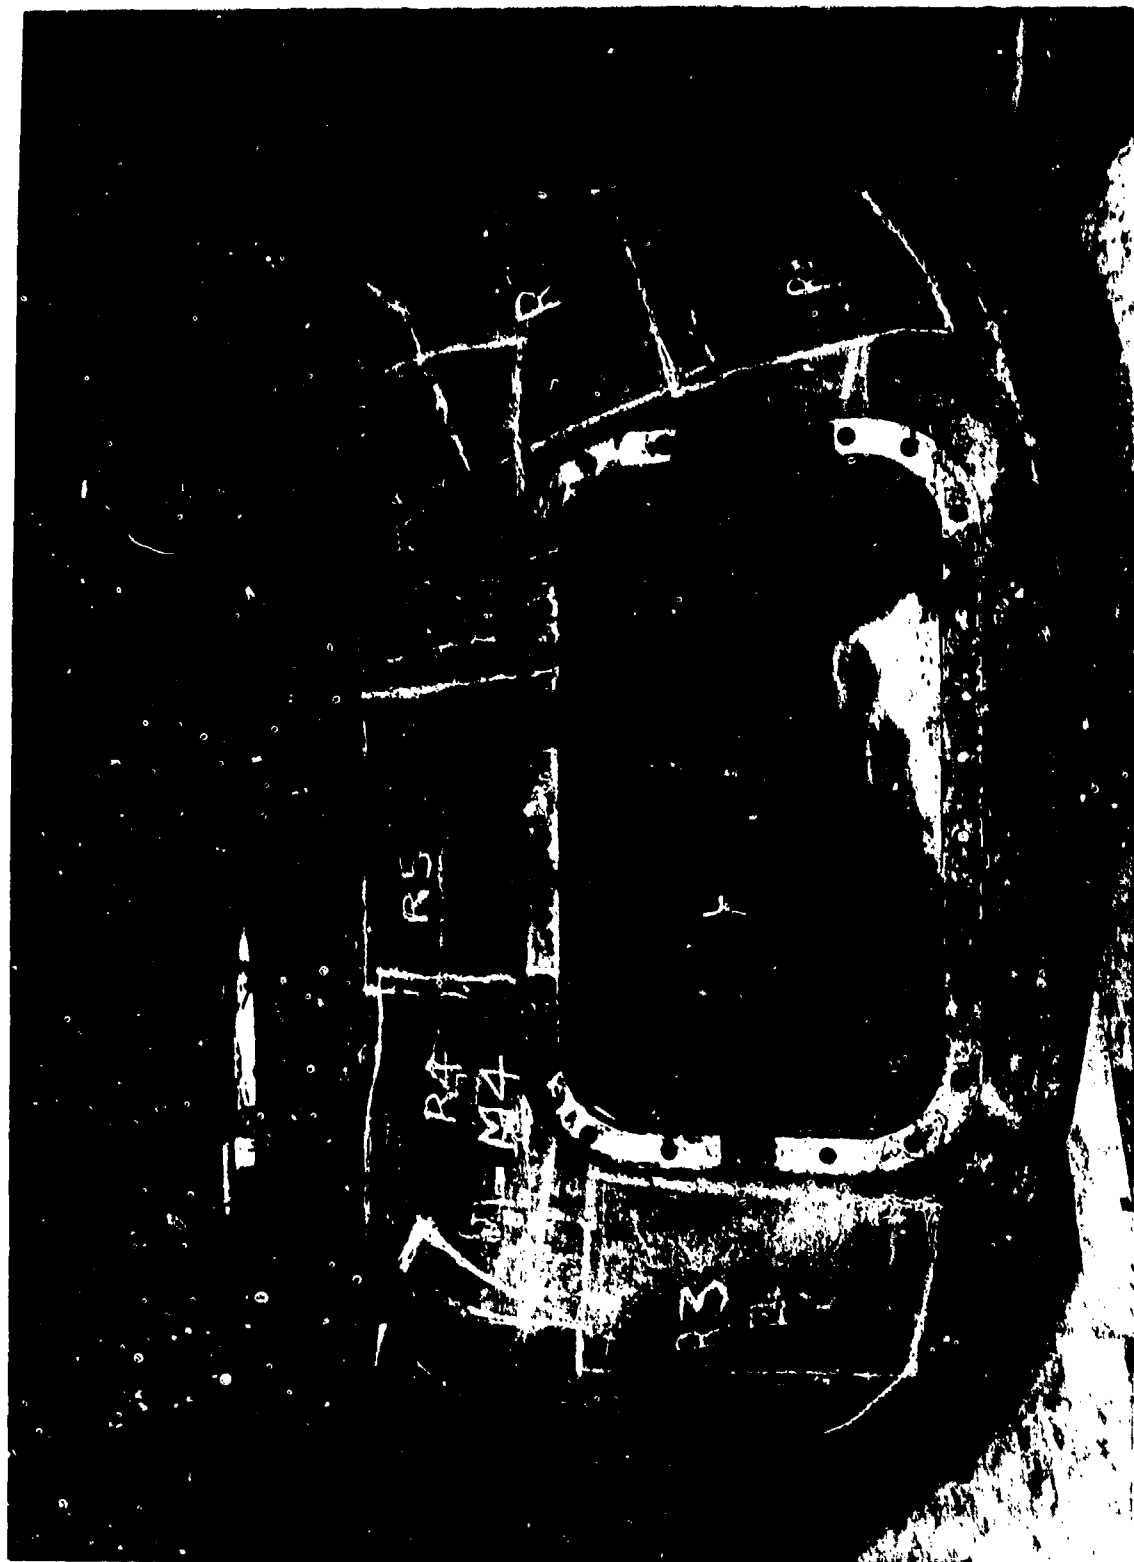
VIEW OF M4 TURRET MFG BY UNION STEEL CASTINGS CO. TESTED AT CAMP SHILO,  
CANADA, SHOWING AREAS RADIOGRAPHED AND SELECTED FOR METALLURGICAL EXAMINATION  
WTN. 710-2093

The projectile impacted the left front of the turret 13" from the bottom edge. Partial penetration with two 6" cracks originating at the impact. Punching started on inside of turret with 4", 3", 4" cracks. (Radiographic area R8, Figure 1).

The projectile struck the front of the turret 6" above the upper right edge of the casting and ricocheted, causing a 7" crack in the armor on the outside. On the inside of the turret there were cracks 9", 4", 4", 3" and 2" (star cracking). (Radiographic area R4, Figure 1).

The projectile struck the left front of the turret 4" above the top edge of the gun mount casting. The projectile hit the left lifting eye, displacing it and then ricocheted off the turret. Impact was 30" left of impact #5. Crack developed extending the entire distance between impacts #5 and #6. Further cracks 8" and 7" long developed on Round #5. On the inside of the turret 30" long crack developed between impacts #5 and #6. 3 cracks, 6", 5" and 3" (star cracking) on inside of impact #6. (Radiographic area R6, Figure 1).

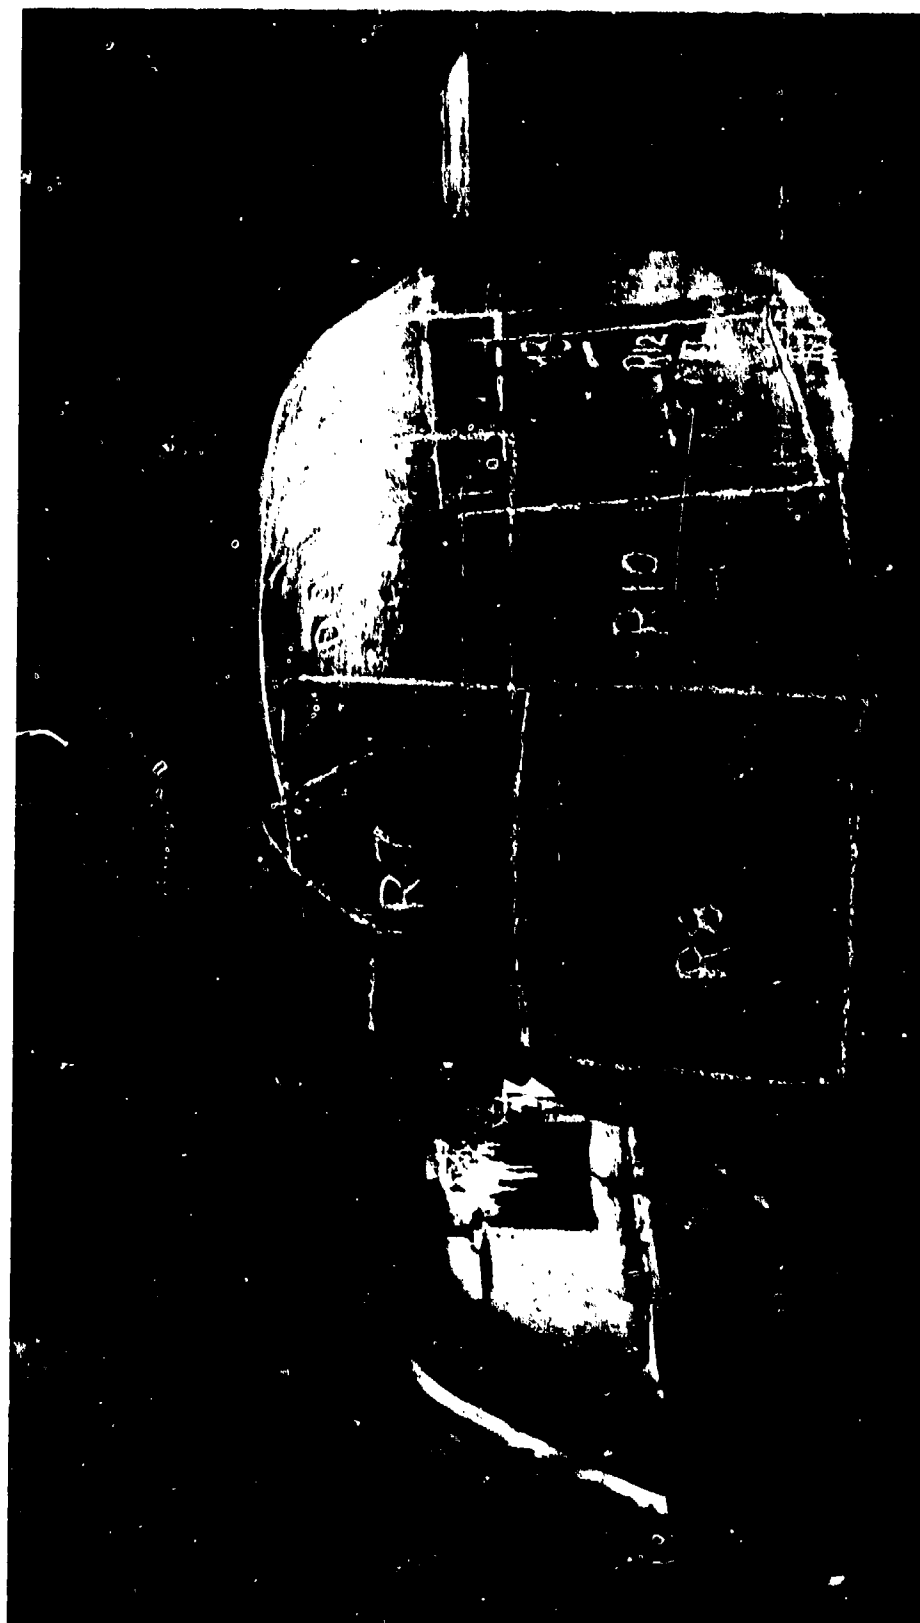
FIGURE 2

VIEW OF M4 TURRET MFG BY UNION STEEL CASTINGS CO. TESTED AT CAMP SHILO,  
CANADA, SHOWING AREAS RADIOGRAPHED AND SELECTED FOR METALLURGICAL EXAMINATION  
WTN.710-2092

The projectile impacted the right side of the turret 18" above the bottom edge. The casting cracked through the entire thickness of the armor, from the base to the top edge of the turret hatch opening, the crack being 37" long. An additional 10" crack developed through the impact and a 20" crack 10" from the impact. Star cracking developed on the inside of the turret and a punching started, no fragment being thrown into the interior of the turret. (Radiographic area R19, Figure 2).

The projectile struck the rear of the turret, 12" from the bottom edge of the casting. The projectile ricocheted but caused a punching in the armor 5" x 3" on the outside and 9" x 6" on the inside including back spall. 12" crack on outside of armor, 10" below point of impact. Fragment of armor thrown into the turret caused considerable damage to installations and dummy personnel. (Radiographic area R14, Figure 2).

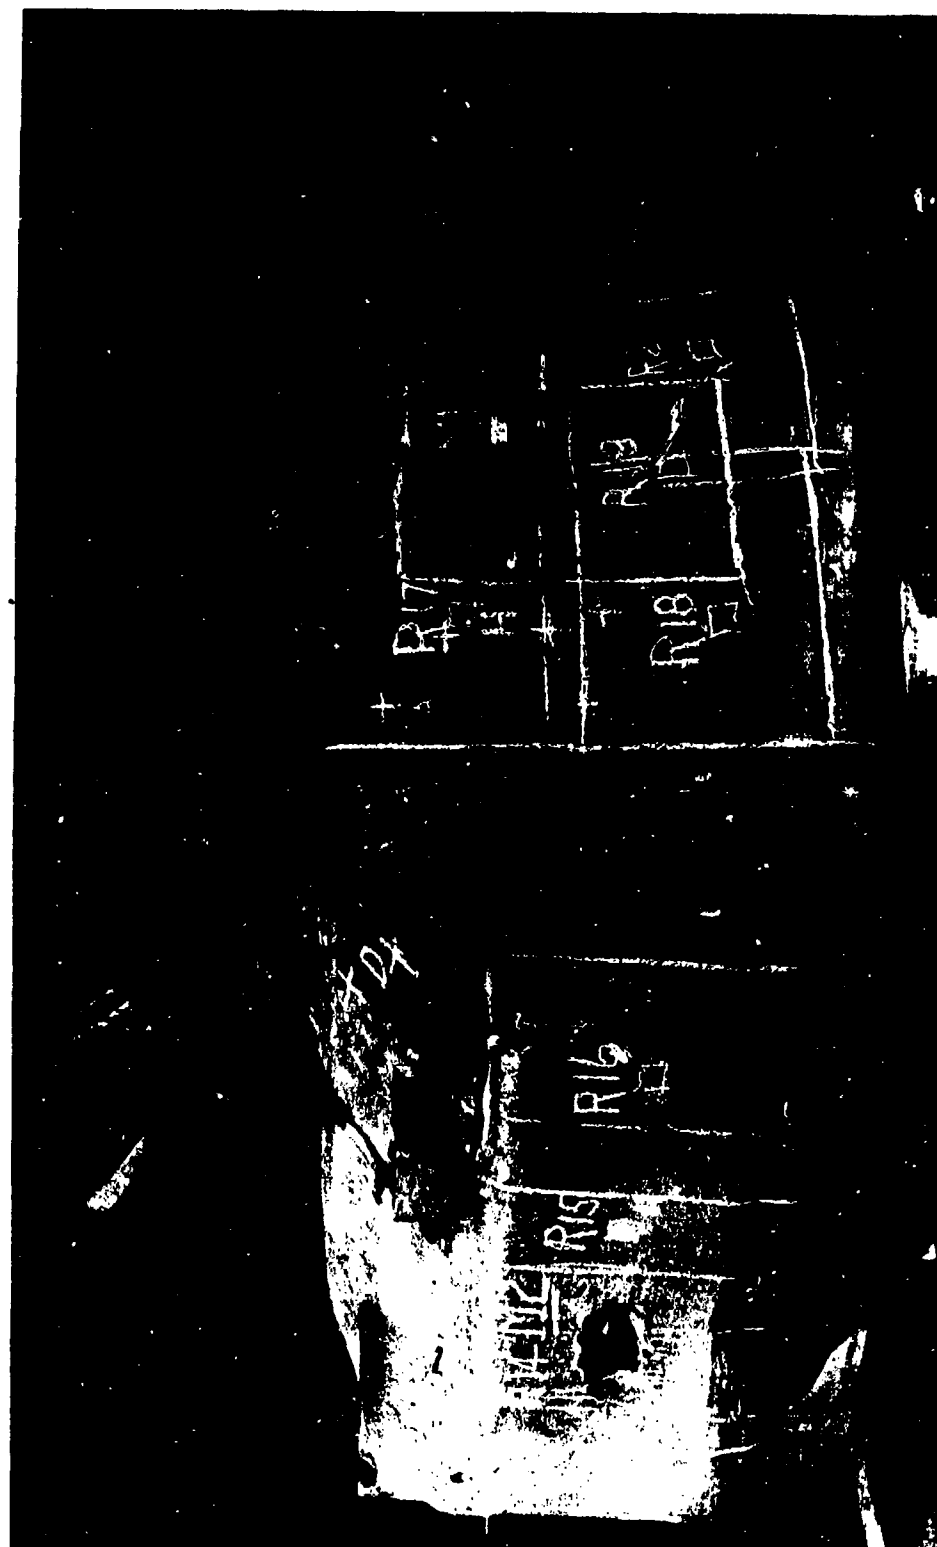
FIGURE

VIEW OF M4 TURRET MFG BY UNION STEEL CASTINGS CO. TESTED AT CAMP CHILLO,  
CANADA, SHOWING AREAS RADIOGRAPHED AND SELECTED FOR METALLURGICAL EXAMINATION  
WT#1,71 - 1,004

The projectile struck the left side of the turret 12" above the bottom edge of the casting. Partial penetration. No cracks on the outside; on the inside there were cracks 4", 4", 4 $\frac{1}{2}$ " and 2" long, with incomplete backspall. (Radiographic area R12, Figure 3).

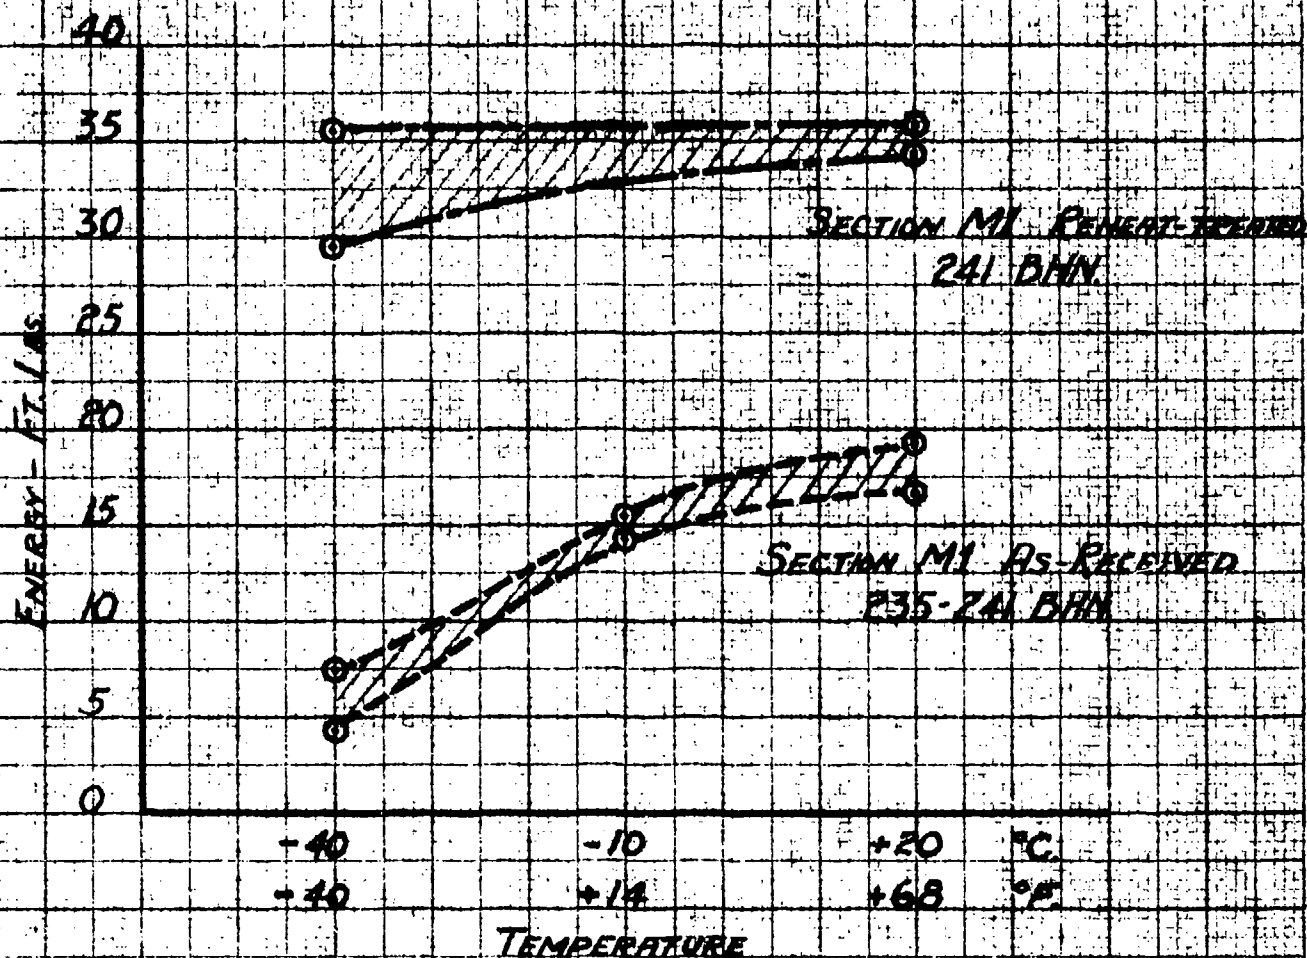
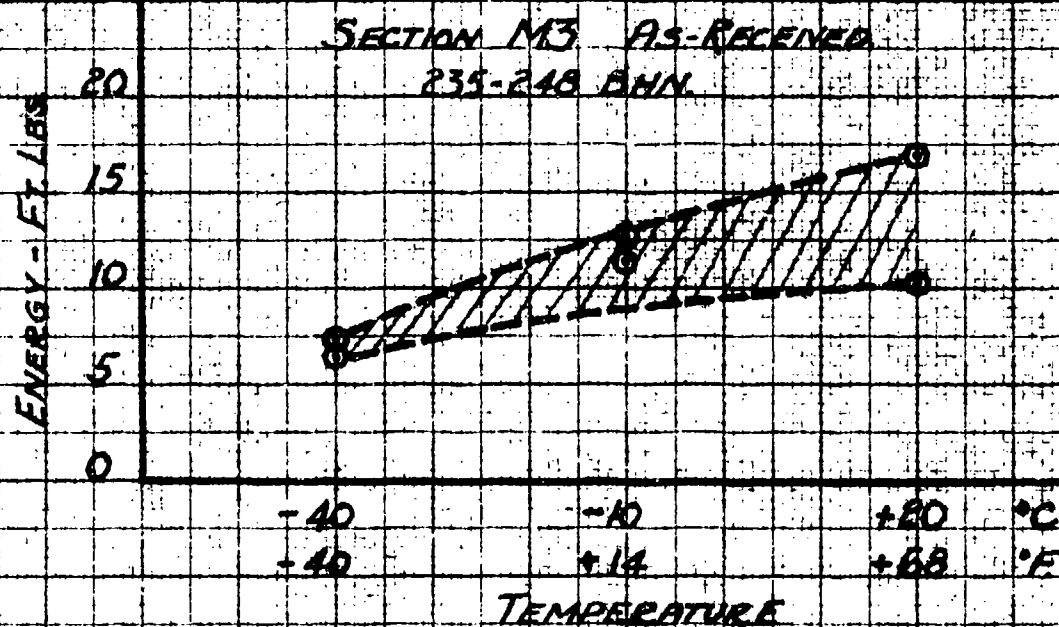
FIGURE 6

The results of the individual tests and a description of the resulting fractures are contained in Appendix C, and curves of impact strength vs. temperature are shown in Figure 6. The room temperature impact strength of the turret steel (10-20 ft.lbs.) is at least 40 ft. lbs lower than that usually possessed by sound, well heat-treated cast armor steels at a hardness of 240 Brinell. The impact strength at the temperature level at which the ballistic testing was conducted, namely -15° to -25°F (-25° to -30°C), is 7-10 ft.lbs. The poor resistance of the turret to shock at subzero temperatures is readily understandable

Considerable improvement was however, effected in the impact strength, see Figure 6 and Appendix C. The room temperature V-notch Charpy impact strength was raised from 10-20 ft.lbs. to approximately 35 ft.lbs. at the same hardness. After reheat-treatment, the impact strength remains relatively constant down to a temperature of  $-40^{\circ}\text{C}$  ( $-40^{\circ}\text{F}$ ).

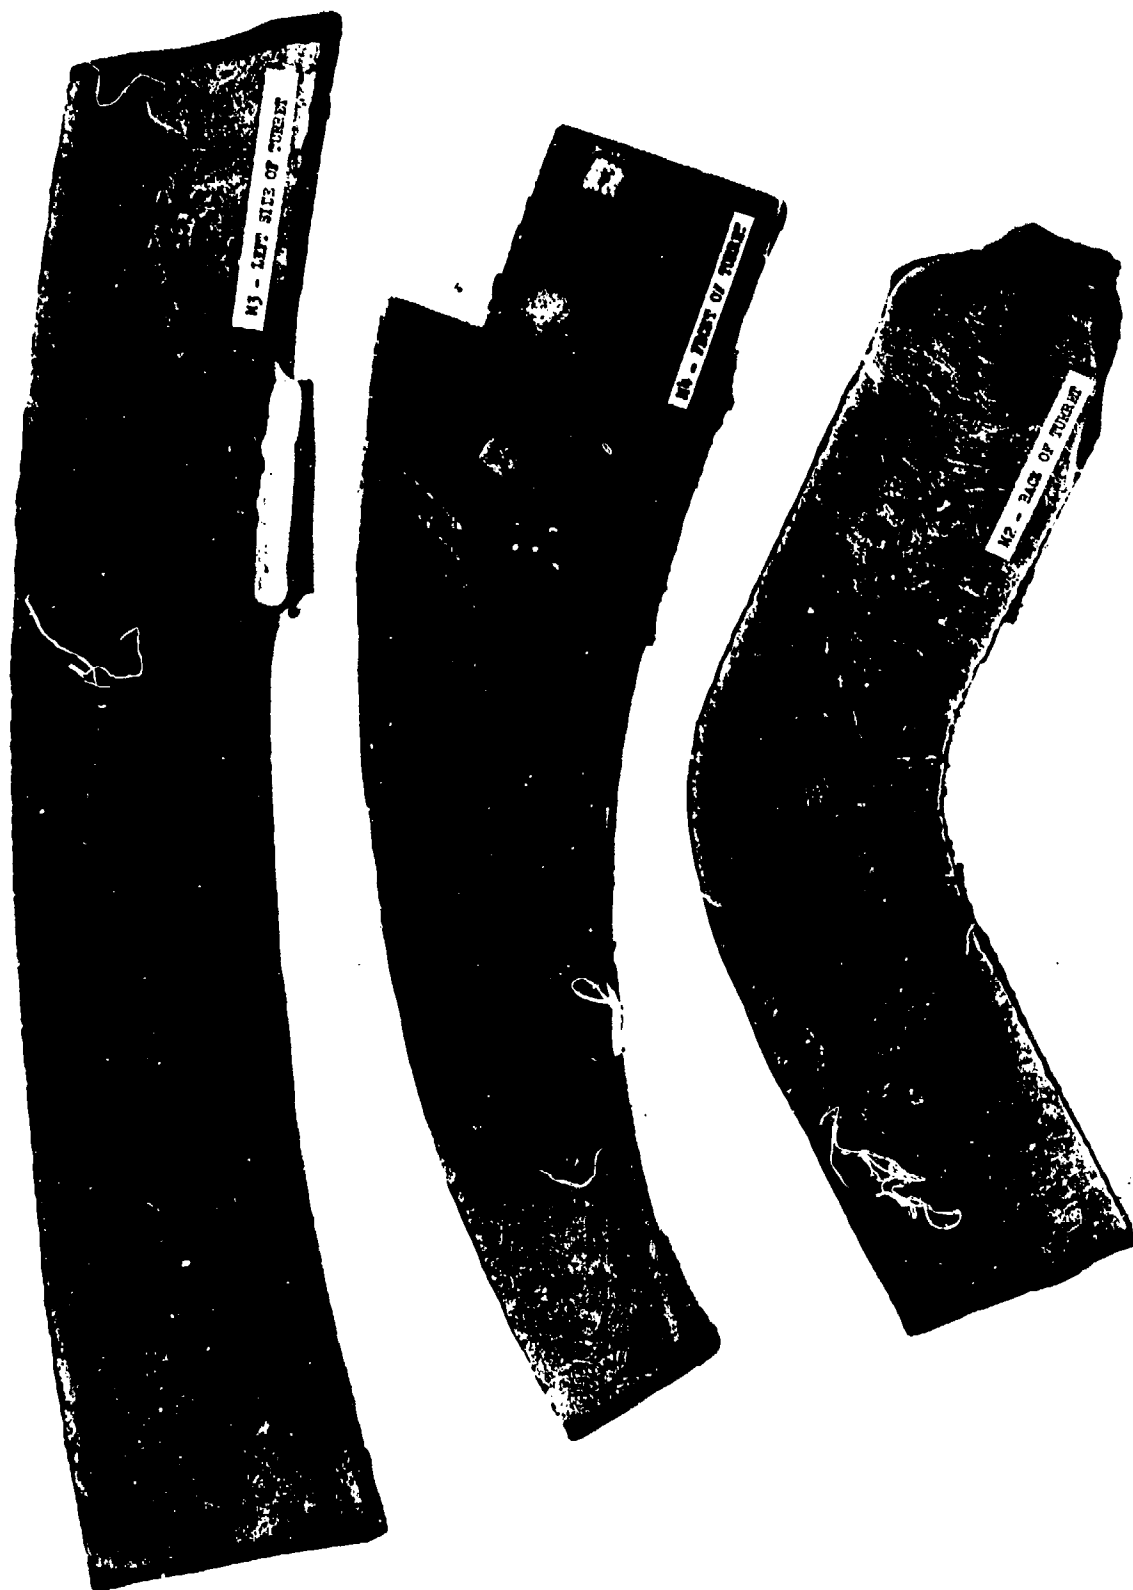
Sections M1 and M3 have identical macrostructures. The metal is free of centerline shrinkage, but very fine interdendritic shrinkage is uniformly distributed throughout the sections. Section M42 represents the junction of the back and the sloping roof of the radio compartment, and the jagged end of the section is the area from which a punching was driven through the casting as a result of impact #3, see radiographic area R14, Figure 3. A repair weld with a ferritic electrode had been made in the sloping roof section. Porosity, incomplete fusion, and weld cracking occur at the root of the weld. Hot tears and centerline shrinkage occur at the region of the inside curvature.

Section M4 contains the ballistic crack which opened up between the impacts of rounds #5 and #6. Incompletely fused chaplets or tie-rods are located near the gun mount opening in the front of the turret. The thick section of area M4 contains center-line shrinkage, while hot tears and fine shrinkage exist in the thinner section.

MACROETCHED SECTIONS OF M4 TURRET MFG BY UNION STEEL CASTINGS CO.  
WTN.710-2138
