WATERTOWN ARSENAL
LABORATORY

NO. WAL 710/676

Metallurgical Examination of Sections from Two 4 Inch Thick
Cast Armor Plates Manufactured by
Continental Foundry and Machine Company

DATE 14 July 1944

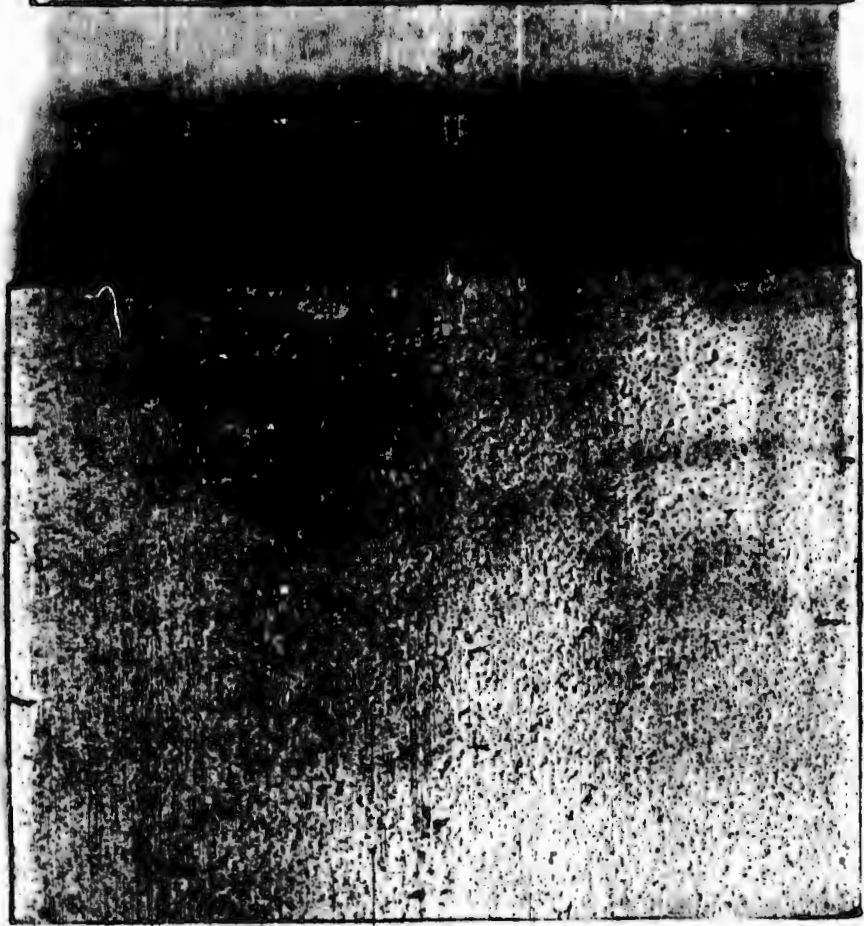
PLATE 1, HEAT 2123

b. Macroetch tests. Macroetch tests were made of the full section of each plate. The photographic results appear as Figure 1. It will be observed that the two plates are very similar in macro appearance and both are extremely sound. The surface defect is plainly visible on one face of each plate. The etched original plate face of these sections showed a continuous network of the cracks illustrated. Such cracks would form stress concentrations if on the back face of the plate during testing, but it is not considered that this condition was the primary cause of the observed differences in ballistic behavior.

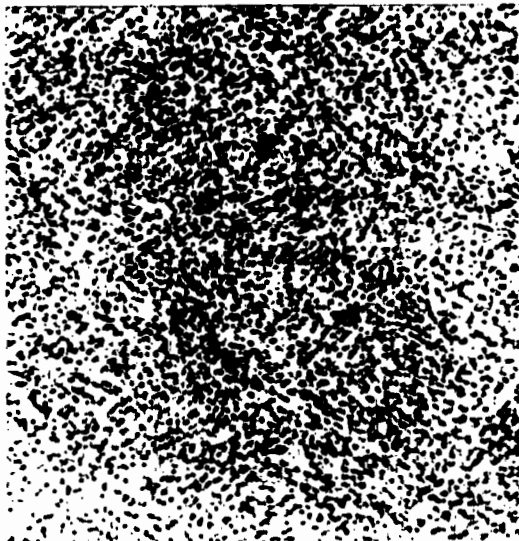
e. Microscopic examination. A detailed metallographic study was made of the characteristics of the surface crack system which was common to both plates but which was more extensive in the case of plate 2123-1. In addition, the microstructures of the two plates were compared. Figure 2A shows a photomicrograph at low magnification of the nature of the surface cracks or checks which were common to both plates. It will be observed that the cracks are filled with iron oxide and that the metal around the crack systems is severely decarburized. Figure 2 also shows the microstructures of the two plates at the center of the sections. Both structures appear satisfactory and very similar. Examination of the microstructure alone would lead to the expectancy that the shock properties of the two plates would be satisfactory and comparable.

Plate 2123-1, Uniform tempered structure.

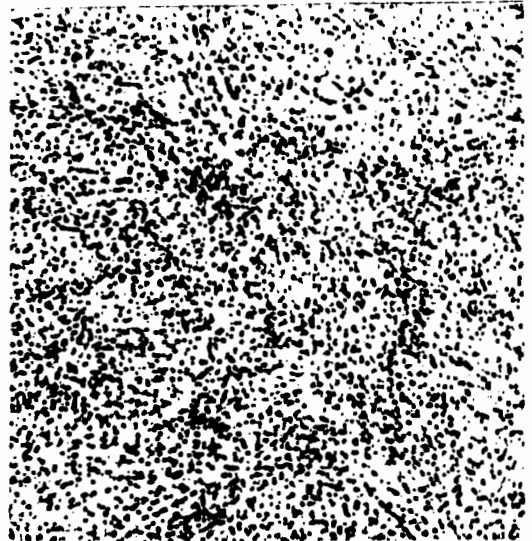
Plate 2123-4, Uniform tempered structure.

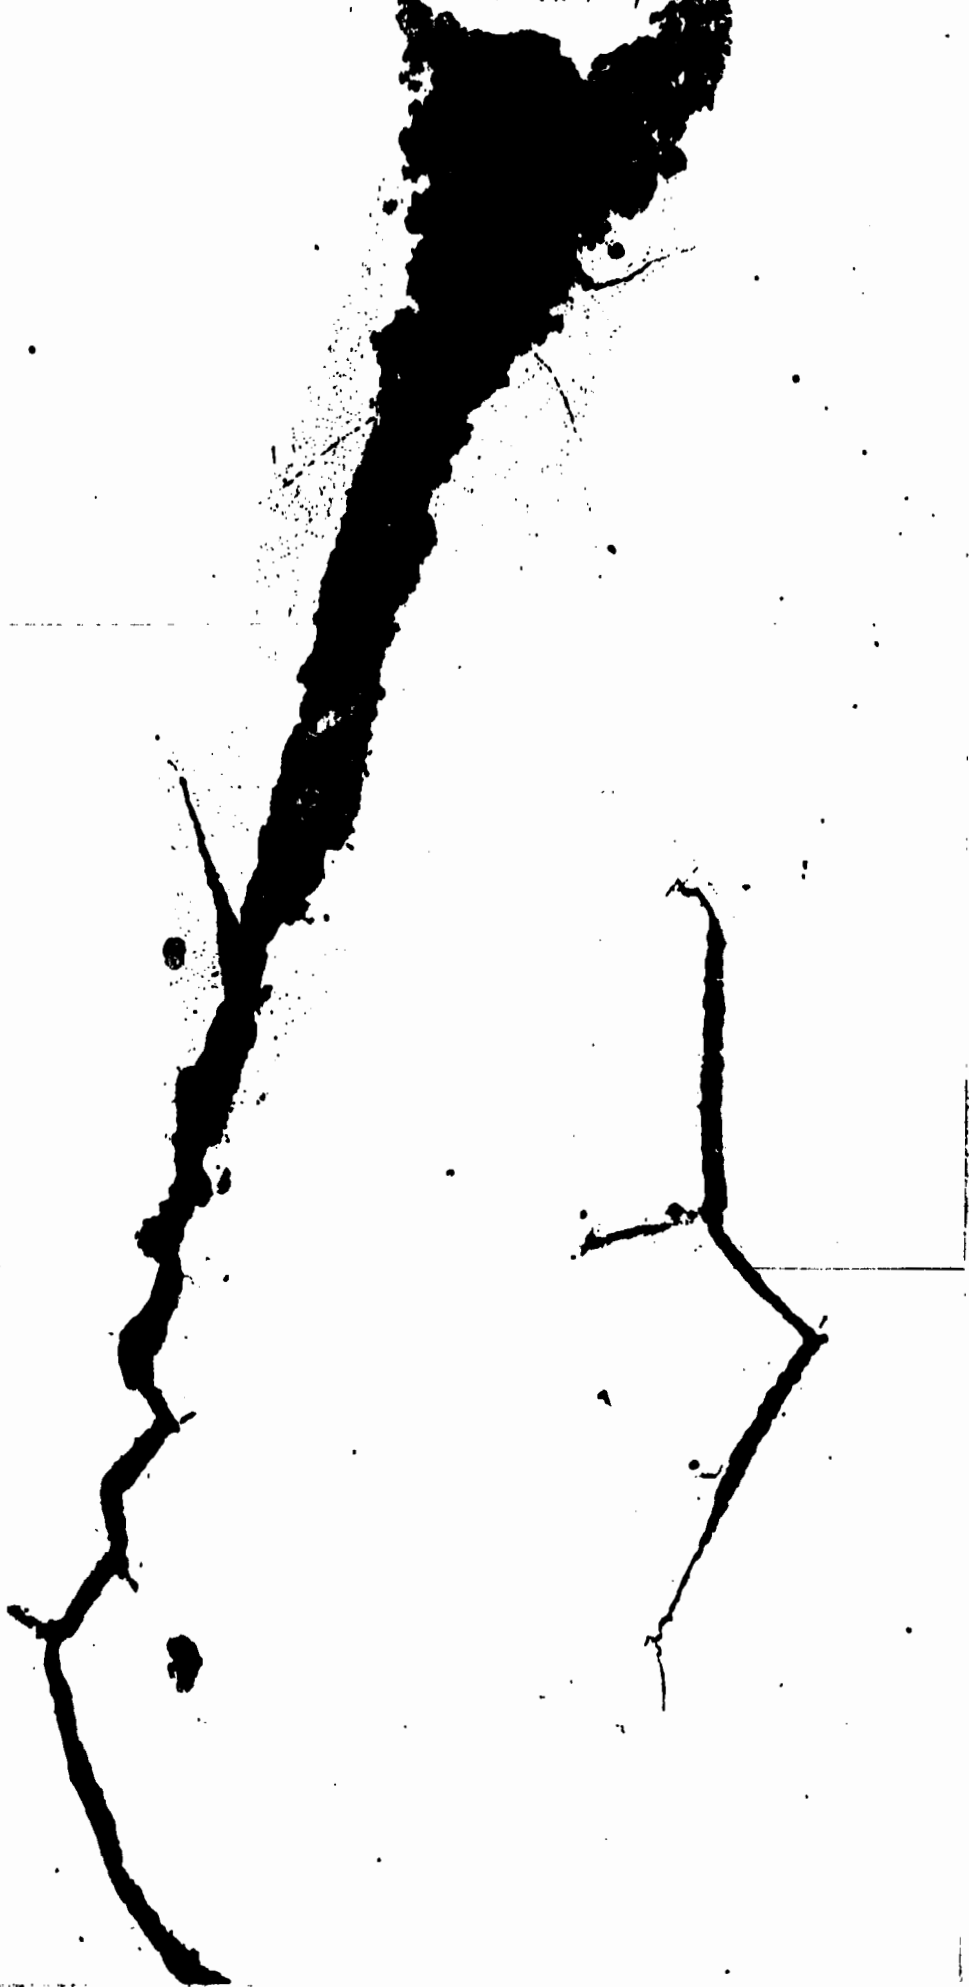
Figure 3 shows a panorama of a typical crack system at the surface of plate 2123-1. It will be observed that the crack is filled with iron oxide, and that, surrounding the crack, there is a considerable zone which contains iron oxide particles randomly distributed. Figure 4C shows a detail of the globular iron oxides surrounding the cracks, and Figure 4D shows the complete decarburization to ferrite of the metal adjacent to the cracks.

Surface cracks in cast armor. Oxides in cracks and heavy concentration of small globular oxides around cracks.

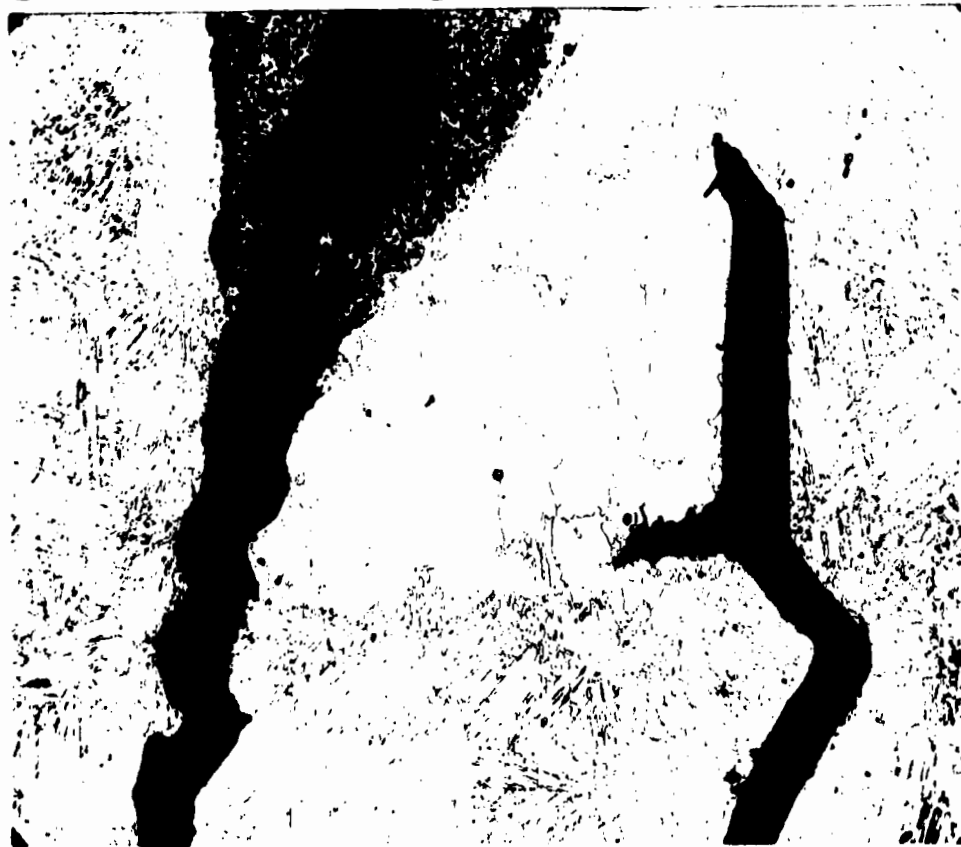
-D-

Nital Etch. Same area as in previous photo. (D) Magn. X100
Areas rich in small globular oxides are darkened by etching.
Regions show complete decarburization to ferrite.
