Investigation of Factors Responsible for Service Cracking of M1 Helmets

A. HURLICH
Assoc. Metallurgist

Watertown Arsenal Laboratory
Report No. WAL 710/700
Problem No. B-7.2

18 September 1944

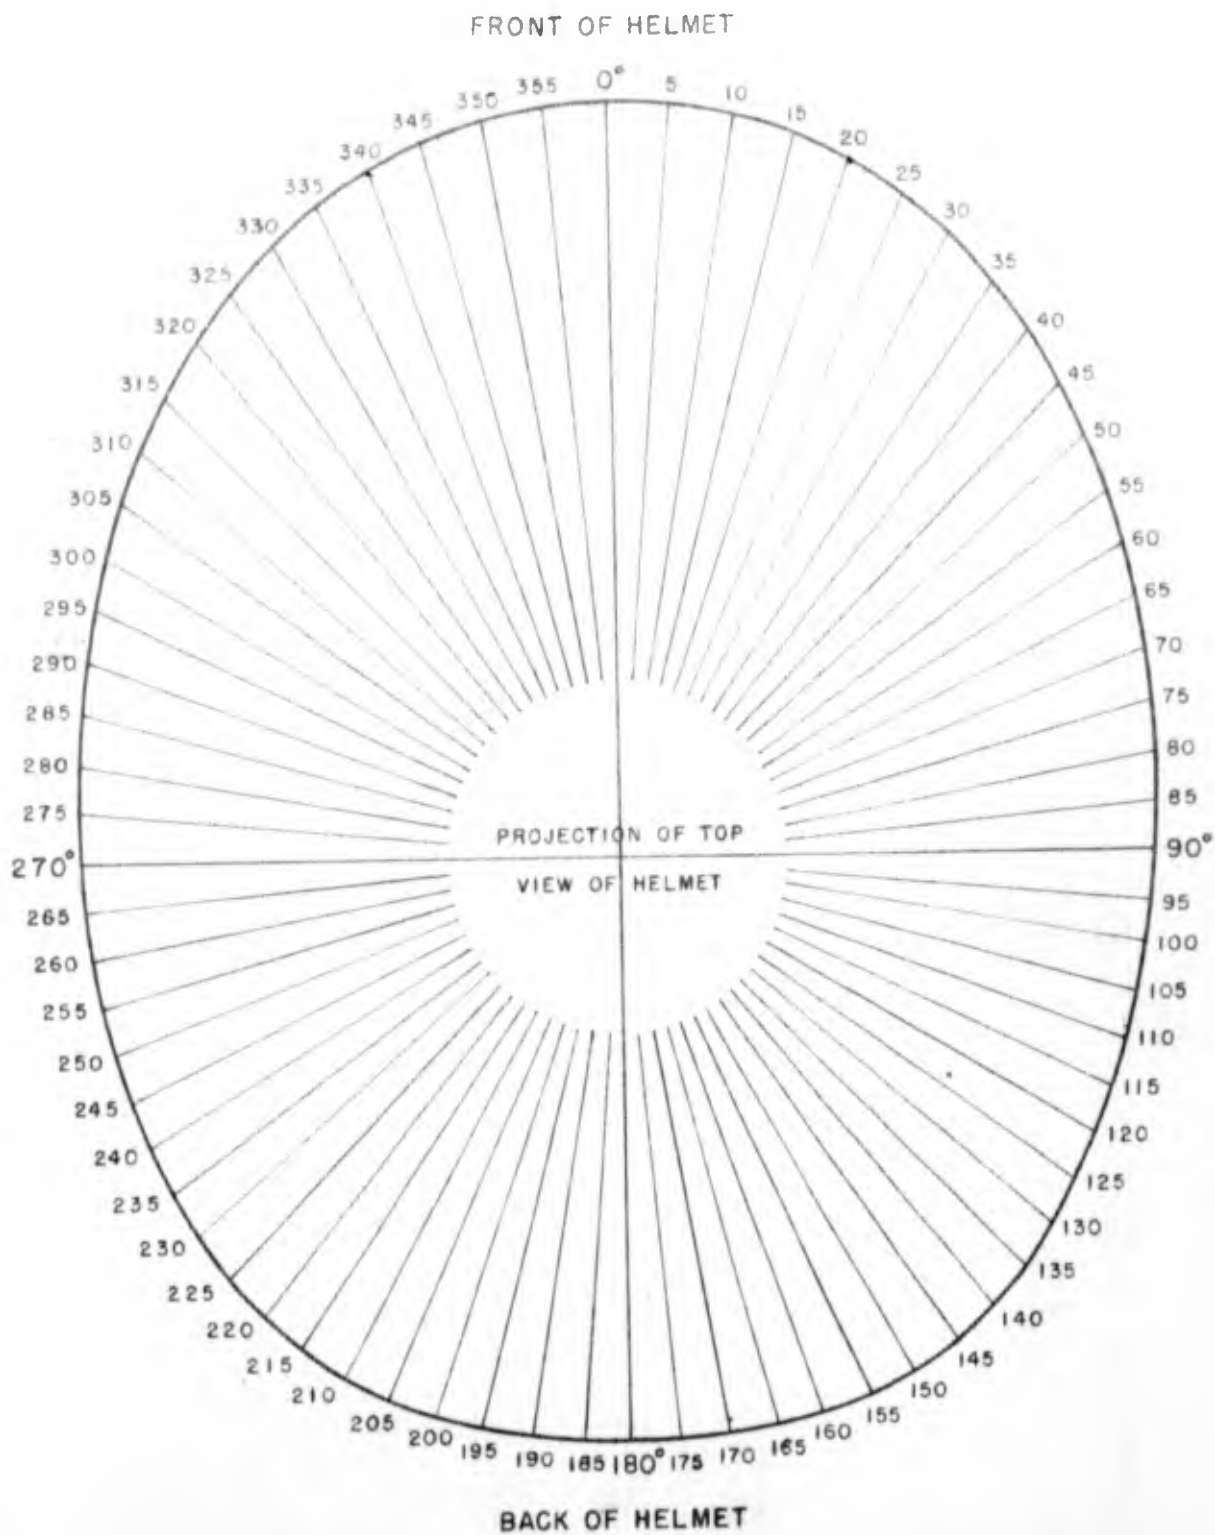
FIGURE 1

The locations of the cracks were determined according to instructions from the Office, Chief of Ordnance⁸, by measuring the position of the cracks in degrees, starting from the middle of the visor as zero degrees and rotating clockwise around the helmet. The outline of the M1 helmet was projected upon a piece of plywood and each five (5) degree step was laid off as shown in Figure 1. The cracks were located by placing the helmets down on the plywood and recording the position of the cracks as lying between two five (5) degree steps.

**SYSTEM USED TO DETERMINE LOCATIONS OF CRACKS
ON M1 HELMETS WHICH CRACKED IN SERVICE**

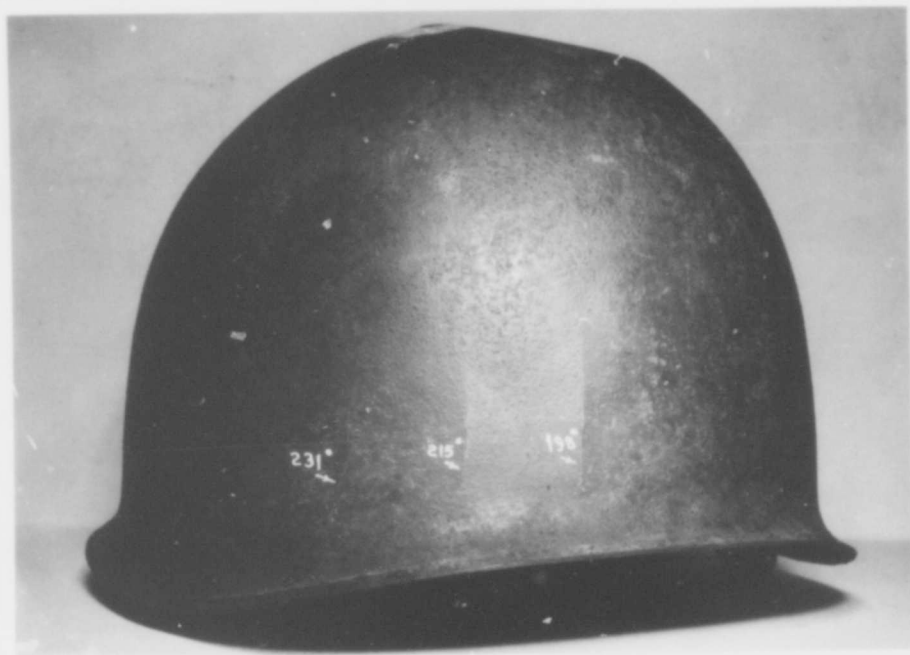
Helmet No. 79. McCord Lot 40B1. Camp Pickett. Mag. X $\frac{1}{2}$
Body cracks at back of helmet. Numbers refer to positions shown in
Figure 1.

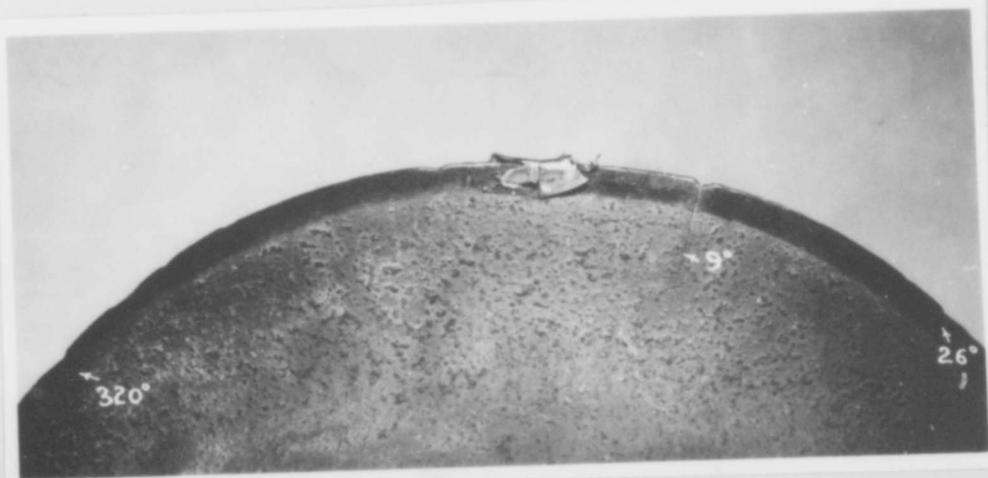
A discussion of the notches observed in the helmet rims is in order at this point. A crack was designated as being associated with a notch when a very apparent nick in the rim was observed at the base of the crack, as shown in the lower photograph of Figure 2 where the crack at 9° is very definitely associated with a notch. When no nick was observed, the crack was assumed to have occurred in a region free from notches. It must be recognized, however, that once the crack has occurred, the evidence of a small notch which may have existed prior to the cracking may be removed by the crack. Hence, a greater number of rim cracks must have been actually associated with notches than are indicated in Figures 3 and 5.

Helmet No. 98. McCord Lot 149A. Camp Livingston. Mag. XI
Edge cracks at visor of helmet. Crack at 9° definitely associated with notch.
Stainless steel edging has been removed.

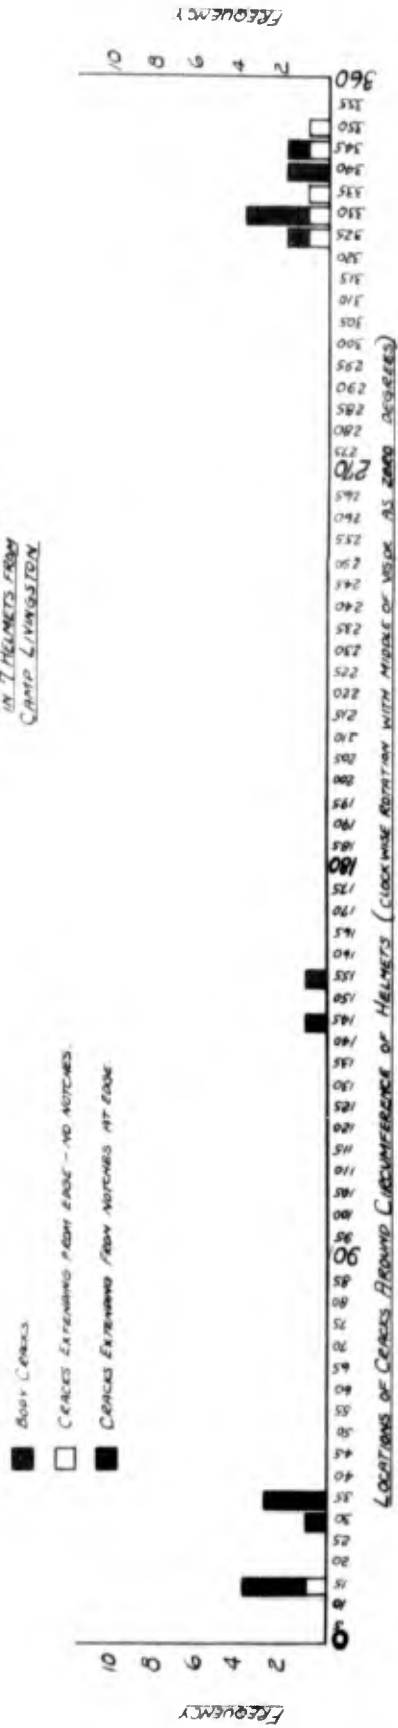
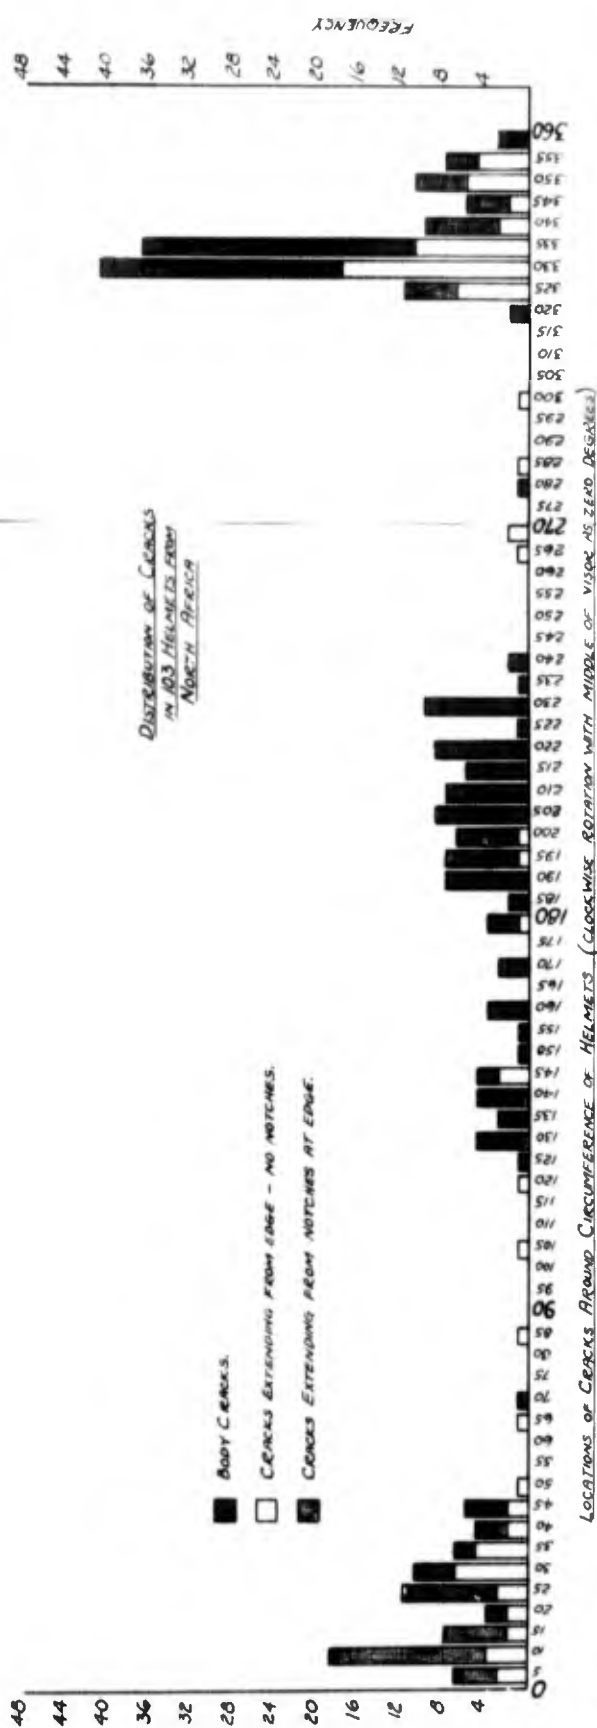
FIG. 3

The distribution of the cracks observed in the various lots of helmets examined at this arsenal are plotted in Figures 3, 4, and 5. Figure 3 shows the distribution of cracks found in the 7 helmets from Camp Livingston and the 103 helmets from North Africa. Figure 4 shows the crack distribution in the 34 unused helmets which had been in storage at Watertown Arsenal since 9 April 1942 and the crack distribution observed in a series of 20 additional helmets which were submitted by the McCord Radiator and Manufacturing Co. This last group of helmets is more fully discussed in a letter to the Office, Chief of Ordnance, a copy of which is included in Appendix B⁹. Figure 5 shows the crack distribution in the group of 95 helmets from Camp Pickett and the sum of the crack distributions in the helmets from Camp Pickett, North Africa, and Watertown Arsenal.

DISTRIBUTION OF CRACKS IN 7 HELMETS FROM CAMP LIVINGSTON

DISTRIBUTION OF CRACKS IN 103 HELMETS FROM NORTH AFRICA

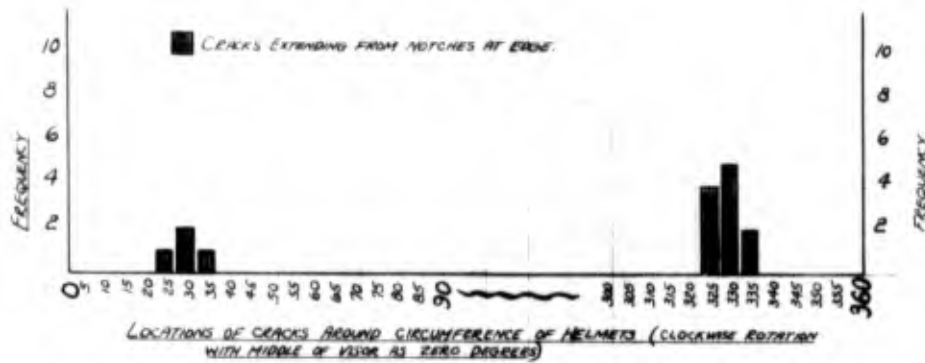
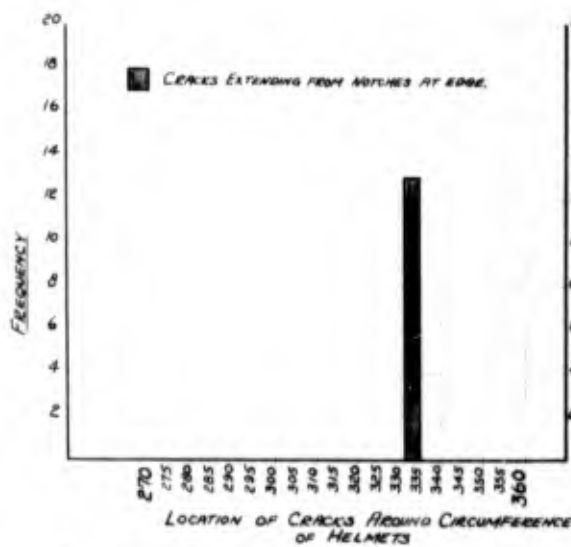
FIG. 4

DISTRIBUTION OF CRACKS FOUND AFTER REMOVAL OF EDGINGS FROM 34 HELMETS (UNUSED) IN STORAGE AT WATERLOO ARSENAL SINCE APRIL 9, 1942.

CRACKS AVERAGE $\frac{1}{8}$ " - $\frac{3}{16}$ " IN LENGTH

14 HELMETS CRACKED
20 HELMETS FREE OF CRACKS

60 HELMETS FROM McCORD RADIATOR & MFG. CO.

ALL HAVE A CRACK AT 333° EXTENDING UP FROM A NOTCH AT THE EDGE OF THE HELMET.

3 HELMETS HAVE A CRACK AT 333° EXTENDING UP FROM A NOTCH AT THE EDGE.

5 HELMETS HAVE NO CRACKS, BUT HAVE NOTCHES AT RIM AT 333° (INCLUDES HELMET FROM LOT 643D)

2 HELMETS HAVE NO CRACKS AND NO NOTCHES.

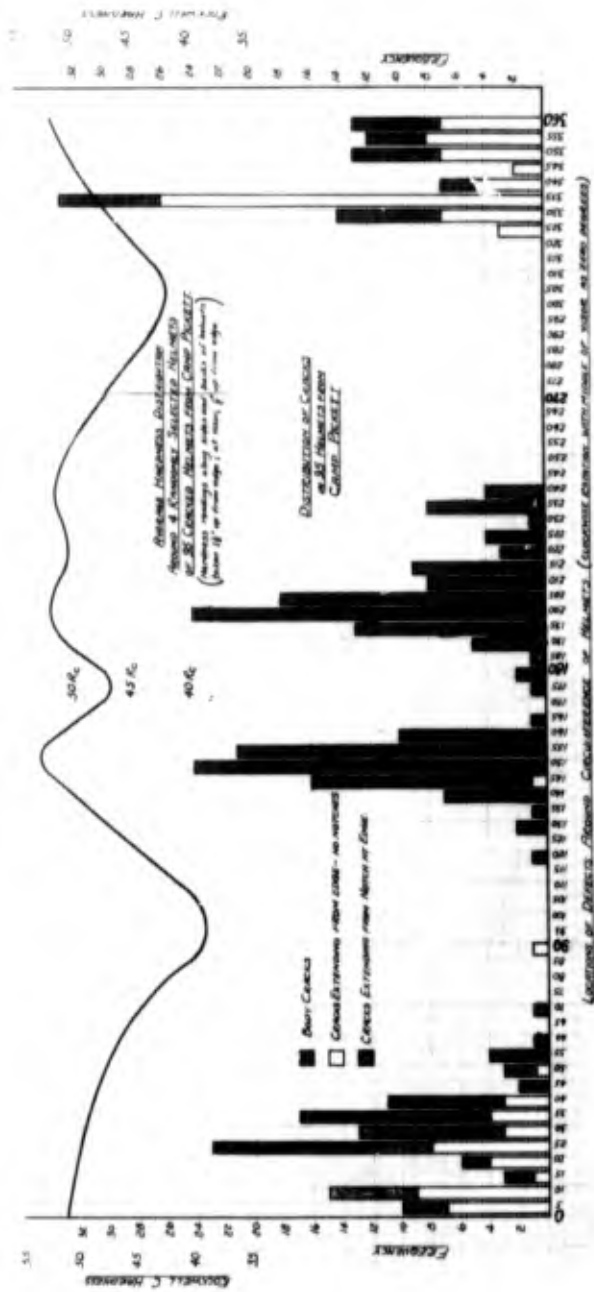
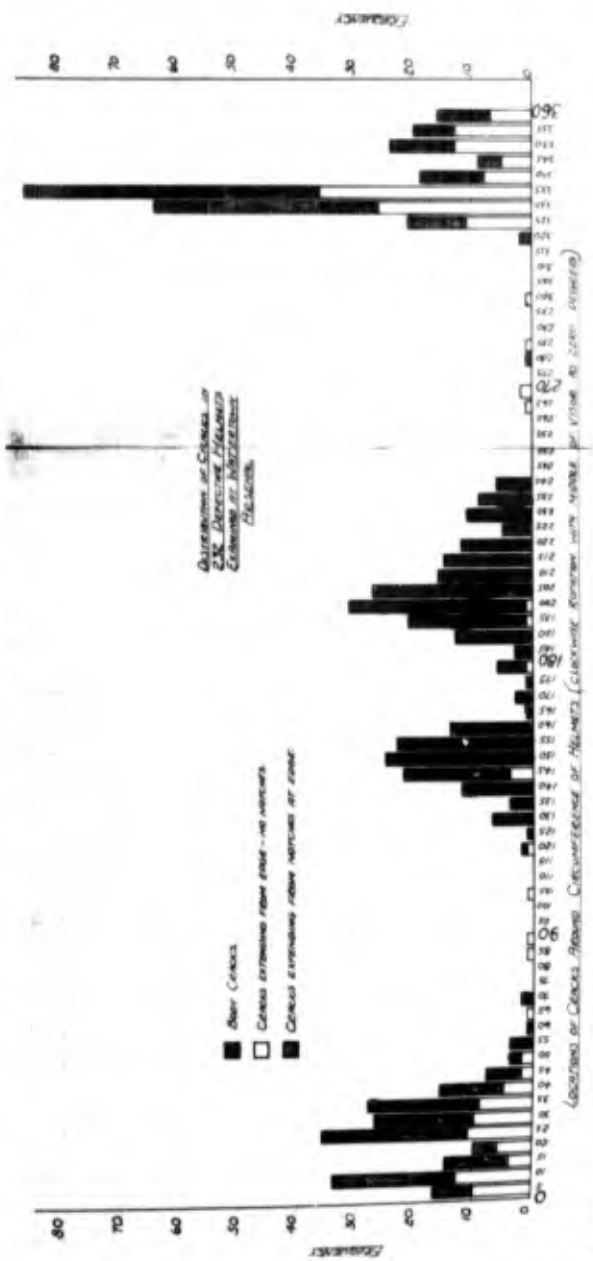
FIG. 5

From the lower chart in Figure 5 it is apparent that the service cracking of helmets is confined to three unique zones: (1) the visor, extending from 320° to 40°, where the cracks generally extend up from the rim; (2) the right rear of the helmet, from 130° to 160°, where the cracks occur in the body of the helmet; and (3) the left rear of the helmet, from 190° to 240°, where the cracks occur similarly to those in the right rear of the helmet.

It is noteworthy that a large preponderance of rim cracks occur in the visor between 325° and 335°, and that this preponderance was observed in every group of helmets examined except that from Camp Livingston, which was too small to yield significant results. Except for the group of helmets from Camp Pickett, the great majority of cracks in the zone between 325° and 335° are associated with notches resulting from trimming die defects.

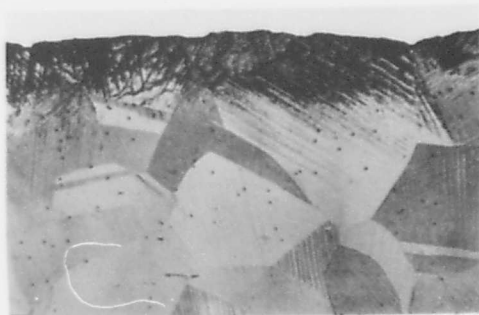
-A-

Helmet D4, McCord Lot 544B, Carnegie Heat 255739. Martensitic surface layer resulting from decarburization. Width of layer - 0.0016". Magnetic Traverse - 23.0".

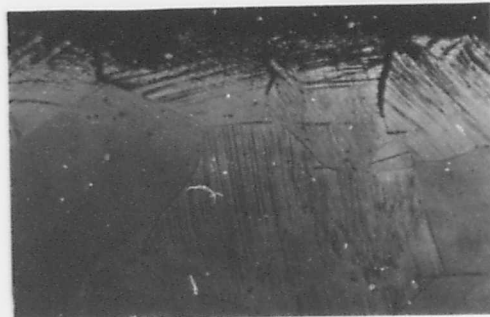
-B-

Helmet D4. Typical cracks in martensite layer resulting from deformation of brittle constituent.

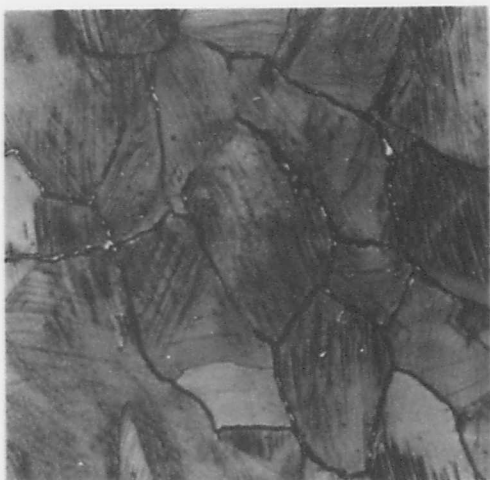
-C-

Helmet E1, McCord Lot 5410, Sharon Heat 72203. Network of undissolved carbides at grain boundaries. Magnetic Traverse - 3.0".

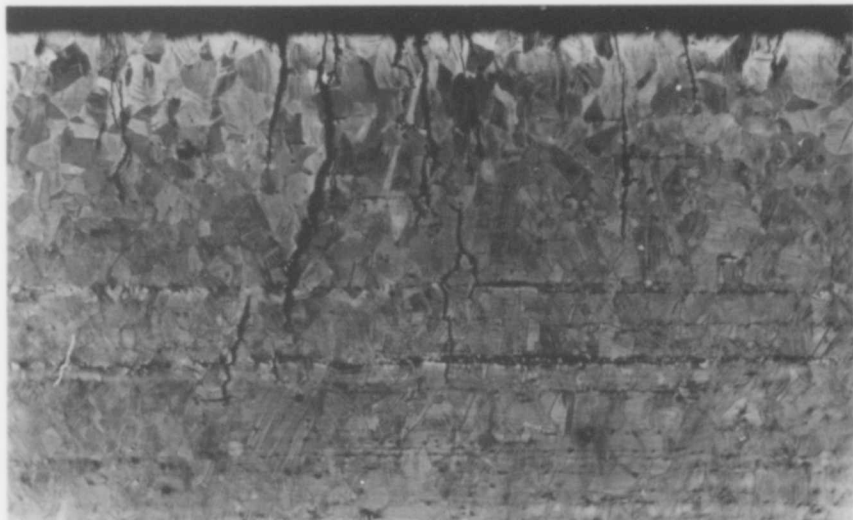
Helmet No. 34. McCord Lot No. 39A3 X100
Cracks originating at outside surface of helmet. Microstructure
contains heavy streaks of undissolved globular carbides and
some grain boundary carbide network.

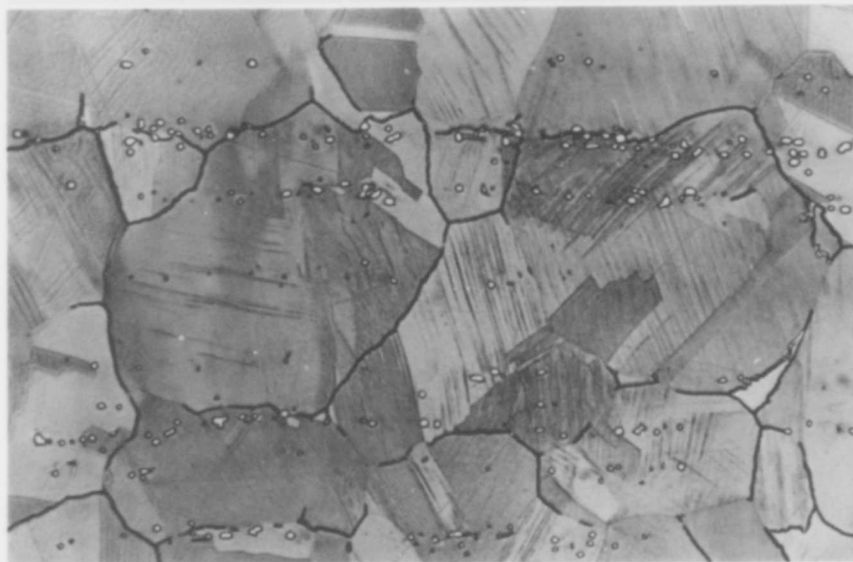
Helmet No. 95. McCord Lot No. 165 X1000
Streaks of undissolved globular carbides and grain boundary
carbide network.

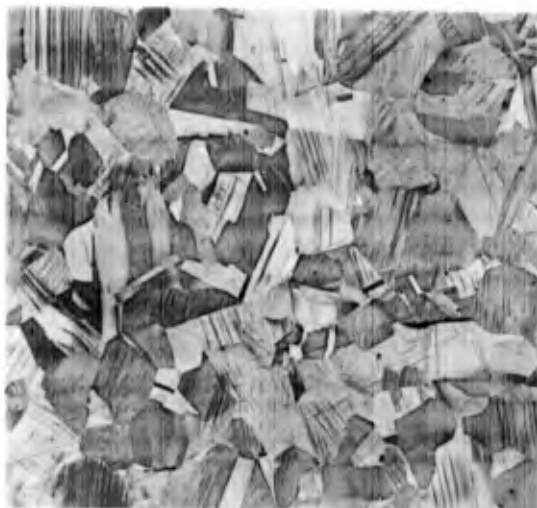
Helmet No. 93
McCord Lot No. 149C
Satisfactory microstructure. No
undissolved carbides.

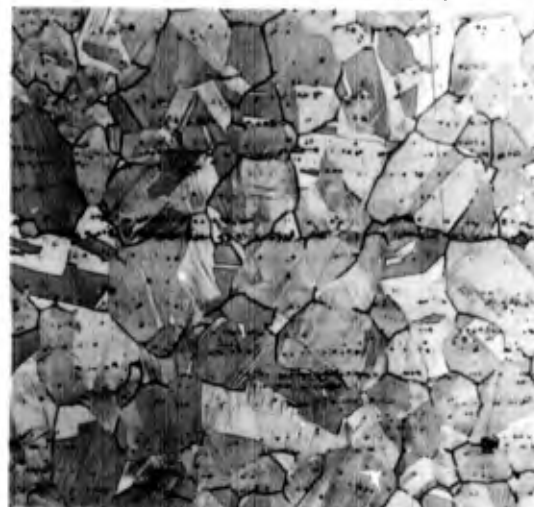
Helmet No. 95
McCord Lot No. 165
Streaks of globular carbides and
grain boundary carbide network.

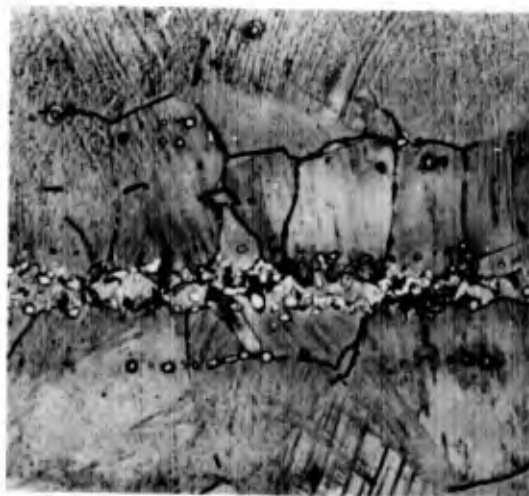
Helmet No. 16
McCord Lot No. 37C3
Segregation of globular carbides
and grain boundary carbides.

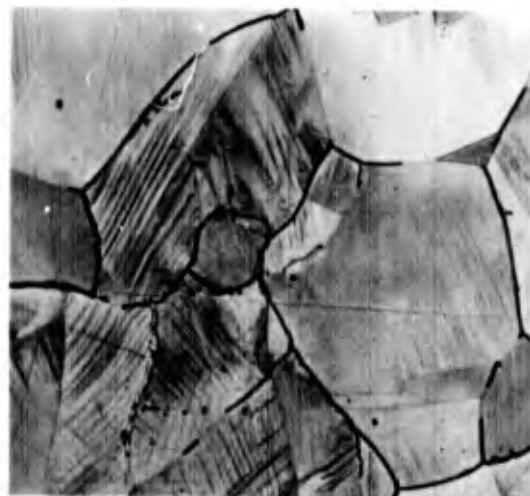
Helmet No. 92
McCord Lot 148B
Grain boundary carbide network.
