WATERTOWN ARSENAL LABORATORIES

FRACTURED LEAF SPRINGS — METALLURGICAL EXAMINATION

TECHNICAL NOTE NO. WAL TN 381/16

DECEMBER 1959

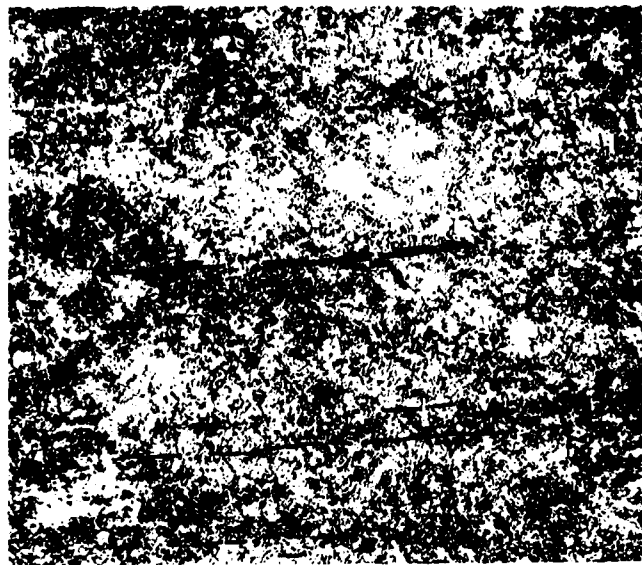
Broken Leaf Springs - The springs were made from a commercial grade of steel. Typical segregations of elongated nonmetallic inclusions are shown in Figure 1. A study of the microstructure of the springs indicated the grain size varied from ASTM #1 to #6 (Figures 2 and 3). The microstructure of the broken springs consisted of fairly coarse tempered martensite (Figure 4). Corrosion products were present on the surfaces of the spring which had a maximum thickness of 0.06". Also, severe pitting was present on the surfaces of the springs. This pitting extended into the cross section in some cases to a depth of 0.020"; Figure 5 illustrates a typical surface corrosion deposit and pitting extending into the cross-section. Such pitting could easily act as stress risers which would promote failure in service conditions. Figure 6 shows a typical pit at the surface of a failed spring and the corrosion of metal below the pit. A study of the crack systems indicate that the cracks followed the grain boundaries in many cases. Such a condition is occasionally present in the steels subjected to stress corrosion.

Leaf Spring, "As Received" - The steel base is also dirty, containing segregated elongated nonmetallics similar to the broken springs (Figure 1). The grain size was found to be ASTM #3 to #6 (Figure 7). Since the grain size of this spring was smaller than some of the broken springs, it is apparent that there were variations in the quenching temperature of the various spring stock. Some of the springs were undoubtedly overheated in heat treatment. Figure 8 illustrates the microstructure of the spring which consists of medium size tempered martensite. A slight decarburization of 0.005" was present on the surface; this amount of decarburization is not considered harmful.

FIGURE 1: TYPICAL SEGREGATED NONMETALLICS
IN BROKEN AND "AS RECEIVED" SPRINGS

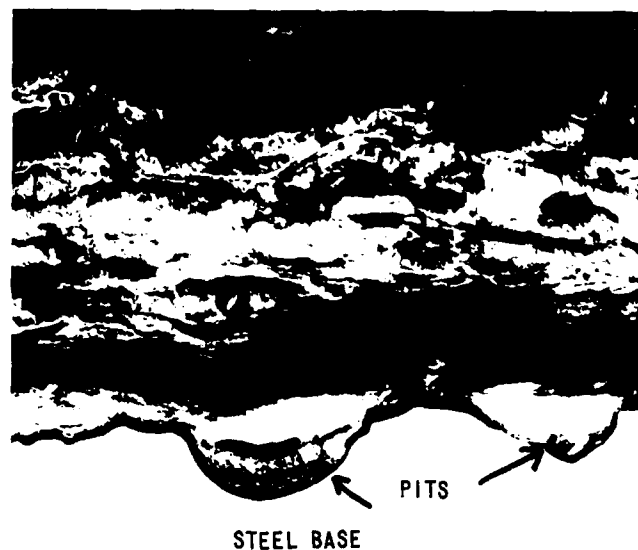
1. The surface of the broken leaf springs showed general corrosion and severe pitting as a result of contact with salt mixtures. It is believed that failure occurred by stress corrosion.
2. The springs are made of a commercial heat of chromium-vanadium steel containing segregations of nonmetallics and slight variations in carbon and vanadium as specified in ASTM Specification A60-49.
3. Considerable scale resulting from heat treatment is present on the surface of the leaf springs "as received."
4. Some of the leaf springs were overheated in heat treatment resulting in large grain size which may lower the fatigue limit.
5. The Brinell hardness of the leaf springs is acceptable (429 to 414).
6. A small amount of decarburization is present on the surface of the "as received" spring (0.005") which is not considered harmful.

FIGURE 5: SURFACE CORROSION DEPOSIT AND PITTING ON SURFACE OF BROKEN SPRING

3. In order that the surfaces of the springs be protected from the action of salt, it is recommended that they be sprayed with cadmium or zinc metal at this installation before assembly. This procedure would protect the surfaces of the springs against salt corrosion more efficiently than lubricants and other coatings. Before metal spraying it is essential that the paint on the spring be removed by abrasive blast cleaning.

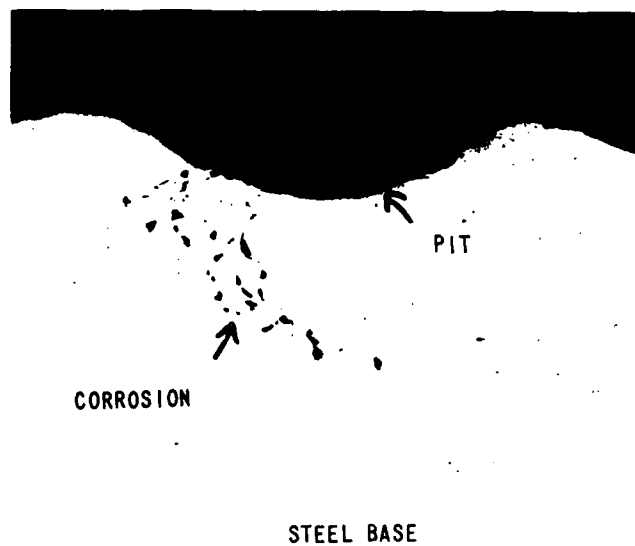
FIGURE 6: TYPICAL PIT ON SURFACE OF BROKEN SPRING AND CORROSION OF STEEL BELOW PIT
