**WATERTOWN ARSENAL
LABORATORY**

NO. WAL 710/722

Metallurgical Examination of 4" Thick Cast Armor

DATE 13 February 1945

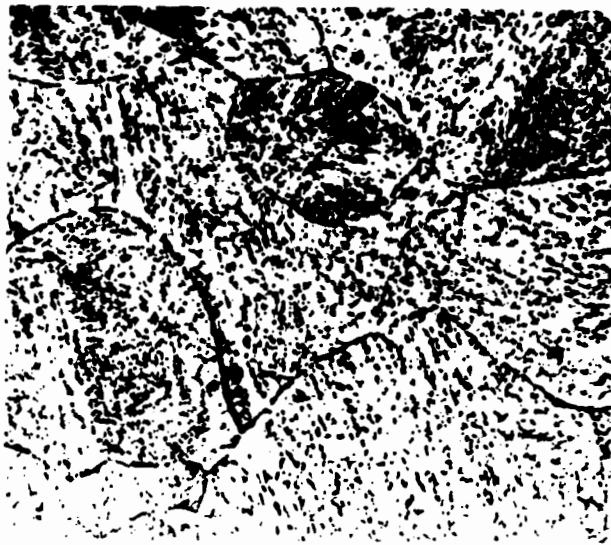
"As-Received" Condition

Microscopic examination was made on samples "as-received" and after the Watertown Arsenal quench and tempering treatment. In regard to nonmetallic inclusion content, the casting was fairly clean with occasional segregated areas of sulphide inclusions in the primary grain boundaries. The microstructure in the "as-received" condition consisted of fine carbides in a ferrite matrix with carbides at the grain boundaries. A tempered martensite microstructure containing some ferrite was evident in the microstructure after the Watertown Arsenal reheat treatment. Typical microstructures of the casting "as-received" and after reheat treatment are shown in Figure 1.

X1000 Picral
Fine carbides in a matrix of ferrite
with carbides at great boundaries.
