Watertown Arsenal Laboratory Report No. Wal 710/750 Problem B-4.74

26 May 1945

Metallurgical Examination of Armor and Welded Joints from the Side of a German PzKw V (Panther) Tank

To conduct a metallurgical examination of a two inch thick section of armor broken from the side of a German tank during ballistic testing.

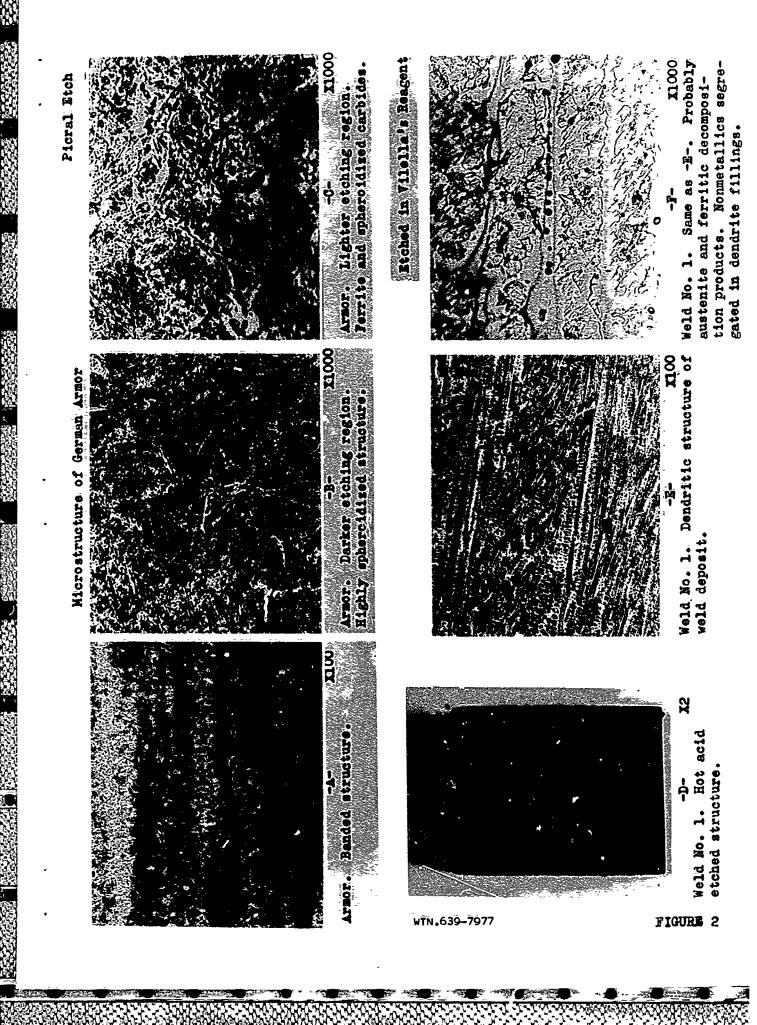
The microstructure of the armor consists of highly spheroidized carbides and ferrite segregated in alternate light and dark etching bands. The light etching bands contain greater amounts of ferrite than are found in the dark etching bands, see Figures 2A, 3, and C. It is surmised that the steel had probably been oil quenched and tempered at approximately 1200°F. The hardenability characteristics of the steel are such that a predominately bainitic structure was probably formed upon quenching. The microstructure is characteristic of tempered bainite.

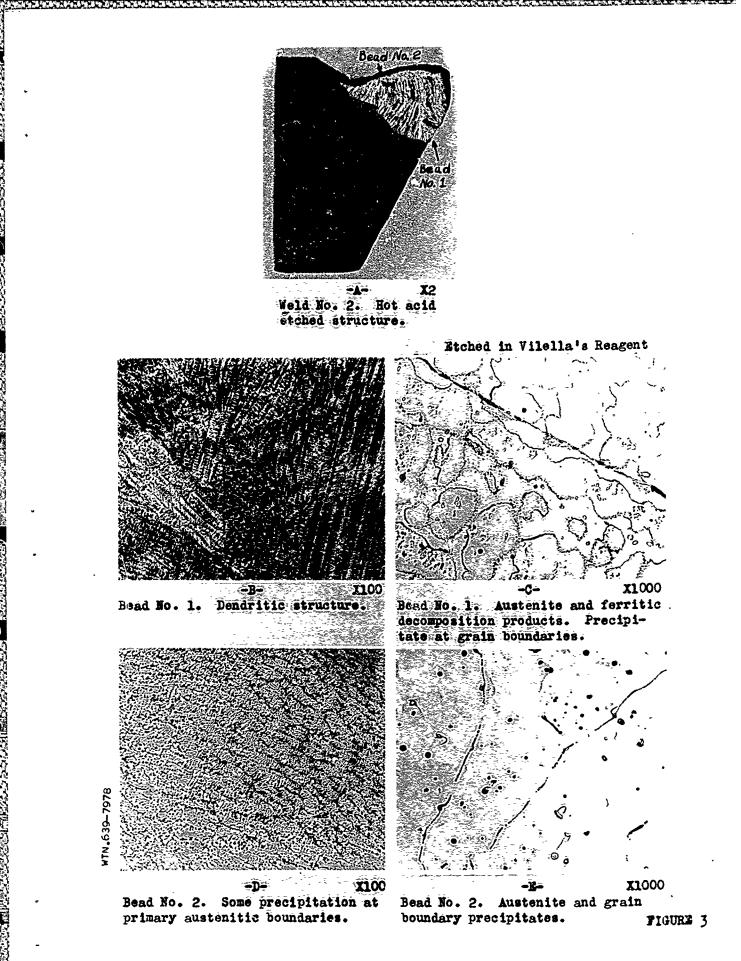
The 12% Cr, 4.5% Ni, 3% in single bead weld deposit (weld deposit No. 1) is strongly magnetic. The microstructure consists of austenite and ferritic decomposition products (probably mainly low carbon martensite) with nonmetallics segregated in the austenitic regions. The austenite, being richer in alloying elements, was the last metal to solidify and is consequently segregated in the dendrite fillings, see Figures 22 and F.

The 15% Cr, 6.5% Ni, 3.5% Mn weld deposit was laid on in two beads. The first bead which was deposited is quite strongly magnetic while the second bead is nonmagnetic. Spectographic analysis verified that both beads are of identical analysis. The microstructure of the first bead consists of austenite and ferritic decomposition products (probably martensite as in the case of weld No. 1), Figures 3B and C. again, the austenite occurs at the dendrite grain boundaries. The second bead is essentially austenitic, with nonmetallics distributed throughout the grains and nonmetallics and carbides outlining the grain boundaries, Figures 3D and E.

No cracks were observed in either weld deposit No. 1 or in the top bead of weld deposit No. 2. Gracking was observed in the lower bead of weld No. 2, being associated with the heavy precipitate occurring at the dendrite boundaries. No cracks were found in the base armor in the vicinity of the welds.

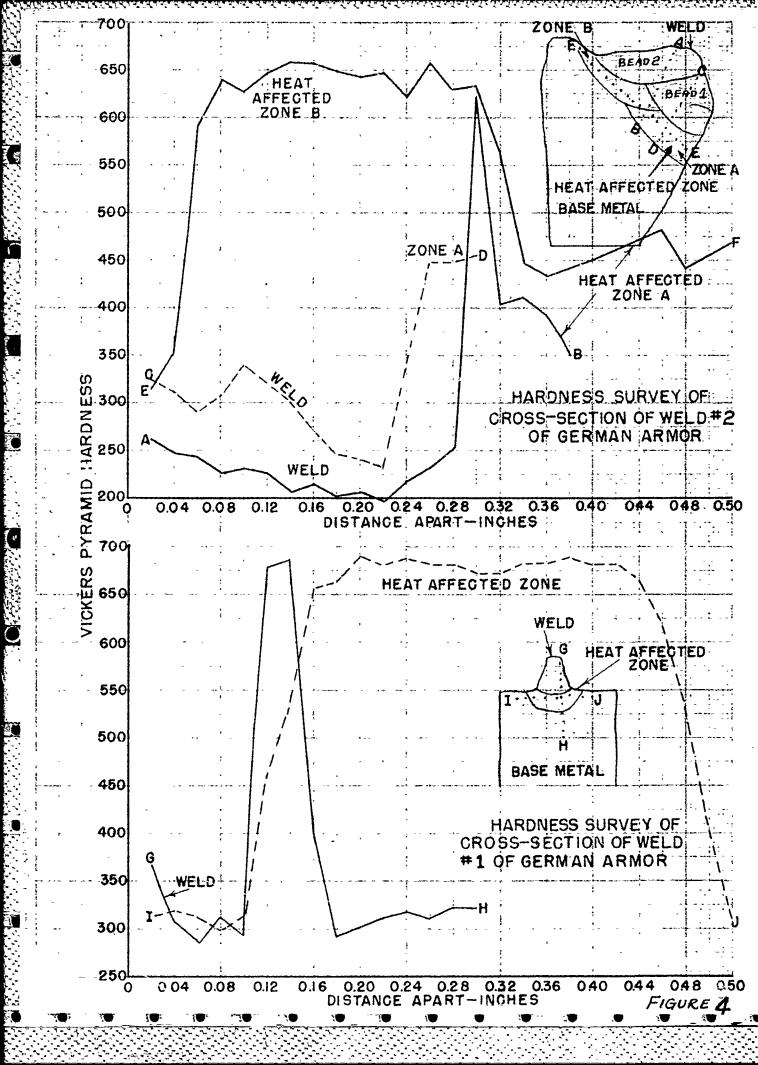
The results of Vickers-Brinell hardness surveys of the weld deposits of the heat affected zones are shown graphically in Figure 3 and are summarized in Table III.

The top bead of weld No. 2, being essentially austenitic, is considerably softer than weld deposit To. 1 and the bottom bead of weld No. 2, both of which contain considerable quantities of low carbon martensite.

The hardnesses of the heat affected zones of the base armor approach that of fully quenched martensite of a .45% carbon steel. The heat affected zone beneath the first weld bead applied to weld ro. 2 has been tempered by the application of the second weld bead; the hardness being reduced from 600-650 Vickers to 400-450 Vickers. The welds appear to have been deposited, without preheat, upon the armor in the final heat treated condition.
