WATERTOWN ARSENAL LABORATORY

EXPERIMENTAL REPORT

NO. WAL. 710/715

Metallurgical Examination of a 3-1/4" Thick armor Plate
from a German PzKw V (Panther) Tank

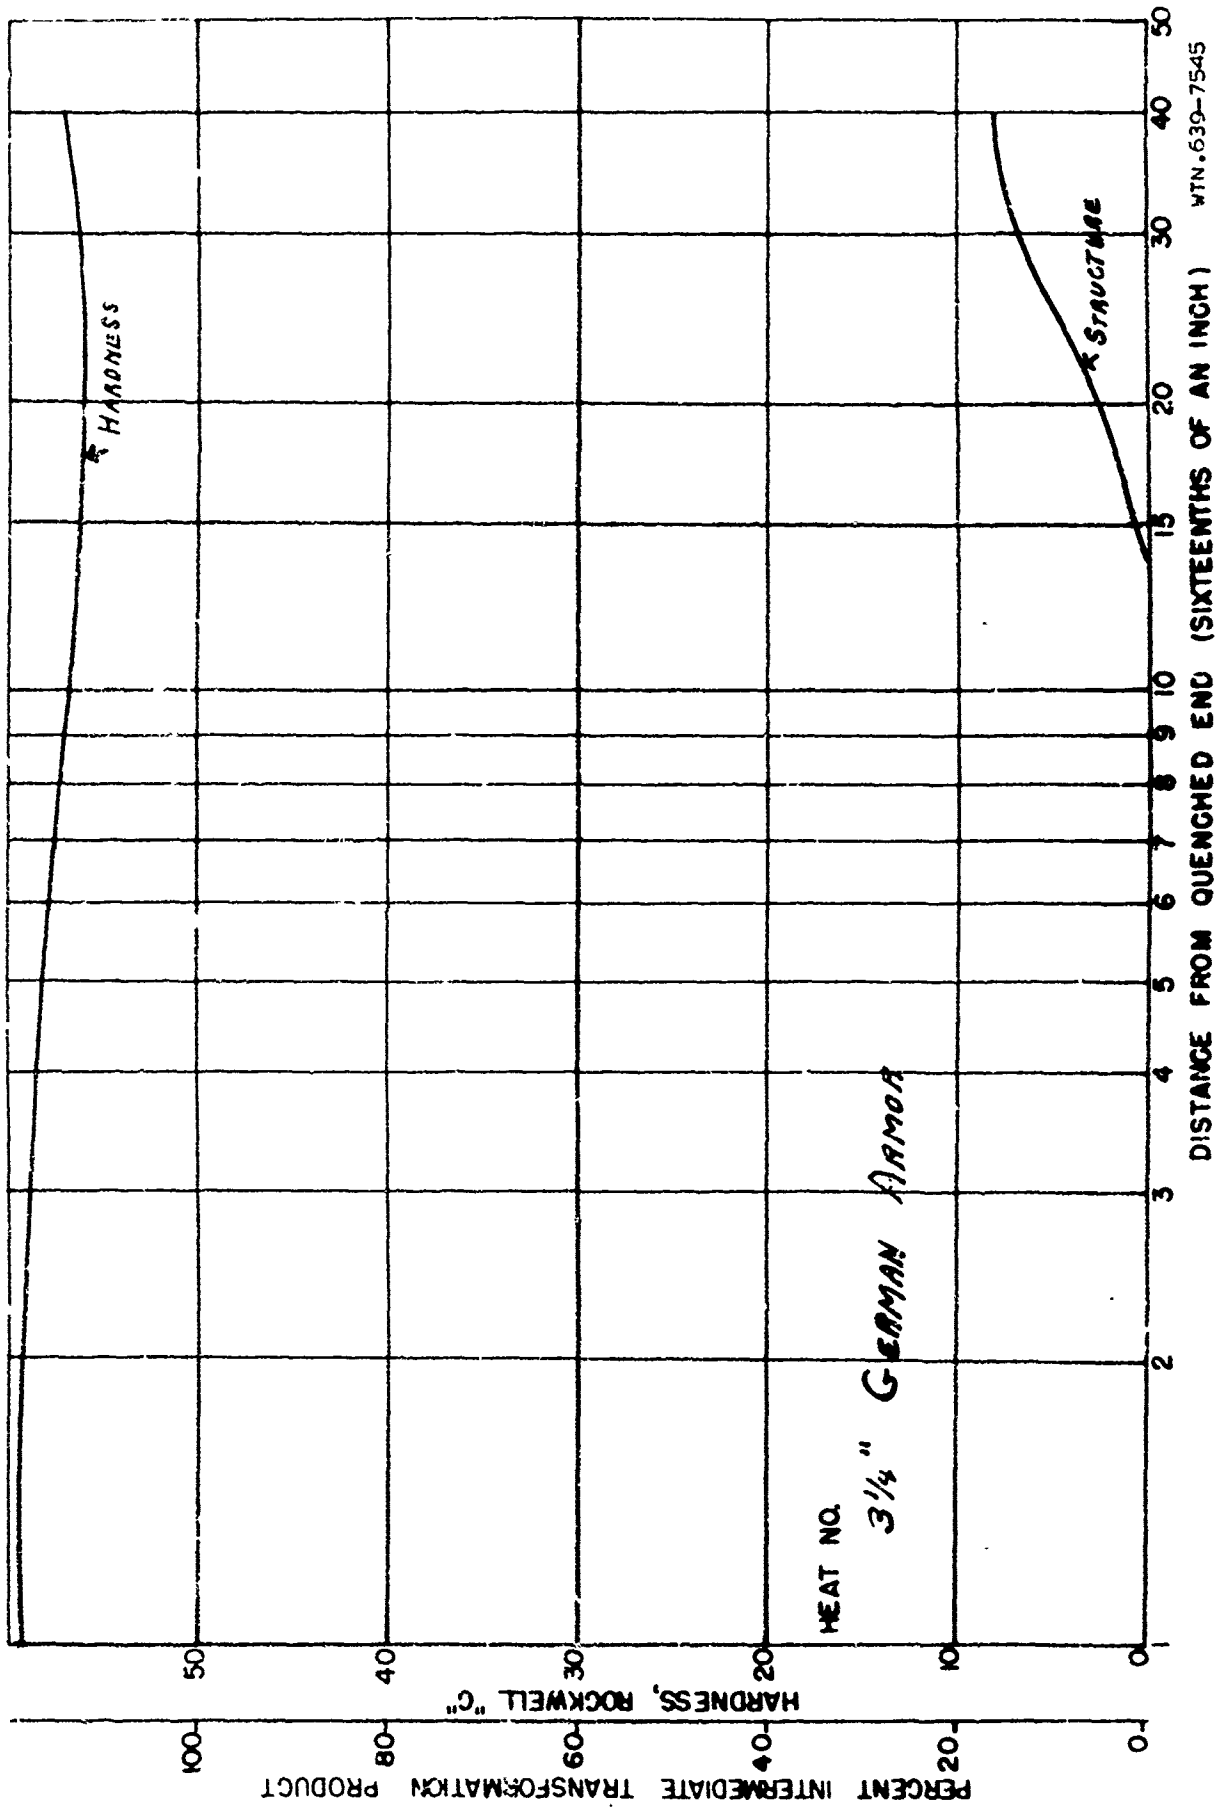
FIG. 1

A Jominy type end-quench test was conducted to evaluate the hardenability of this steel. Austenitizing prior to the quench consisted of a soak at 1700°F. for 3 hours. There was very little drop in hardness between the water quenched and air cooled ends of the bar, Figure 1. However, since it is the transformation constituents which are primarily responsible for the toughness observed after tempering, the as-quenched microstructure was examined. It was found that about 15% nonmartensitic transformation constituents were formed at the air cooled end of the bar.

The cooling rate at the 20/16" location on the end-quenched bar is equivalent to that of the center of a 3-1/4" thick plate when water quenched. On the other hand, the cooling rate at the 32/16" location on the end-quenched bar is equivalent to that at the center of a 3-1/4" thick plate when oil quenched.⁶ The amount of transformation constituents in the plate appeared to be greater than should be expected by either water or oil quenching, indicating that a slow cooling medium such as air may have been used. It will be shown that there were sufficient nonmartensitic transformation constituents present in the plate as heat treated by the German manufacturer to cause inferior notch bar toughness at -40°F.
