MEMORANDUM REPORT

NO. WAL 710/690

Metallurgical Examination of 2" Cast Armor Manufactured by
Continental Foundry and Machine Company

DATE 22 August 1944

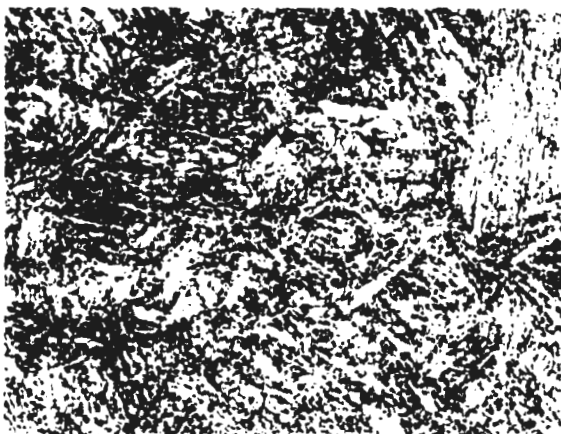
X1000 -A- Picral
Plate 6777-7. Tempered martensite
at 302 BHN.

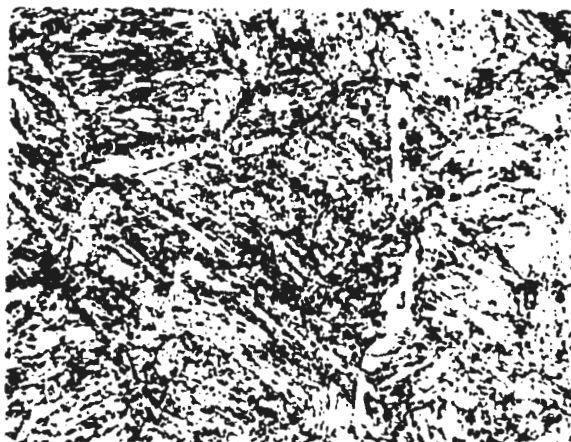
X1000 -B- Picral
Plate 6777-5. Tempered martensite
at 307 BHN. A small amount of
proeutectoid ferrite is present.

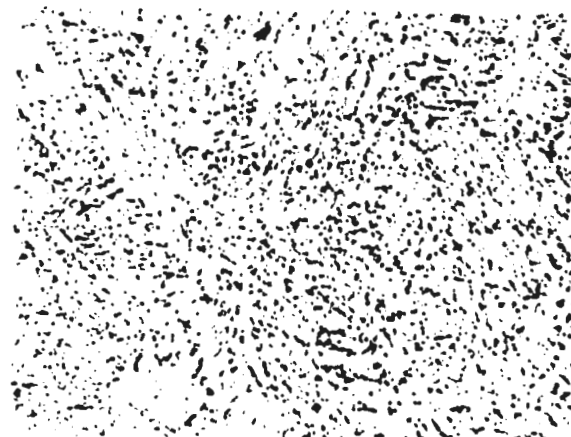
X1000 -D- Picral
Plate 6777-9. Tempered martensite
at 216 BHN.
