MEMORANDUM REPORT

NO. WAL 710/731

Metallurgical Evaluation of a Method of Anti-Personnel

Defense for the Medium Tank M4A1

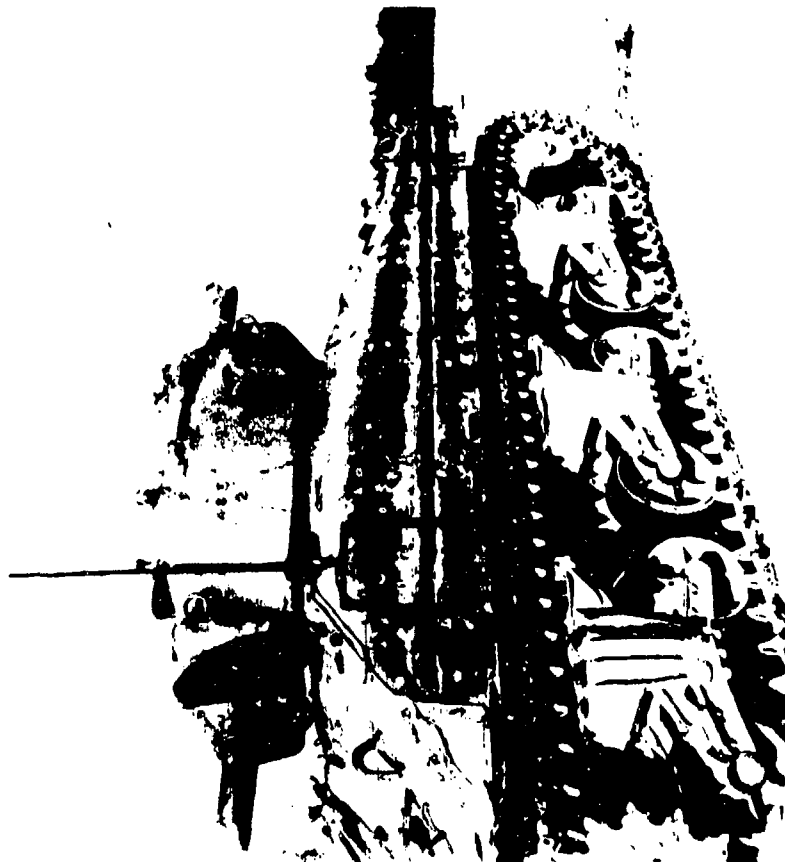
FIGURE 1

5. The submitted section was approximately 10"x16" in size, varying in thickness from 2" at the lower end to 1½" at the upper end. The location of the section is shown in Figure 1 and a drawing showing its details is contained in Figure 2.

Project No. 5478/3-18-12. Explosive Pipe; Anti-Aircraft Defense for Tanks. LEFT: Pipe held by modified triangular blocks and shielded by 3/8" thick angle iron. RIGHT: Close up of mounting.

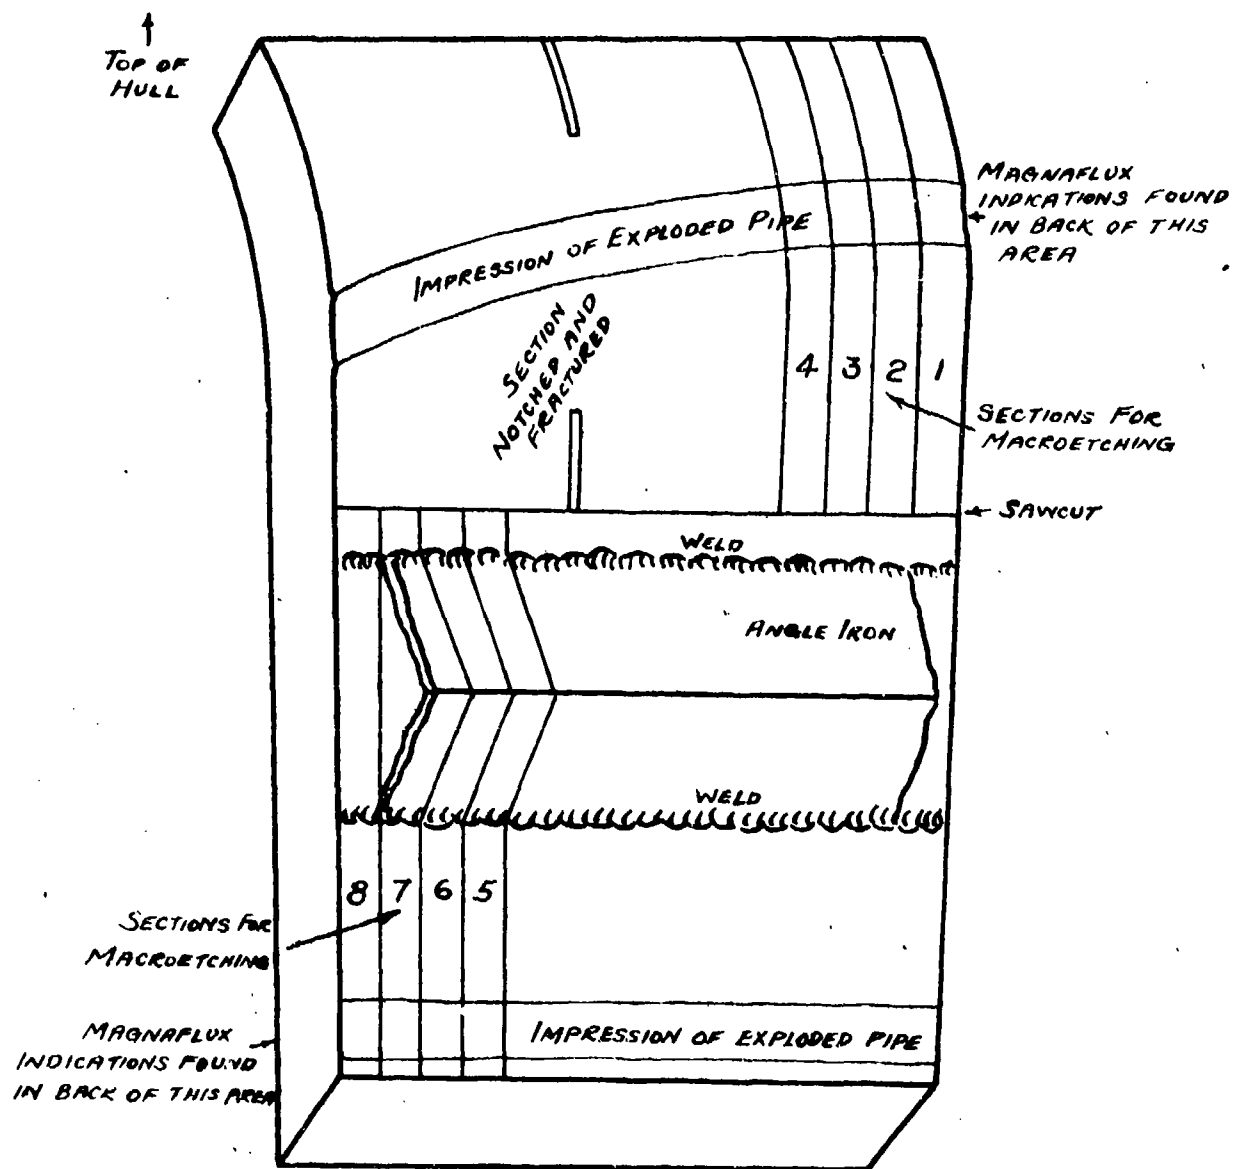
FIGURE 2.

Eight sections approximately  $\frac{1}{2}$ " wide and 8" long were machined from the casting in the areas containing the magnaflux indications, see Figure 2. After surface grinding, the eight sections were macroetched in a hot 50% hydrochloric acid solution for approximately 20 minutes. The appearance of the macroetched sections taken from the vicinity of the upper pipe is shown in Figure 7. Figure 8 contains photographs of the macroetched sections cut from the vicinity of the lower pipe. All of the macroetched sections reveal a considerable amount of centerline shrinkage. The white arrows in Figures 7 and 8 point to the cracks on the inside surface of the hull casting. These cracks are directly behind the area impacted by the force of the exploding pipes. The cracks behind the upper pipe are from 0.2" to 0.4" deep while those behind the lower pipe are from 0.2" to 0.3" deep.

SECTION OF CAST ARMOR HULL OF MEDIUM  
TANK M4A1 SUBMITTED FOR EXAMINATION.

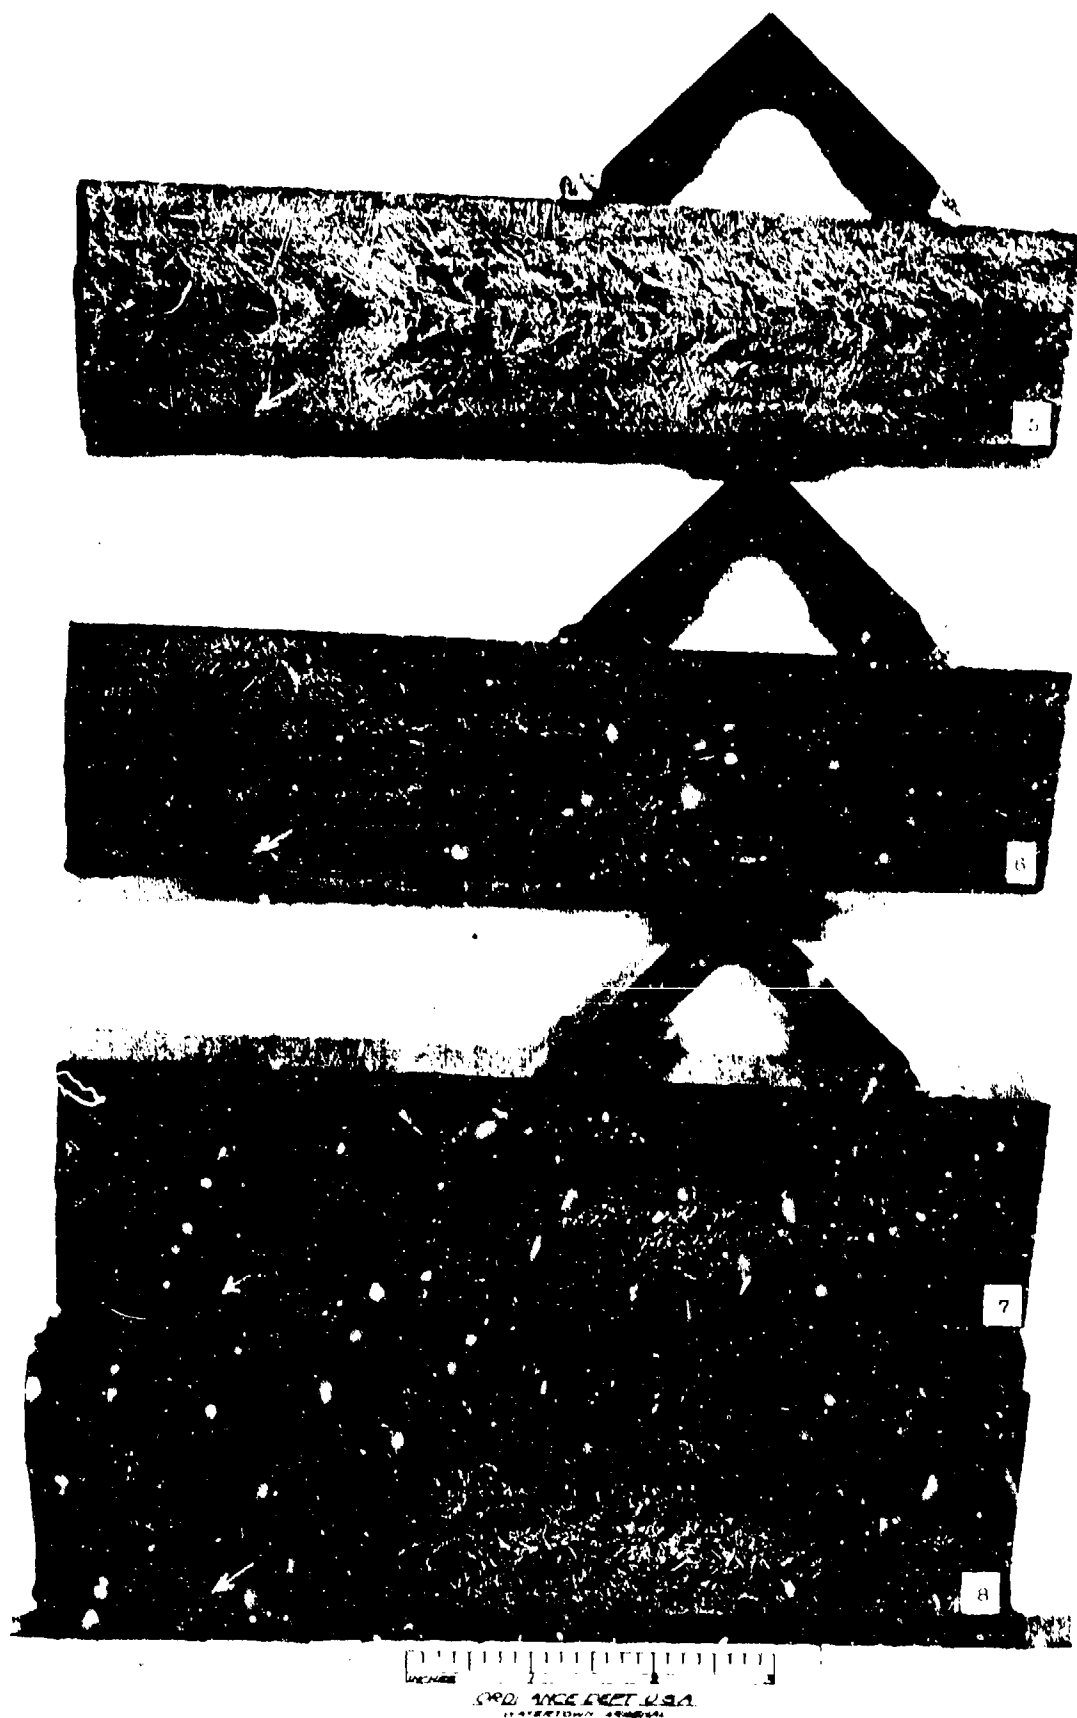
FIGURE 3

Since the armor in the vicinity of the upper pipe is  $1\frac{1}{2}$ " thick whereas in the vicinity of the lower pipe it is 2" thick, it is indicated that the upper portion of the hull would be more vulnerable to damage by the explosion of the anti-personnel device.

MACROETCHED SECTIONS OF M4A1 TANK HULL. AREA NEAR LOWER DETONATED PIPE.  
 ARROWS POINT TO CRACK ON INSIDE OF HULL. 28 FEB 1945 WTN.710-2363
