Ballistic and Metallurgical Investigation of Helmets
Edge-Annealed in a "Tocco" Induction Heating Unit

MEMORANDUM REPORT NO. WAL 710/679

Final Report on Problem B-7.4

18 July 1944

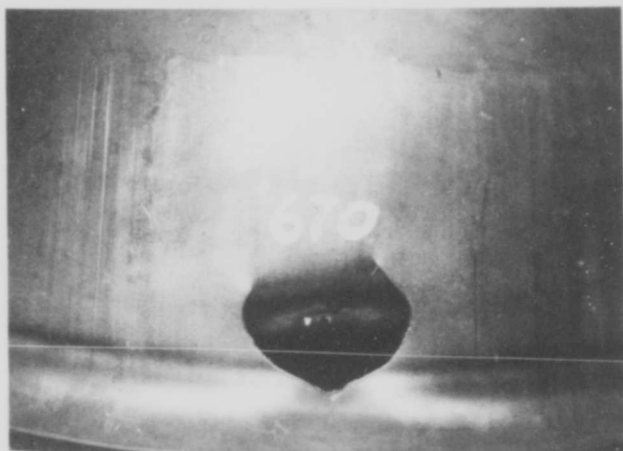
Typical results of the ballistic tests are shown in Figures 1A through E. Examination of these photographs reveals that the edge-annealing process produces no noticeable change in the ballistic characteristics of the zone lying within 1" of the edge. There is no tendency for crack propagation through either the annealed or the transition zone. Figure 1E is a photograph of an edge-annealed helmet which was struck by a projectile exactly on the edge of the rim, which was pushed inwards 0.7". No cracks resulted and the helmet displayed excellent ductility.

Helmet S3. Schlueter 213B7. -A-
Edge Annealed. Impact 1.0" up from rim
at 265°.

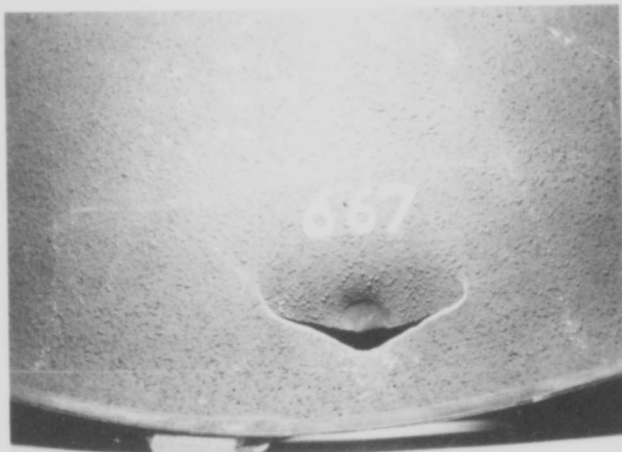
Helmet 14. McCord 608A. -B-
Normal Helmet. Impact 0.9" up from rim
at 250°.

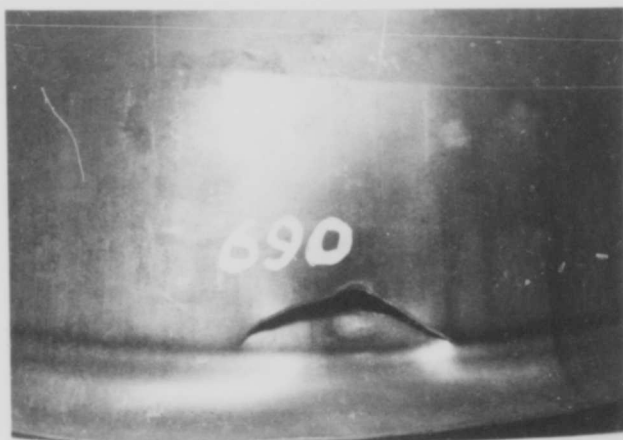
Helmet S1. Schlueter 213B7. -C-
Edge Annealed. Impact 1.2" up from rim
at 255°.

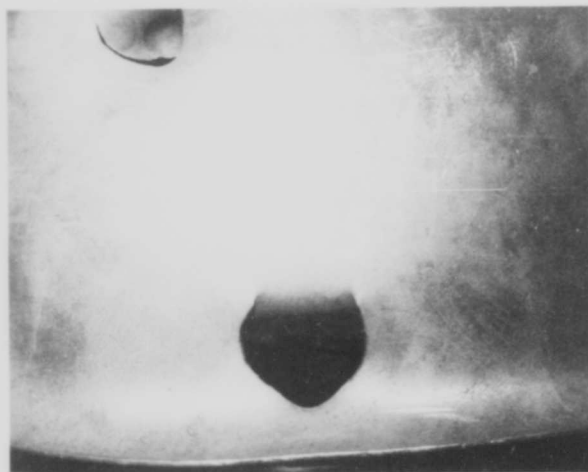
Helmet 16R. McCord 854C. -D-
Normal Helmet. Impact 0.7" up from rim
at 83°.

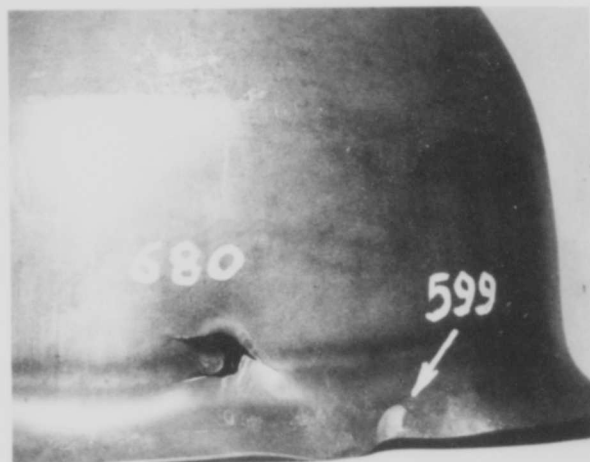
Helmet S1. Schlueter 213B7. -E-
Edge Annealed. 680 ft./sec. - 1.1" up
from rim at 83°. 599 ft./sec. - edge of
rim at 60°, rim pushed in 0.7".

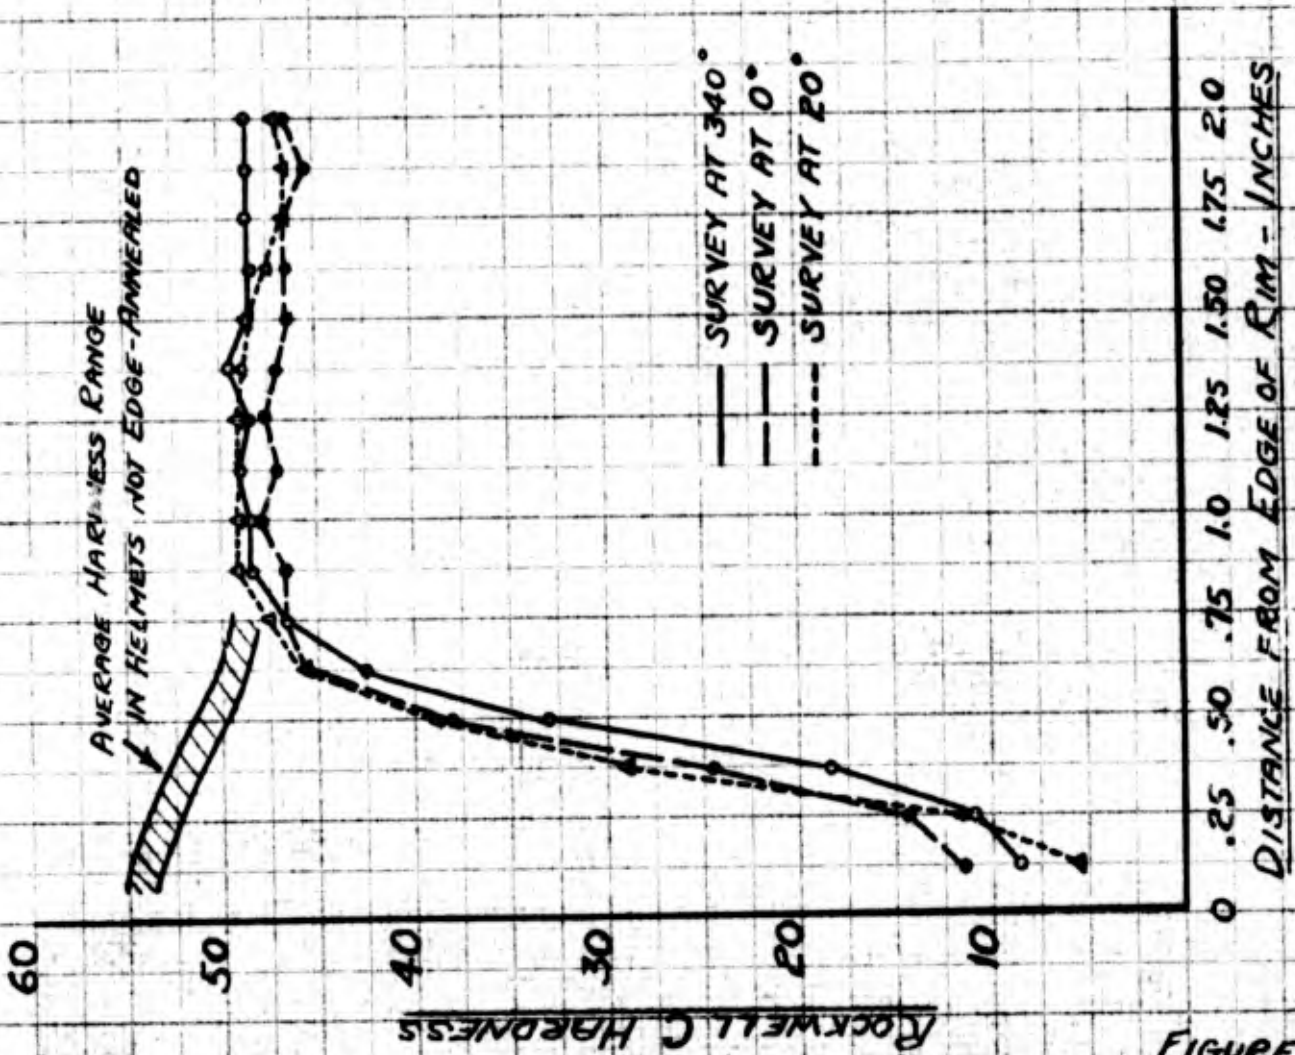
FIGURE 2.

Hardness surveys at 340°, 0° and 20° on helmet No. S5 are plotted in Figure 2. All the other hardness surveys made upon both this helmet and helmet No. S4 coincide with these curves. For a distance of approximately 1/4" the hardness is that of the material in the dead soft condition, Rockwell C 5.5 - 14 (Rockwell B 89 - 95). The unaffected cold worked base metal has a hardness of Rockwell C 47 - 49.5, and between this region and the dead soft zone is a transition zone approximately 1/2" in width.

ROCKWELL C HARDNESS SURVEYS
TAKEN PERPENDICULARLY UP FROM
EDGE OF "TOCCO" ANNEALED RIM
OF M1 HELMET.

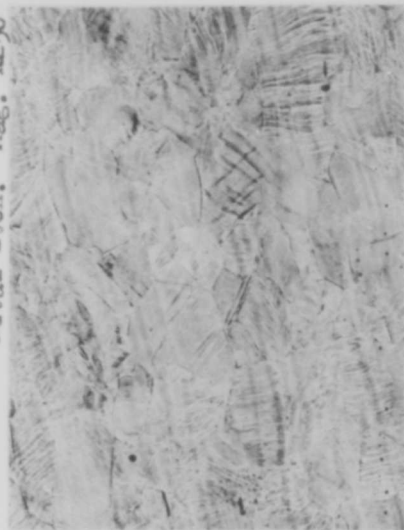
e. Microscopic examination. Specimens for microscopic examination were cut from helmets Nos. S4 and S5. For a distance of approximately 0.25" from the edge the microstructure consisted of a completely recrystallized structure with undissolved carbides at the grain boundaries, Figure 3A. The 1/2" wide transition zone consisted of a partially recrystallized structure with a large amount of carbides precipitated along slip lines and at grain boundaries, Figure 3B. Figure 3C shows the cold worked structure of the unaffected base metal.

Helmet S4. -C- 0.750" from edge.
Unaffected cold worked region.
Severely deformed grains.
Rockwell C 47.

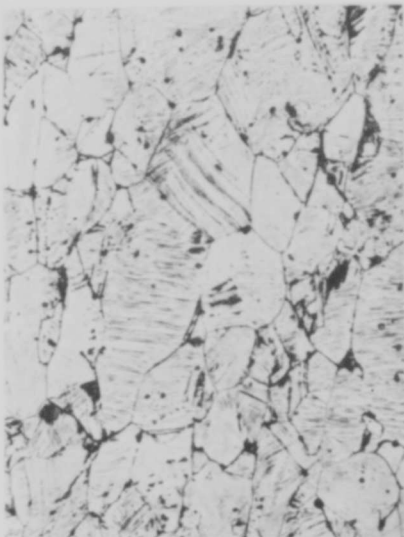
Helmet S4. -B- 0.540" from edge.
Partially recrystallized zone.
Some grains show evidence of cold
working. Extensive carbide
precipitation. Rockwell C 35.

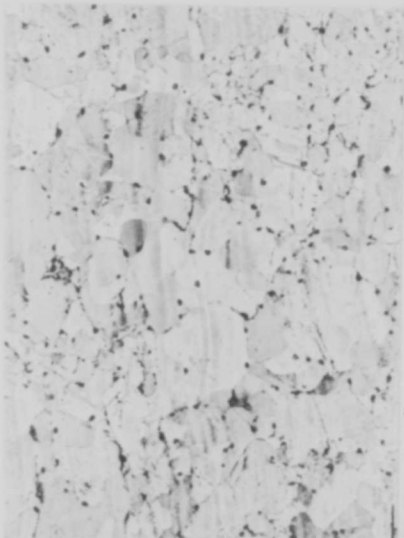
Helmet S4. -A- 0.080" from edge.
Recrystallized austenitic grains.
Some undissolved carbides at grain
boundaries. Hardness, Rockwell C 10.

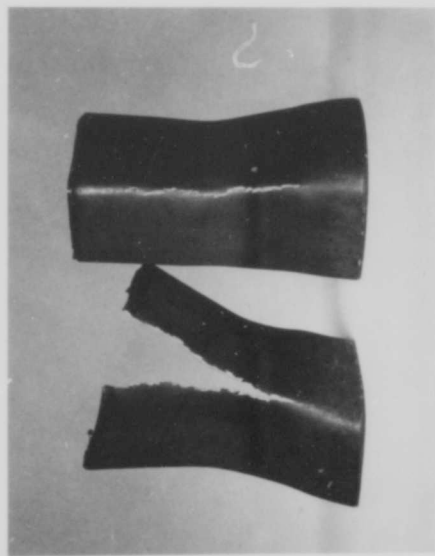
-D- Mag. X 2/3

c. 90° Bend Testg. Bend tests were conducted upon the sections lying between 350° and 0° cut from helmets S4 and S5. Photographs of the bent sections are shown in Figure 3D. The region lying between the edge and 1/2" up from the edge developed no cracking upon being bent through 90°. The cold worked zone broke apart in one case and cracked severely in the other. Previous tests at this arsenal² upon helmets that were not edge annealed resulted in complete breakage of the sections. This test reveals the excellent ductility produced by the annealing of the helmet edge.

90° bend tests on sections cut from
visors of edge annealed helmets.
Similar tests on helmets without edge-
annealing resulted in complete breakage.
