Rpt. No. WT-809

# Operation UPSHOT-KNOTHOLE

ADDITIONAL DATA ON THE VULNERABILITY  
OF PARKED AIRCRAFT TO ATOMIC BOMBS

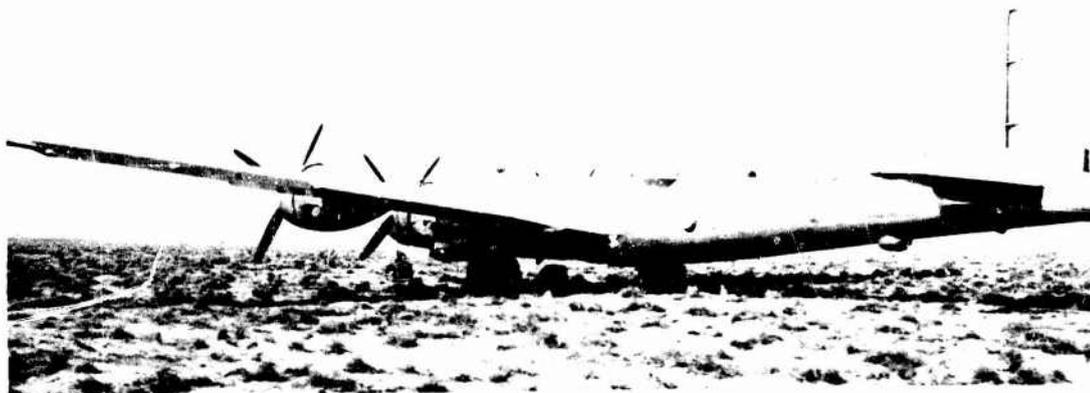
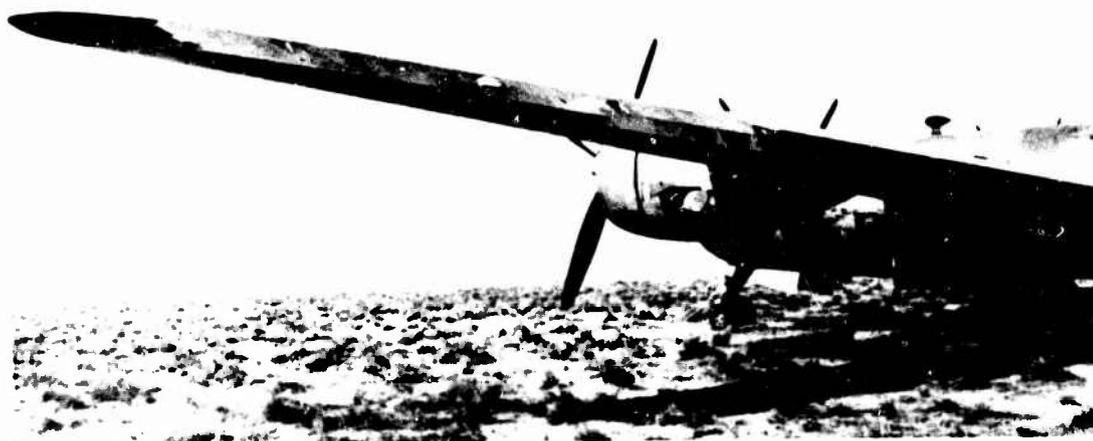
Fig. 3.6 B-29 (066), Tail-in, 7700 Ft (1.8 psi), Shot 1

1. Left wing tip damaged on rear inboard side adjacent to the aileron at Station 820.
2. Left-hand aileron twisted and bent upward on outer end at Station 820.
3. Fabric of left-hand aileron torn at three places on top side.

Condition of Aircraft After Exposure

Left Wing After Exposure

Estimated man-hours required for complete repair, 322.

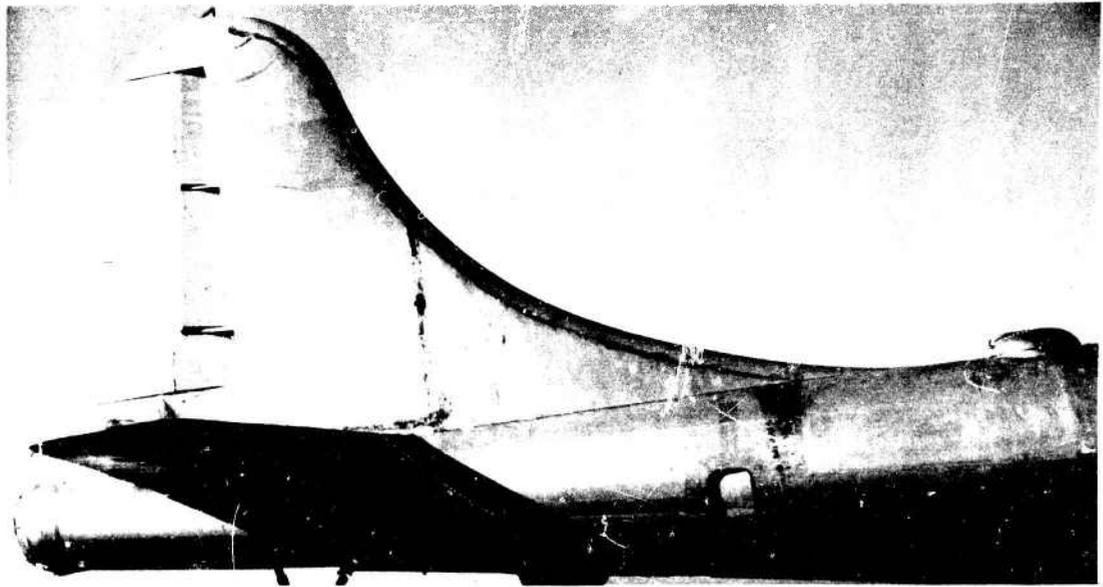
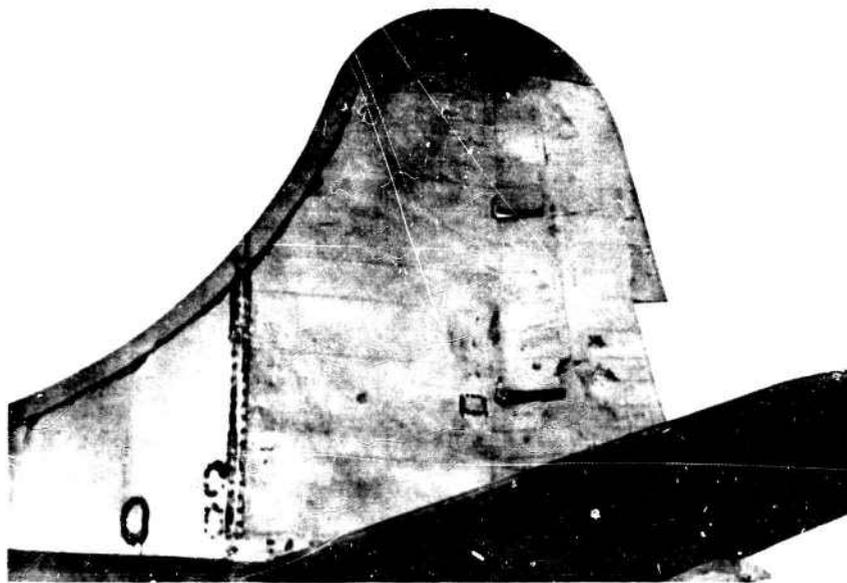
Fig. 3.7 B-29 (066), Right Side-in. 2800 Ft (1.2 psi), Shot 3

Rear of Fuselage and Empennage: Note Sprung Door and Missing Trim Tab

Compression Side of Empennage: Note Buckling of Vertical Stabilizer

Estimated man-hours required for complete repair, 150.

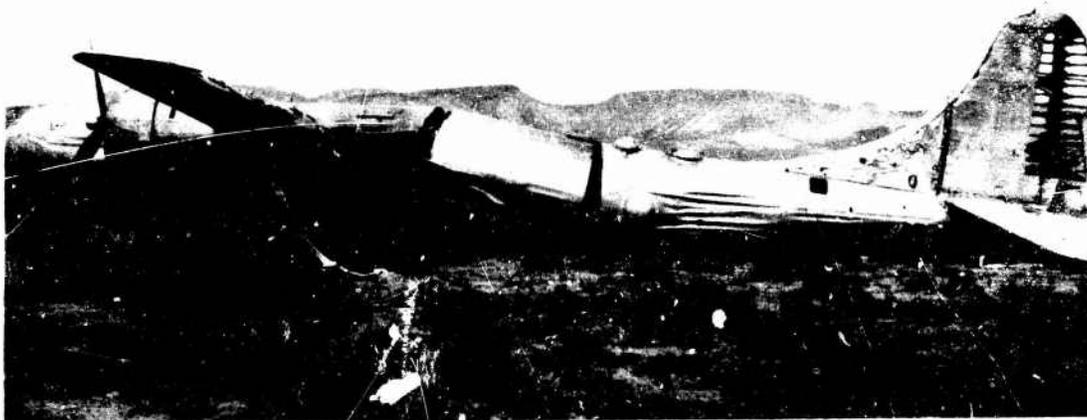
Fig. 3.8 B-29 (066), Left Side-in, 6200 Ft (3.5 psi), Shot 7

- b. Skin buckled and twisted from Station 63 to Station 218.
2. Bomb bay, Station 218 to Station 646:
  - a. Fuselage broken off around entire periphery at Station 485 and Station 646. Rivets sheared, skin torn, and formers broken, lower left longeron bent extensively, left-hand catwalk broken, right-hand catwalk and longeron broken.

Over-all View of Damage Incurred: Note Double Break in Aft Section of Fuselage

Mid-fuselage, Showing Break in Skin

Aircraft damaged beyond repair.

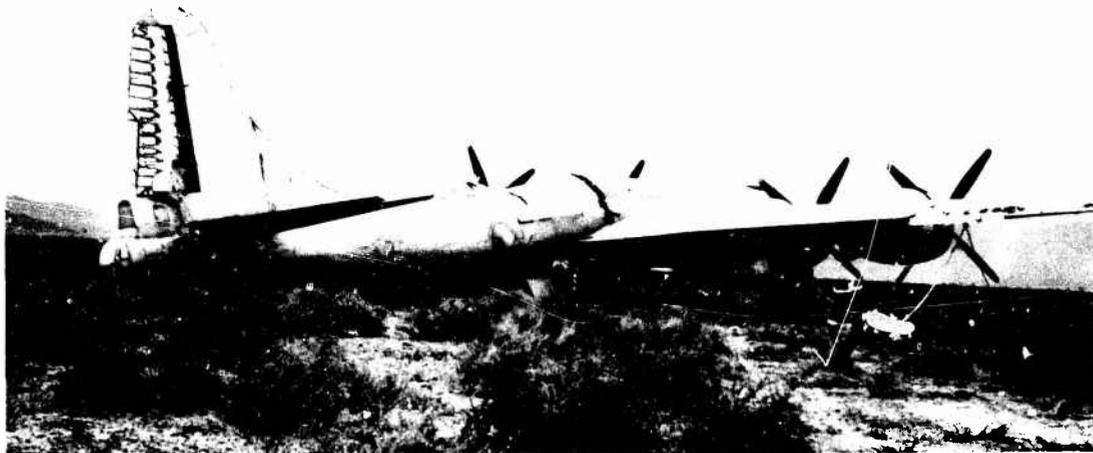
Fig. 3.9 B-29 (066), Left Side-in, 6200 Ft (3.5 psi), Shot 7

1. Forward pressurized cabin, Station 6 to Station 218:
  - a. Formers broken and twisted and extrusions twisted on left-hand side, Stations 63, 81, 99, 117, 135, 169, and 185.

General View, Unexposed Side

Left Side of Forward Fuselage: Note Ring Failures

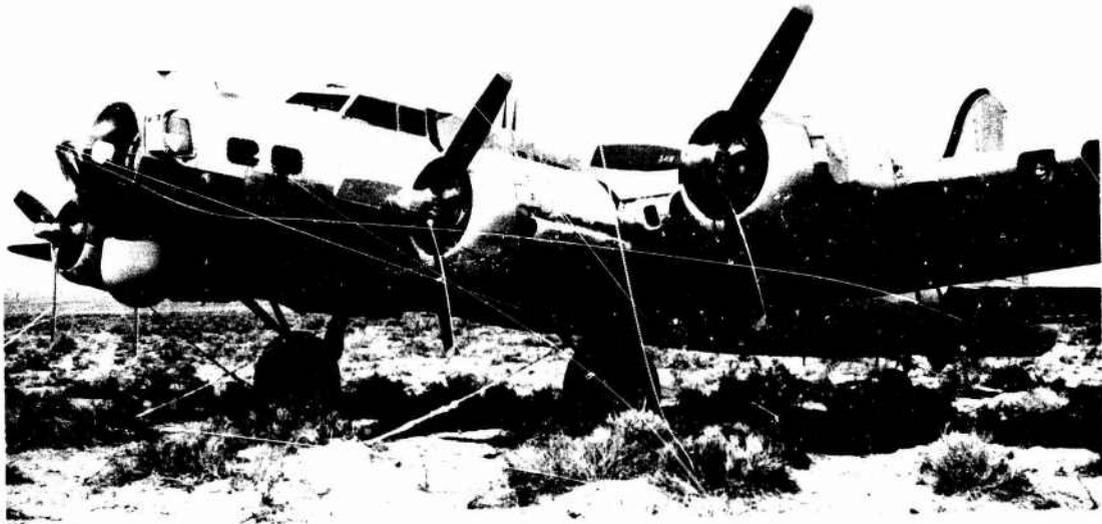
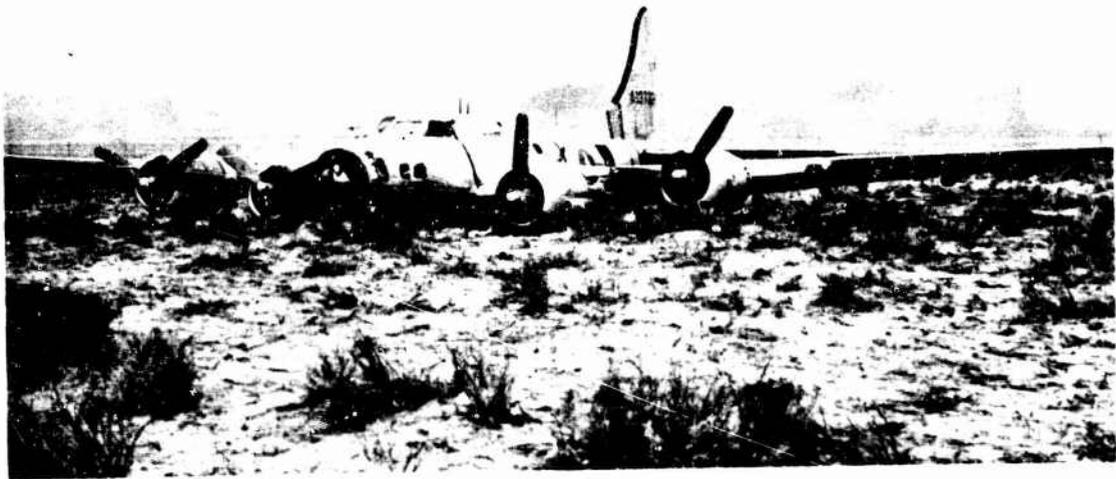
Fig. 3.10 B-17 (730), Nose-in, 4450 Ft (4.8 psi), Shot 8

1. Forward section:
  - a. Formers and bell frame buckled and/or broken over entire area from Station 0 to Station 409. Skin in this area severely buckled and torn at several places.
  - b. Pilot compartment enclosure buckled, torn, and
  - c. Right and left-hand bomb-bay doors heavily bent, skin torn and buckled.
2. Fuselage rear section:
  - a. Skin buckled and canned from Station 409 to Station 808.
  - b. Light to moderate skin canning over entire surface.

Postshot View

Aircraft damaged beyond economical repair.

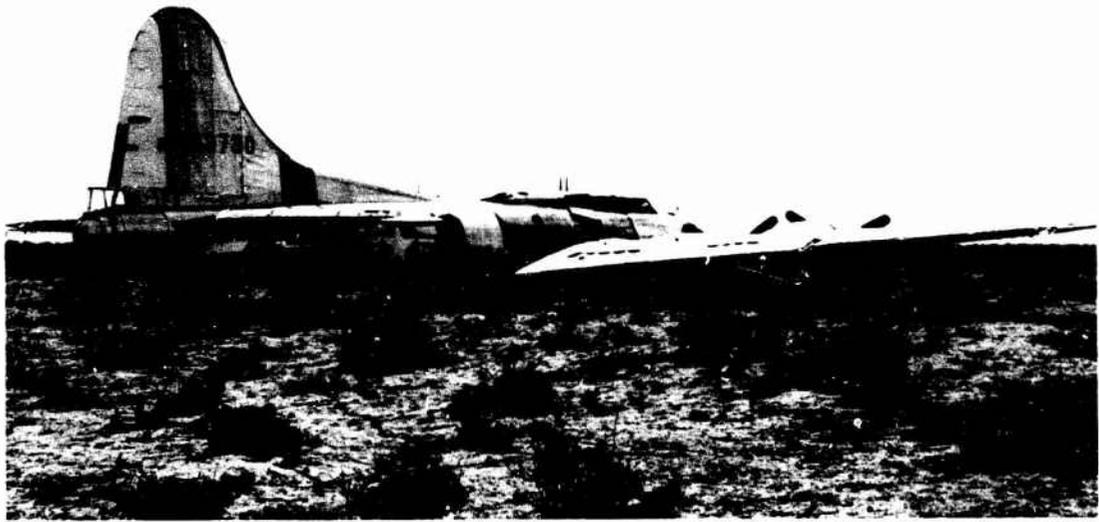
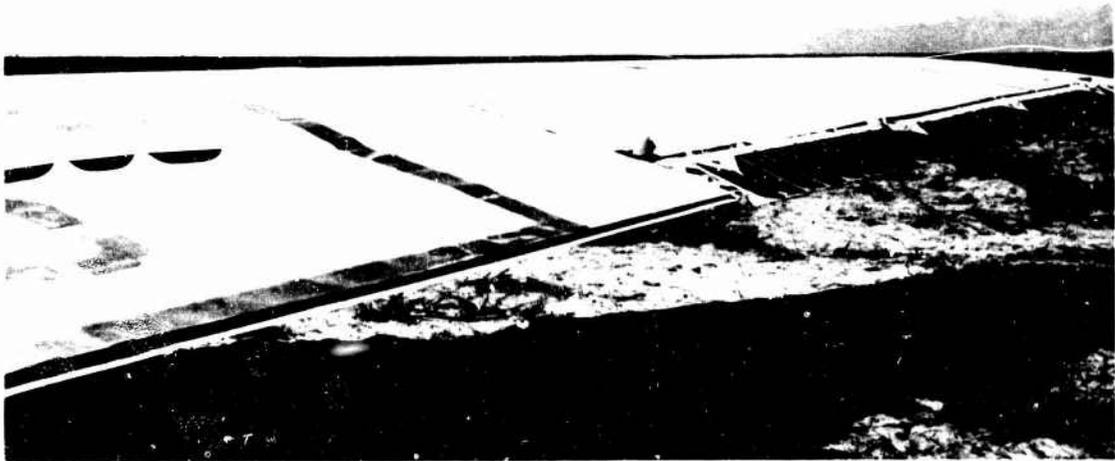
Fig. 3.11 B-17(9730), Nose-in, 4450 Ft (4.8 psi) Shot 8

General View Showing Damage to Right Side: Note Damage to Forward Fuselage and Compression Buckles in Vertical Stabilizer

Damage to Trailing Edge and Outer Panel of Right Wing

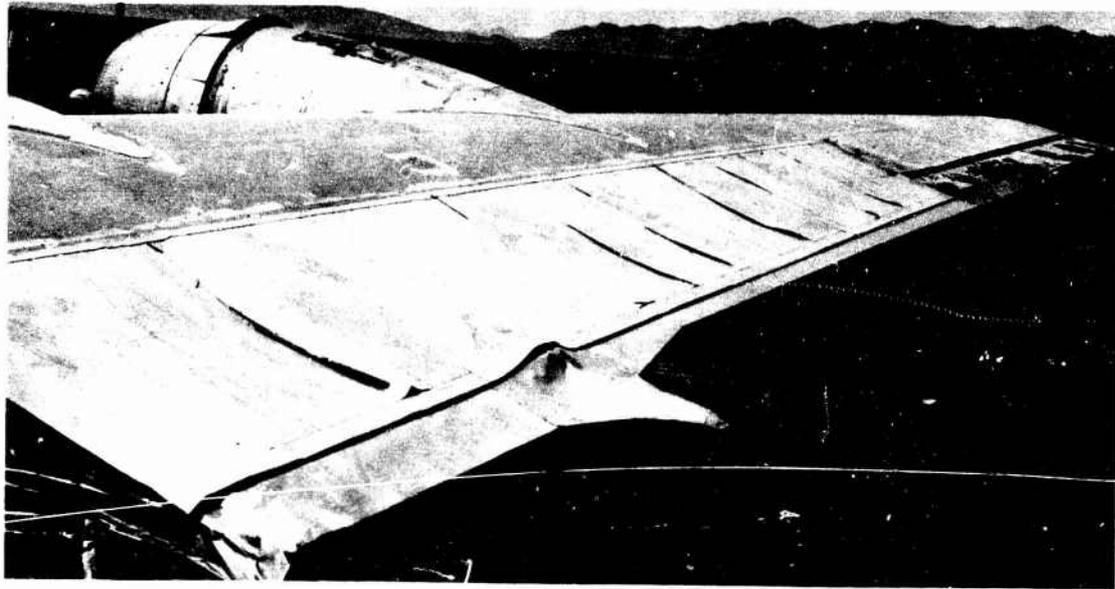
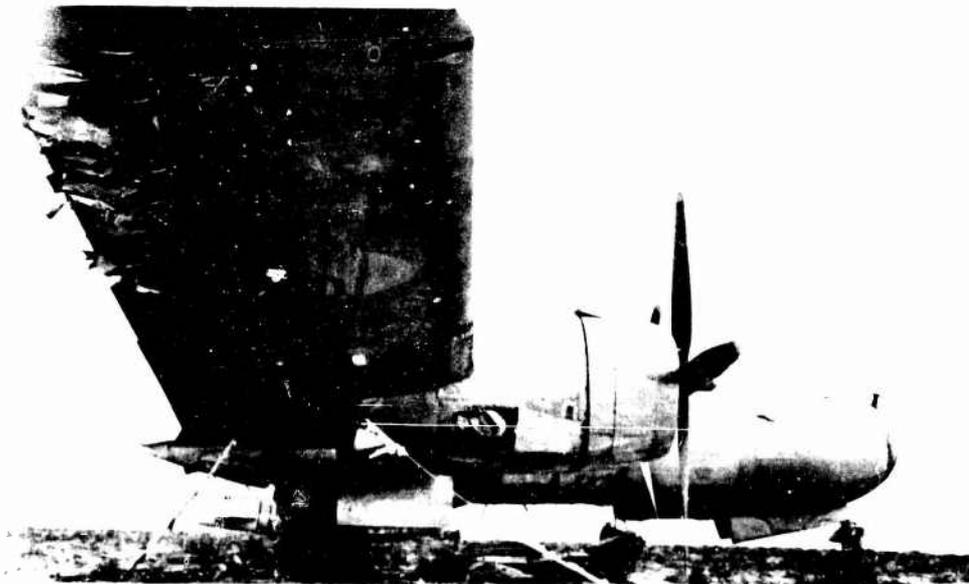
Fig. 3.12 B-29 (066), Nose-in, 4450 Ft (4.8 psi) Shot 8

1. Left-hand inboard wing:
  - a. Stress plate buckled under inboard fuel cell.
  - b. Trailing edge of wing aft of rear spar buckled, twisted, rivets pulled, ribs bent and/or broken from Station 62 to Station 510.
  - c. Wing to fuselage fillets dented and torn.
  - d. Flap assembly - over-all structure of flap deformed, skin canning over entire area, top and bottom.
2. Left-hand outboard wing:
  - a. Trailing edge of wing aft of rear spar buckled, ribs and stiffeners buckled and/or broken, skin stretched and torn (major damage).
  - b. Skin of outboard wing buckled and rivets pulled, ribs buckled and/or broken between front and rear spar.

- c. Wing tip assembly - tip twisted, rivets pulled, ribs buckled and/or broken, skin collapsed on top and bottom side.
- d. Aileron assembly - frame twisted, ribs buckled, and fabric blown from aileron.

Damage to Right Wing: Note Heavy Damage to Trailing Edge

Under Side of Right Wing, Showing Damage to Outer Panel

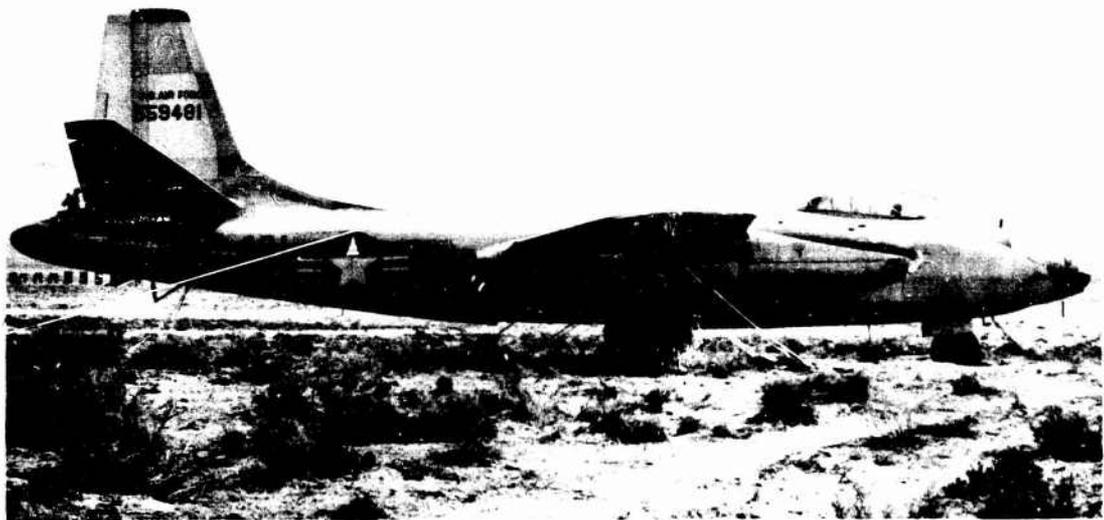
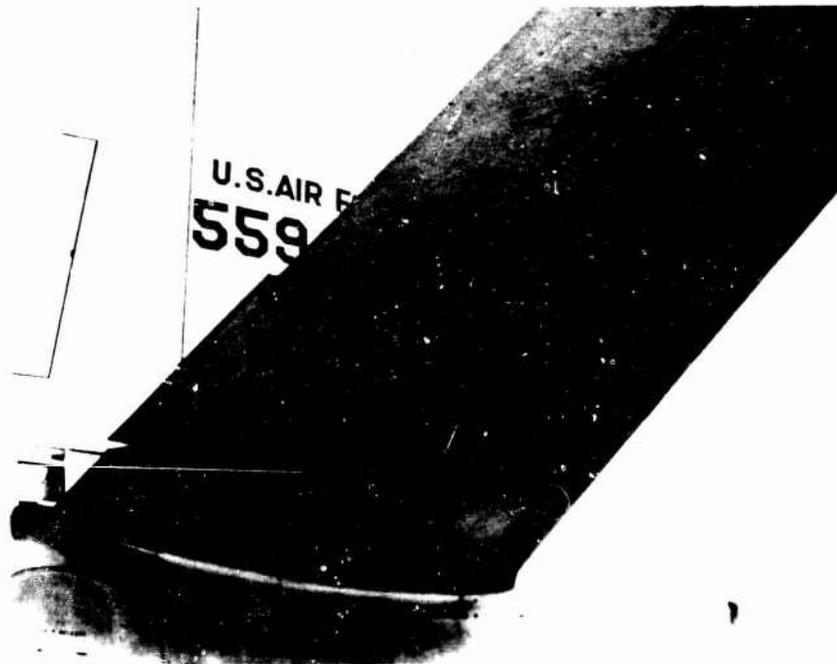
Fig. 3.13 B-45 (481), Nose-in, 3700 Ft (6.7 psi) Shot 8

Vertical and Horizontal Stabilizer: Note Skin Buckling

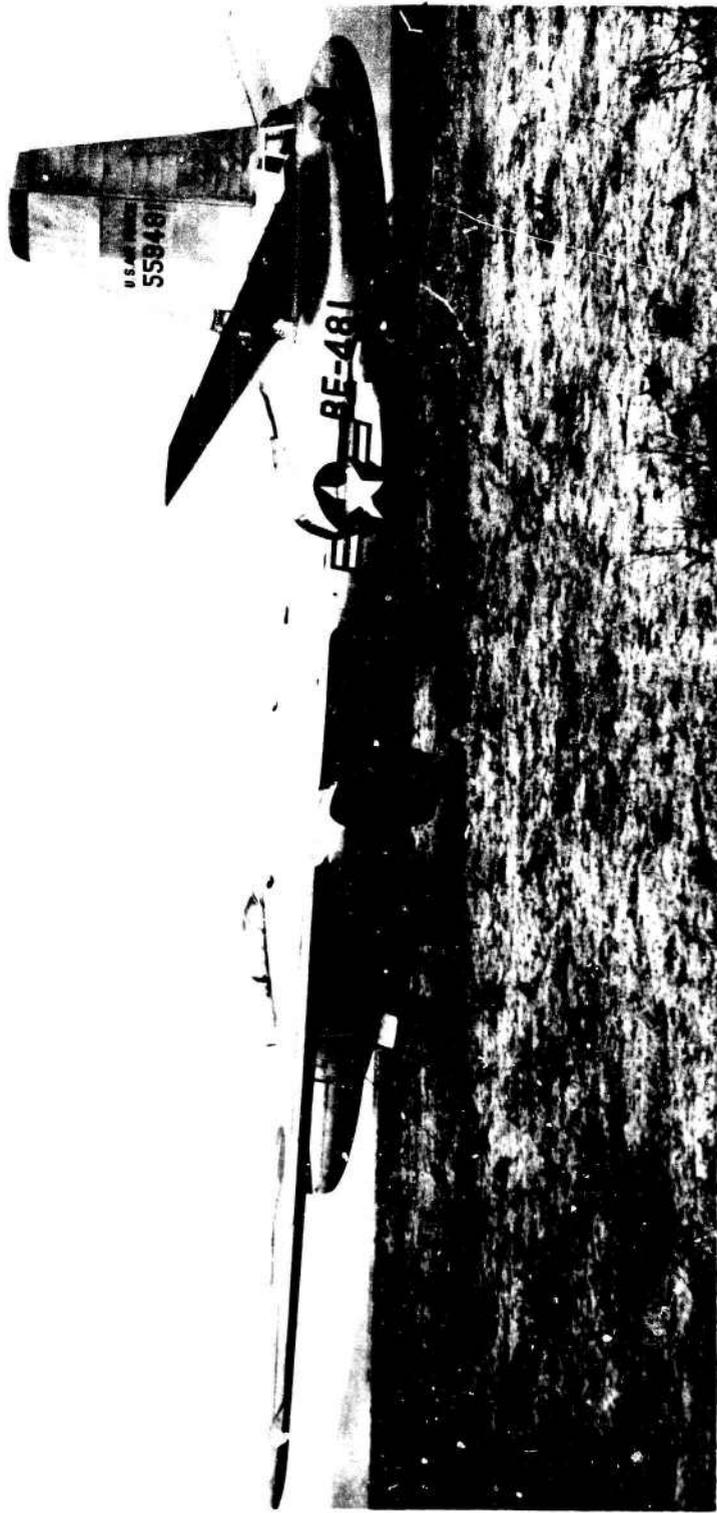
Fig. 3.14 B-45 (481), Nose-in, 3700 Ft (6.7 psi), Shot 8, Showing Over-all View of Left Side after Exposure

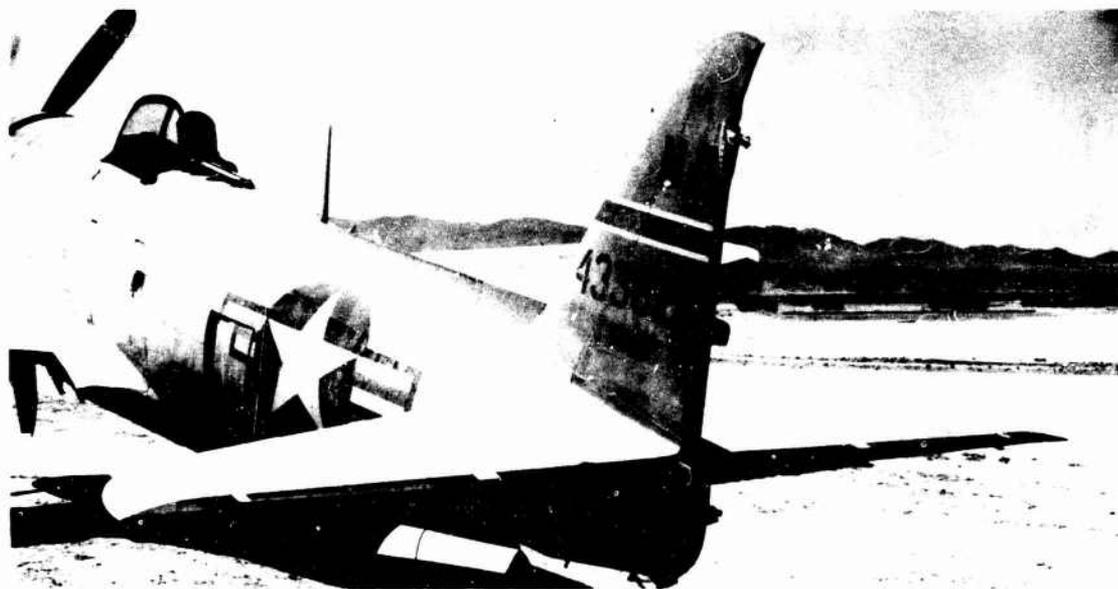
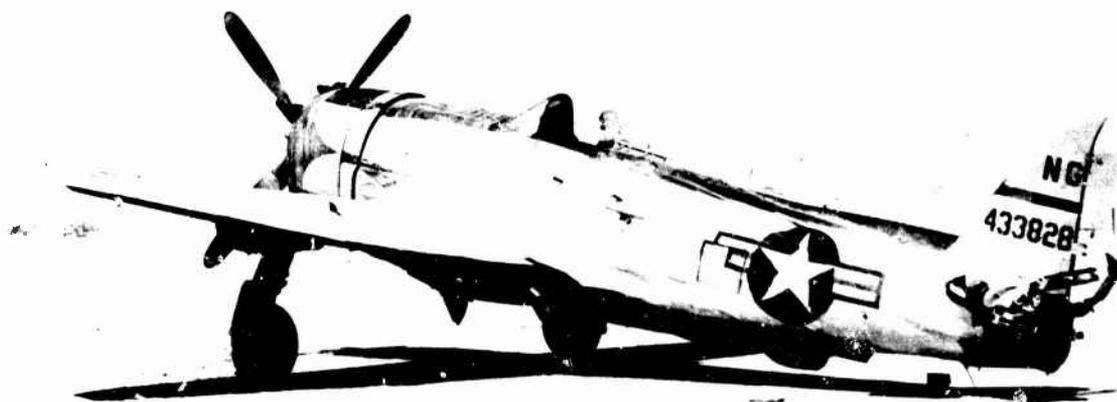
Fig. 3.15 F-47 (828), Nose-in, 2441 Ft (12.5 psi), Shot 9

Over-all Damage to Left Side: Note Buckling in Fuselage and Excessive Damage to Empennage

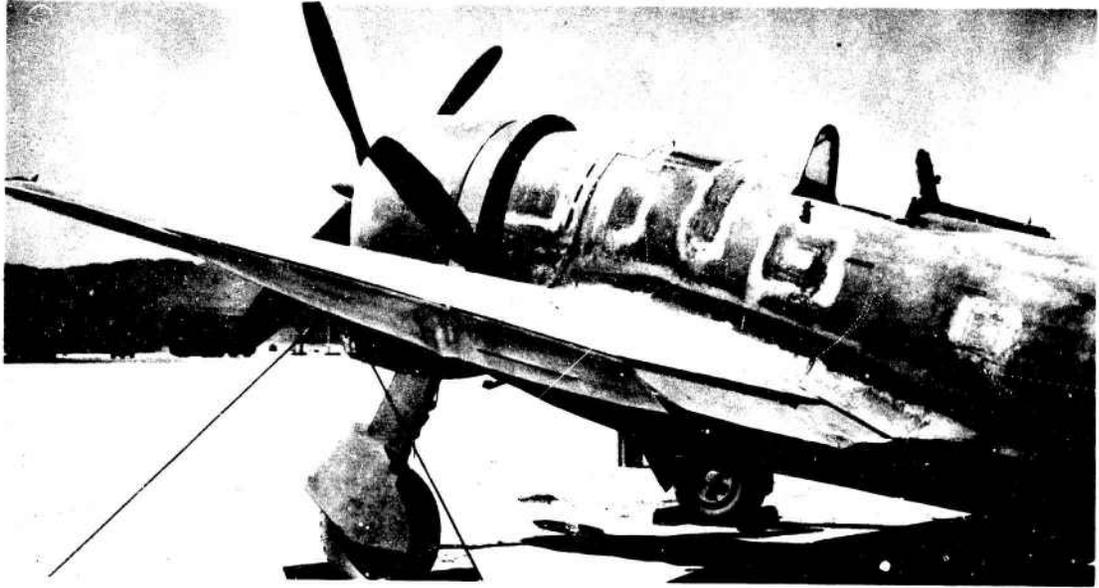
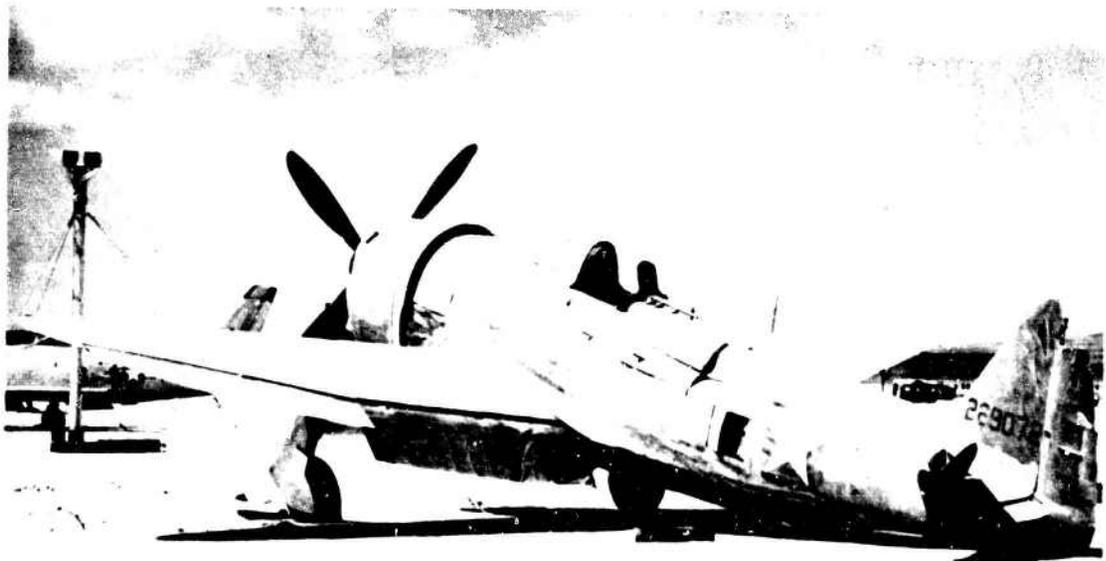
Fig. 3.16 F-47 (072), Nose-in 2981 Ft (12 psi), Shot 9

Over-all View, Left Side: Note Heavy Fuselage and Empennage Damage

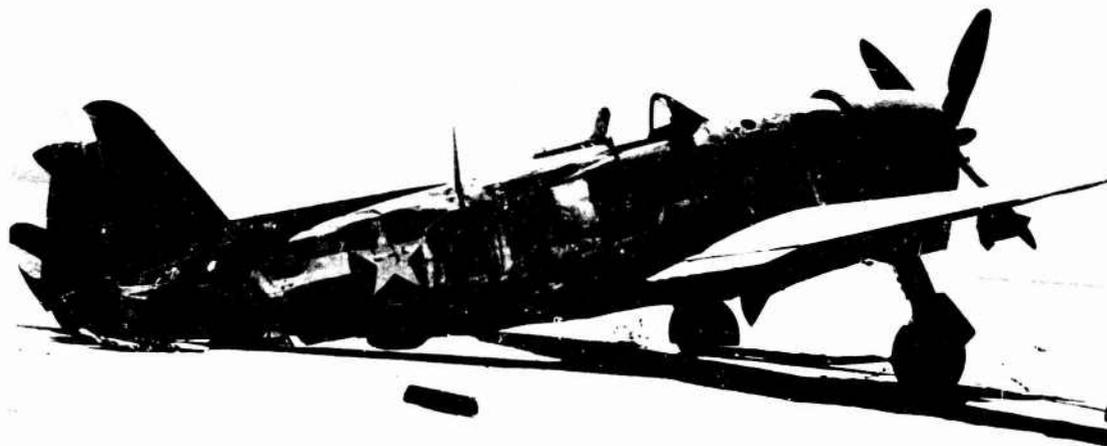
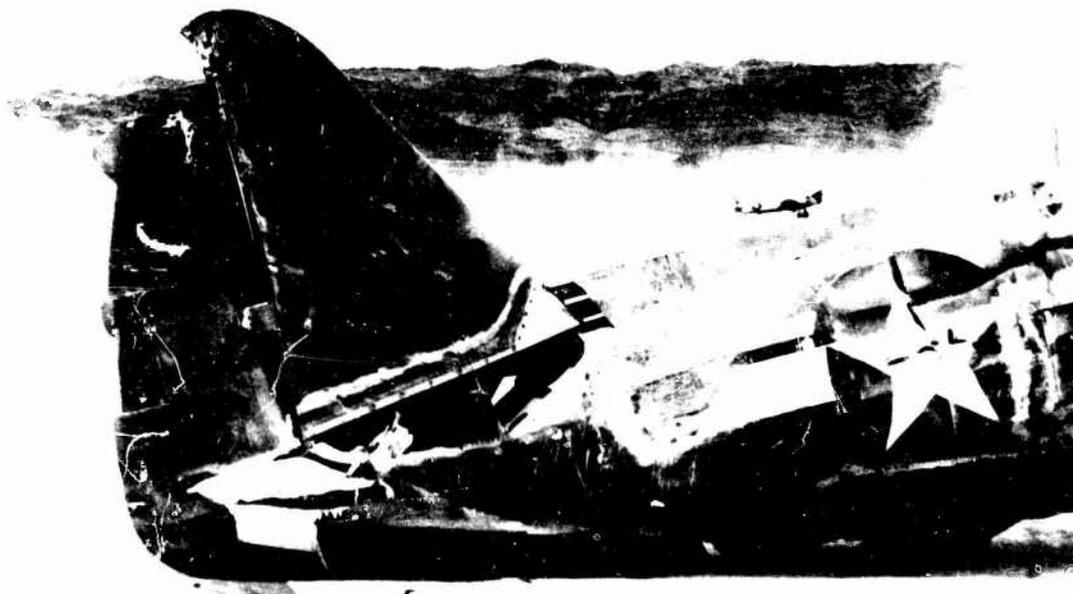
Fig. 3.17 F-47 (072), Nose-in, 2981 Ft (12 psi), Shot 9

Over-all View Showing Damage to Right Side

Empennage, Right Side: Note Demolished Right Stabilizer and Twisted and Torn Vertical Stabilizer

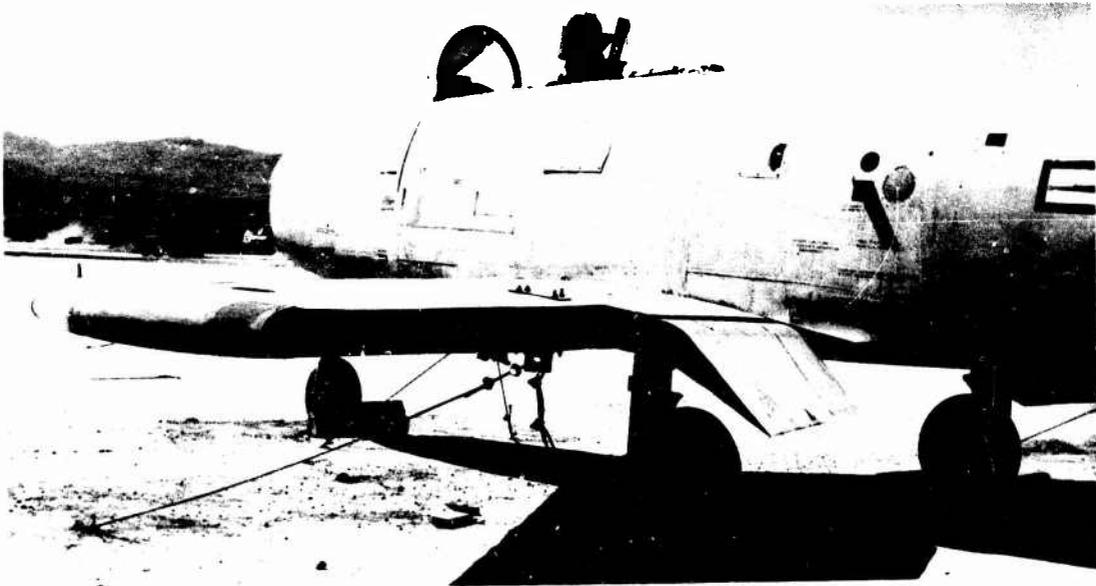
Fig. 3.18 F-86 (597), Nose-in, 2951 Ft (12 psi), Shot 9

Fuselage Damage Aft of Fuselage Disconnect

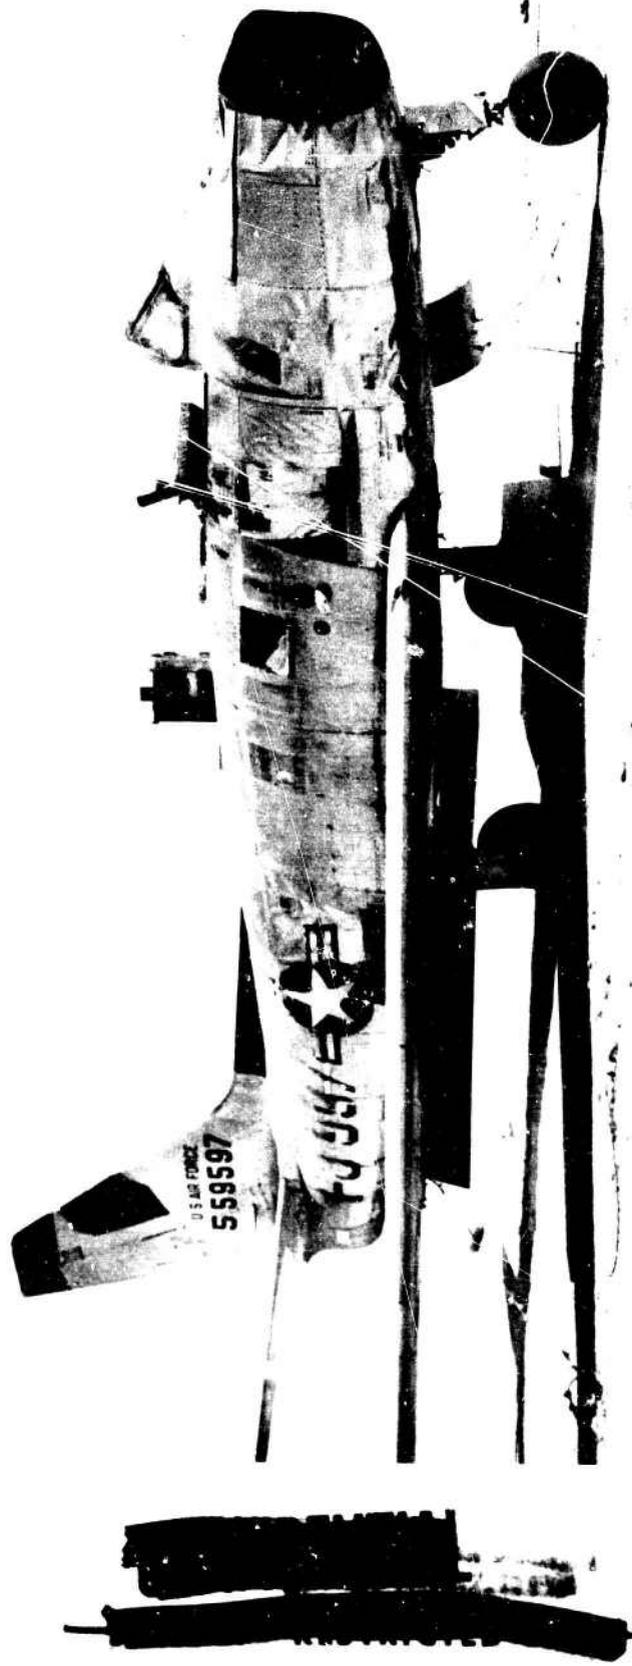
Fig. 3.19 F-86 (597), Nose-in, 2951 Ft (12 psi), Shot 9, Showing Right Side After Exposure

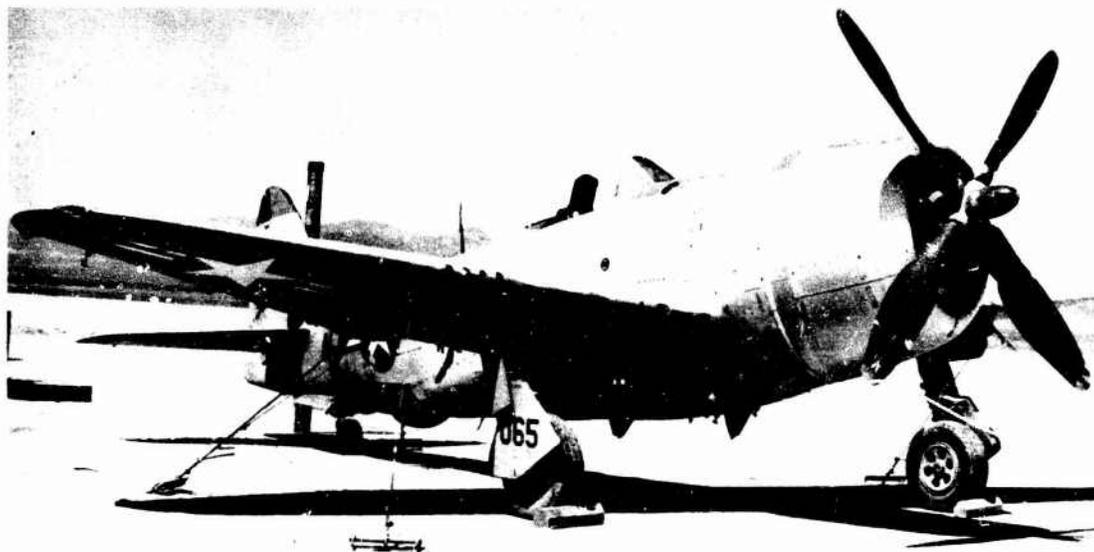
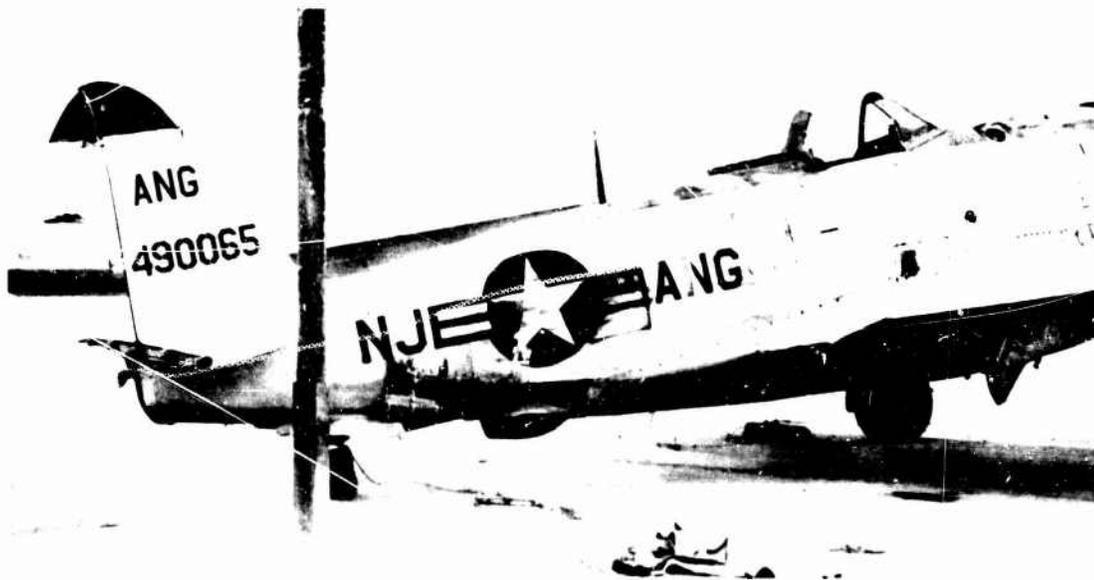
Fig. 3.20 F-47 (065), Right Side-in, 5936 Ft (5.1 psi) Shot 9

Right Side Damage: Note Section of Rudder Blown Off, Also Buckling in Fuselage

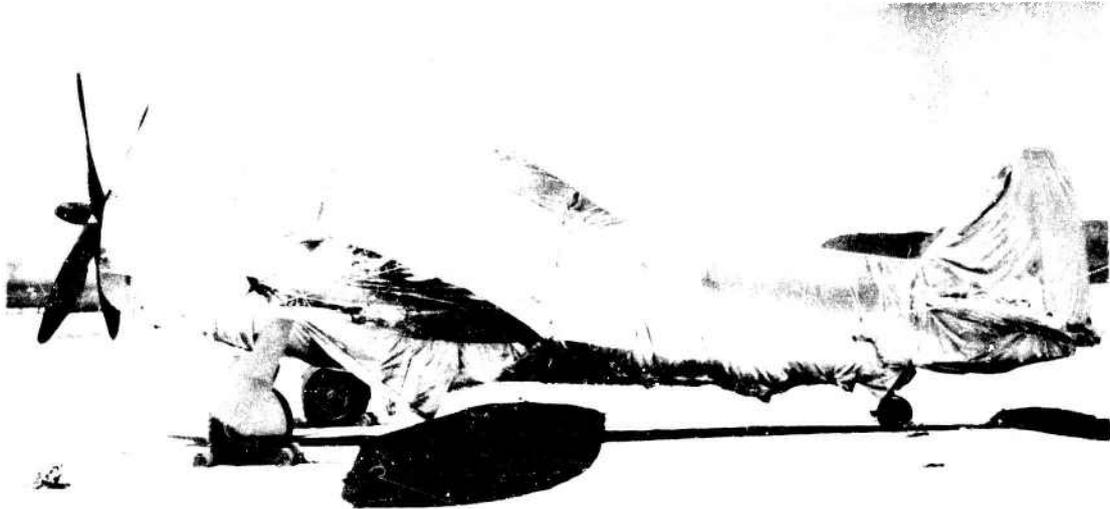
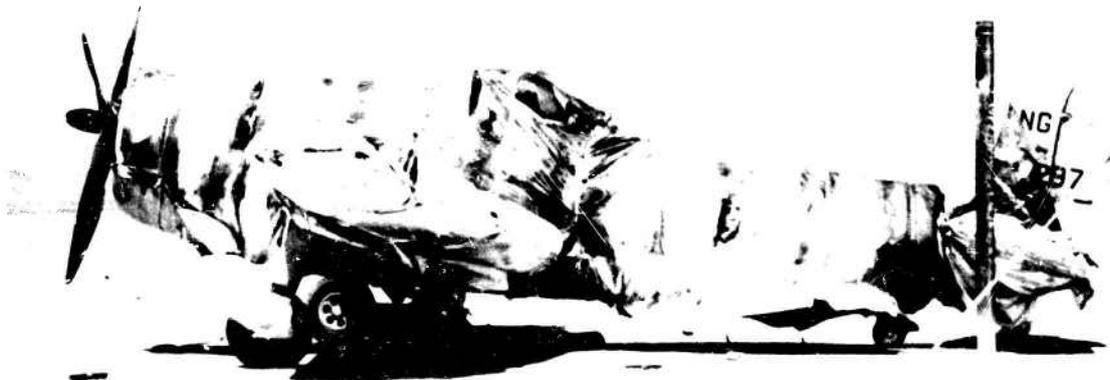
Fig. 3.21 F-47 (297), Left Side-in, 5936 Ft (5.1 psi), Shot 9

place by means of rope covered with thin aluminum foil to prevent burning. Figure 3.21 shows aircraft F-47 (297) equipped with the thermal shield prior to Shot 9.

Postshot View: Note Charred Shield

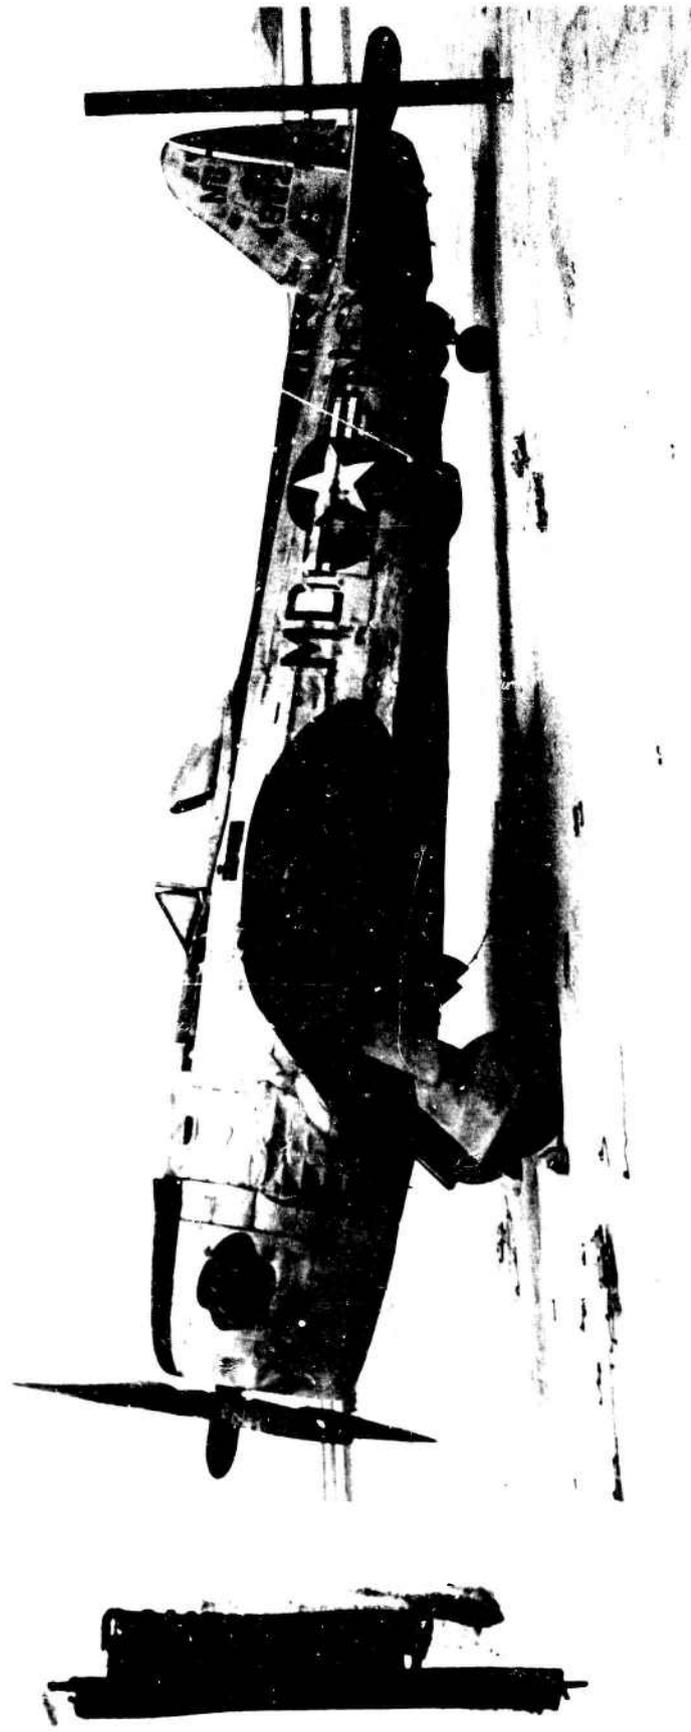
Fig. 3.22 F-47 (297), Left Side-in, 5936 Ft (5.1 psi), Shot 9, Showing Damage to Exposed Side of Aircraft: Note Extensive Buckling of Fuselage

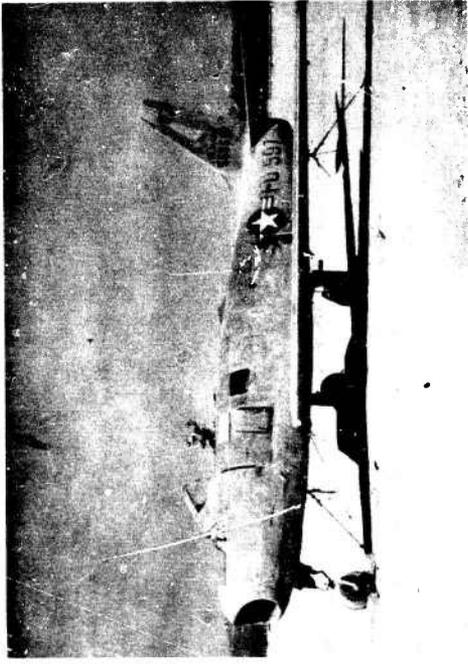
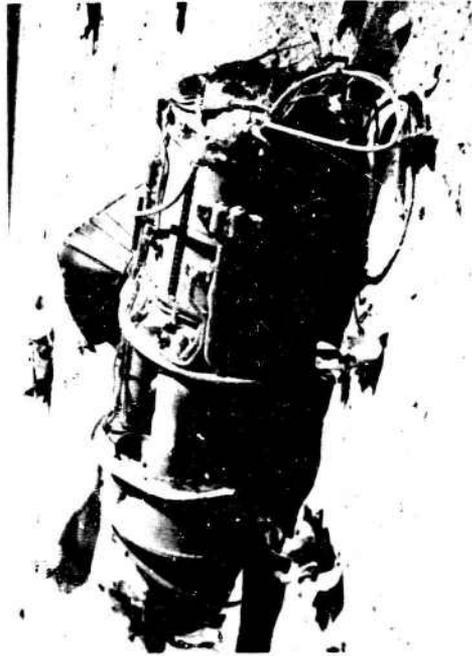
Fig. 3.24 F-86 (597), Nose-in, 1890 Ft (10.2 psi), Shot 10, Showing a Preshot View and Complete Destruction Following Exposure

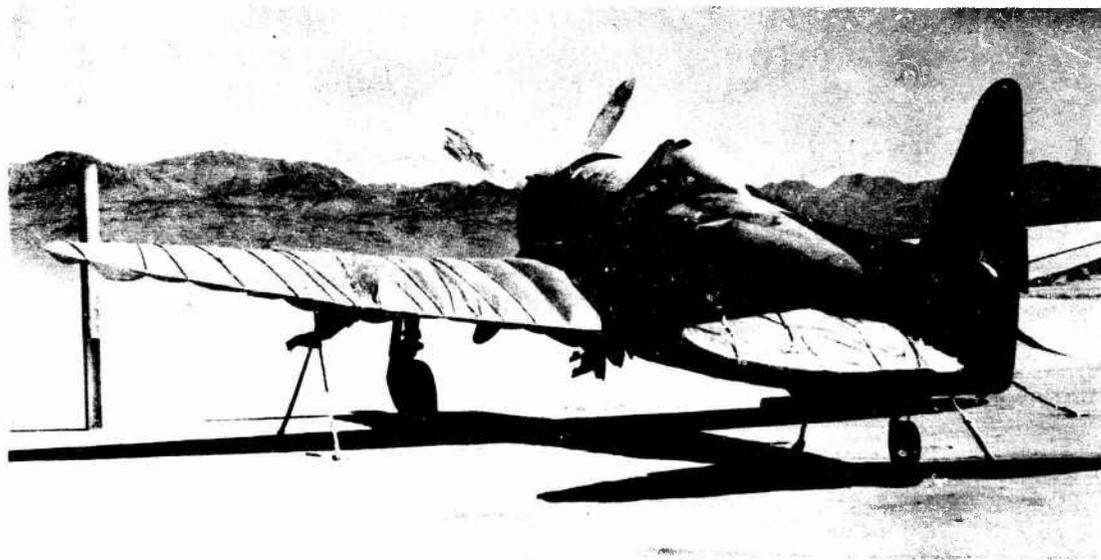
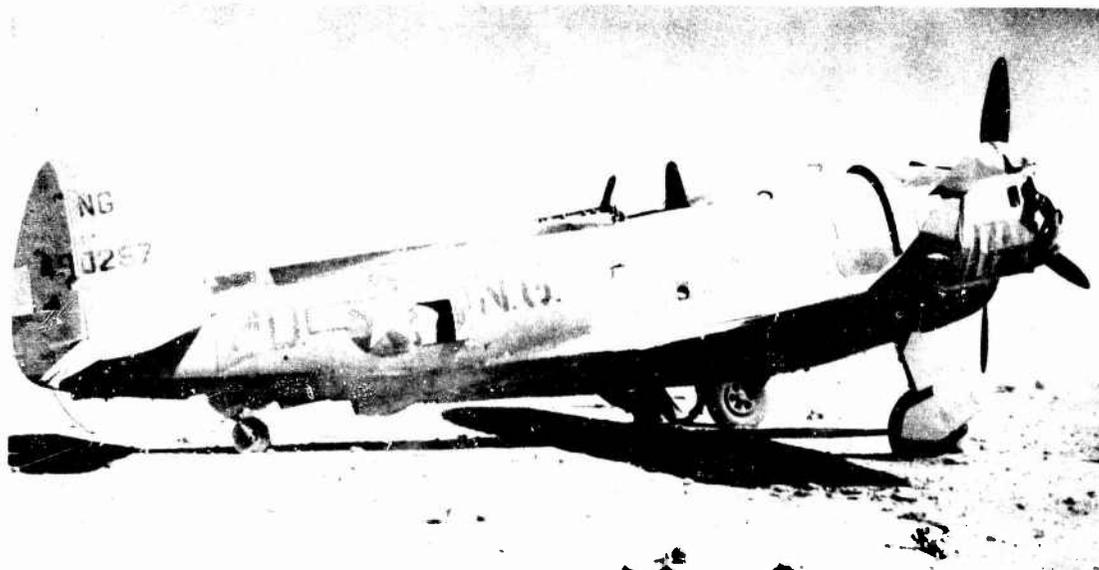
Fig. 3.25 F-47 (297), Nose-in 2345 Ft (9.2 psi), Shot 10

damage but was in much better condition than any of the four aircraft closer to ground zero. The tie-downs failed, and the right wing of the aircraft struck the ground. Wing and stabilizer sections covered by the thermal radiation shield suffered less damage than the openly exposed regions. The inspection report is given below.

Right Side View; Wing Tip Bent Due to Ground Contact

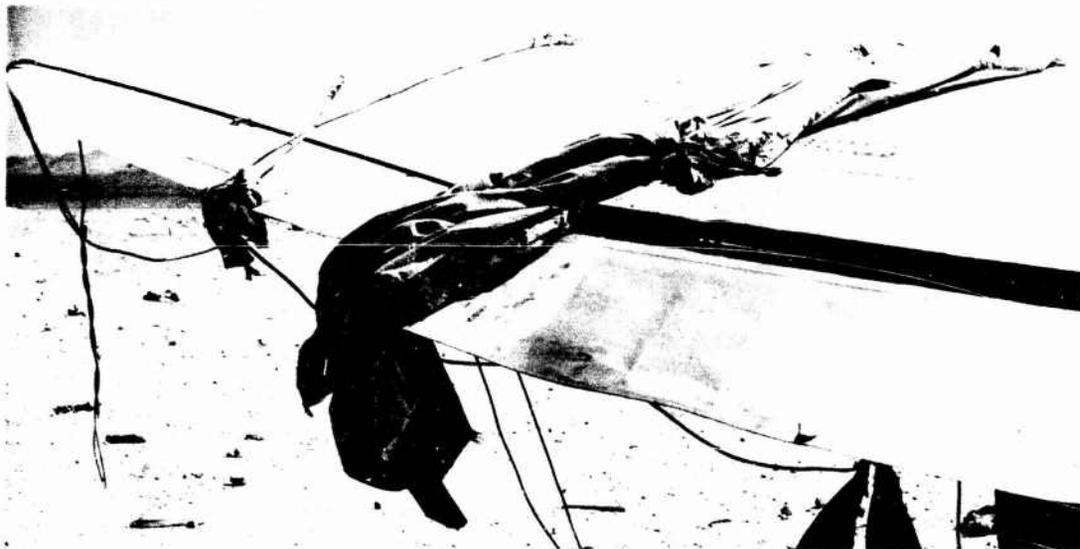
Fig. 3.26 F-47 (297), Nose-in, 2345 Ft (9.2 psi), Shot 10

Damage to Left Wing

Right Wing After Exposure
