# FIELD FORTIFICATIONS TEST EXERCISE DESERT ROCK VI

## Project 8-12-75-001

2 November 1956

Nevada Test Site

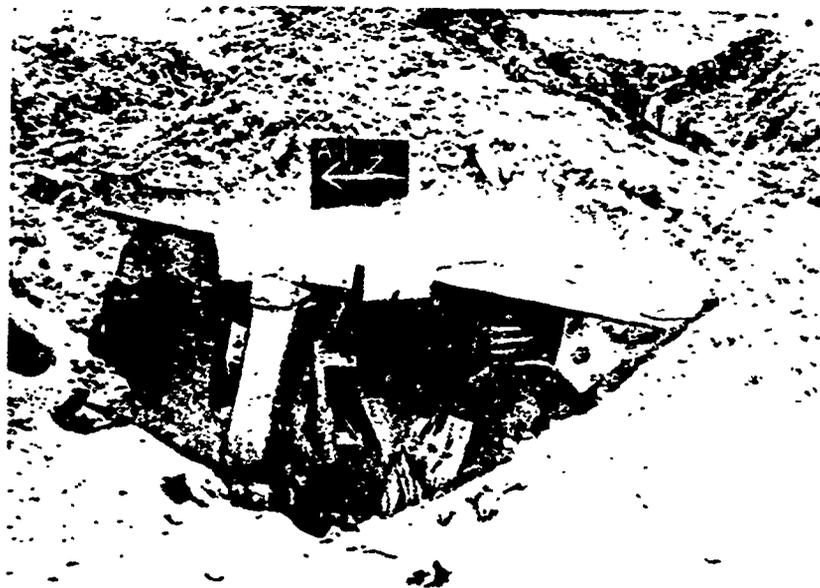
(a) 1000-Ft Range. Although access was possible through both entrances, this structure was severely damaged. Fig. 26 and 27 show damage to the right and left entrances, respectively. (Note: To understand such directions as right, left, and rearward, the reader should assume the observer was facing 3Z.) The front and rear TCS caps (6-in. by 8-in. by 64-in. span) were broken in every span, and the cross bracing was pulled from the posts, and, in several instances, broken. Fig. 28, which is a photograph of the interior of the TCS looking from left to right, gives some idea of the extent of the damage. The caps failed in a surprising number of ways: (1) typical bending failure (Fig. 29); (2) bending failure caused by the horizontal component of the loading (upper left corner of the photograph in Fig. 28); (3) horizontal shear through the vertical dimension (end of the cap showing in the photograph in Fig. 26); and (4) a splitting or tension failure in the rear cap over an interior post which may have been started, initially, by horizontal shear. The splitting failure was a longitudinal separation of the cap along its vertical dimension and can be attributed to two opposing forces: (1) the rearward force transmitted to the cap by the roof stringer spikes; and (2) the restraining action of the drift pin which fastened the cap to the post.

Fig. 27. A-1 structure, left entrance.

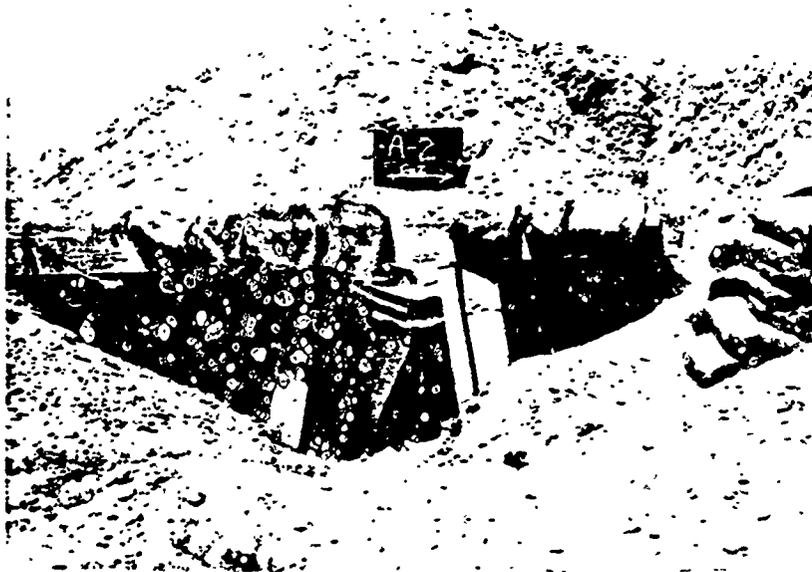
(b) 1150-Ft Range. Damage to the Type A structure at this range was similar to the damage at the 1000-ft range; however, severe damage was noticeably less and more localized. Figs. 31 and 32 show damage to the right and left entrances, respectively, and Fig. 33 is a view of the interior of the trench cover section looking toward the badly damaged right entrance which was approximately one-half filled with cover and backfill material. Only one cap failed in the entire structure. This was a bending failure of the right front span. The only post failure, apparently a bending failure, is shown in Fig. 34 which is a photograph of the left rear wall of the trench cover section.

Fig. 31. A-2 structure, right entrance.

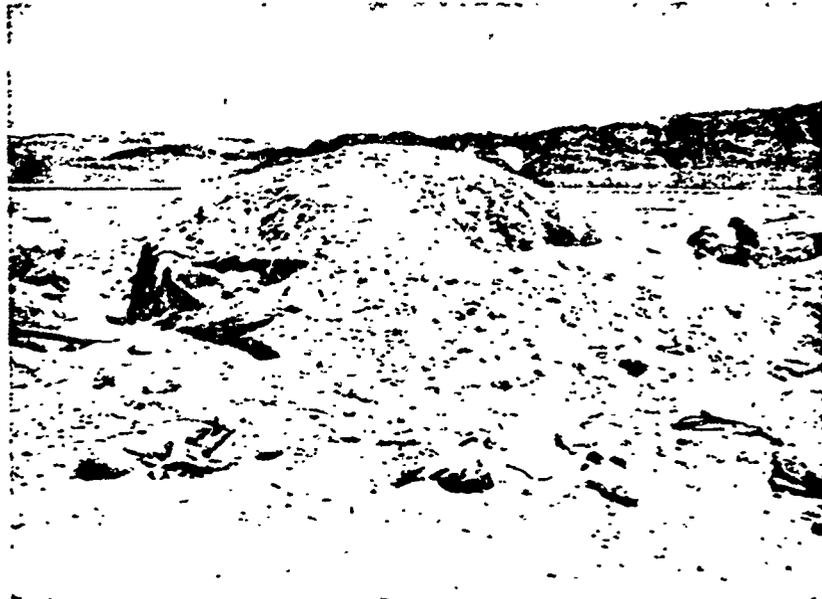
toward the aprons, shows the over-all damage to the earth cover as well as the susceptibleness to blast of the sandbags used at the entrance and firing ports.

Fig. 37. A-2 structure, looking toward firing port aprons  
(GZ to left background).

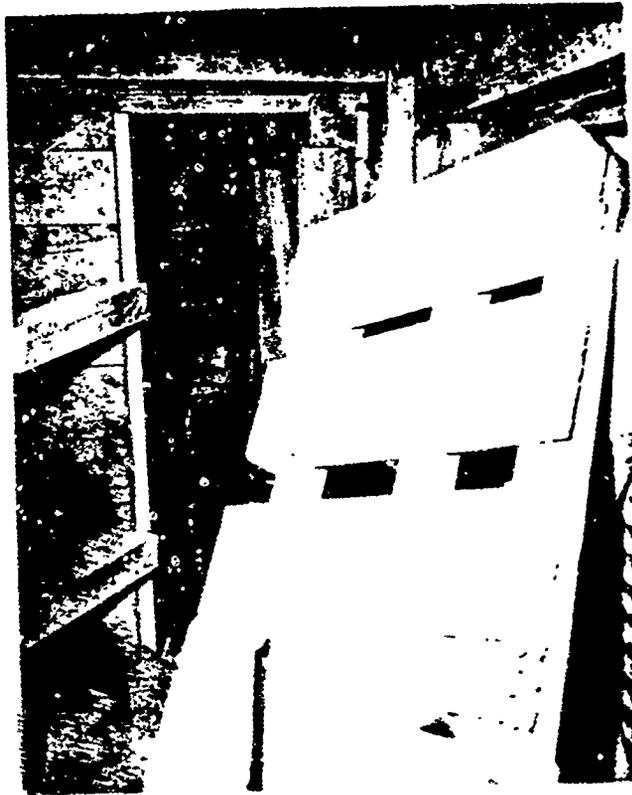
board lining in this type of shelter.<sup>1</sup> The modifications consisted of a blast door and baffle wall installed to protect the diffusion board from blast pressures. Damage incurred by this structure consisted of the removal of the blast door (Fig. 50) and destruction of portions of the diffusion board liner. Damage to the basic shelters and entrance trench was negligible.

Fig. 5D. B-3 structure, blast door damage (looking from GZ).

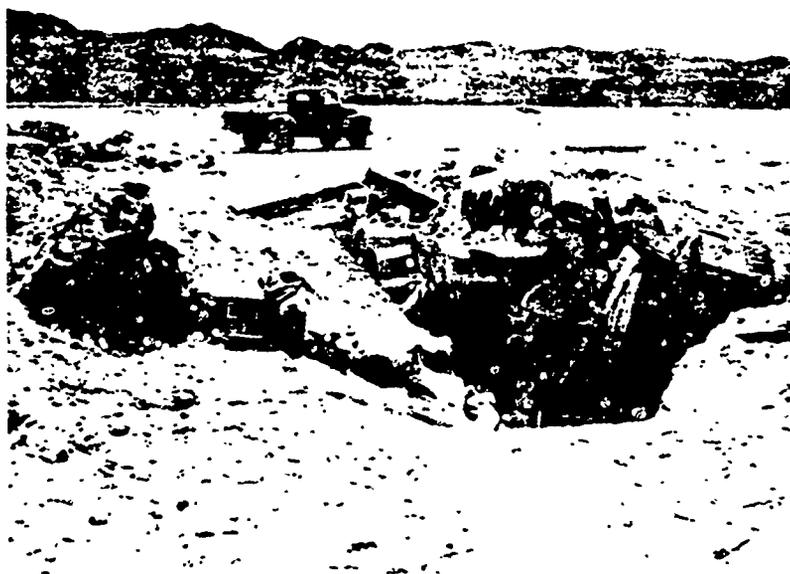
(a) 1000-Ft Range. The emplacement at this range was incapable of even partially withstanding the effects of the blast. Destruction was complete and in no way localized. Some idea of the extent of damage can be obtained from Fig. 61.

Fig. 61. Left side of E-1 structure. A13283

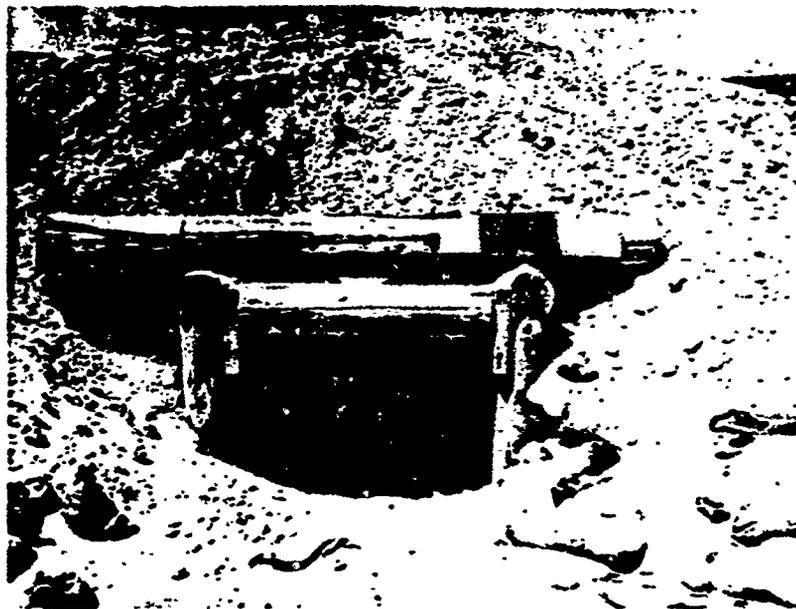
(c) 1400-Ft Range. The log machine gun emplacement at this range suffered only light damage throughout. No failures occurred to critical members. Figs. 67 and 68 show the damage to the right and left entrances, respectively. Wall members (posts and crossbracing) in the entrance trench withstood the effects of the blast well.

Fig. 67. E-3 structure, right entrance.
