OPERATION HARDTACK—PROJECT 3.5

Loading and Response of Submarine Hulls from Underwater Bursts

15 December 1960

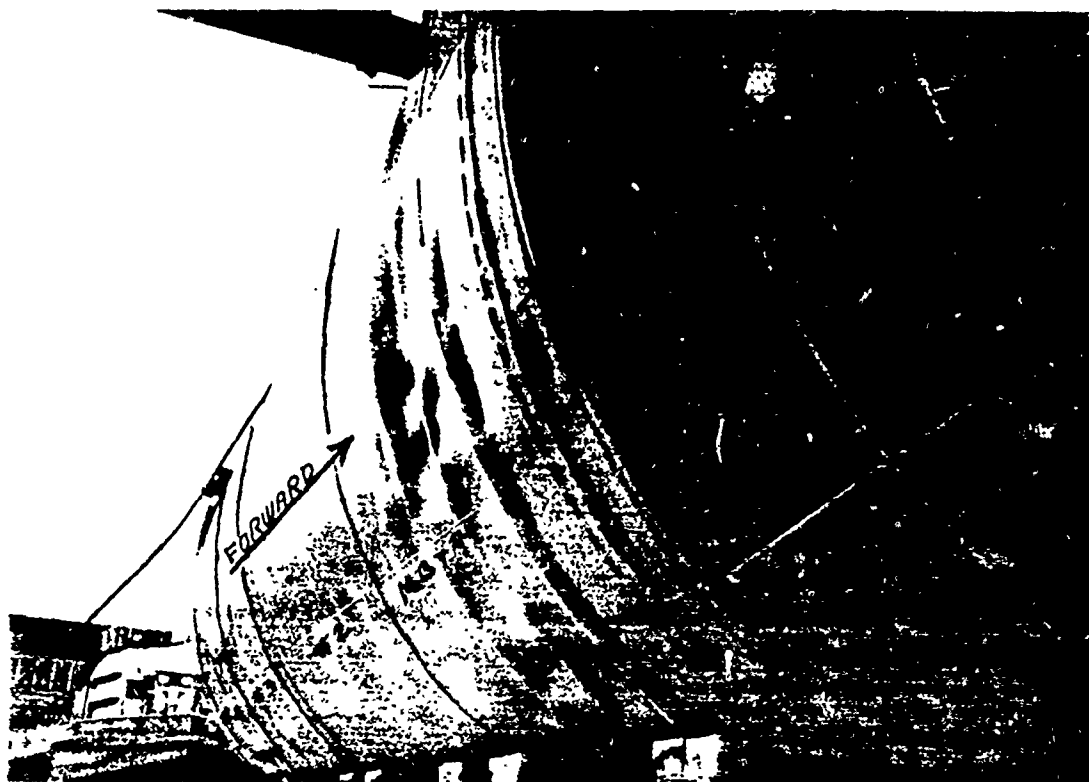
Figure 4.8 Squaw starboard side looking aft, after Shot Umbrella.

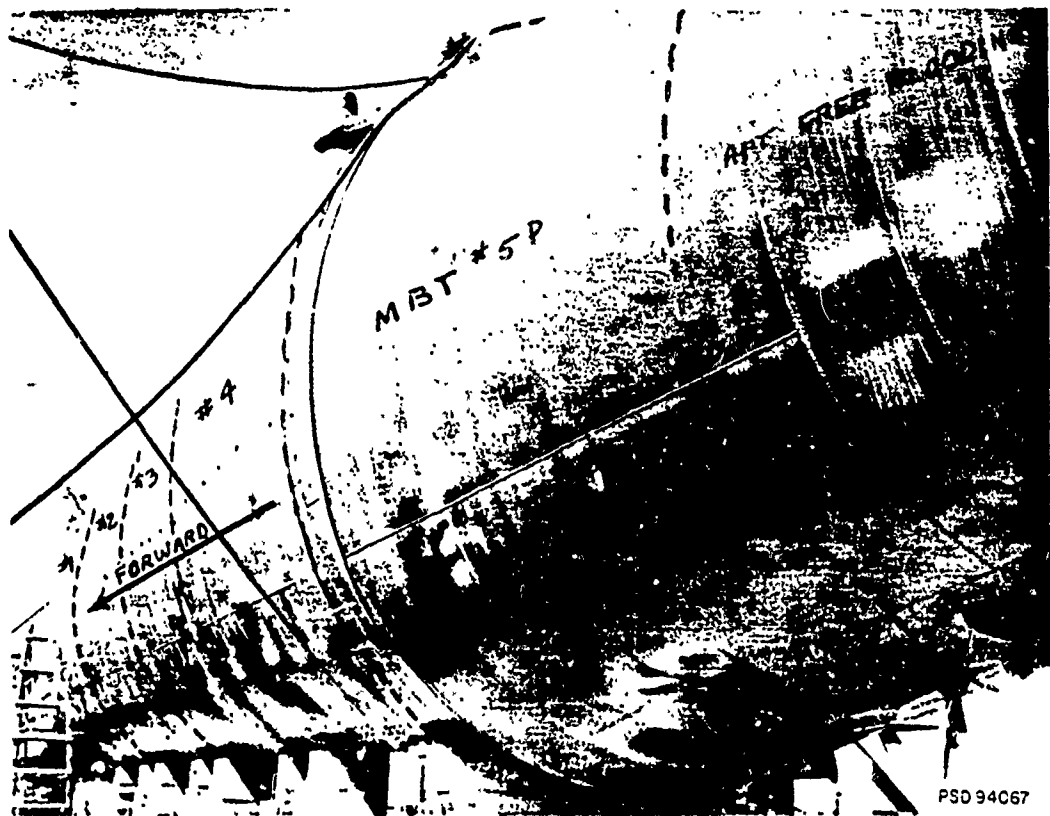
Figure 4.9 Squaw port side looking forward after Shot Umbrella.
Dashed lines show boundaries of tanks.

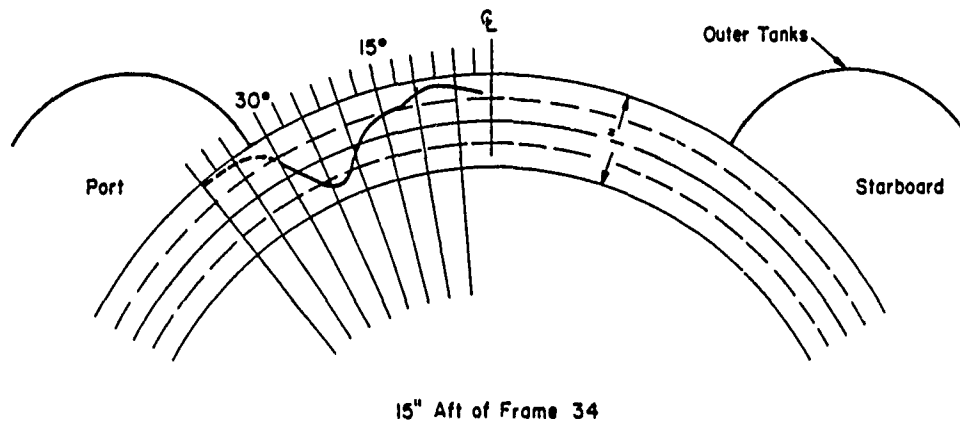
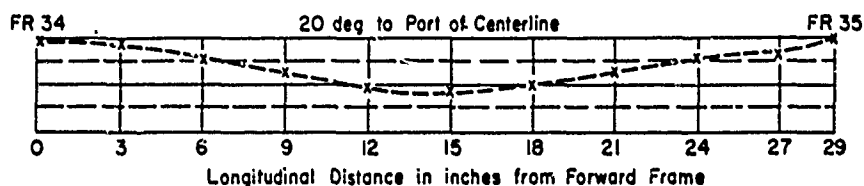
Figure 4.14 Dishing contours for the maximum deformation of the pressure hull in the cylindrical section.

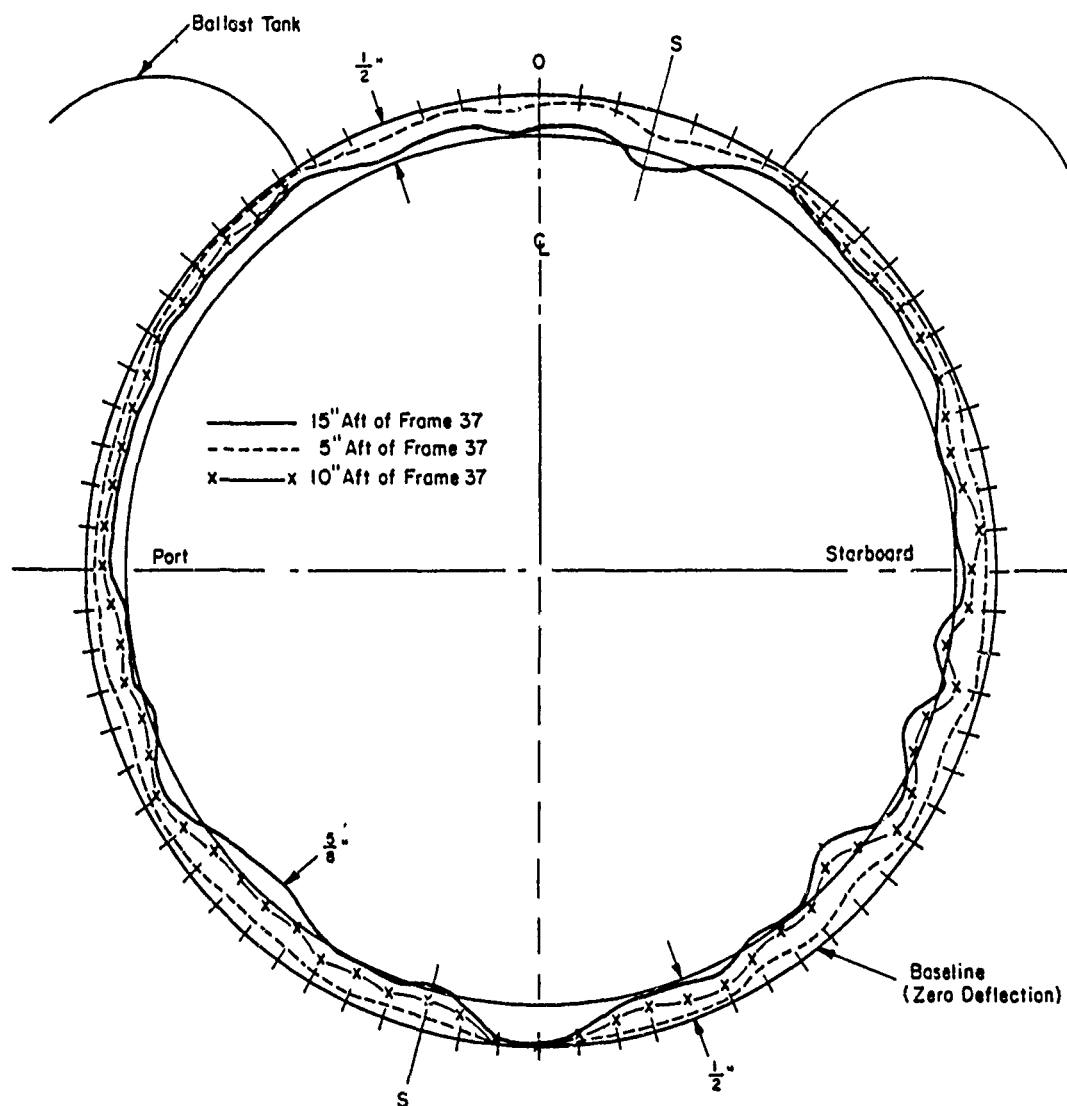
The deflections at three distances between Frames 37 and 38 are plotted in Figure 4.15. The graph shows a deflection of $\frac{3}{4}$ inch at a position 45 degrees to starboard from the keel and a deflection of $\frac{5}{8}$ inch at 45 degrees to port of the keel. The average deflection was $\frac{1}{2}$ inch inward for the lower half of the hull except at the keel, which was not deflected.

Figure 4.15 Plating deflections at positions between Frames 37 and 38. The deflections are measured with respect to stiffeners.

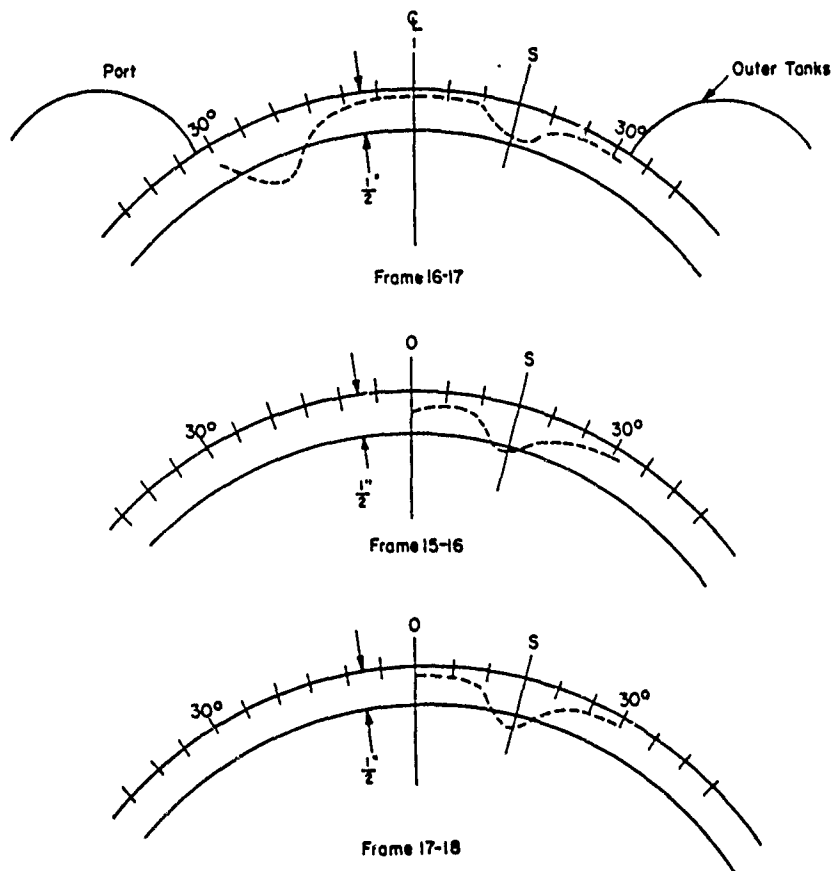
Figure 4.16 Dishing contours at centers of selected bays in the cylindrical section between Frames 15 and 18.

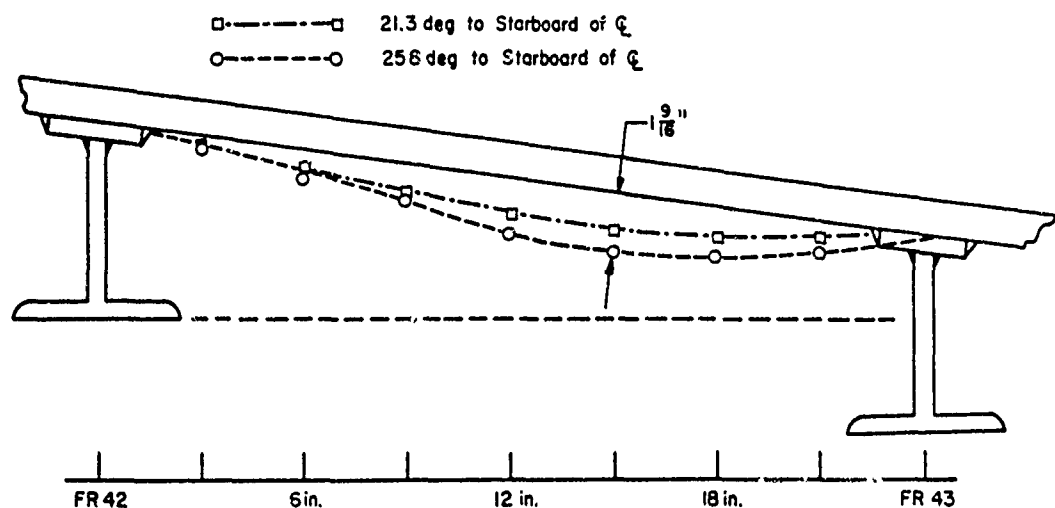
of the pressure hull, ballast tank, and superstructure between Frames 42 and 43. It is shown in Figures 4.4 and 4.5 and plotted in Figure 4.18. It should be noted that in the conical section the frame spacing was only 24 inches. The largest deflection in the cylindrical test section, in which the frame spacing was 29 inches, was $\frac{7}{8}$ inch.

Figure 4.18 Deflection of hull plating in after cone.

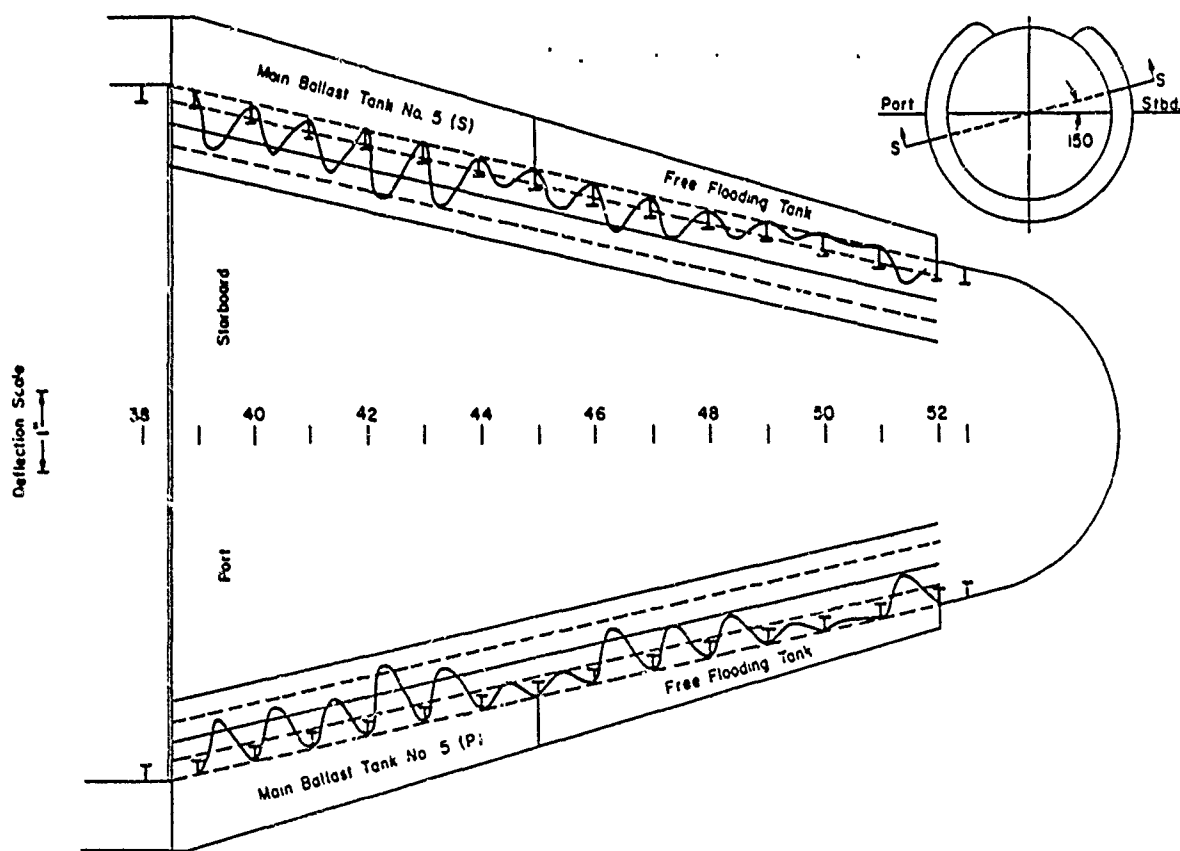
More dishing was centered along the longitudinal welding seam at midbay. Figure 4.19 is a section of the art cone at an angle of 15 degrees to the horizontal, i.e., in the plane of the seams.

Figure 4.19 Dishing between frames along longitudinal seams in aft cone. Location of seam is shown in upper right.

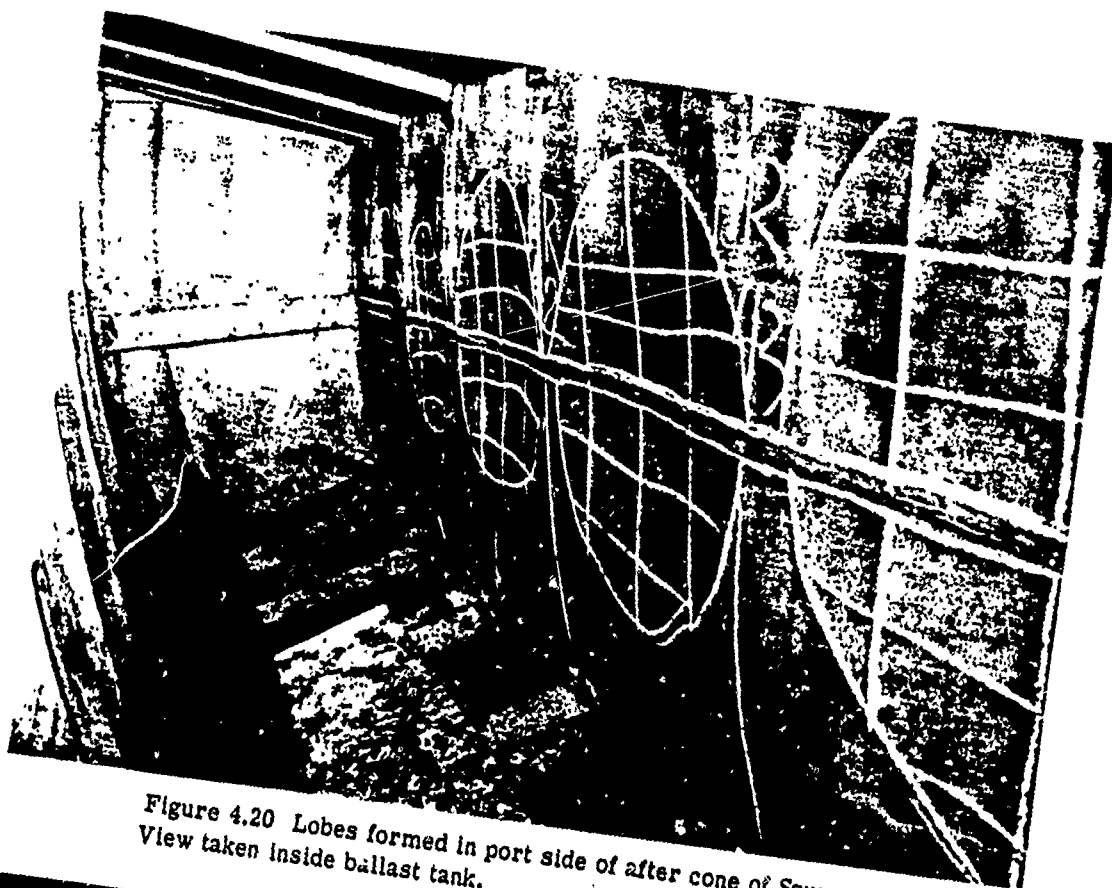
The distortion of the hull plating between frames is shown in this figure and in a photograph, Figure 4.20. The deformations on the port and starboard sides were roughly the same, the maximum deformations on each side, $\frac{13}{16}$ inch, occurring between Frames 42 and 43. On both sides of the compartment, the average deformation was smaller at the narrow end.

Figure 4.20 Lobes formed in port side of after cone of Squaw.
View taken inside ballast tank.

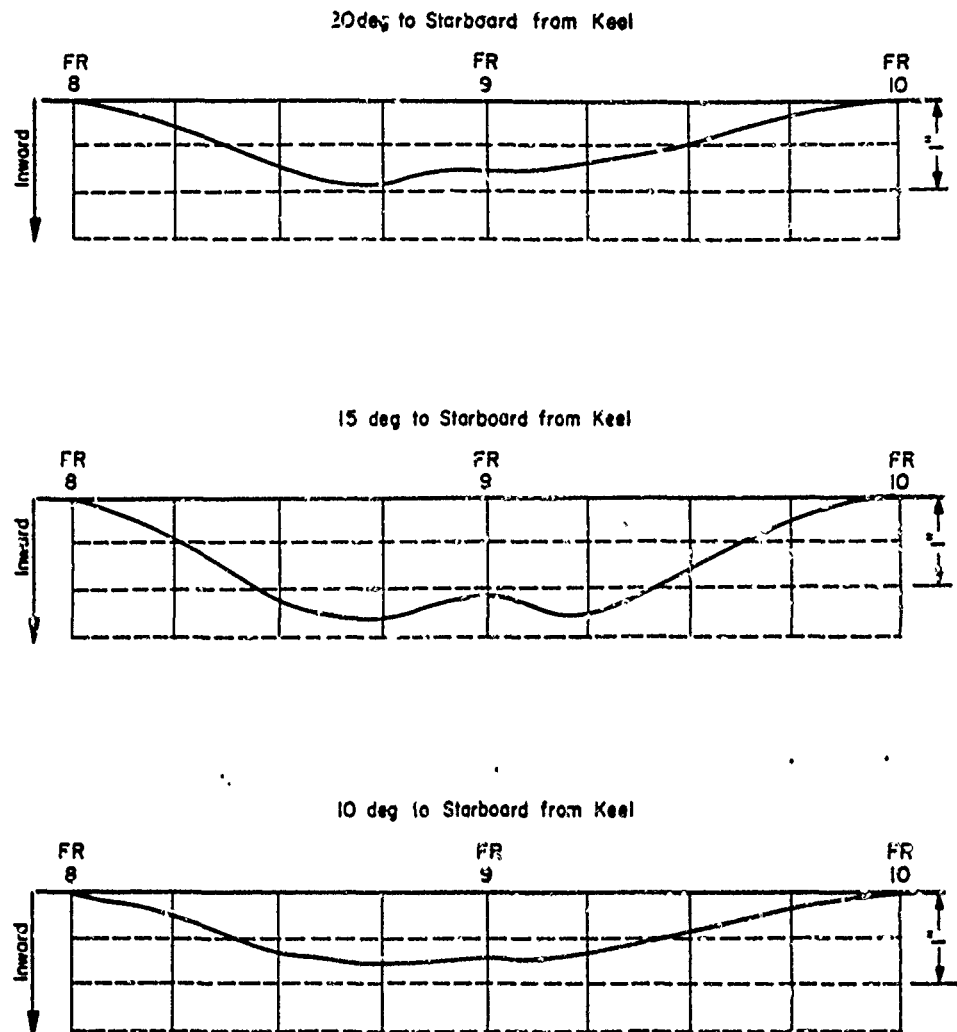
Figure 4.23 Dishing contours resulting from deformation of pressure hull frame and plating between Frames 8 and 10 in the forward cone.

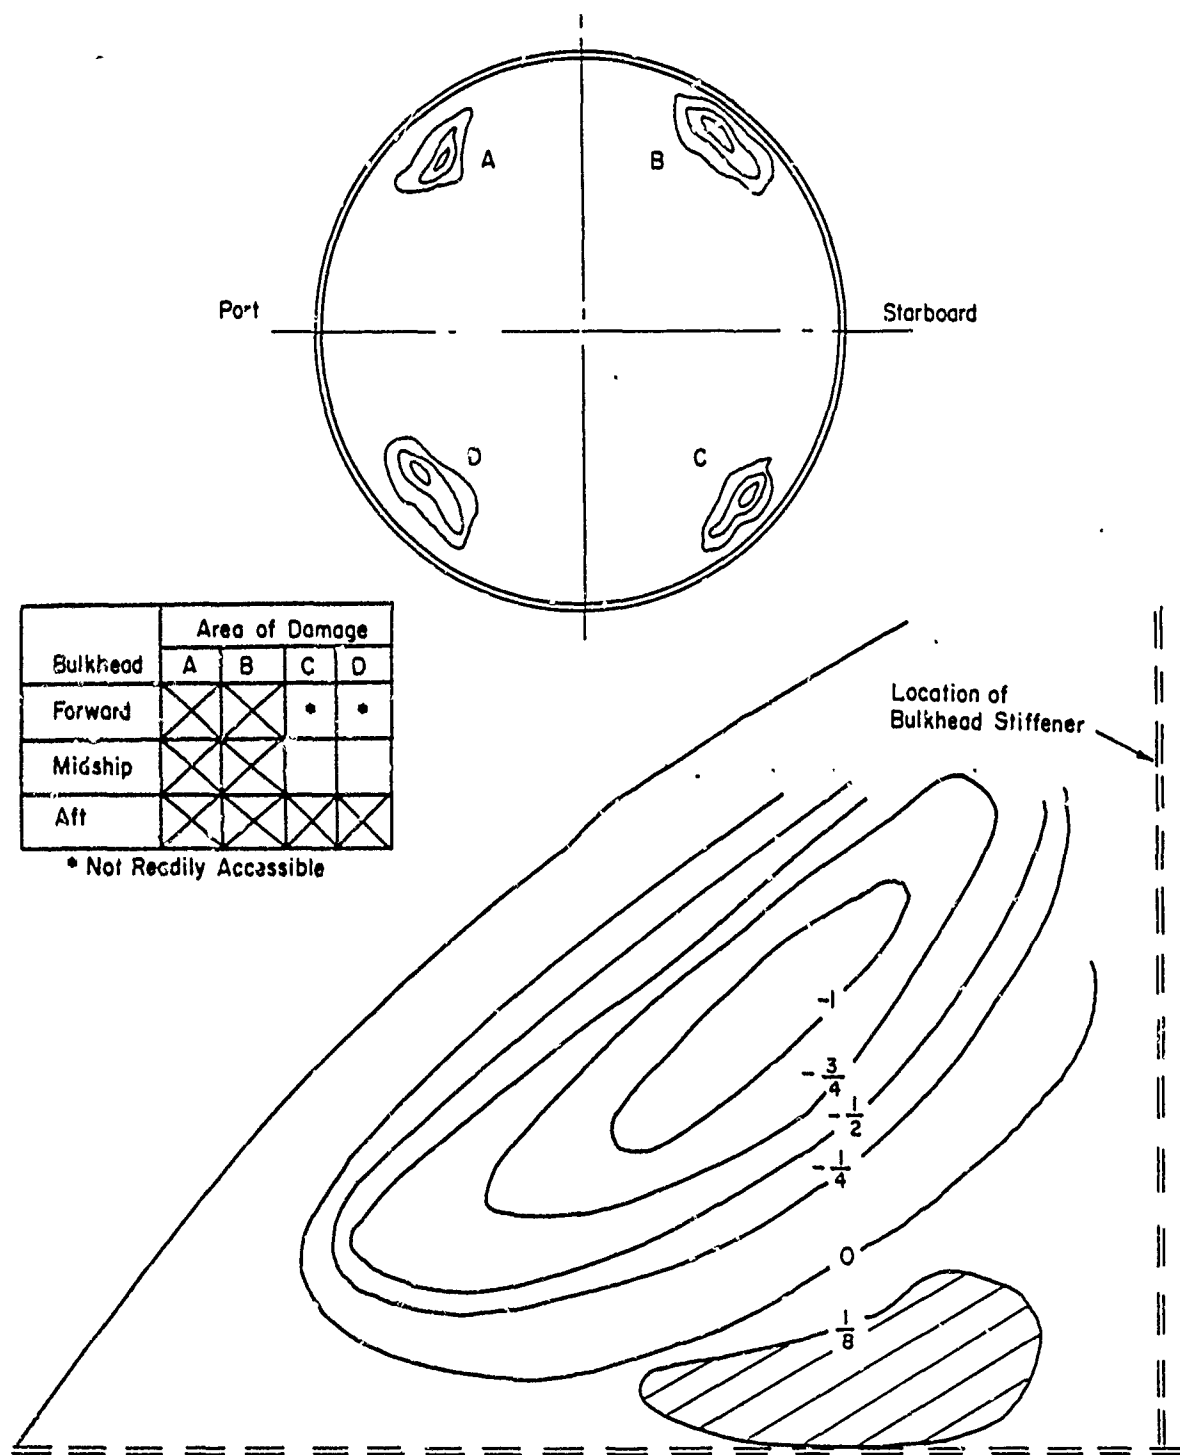
The Squaw has bulkheads at Frames $14\frac{1}{2}$, $26\frac{1}{2}$, and $38\frac{1}{2}$. The $\frac{1}{4}$ -inch plating of all three bulkheads buckled between stiffeners. Although yielding was general, the areas of maximum deflection were near the periphery of the bulkheads about 45 degrees port and starboard from the overhead.

A maximum plating deflection of about an inch was measured in the forward and aft bulkheads and $\frac{3}{4}$ inch in the midships bulkheads. The buckling in the forward and aft bulkheads was

mainly into the test compartments; i. e., away from the bulkhead stiffeners. The bulkhead in the midbulkhead was toward the aft, in this case, toward the stiffeners. Figure 4.23 shows the deformation contours for one area of the aft bulkhead and the areas of major lobing for all the bulkheads.

Figure 4.23 Damage to bulkheads. Upper portion shows schematically the areas of major bulkhead damage. The lower portion shows actual contours of damage to the aft bulkhead in area "A". Insert table shows areas of damage at each bulkhead.
