OPERATION BUSTER

PROJECT 3.8

EFFECTS OF AN ATOMIC DETONATION ON
AIRCRAFT STRUCTURES ON THE GROUND

January 1952

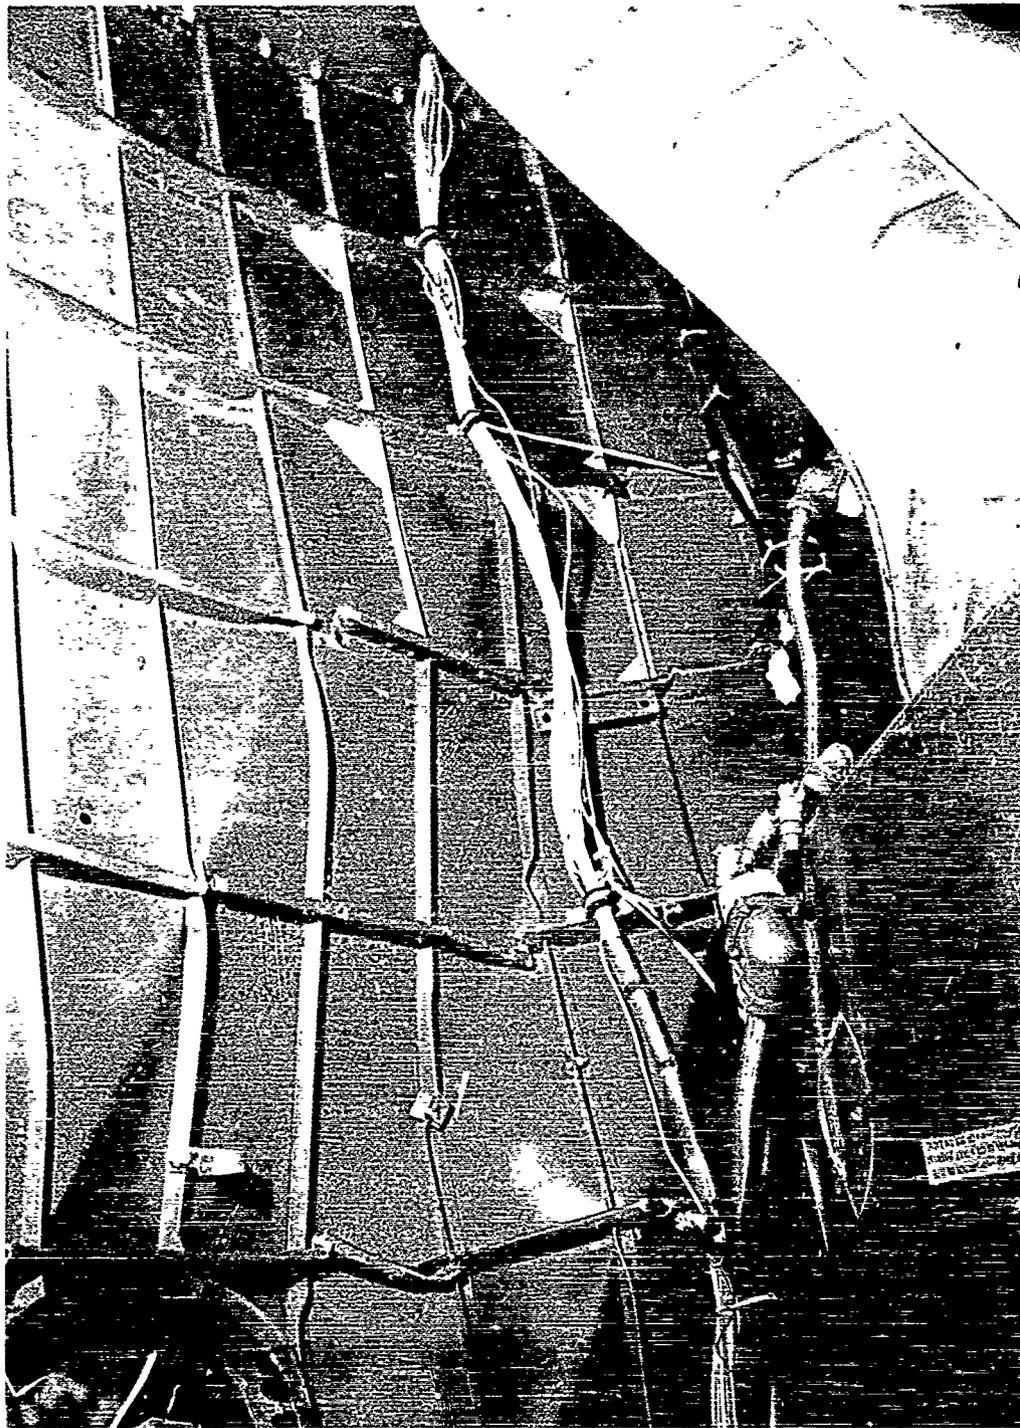
Due to the side-on orientation of the B-17, the fuselage was highly stressed in bending and in torsion produced by the load on the vertical tail, with a buckling failure occurring aft of the wing, in the radio operators compartment. Fig. 3.1 shows typical failure of stringers and frame members where broken on both sides of the fuselage. Fig. 3.2 shows the permanent set (clockwise) in the fuselage aft section, and Figs. 3.3 and 3.4 show details of buckled fuselage. Many of the skin panels were dished in on the side toward the blast as shown in Figs. 3.5 through 3.9. The bomb-bay doors were buckled inward, and some of the door stiffeners were ruptured. Figs. 3.10 and 3.11 show the external and interior views of the bomb-bay doors. A majority of the windows were broken and some of the acrylic fragments from the waist gun window on the left side were blown through the fuselage skin on the opposite side producing the results shown in Fig. 3.12. Paint was blistered or scorched where exposed to the incident thermal energy. Fabric in the cockpit was burned or charred. Although the fire did not propagate or reach a serious magnitude, the hazards of thermal ignition are apparent. Figs. 3.13 and 3.14 show some results of thermal damage in cockpit fabric.

Fig. 3.1 Typical Failure of B-17 Fuselage in Radio Operator's Compartment

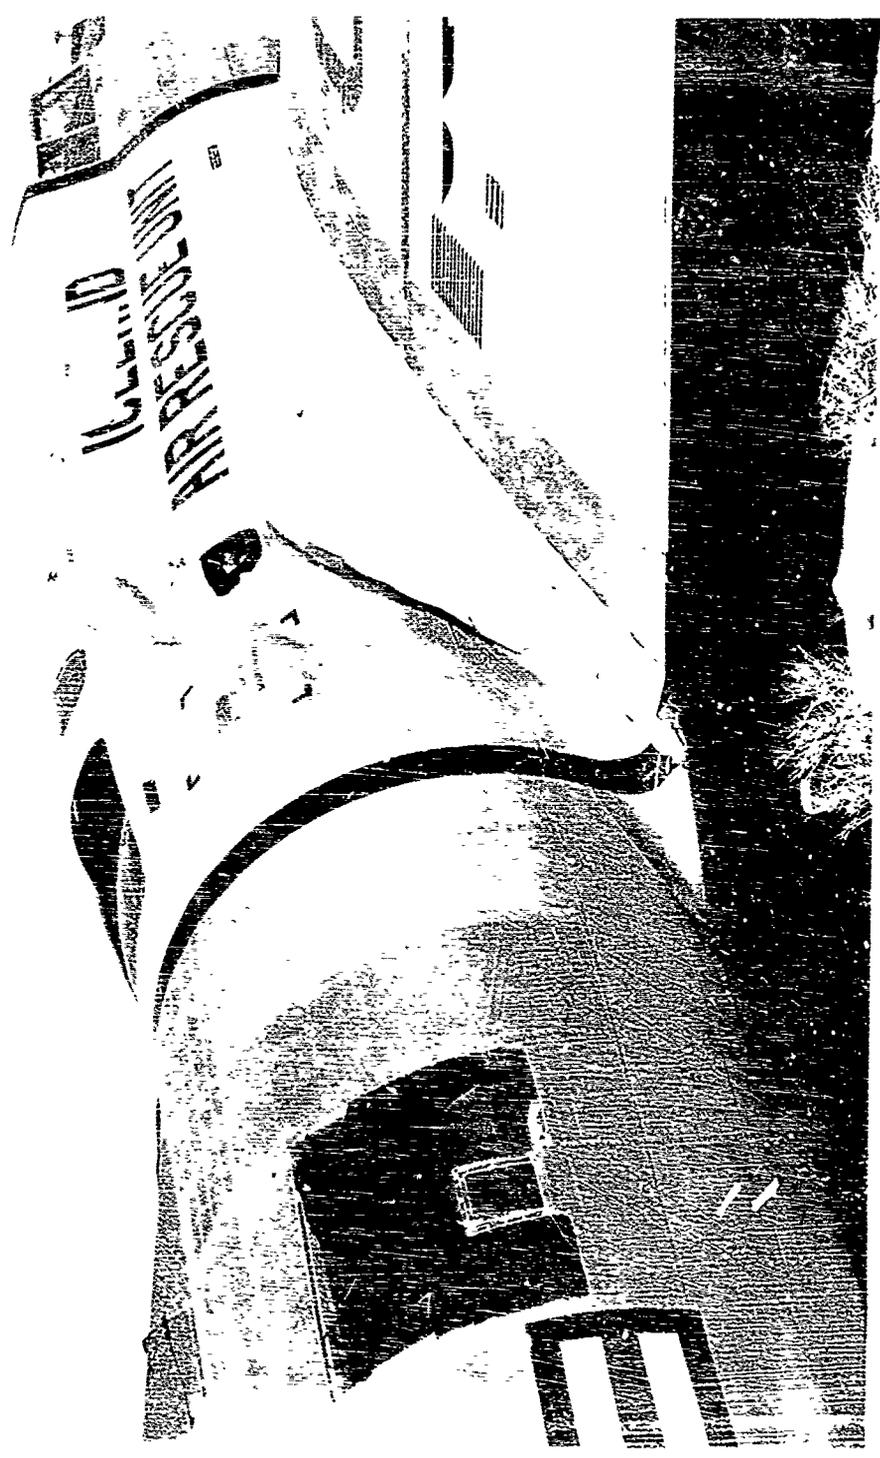
Fig. 3.3 Severe Buckle in Right Side of Fuselage of R-17 Following Dog Shot

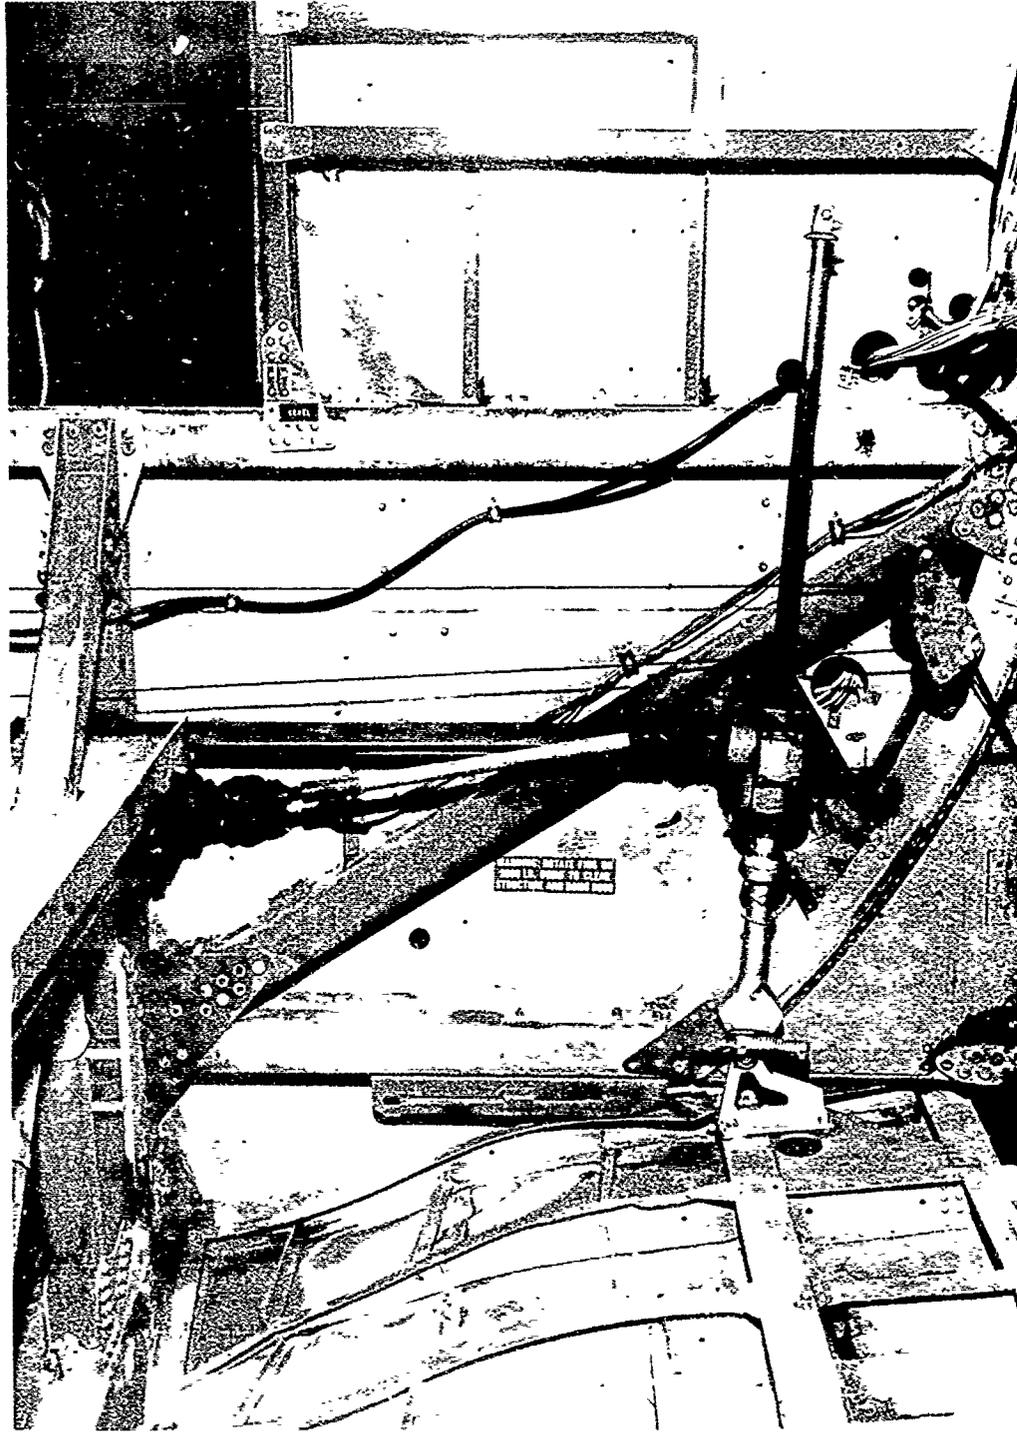
Fig. 3.10 Interior View of Bomb Bay of B-17 Showing Buckle in Door and Also the Buckles in the Upper Portion of the Bulkhead as a Result of Dog Shot

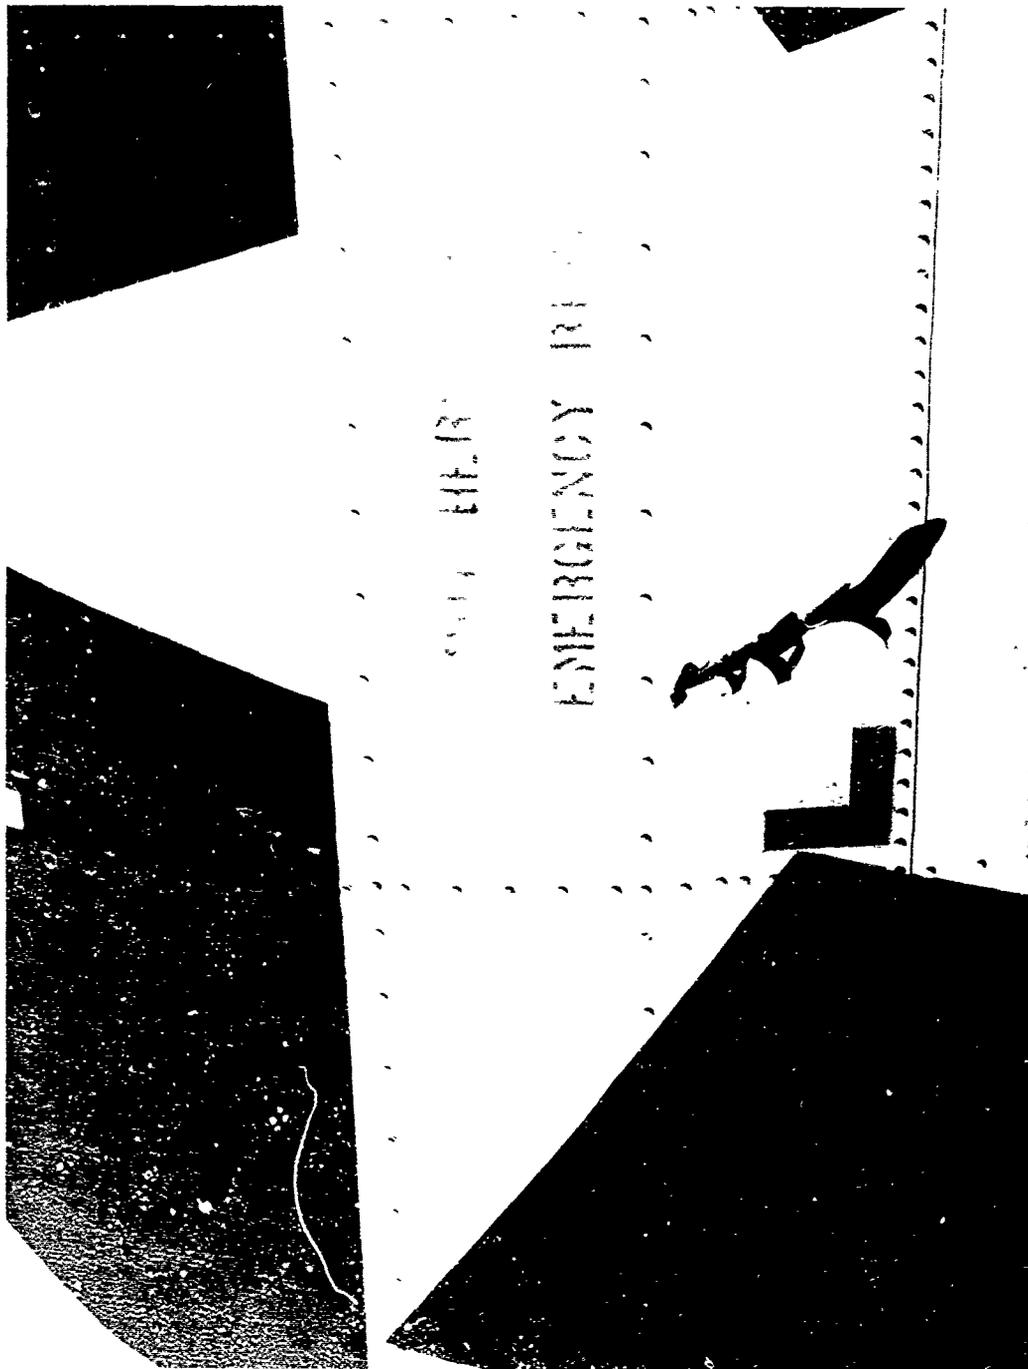
Fig. 3.12 Holes in Fuselage Produced by Waist-Gun Window Fragments

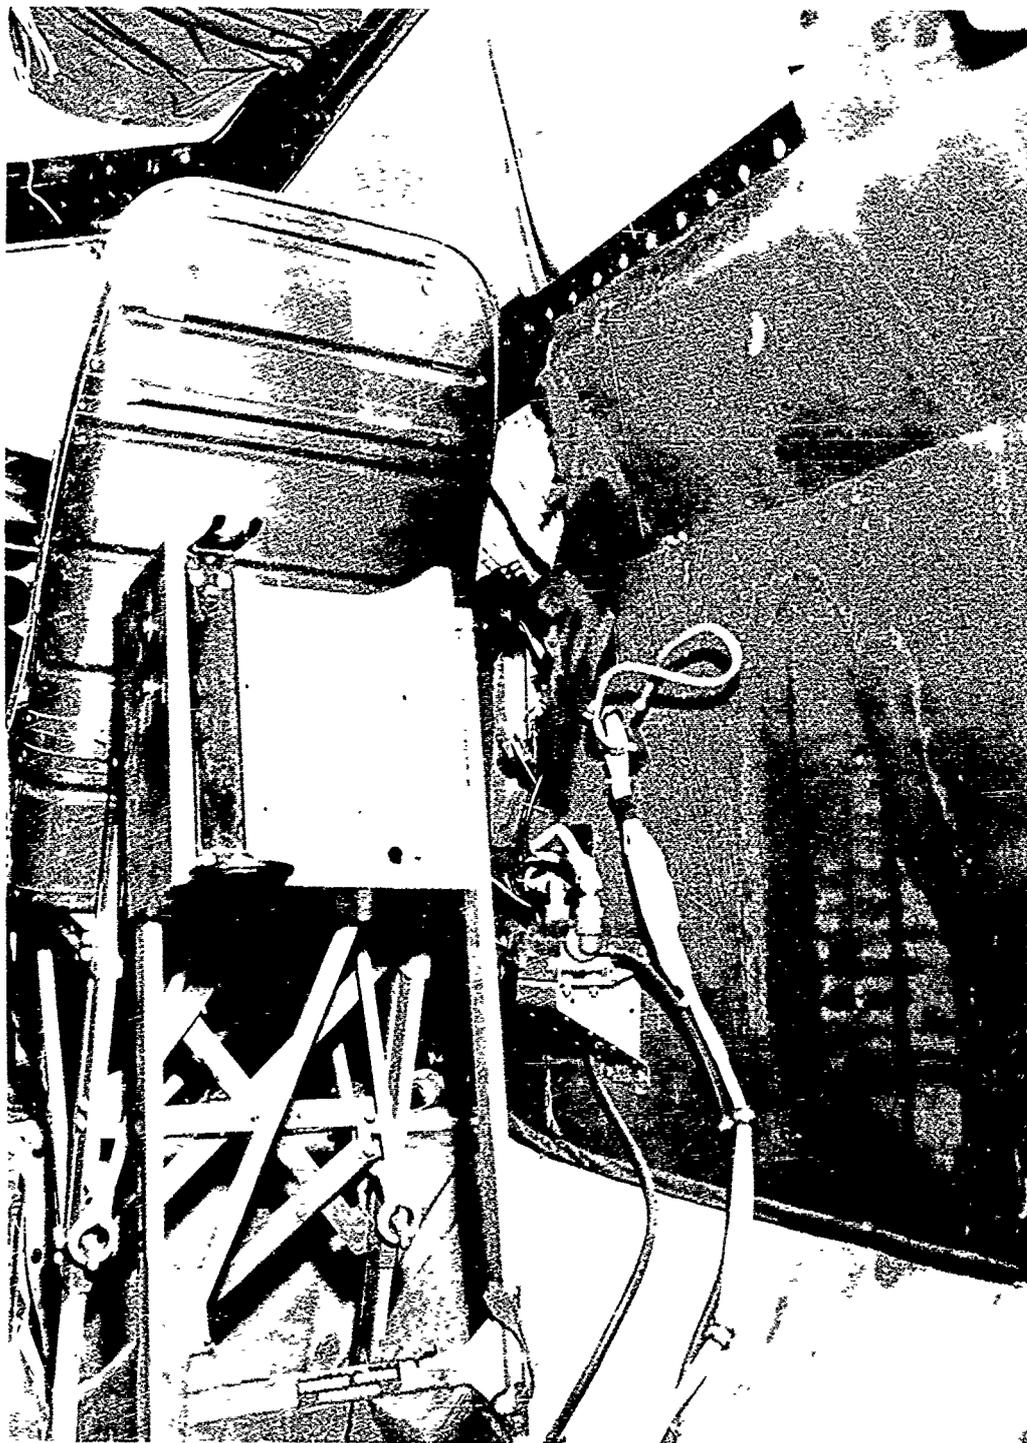
Fig. 3.13 Interior View of B-17 Cockpit Illustrating Thermal Damage to Fabric Resulting from Dog Shot

Fig. 3.14 Interior View of B-17 Cockpit Illustrating Thermal Damage to Fabric Resulting from Dog Shot

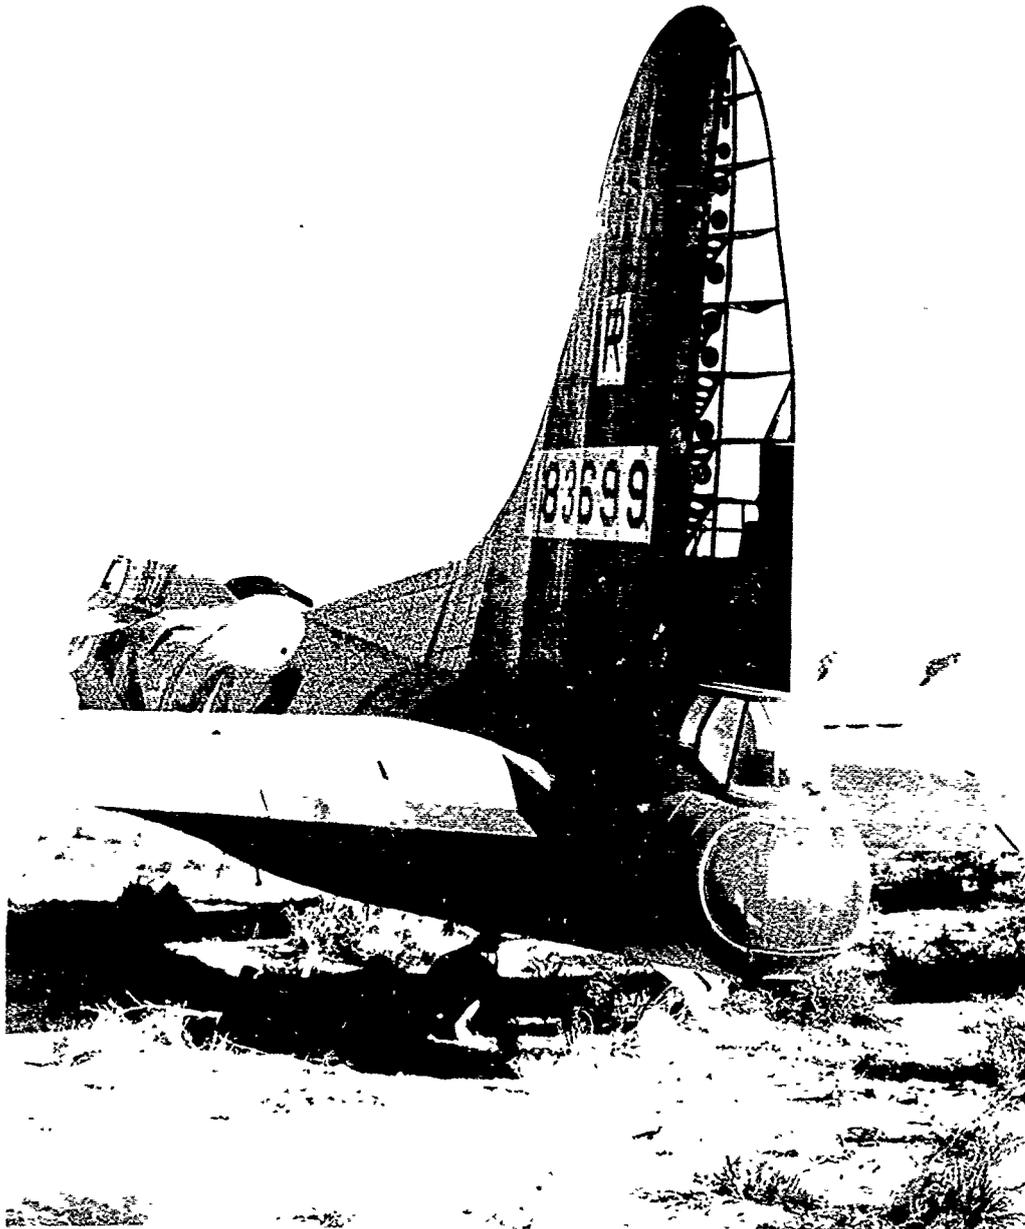
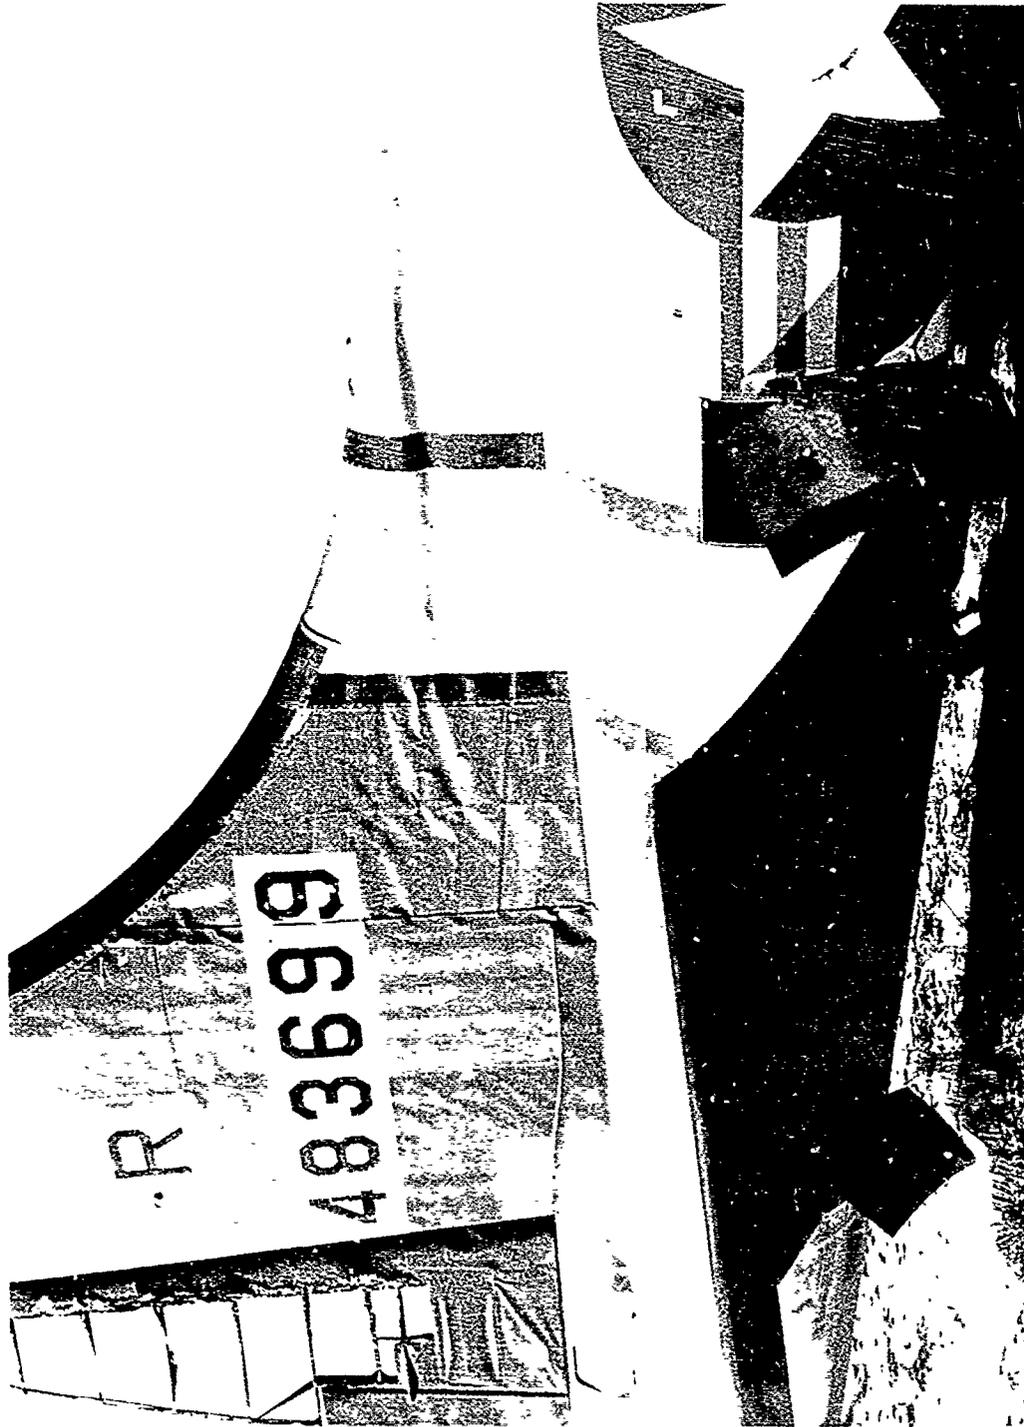
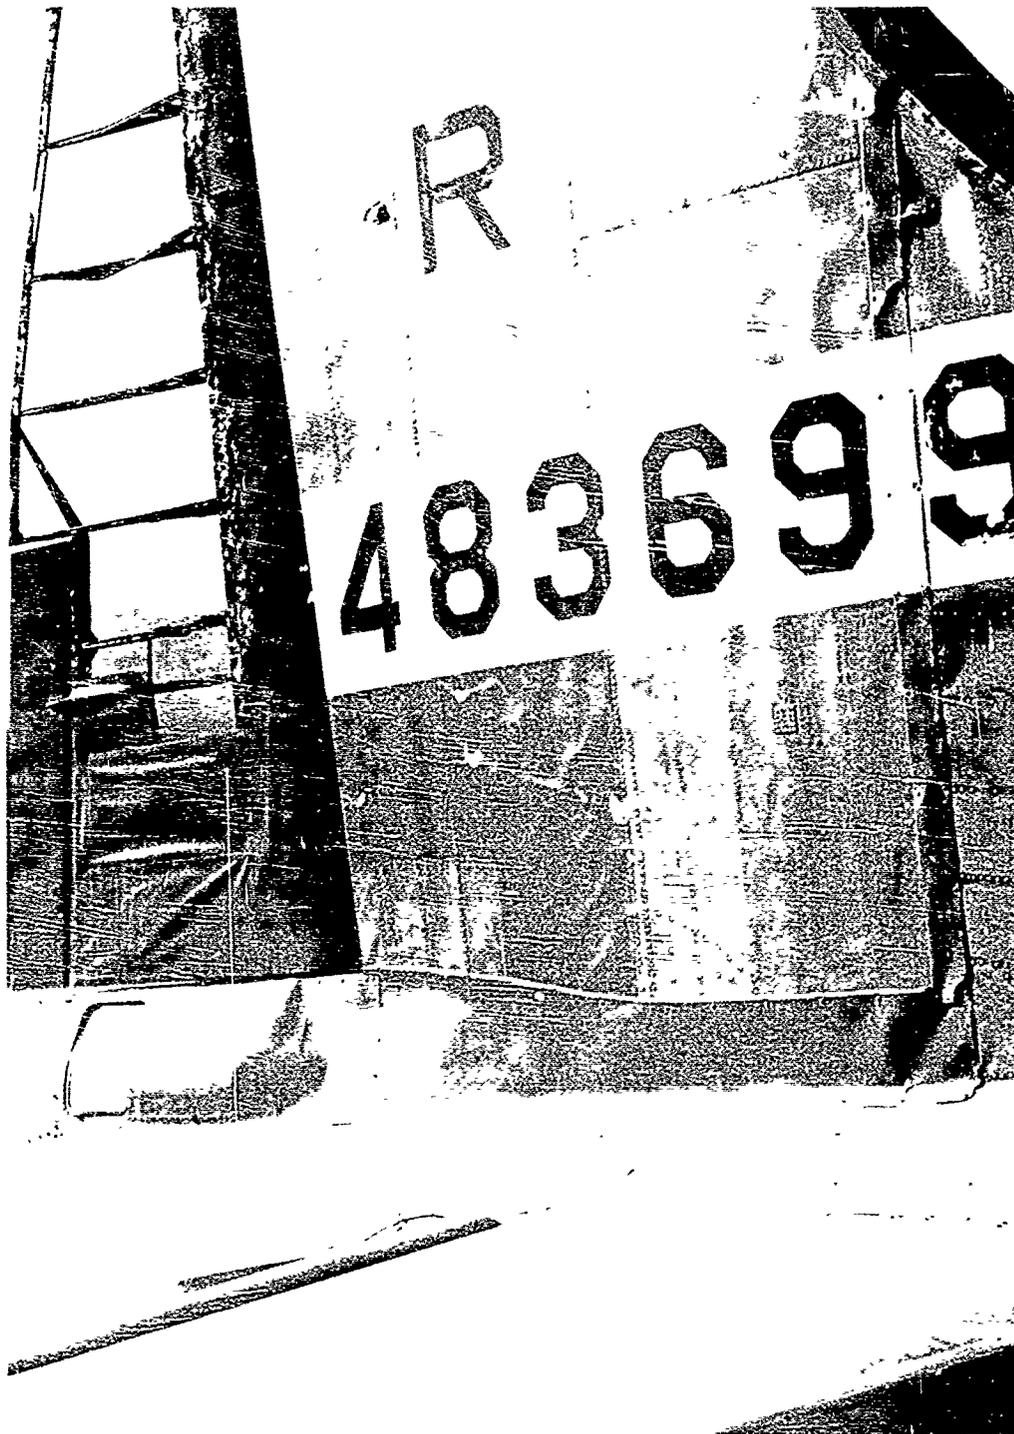
The dorsal fin, vertical stabilizer, and the rudder were severely damaged. The rudder fabric was completely burned except for the lower two panels. Dishing of the skin on the vertical fin and the dorsal fin was extensive. Paint was scorched and blistered with the red paint appearing more severely effected than the black paint in the same region. The combined effects of thermal and blast damage are shown in Figs. 3.17 through 3.19.

Fig. 3.17 View Showing Thermal and Blast Damage to Rudder Following Dog Shot

Fig. 3.18 View Showing Thermal and Blast Damage to Dorsal Fin Following Dc₂ Shot

Fig. 3.19 View Showing Thermal and Blast Damage to Vertical Stabilizer Following Dog Shot

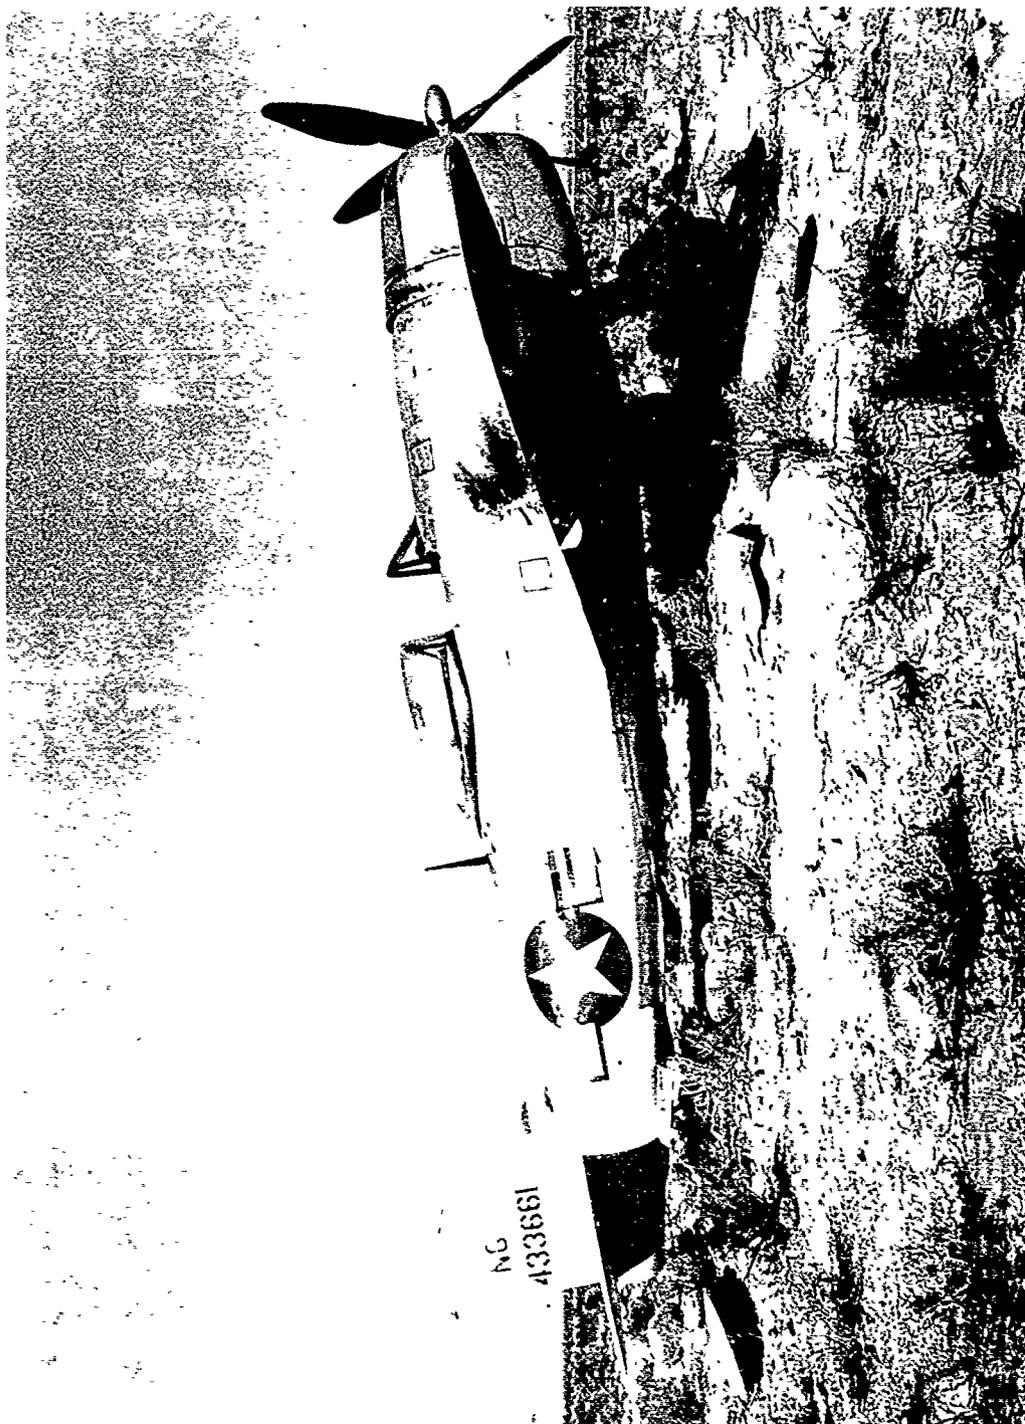
The damaged control surfaces were removed from the aircraft in preparation for Easy Shot resulting in the configuration shown in Figs. 3.21 and 3.22.

Fig. 3.21 F-47 After Dog Shot with Damaged Control Surfaces Removed Prior to Easy Shot

Fig. 3.22 General Condition of F-47 Fuselage After Dog Shot

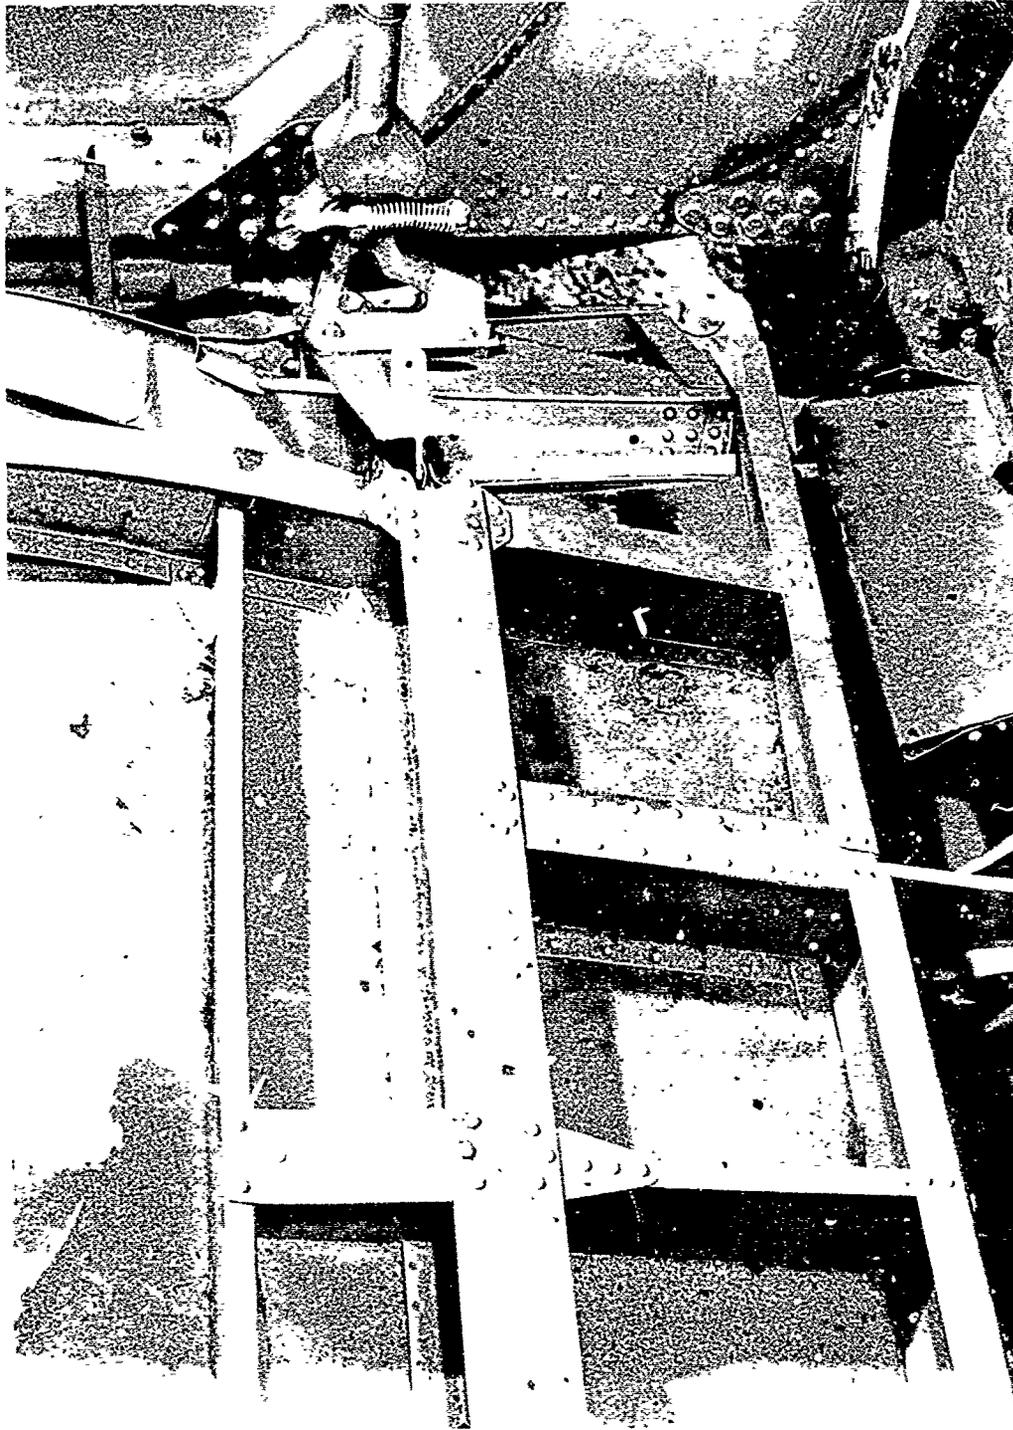
Fig. 3.27 Interior View of Buckled Bomb-Bay Door Showing Failed Structural Member

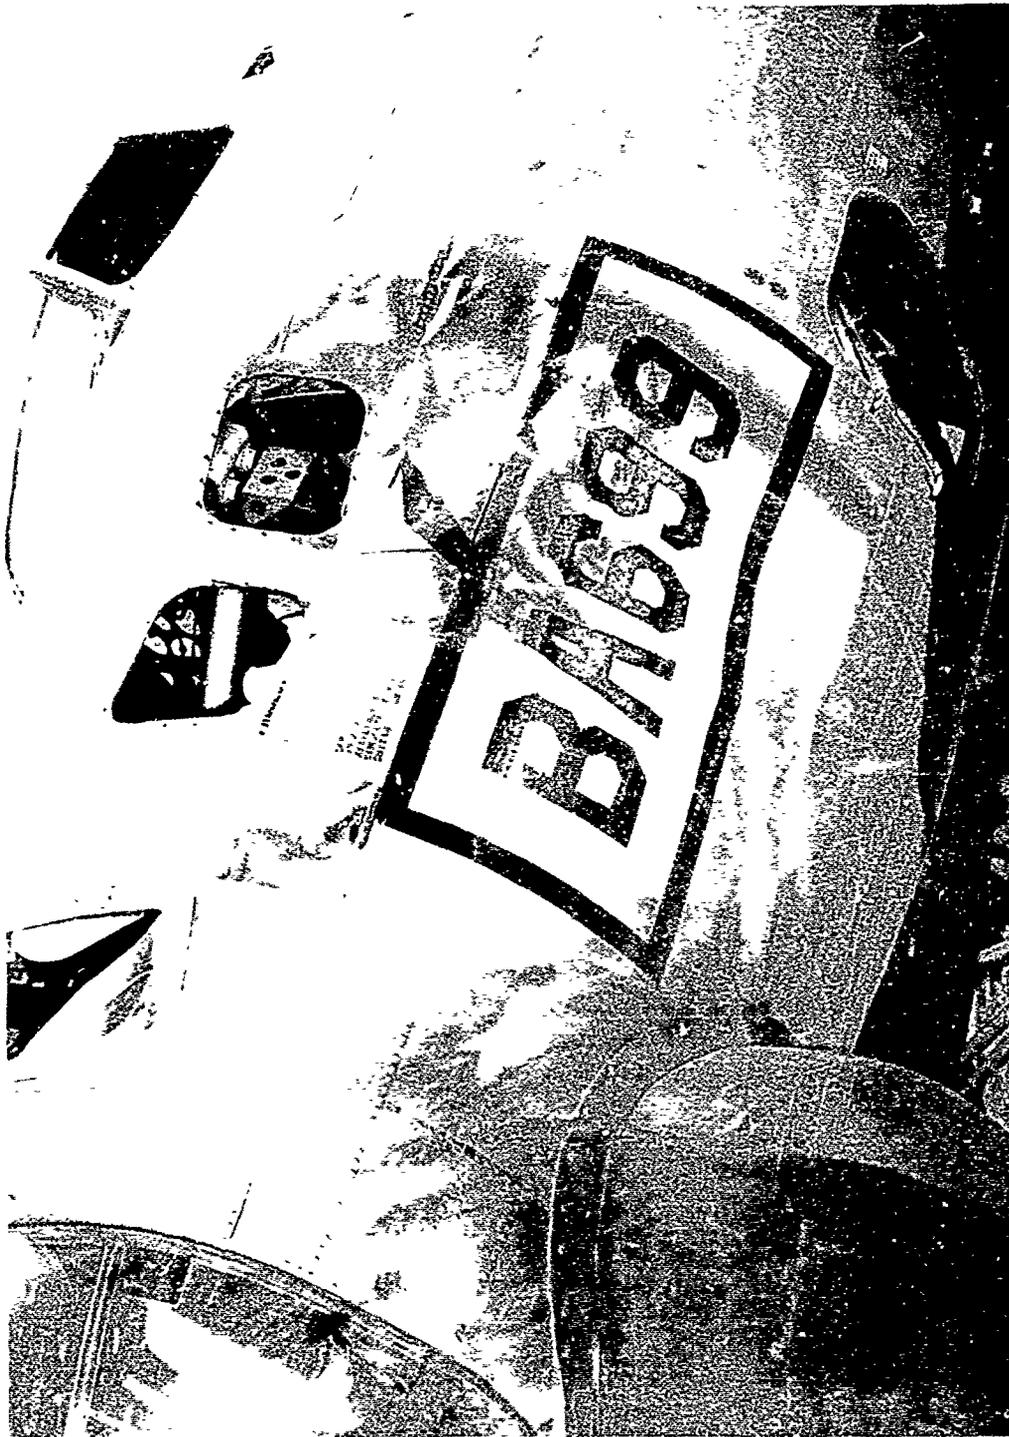
Fig. 3.28 Buckles in Nose Section of B-17 Following Easy Shot

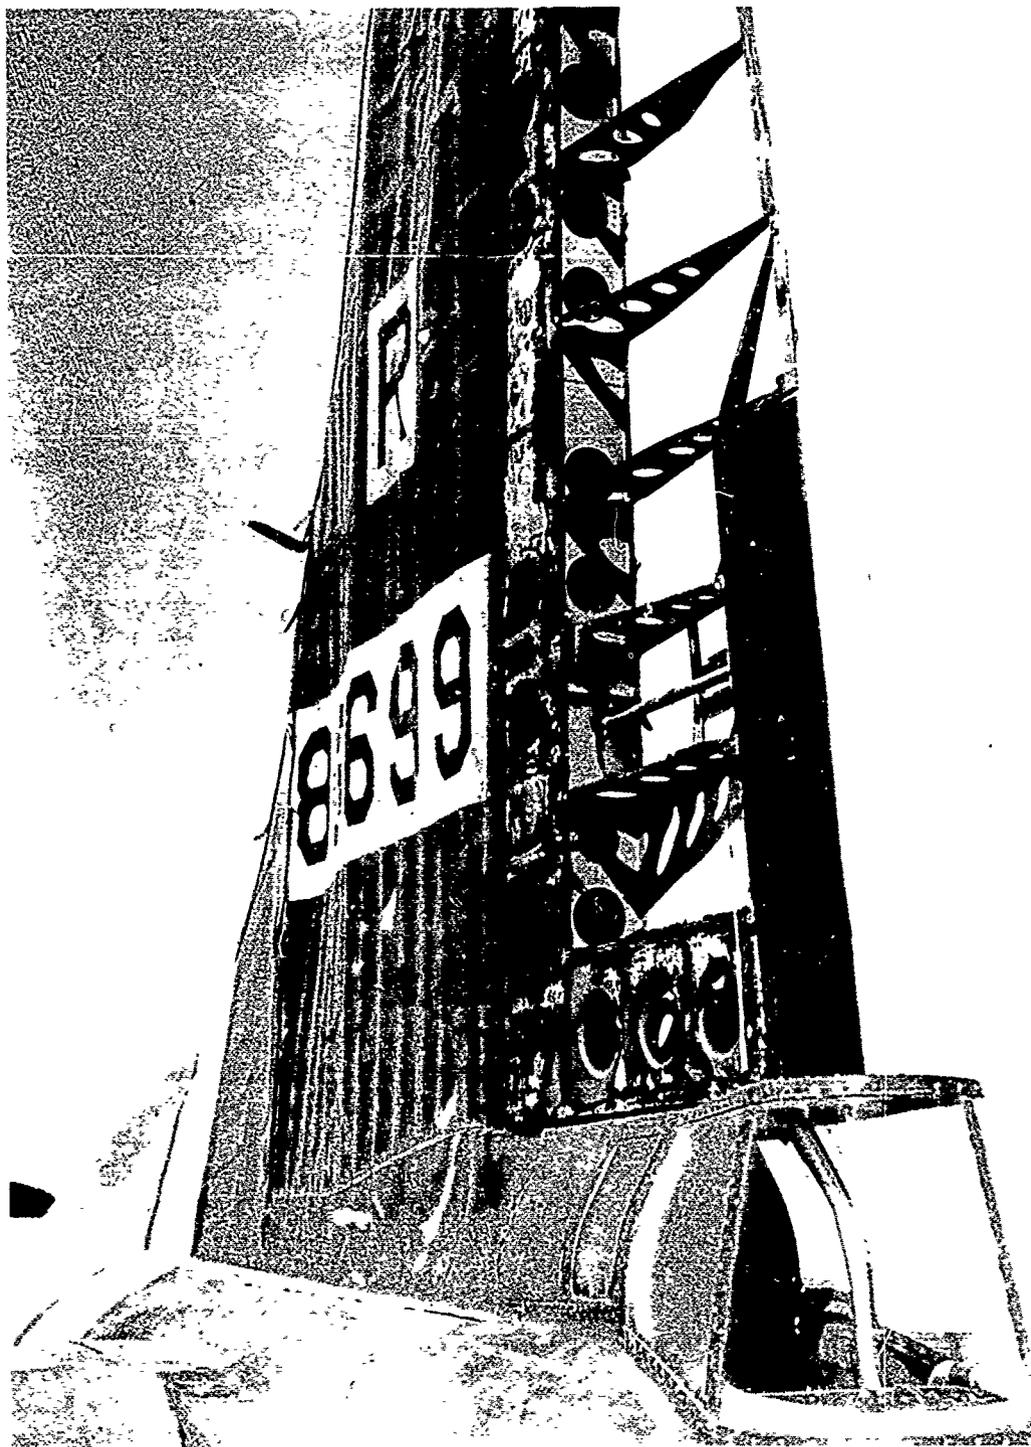
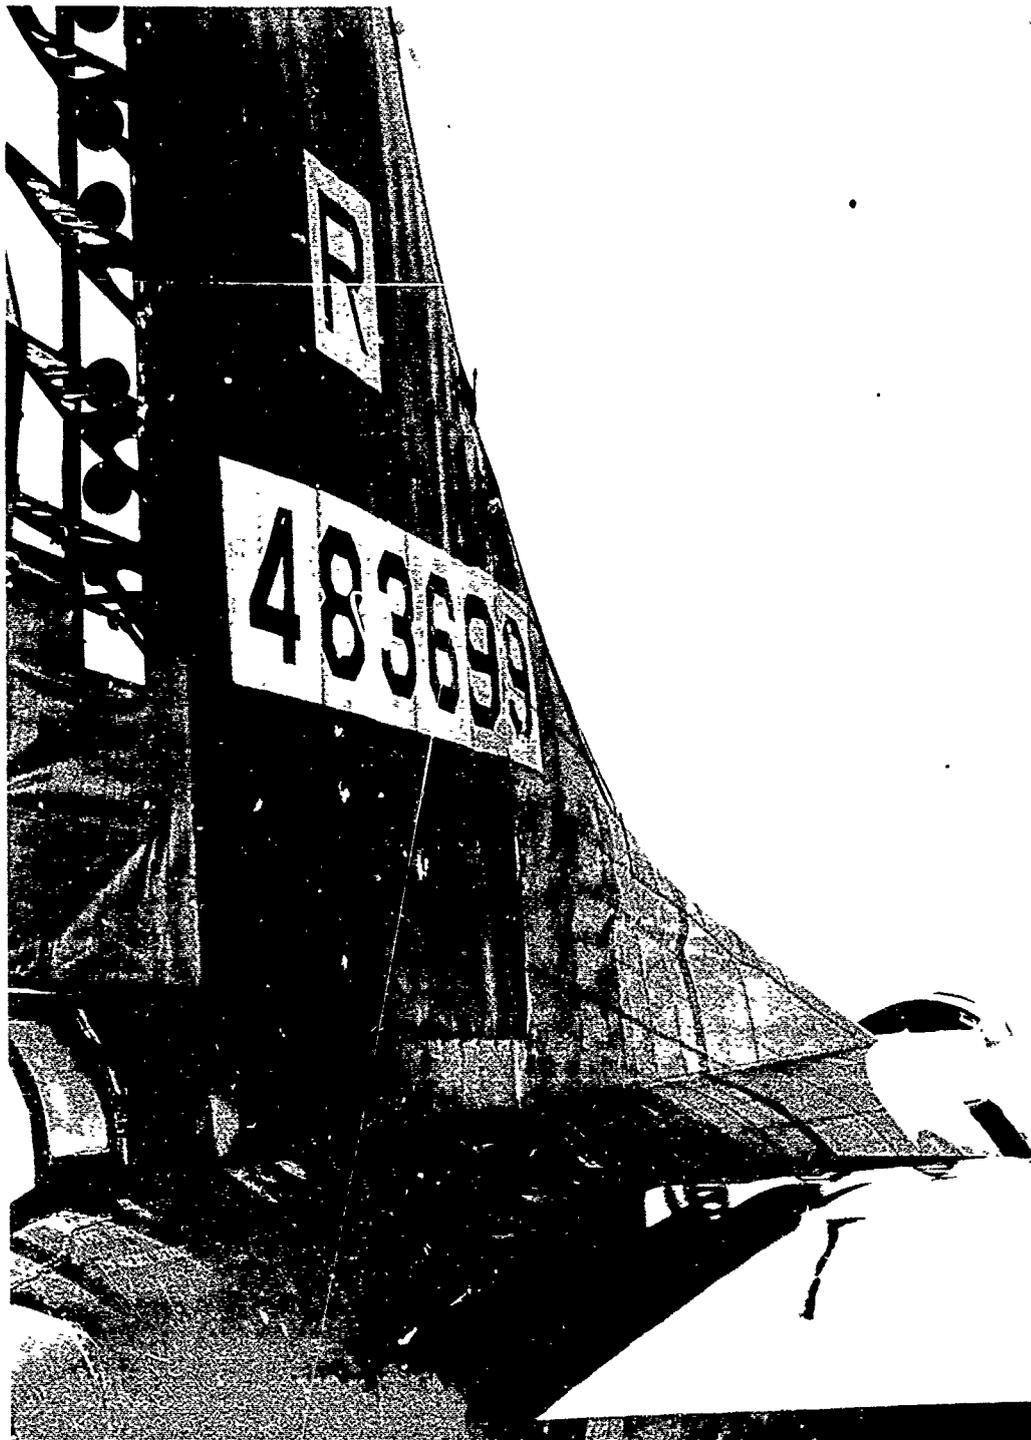
The elevator fabric was ruptured at several places. The dorsal fin and vertical stabilizer were crushed to a greater extent than on Dog Shot. Figs. 3.30 and 3.31 indicate the condition of the vertical tail following Easy Shot.

Fig. 3.30 Condition of Vertical Tail of B-17 After Easy Shot as Seen from the Left Side Previously Incident to the Blast on Dog Shot

Fig. 3.31 Condition of Right Side of Vertical Tail and Dorsal Fin
of B-17 After Easy Shot

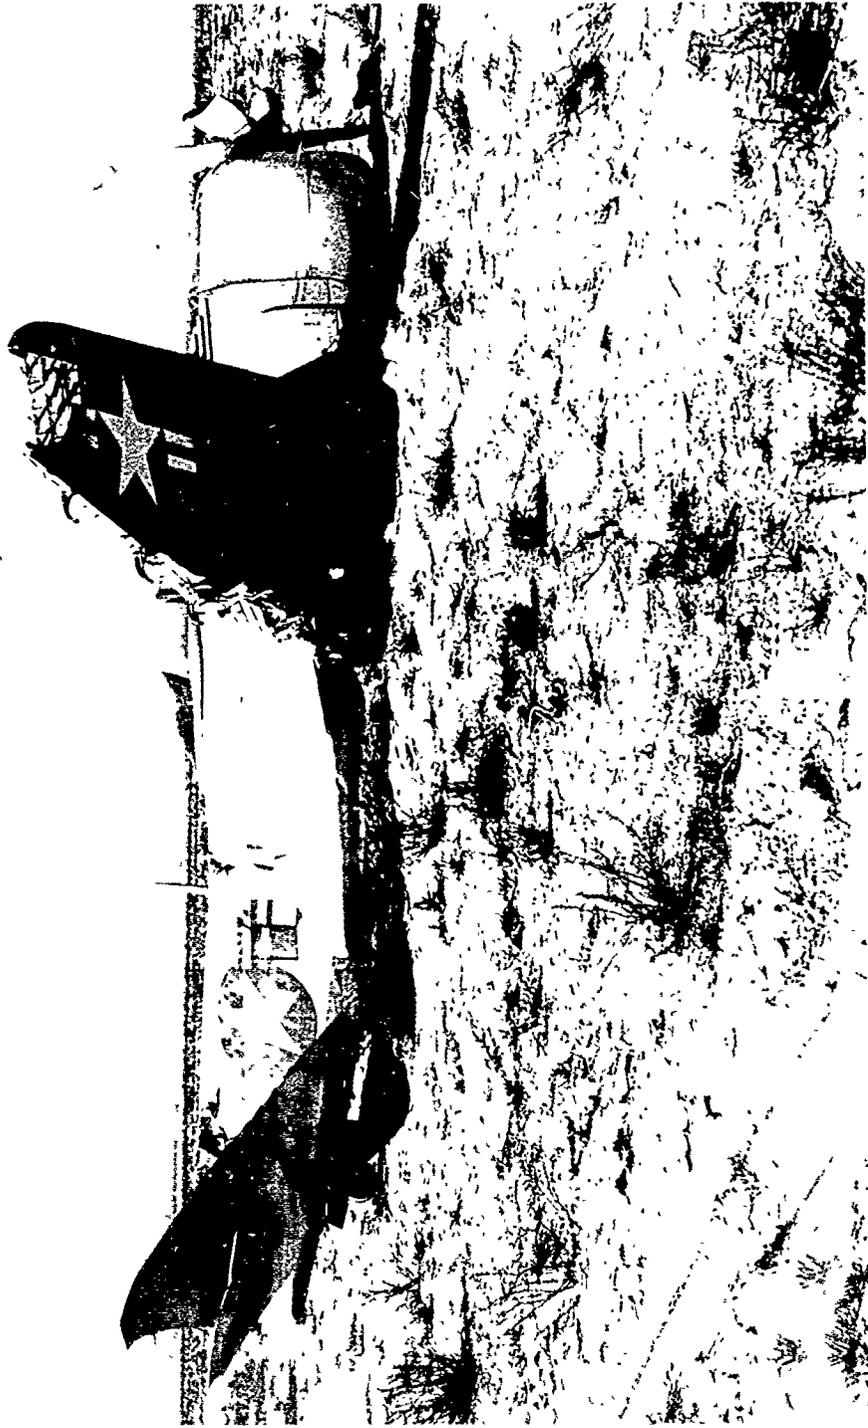
The fuselage of the F-47 sustained a structural failure aft of the cockpit. A portion of this failure is shown in Figs. 3.32 and 3.33. It appeared that considerable sand blasting had damaged one side of the fuselage. The canopy was destroyed. The propeller had the blades bent, probably due to contact with the ground during the blast phase.

Fig. 3.32 Fuselage Failure Aft of Cockpit in F-47 as a Result of Easy Shot

Fig. 3.33 Fuselage Failure Aft of Cockpit in F-47 as a Result of Easy Shot

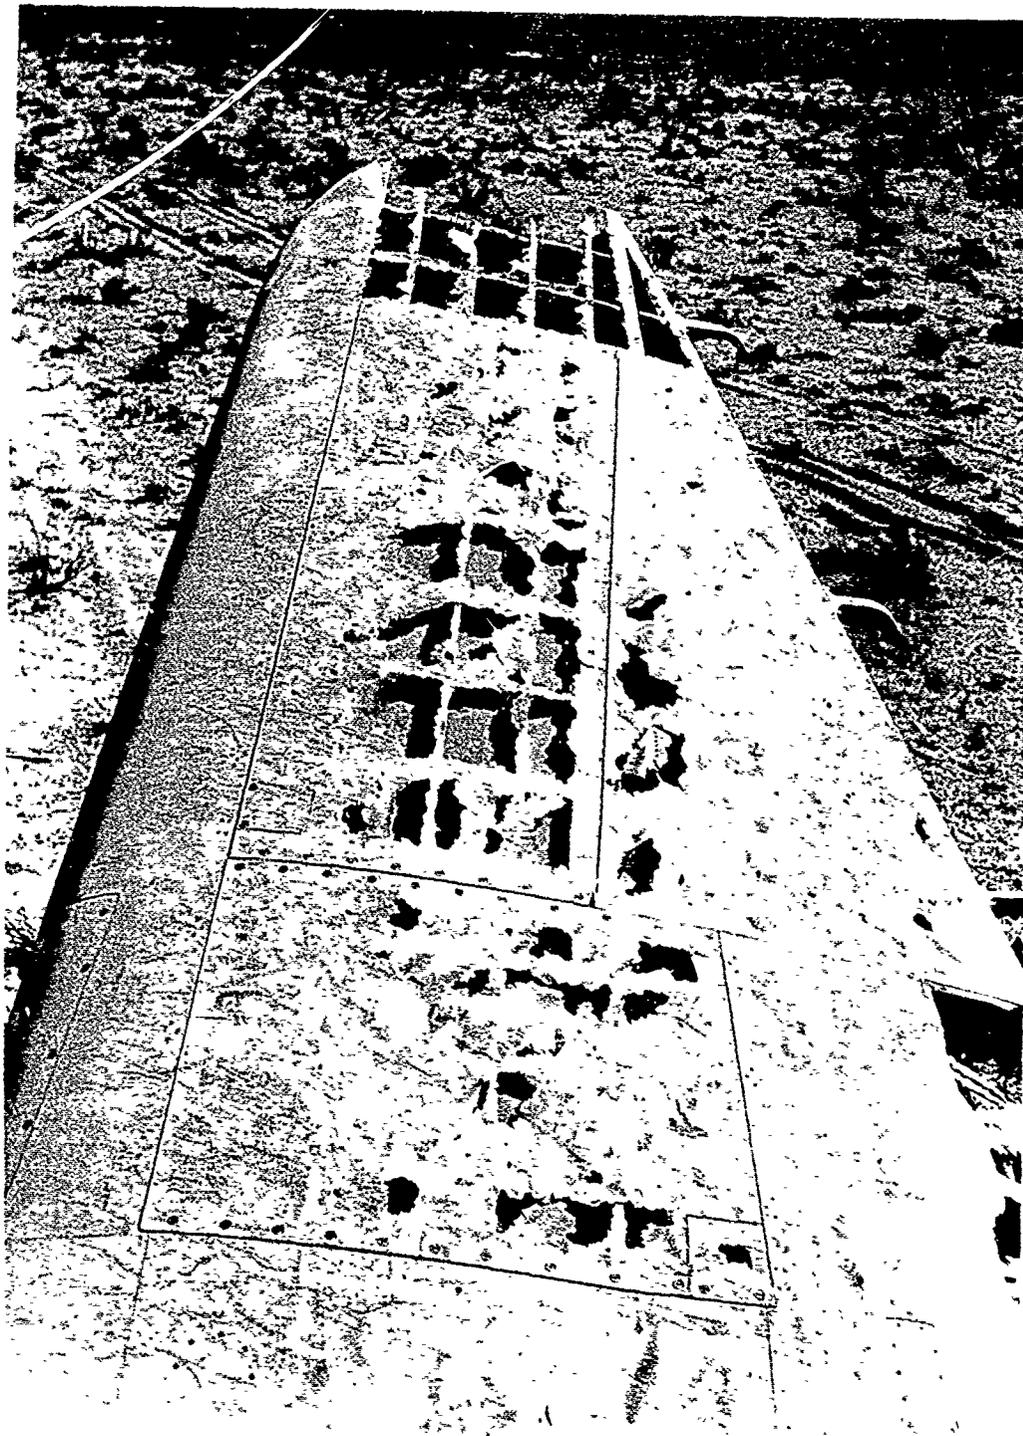
Fig. 3.35 Damage Sustained by Right Wing Panel of F-47 During Easy Shot. Ailerons and flaps were removed prior to this shot.

Fig. 3.36 Damage Sustained by Right Wing Panel of F-47 During Easy Shot. Ailerons and flaps were removed prior to this shot.
