REPORT NO. AML NAM AE 540001

# NAVAL AIR MATERIAL CENTER

## AERONAUTICAL MATERIALS LABORATORY REPORT ON

OPERATION CROSSROADS, TARGET AIRPLANE,  
MODEL TEM-3E, SERIAL NO. 69169;  
TEST OF

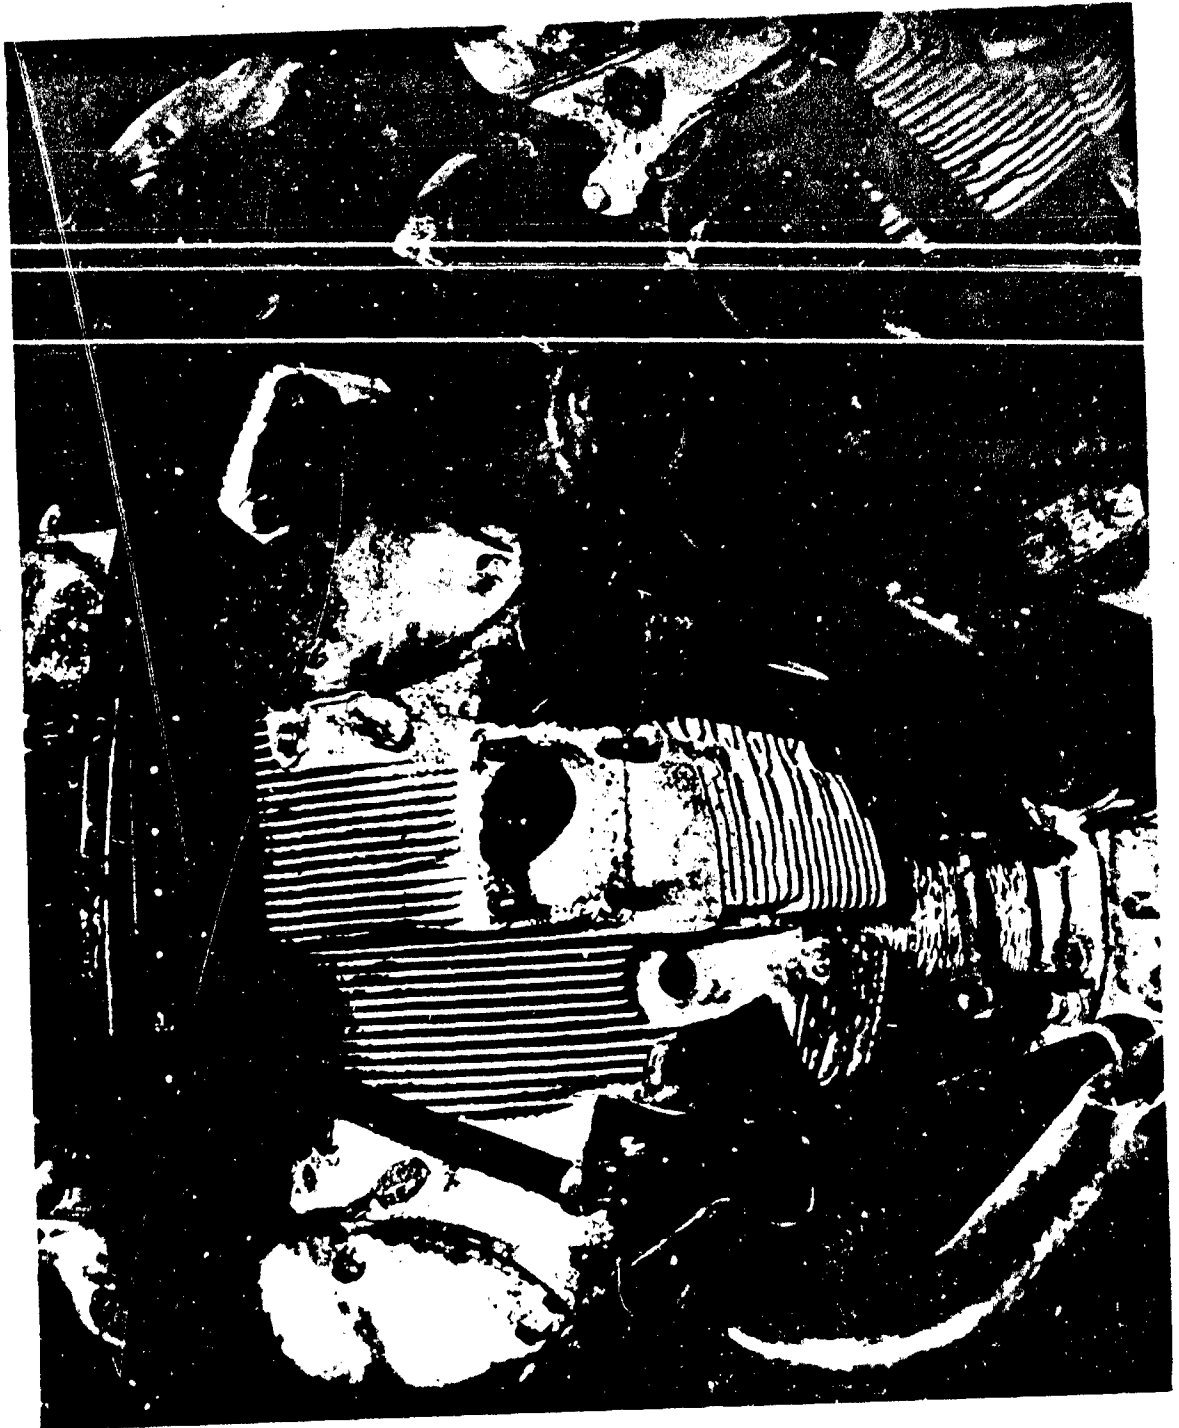
(1) All exposed metal parts (particularly forward of the fire wall) were heavily corroded and rusted; Aluminum parts were coated with a thick layer of gray dust, probably aluminum oxides formed during exposure to the weather and salt atmosphere.

NP(3)-256090(L)-6-48  
VIEW SHOWING CONDITION OF CYLINDER FINS  
R-2600-20 ENGINE

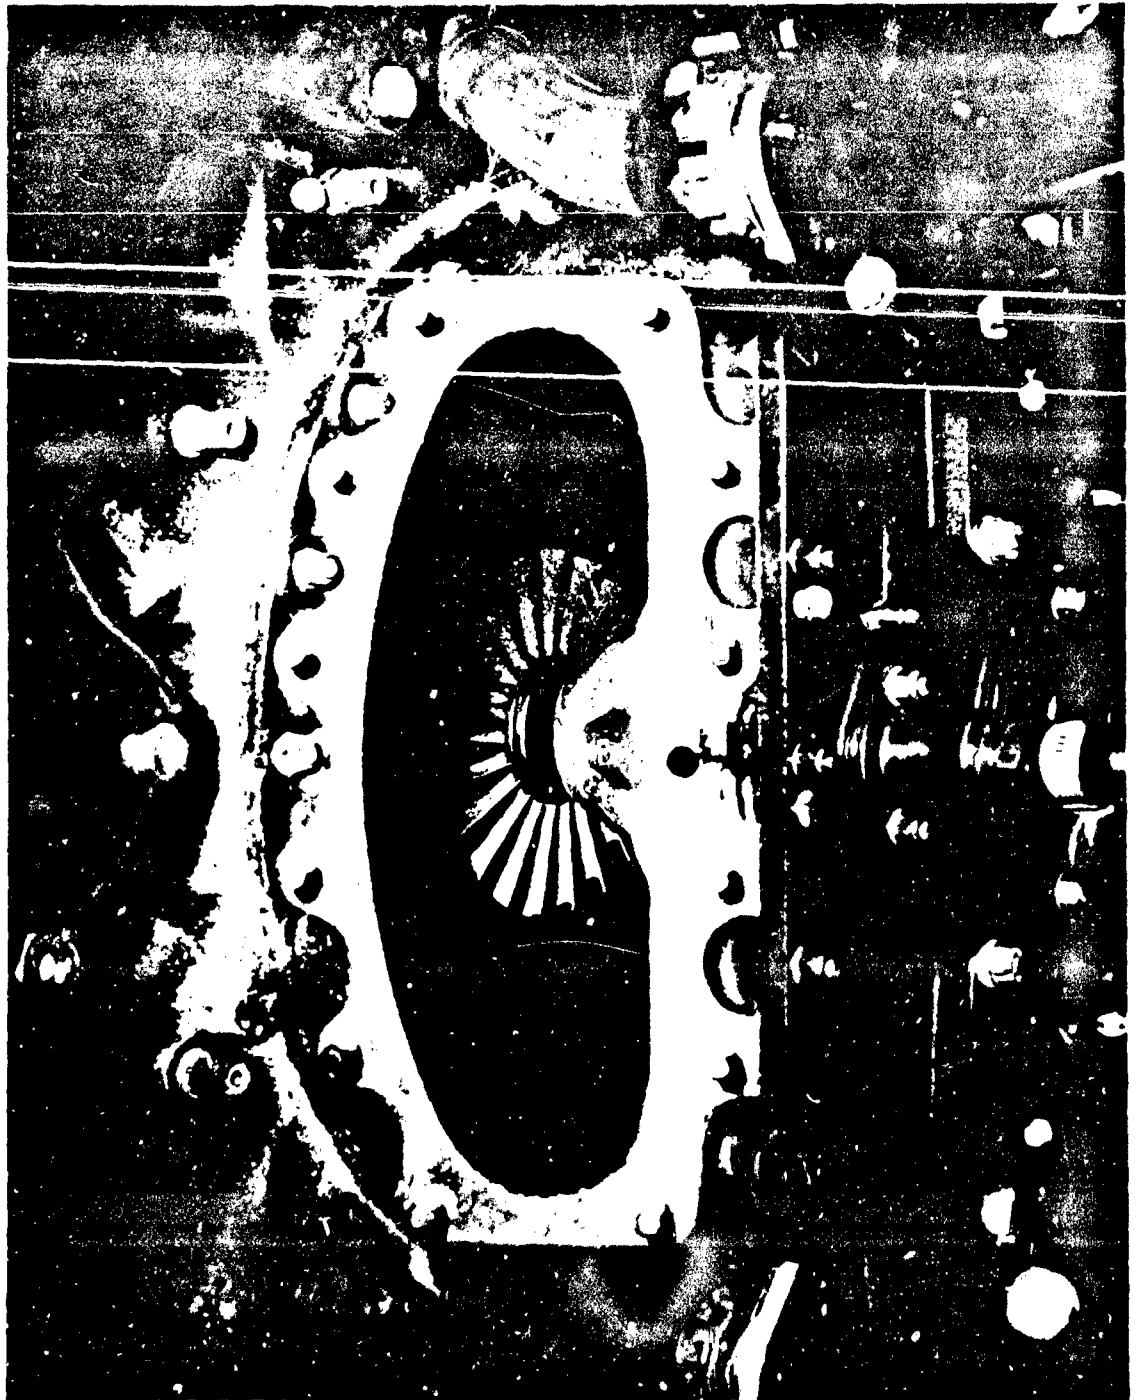
(6) The engine impeller was coated with white flaky particles (see Plate 10) which were probably caused by the entrance of salt water into the engine induction system.

VIEW SHOWING CONDITION OF IMPELLER  
R-2600-20 ENGINE

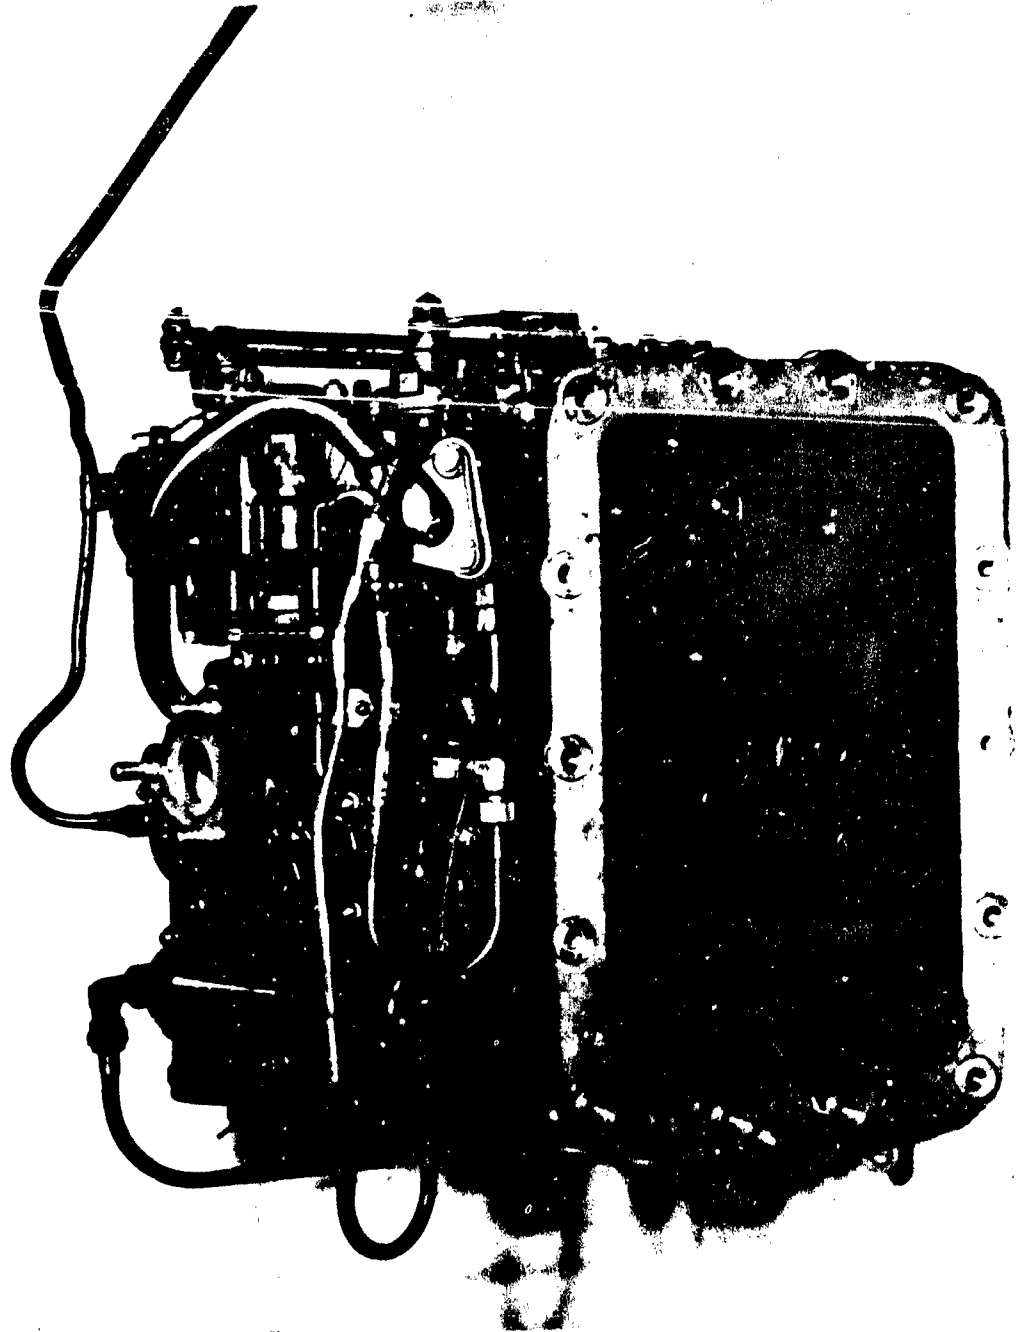
(e) As reported in para 5, ref (e), the overall external appearance of the PR48A2 carburetor, Ser. No. 702552, Parts List No. 395600-2 from the subject airplane was satisfactory with the exception of the corrosive action (appeared to be salt water corrosion) which had taken place in the carburetor main venturi and around the manual mixture control unit. Plates 11 and 12 are general views of the carburetor showing the extent of this corrosion. Disassembly of the carburetor fuel regulator system and a visual inspection of the various component parts and diaphragms indicated these parts to be in good condition. Altitude chamber tests of the automatic mixture control unit showed the unit to be within the specified travel limits and less than 1.0 percent off from the flow bench specified setting at 20,000 ft. altitude. It is concluded that this carburetor is in operable condition and no detrimental effects were produced upon or within the carburetor other than the corrosive action.

C NP(3)-259206(L)-4-49  
CARBURETOR FROM TBM-3E TARGET AIRPLANE  
SHOWING GENERAL CORRODED CONDITION

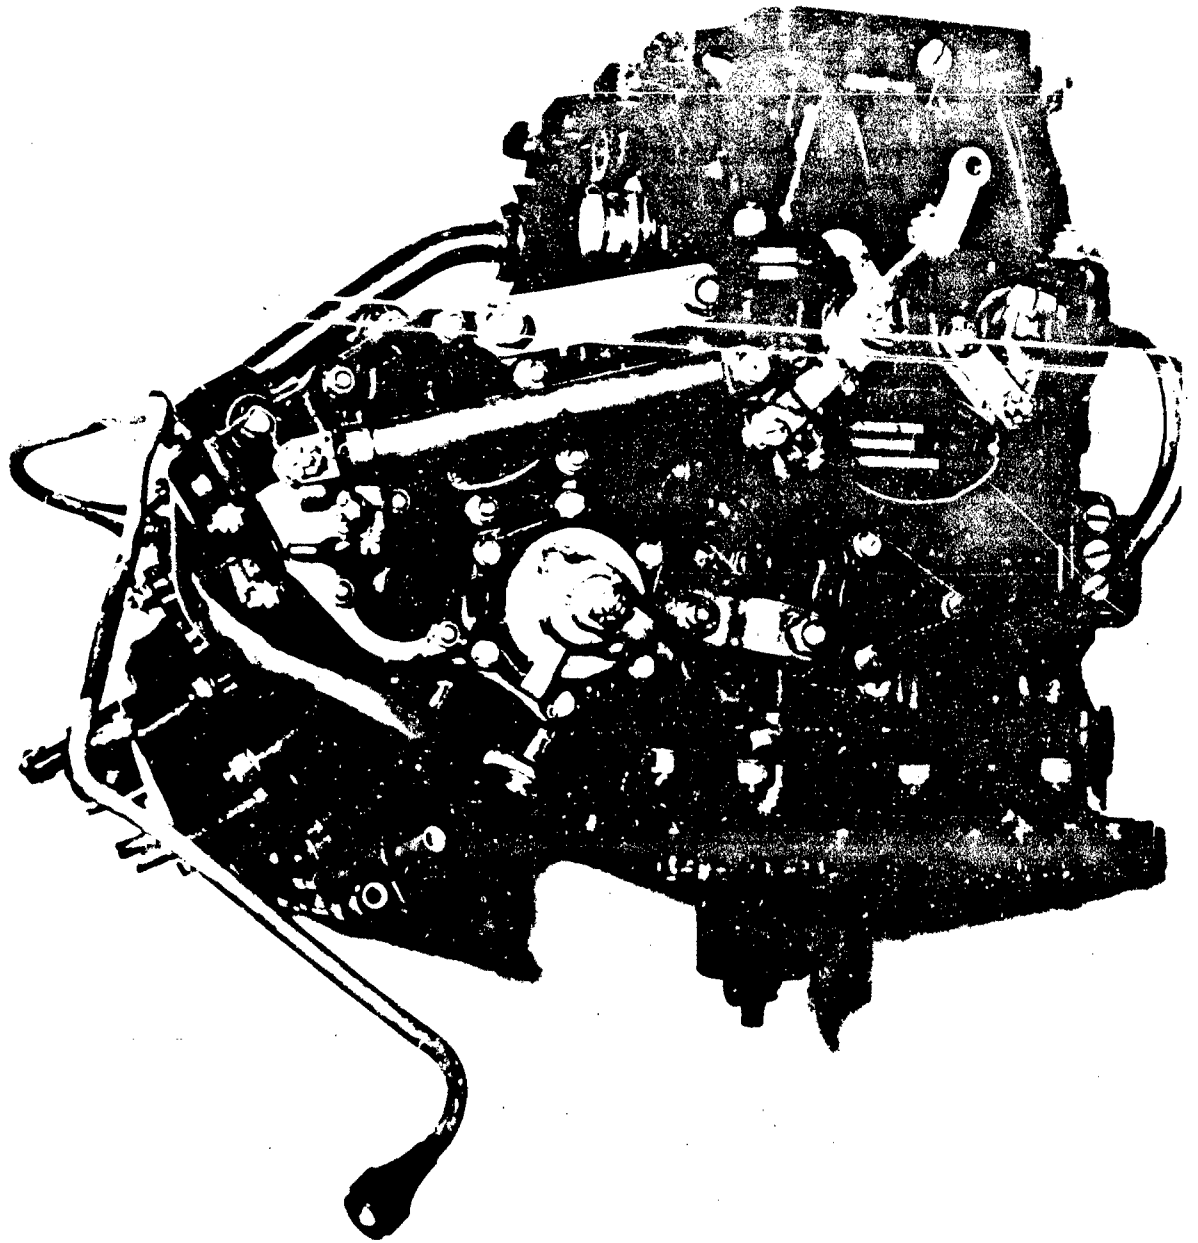
NP(3)-259207(L)-4-49  
CARBURETOR FROM TBM-3E TARGET AIRPLANE  
SHOWING GENERAL CORRODED CONDITION

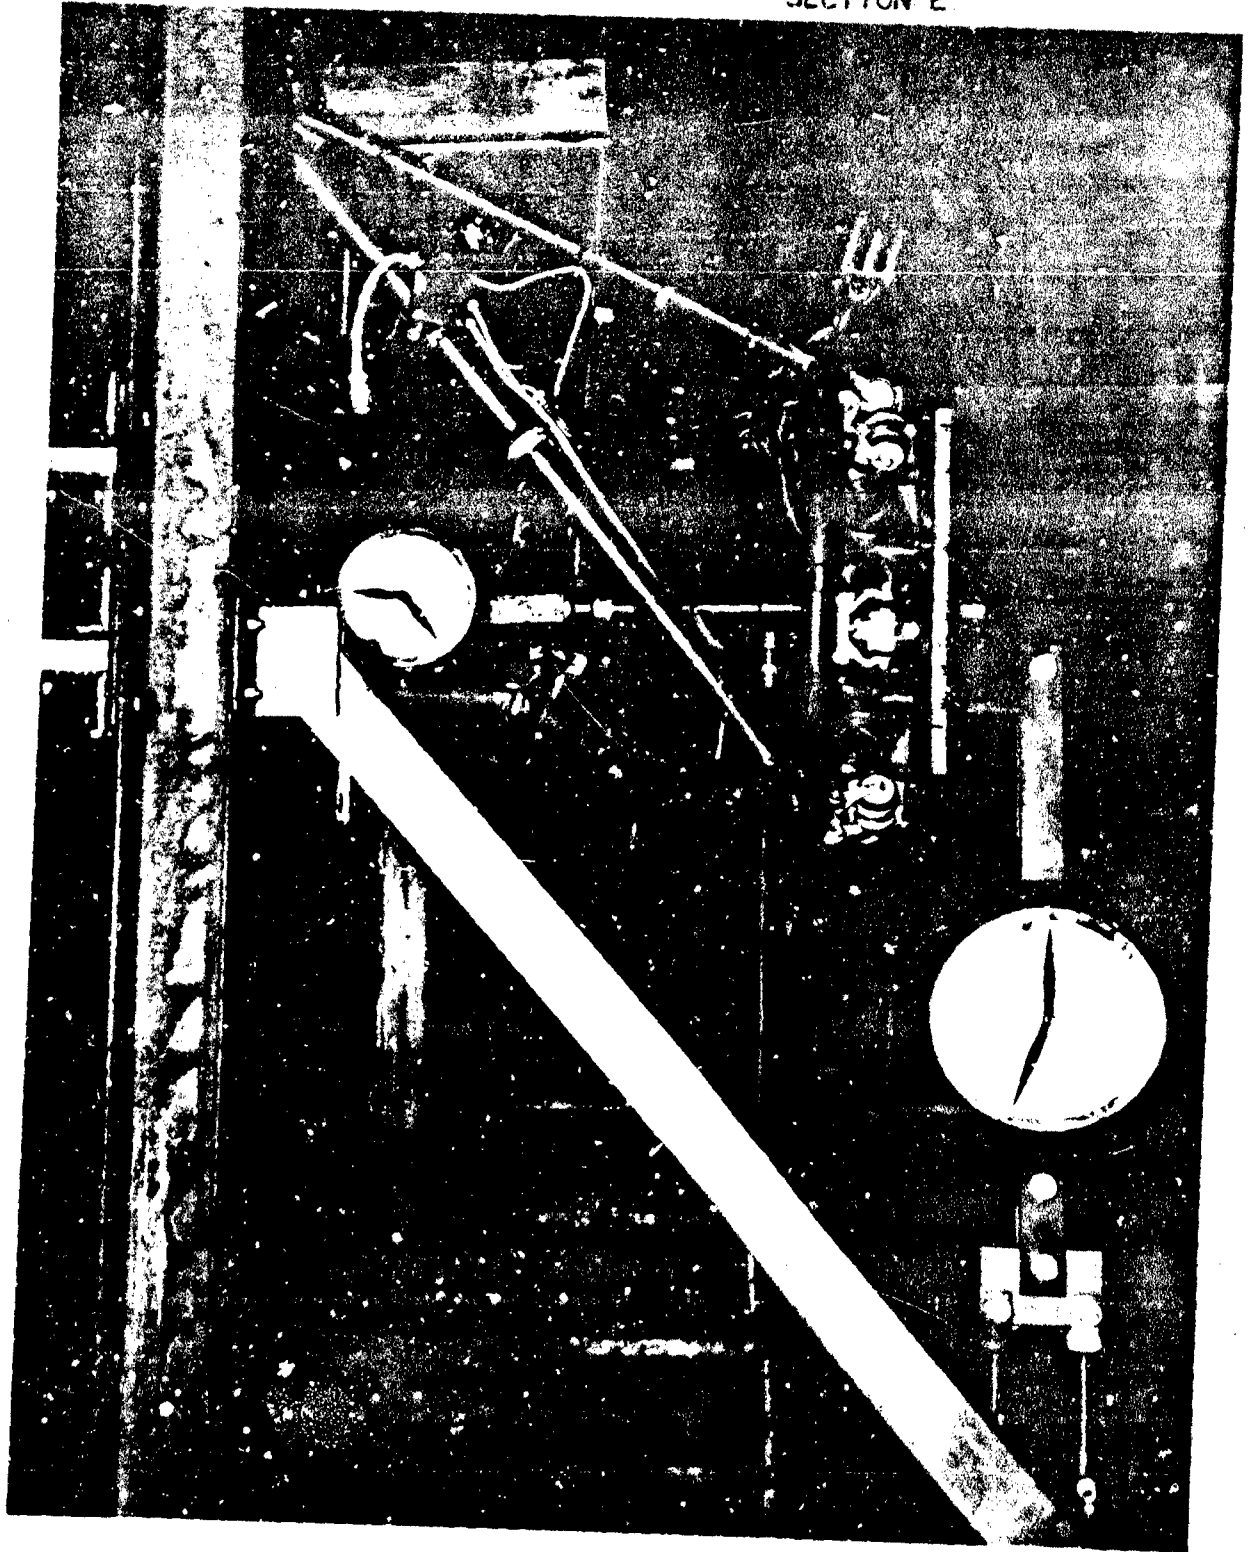
PLATE 3

7. Section E is the report by the Aeronautical Structures Laboratory of tests conducted on the engine mount, tail section and one wing panel of the aircraft. These tests were, in the main, inconclusive. The engine mount failure was as predicted from studies of the contractor's stress analyses (no comparable test data available); the rudder, after repair, failed normally; the tail section gave indication of normal failure; the wing, after extensive repair, failed at the repair, making the test inconclusive.

NP(3)-262399(L)-3-48  
TBM-3E TARGET AIRPLANE - ENGINE MOUNT TEST  
TUBE D FAILURE

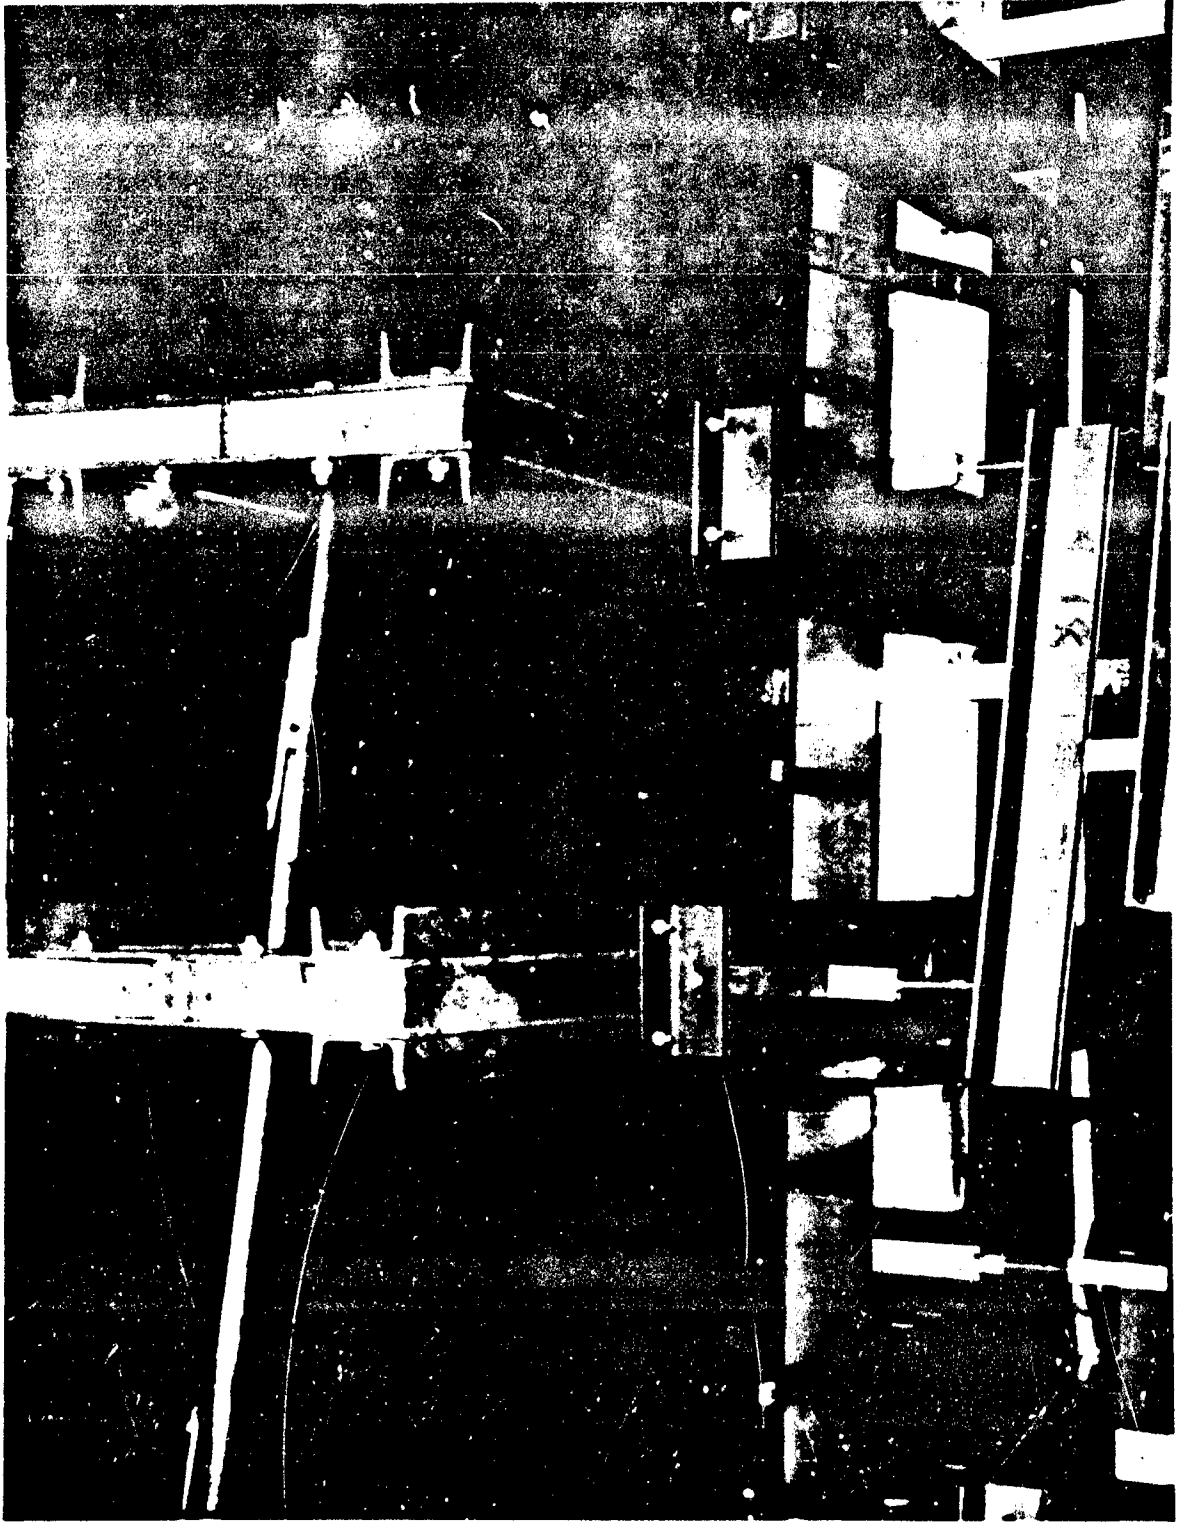
NP(3)-262404(L)-3-48 Q 1711  
TBM-3E TARGET AIRPLANE - PORT STABILIZER - STATION 60  
LEADING EDGE BUCKLE AND UNDERSURFACE WRINKLES AT 155% LIMIT LOAD  
PLATE 8
