## OPERATION DOMINIC

### FISH BOWL SERIES

### PROJECT OFFICER'S REPORT - PROJECT 9.4b

### POD and Recovery Unit Fabrication

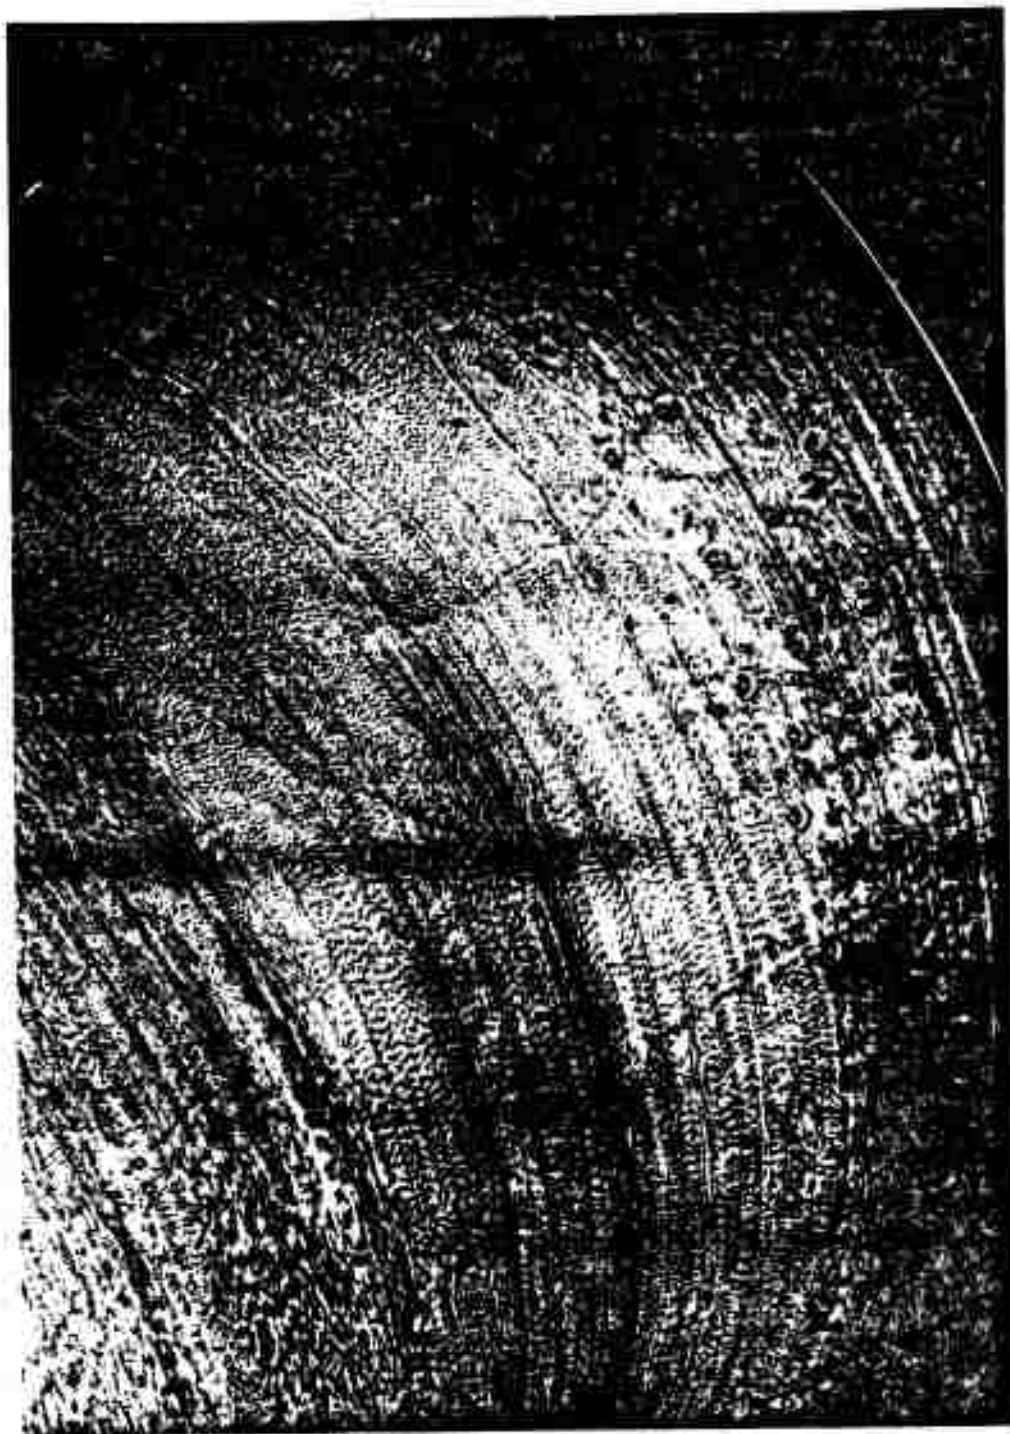
Figure 2.19 Flare damage, P E2. (DASA 26-6460-62)

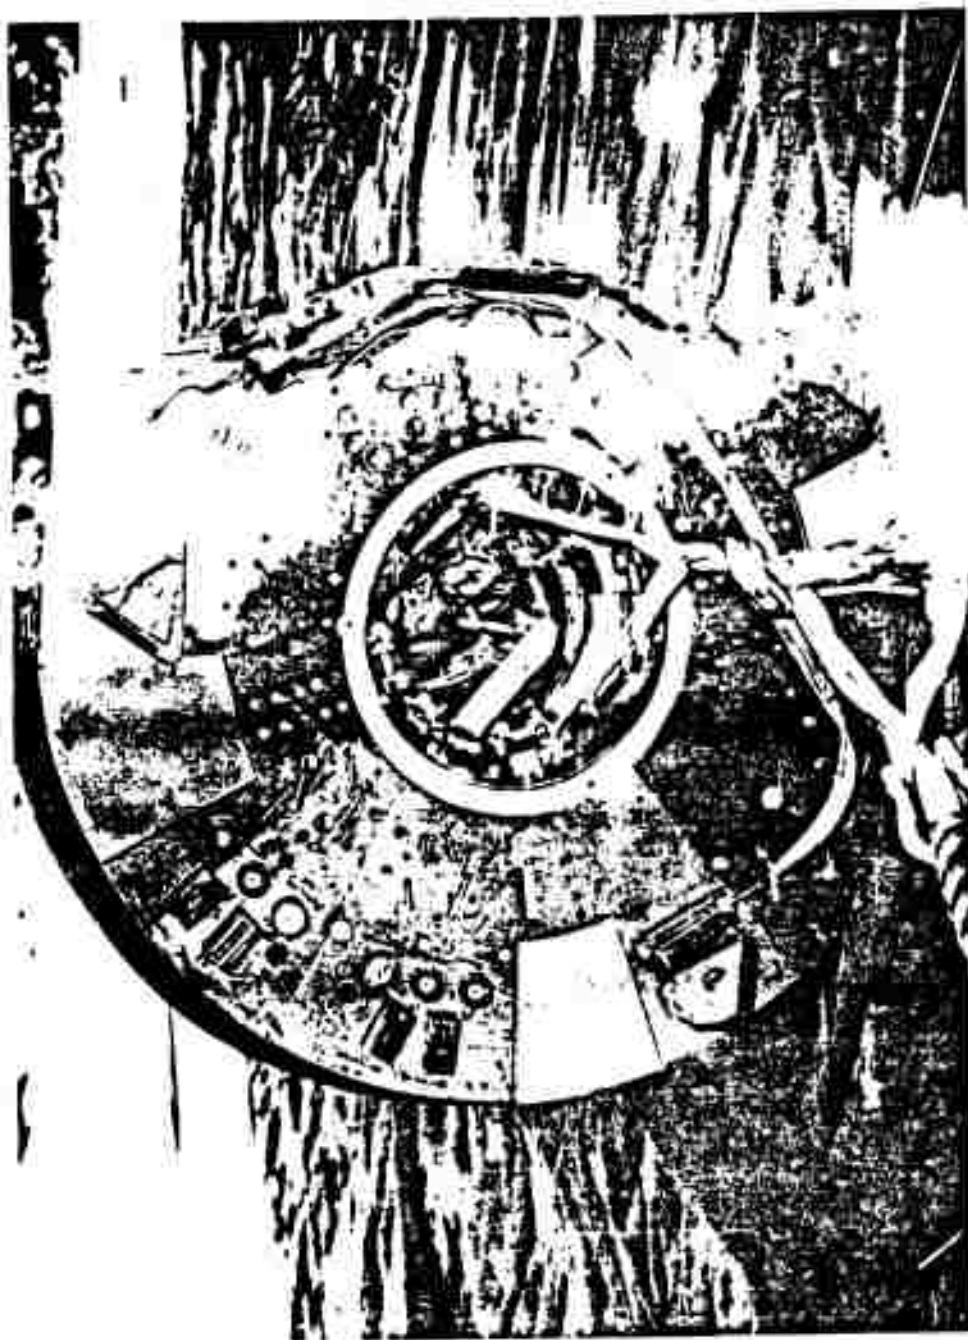
Pod B1 received the most impact damage. Two-thirds of the hardened flare had been broken off. One edge of the rear bulkhead behind the flare was bent over and partially broken off. The nose was dented to a depth of 5 inches on the same side as the rear bulkhead damage (Figure 3.9). On the rear bulkhead, most of the piston-type instruments were bent over. A number of surface-mounted instruments had been sheared off. One DACO Thor mounting fitting was sheared off about 1 inch from the bulkhead (Figure 3.10). The recovery system actuator had blown the door off and deployed the drogue parachute, the drogue chute had released and deployed the main parachute, but the main parachute had not released nor had the flotation bag deployed (Figure 3.11). Over 2,800-psi pressure was still in the release system after recovery. The main parachute had two splits when recovered. One was relatively small, but the other was from skirt to crown.

Figure 3.10 Pod B1DP bulkhead damage. (DASA 26-6726-62)

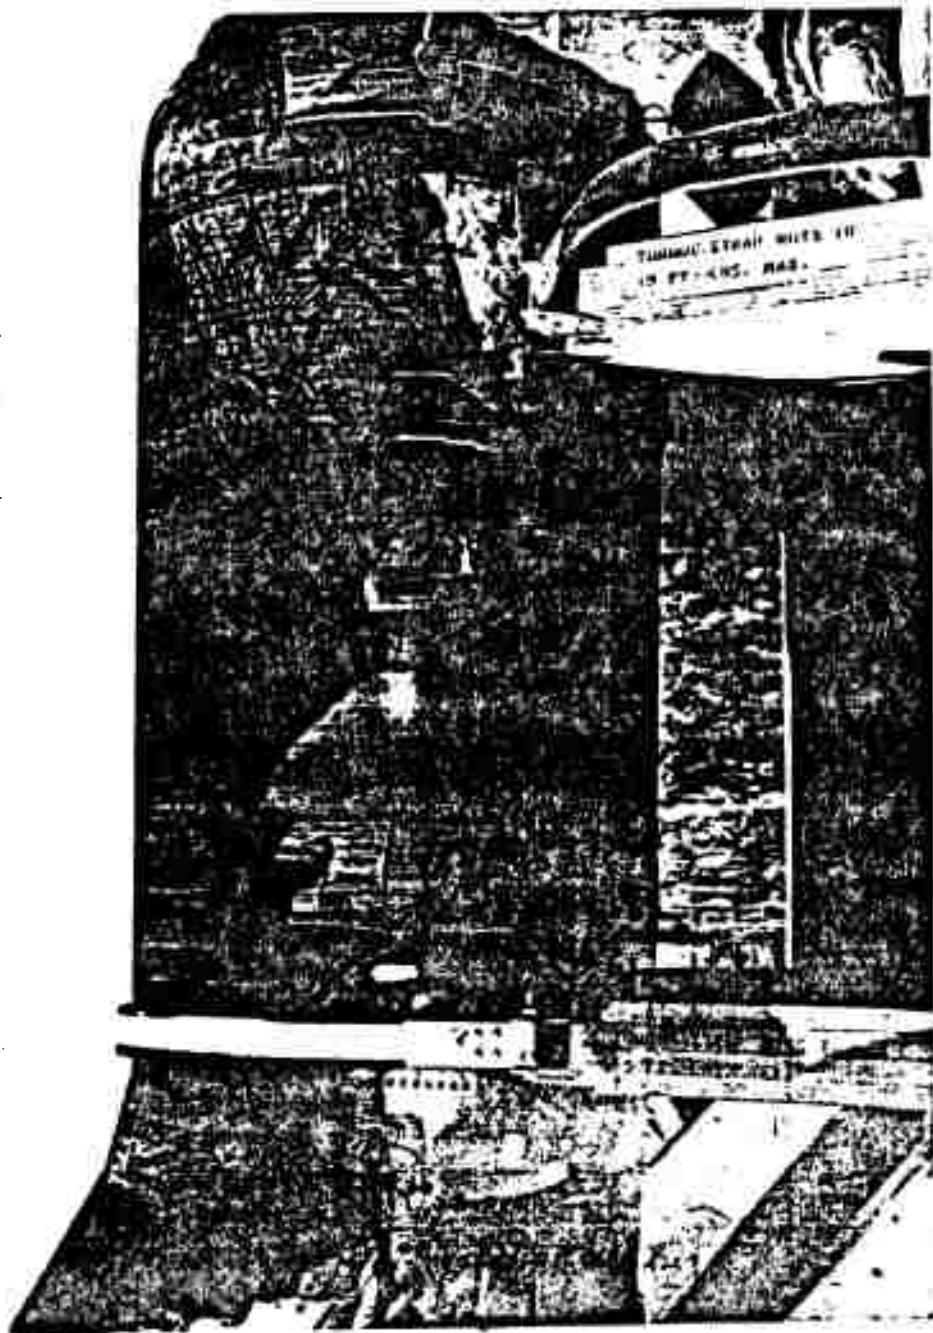
Pod B2 was found and returned to the hot cell area by helicopter. The first sighting took place about 0900 on 26 October. This pod had quite a bit of impact damage. The rear flare section was completely broken off and missing. Most of the bulkhead, however, was in good condition. There was also a slight dent in the nose section. Pod B2 was refurbished using fiberglass instead of refrasil for building up the nose. Because of the fiberglass, the ablation showed a different pattern from the normal refrasil ablation. Metallurgic examination revealed a look angle of  $7 \text{ degrees} \pm 2 \text{ degrees}$ . The recovery system was only partially successful. The actuator fired the door and deployed the drogue parachute. The drogue chute released and deployed the main chute. The main chute did not release, but the flotation bag was out. The risers on the main parachute were cut between the pod and the cross or point where the risers come together below the swivel. The cut was not clean but consisted of a number of short cuts or frictional cuts. The rubber flotation bag fell out of its reinforcing tape when picked up by helicopter. It was concluded that the flotation bag deployed while still airborne, and the flashing light and Sarah beacon were damaged at this time.

Figure 3.17 Pod K2 impact damage, heat shield. (DASA 26-6869-62)

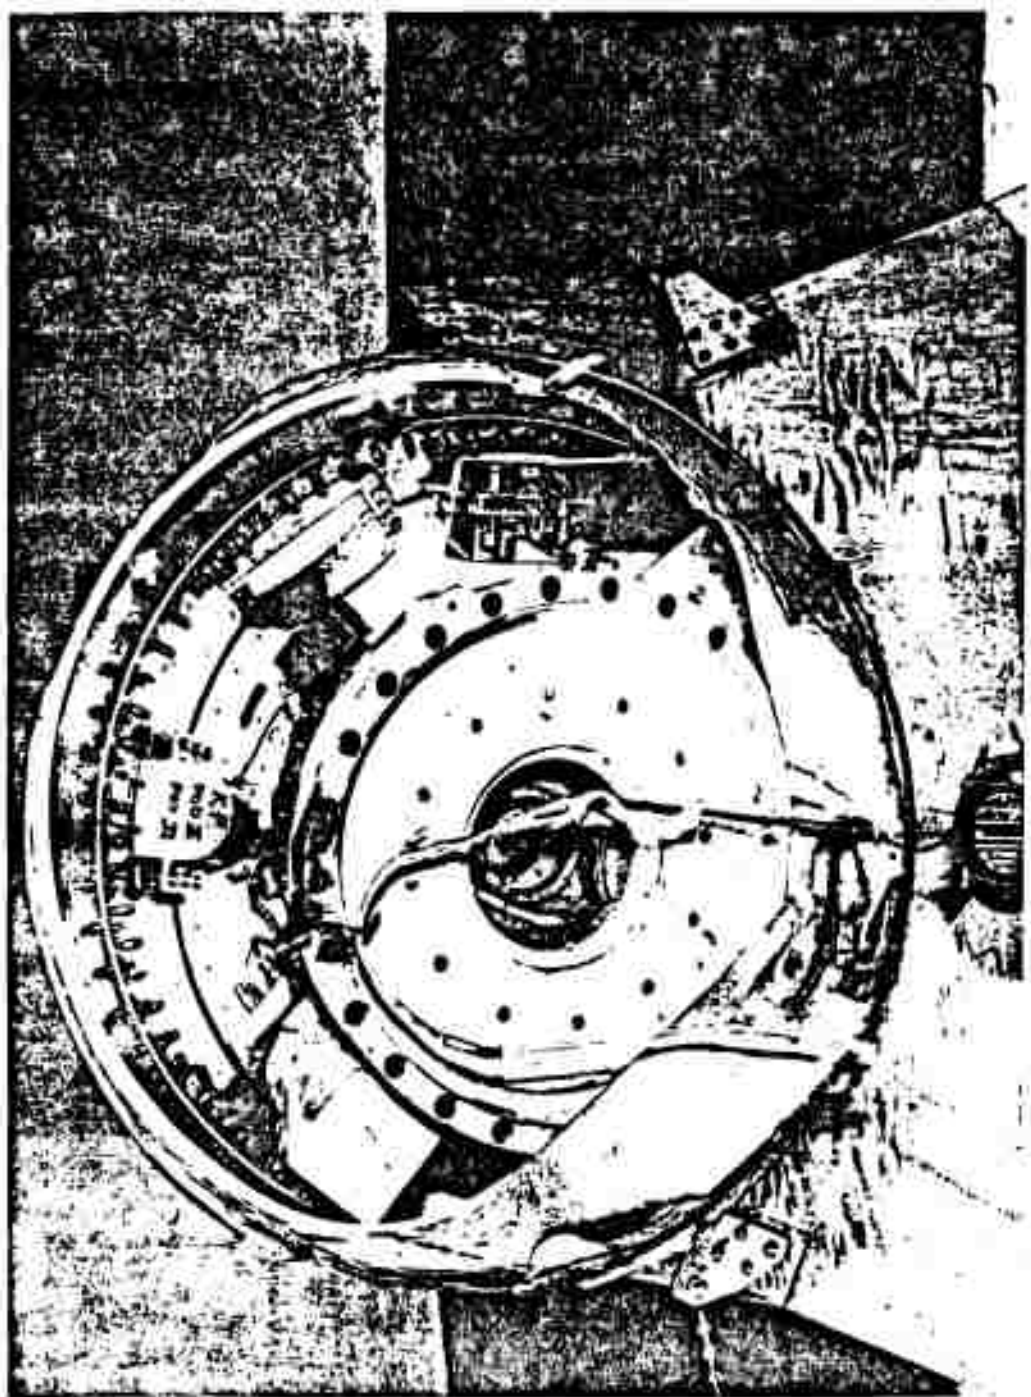
Figure 3.19 Pod K2 impact damage, mounts. (DASA 26-6871-62)
