ASD-TR-77-77

A-10 WINDSHIELD SPALL TESTS

TECHNICAL REPORT ASD-TR-77-77  
FINAL REPORT FOR PERIOD SEPTEMBER 1973-FEBRUARY 1978

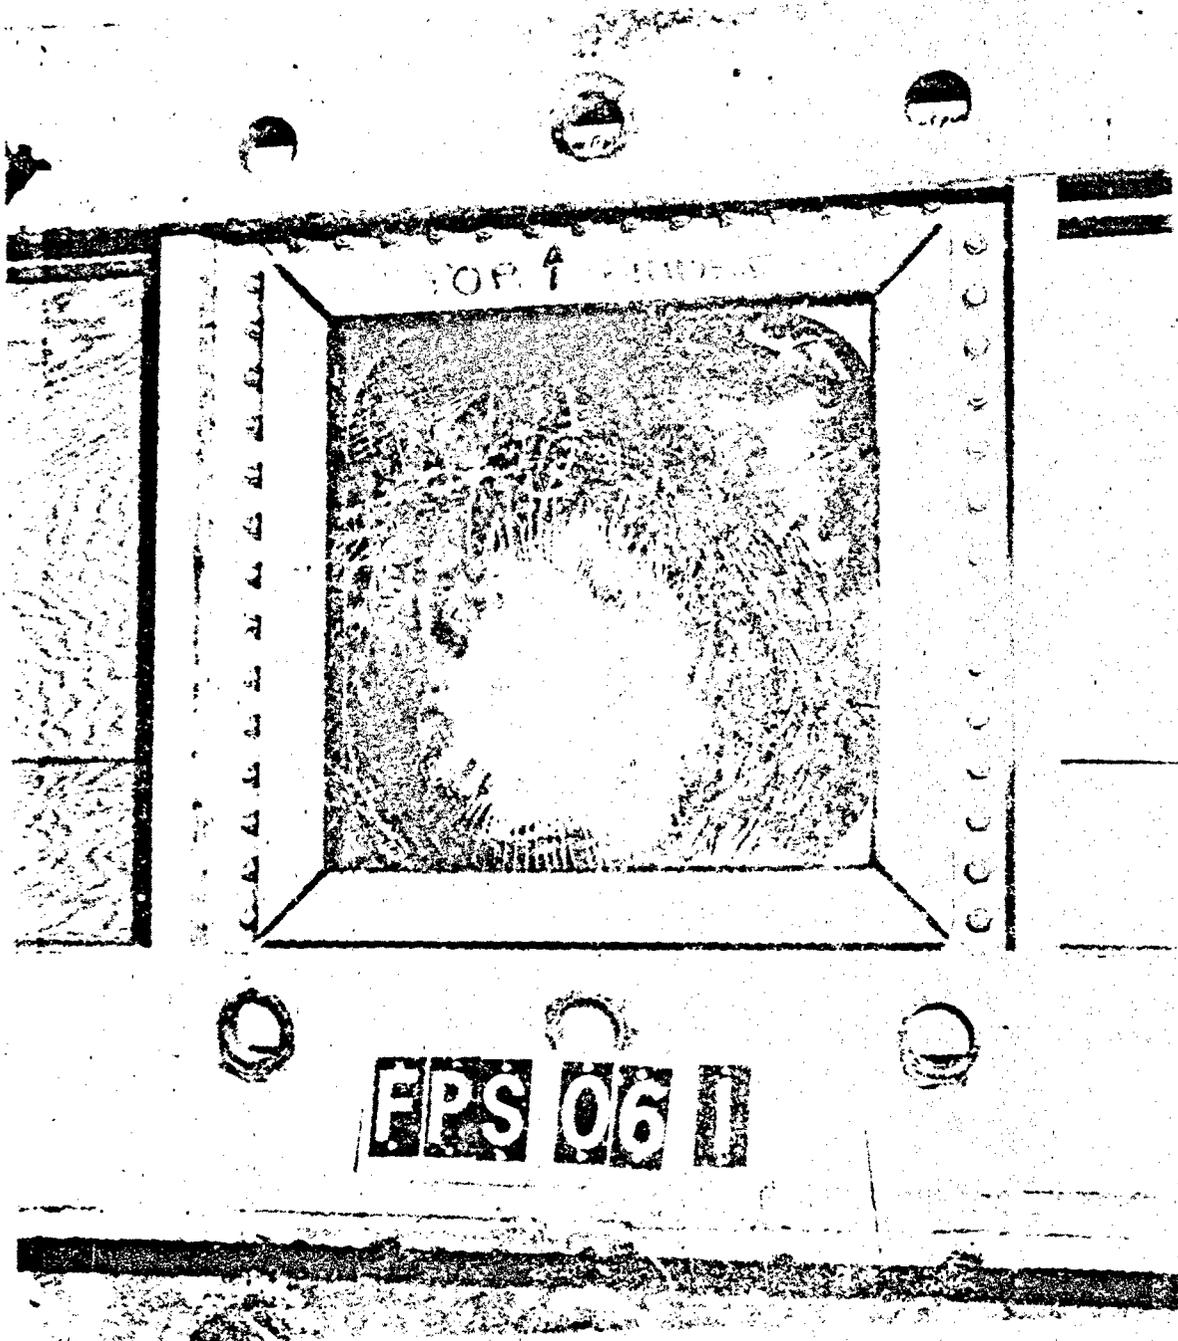
Figure 20. Poststrike Condition of Specimen FPS-06  
Shot No. 6, Type 1 Specimen

6 (FPS-06)	2147	None	3-1/4" x 2-1/2"	Good outside of impact area	Cracks emanate radially from a 3-1/2" crater containing the impact point at its center. These cracks terminate at a concentric crack.
