MTMC REPORT OA 81-4a-27

# ANALYSIS OF MTMC PARTICIPATION IN THE REFORGER 81 EXERCISE

MAY 1982

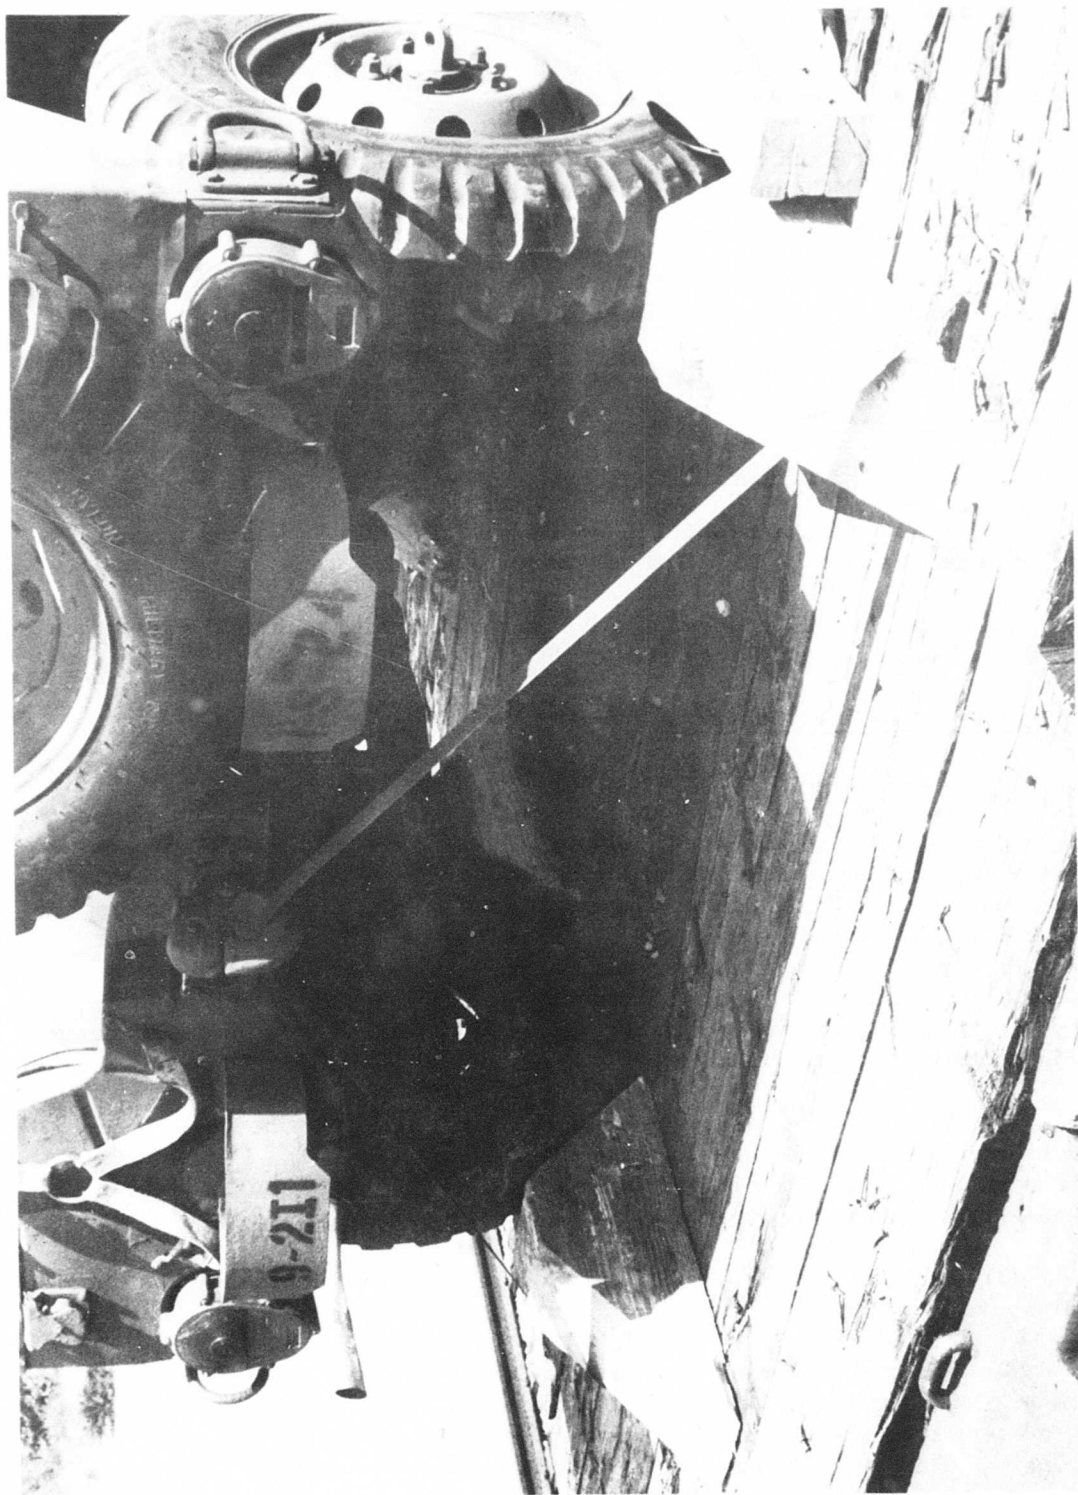
(2) Jeeps loaded on standard flatcars were secured with 1-inch banding (fig 4-2), in accordance with TM 55-2200-001-12, section 6, figure 49, item E; however, the banding was found to be broken upon arrival at the SPOE.

Figure 4-2. Jeep secured with 1-inch banding.

(c) Several 1-inch bands securing 1/4-ton vehicles onto the Fort Lewis train were broken in half, and a gamma goat had sustained damage to the tailgate and left side of cargo bed.

(3) Standard blocking and bracing methods using wire rope, instead of banding, be used to secure vehicles onto standard flatcars, and that TM 55-2200-001-12 be changed to reflect this recommendation.

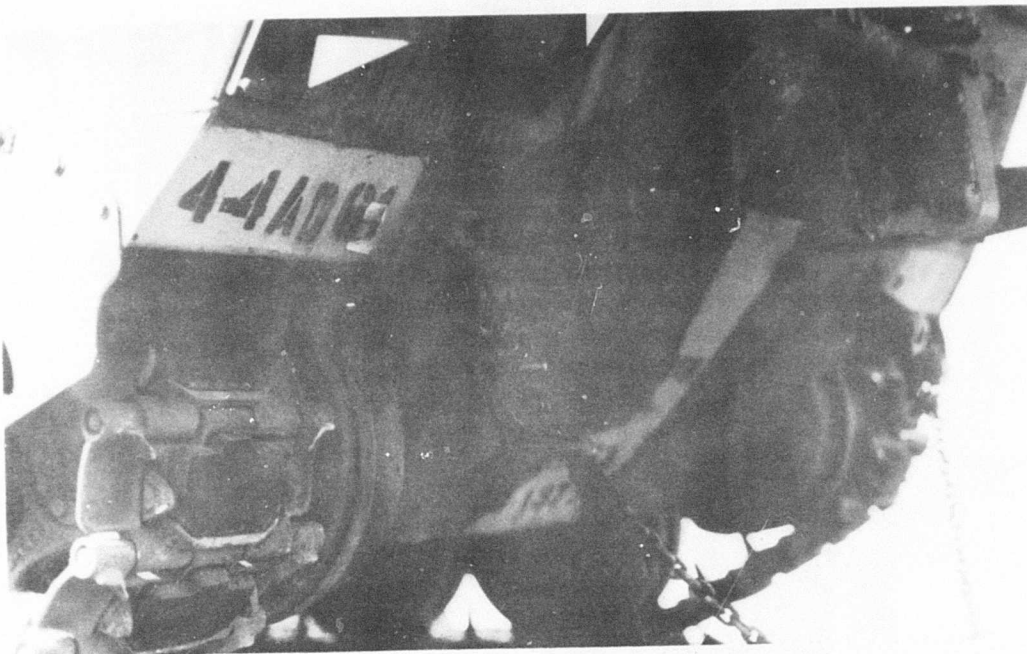
Figure 4-6. Vehicle fitted with "T" shackle instead of "U" shackle.

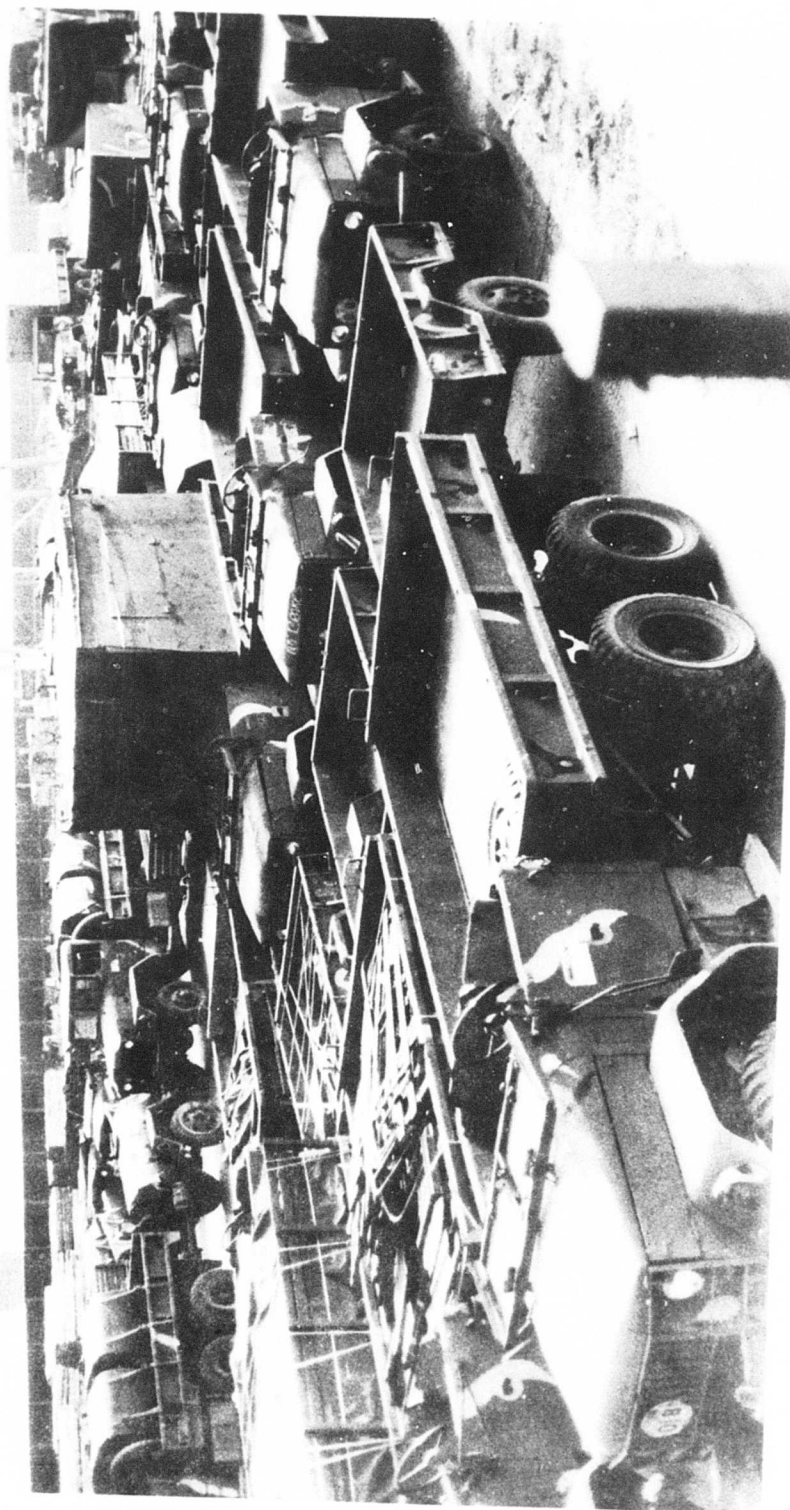
Figure 4-7. Vehicles with unused cargo space.

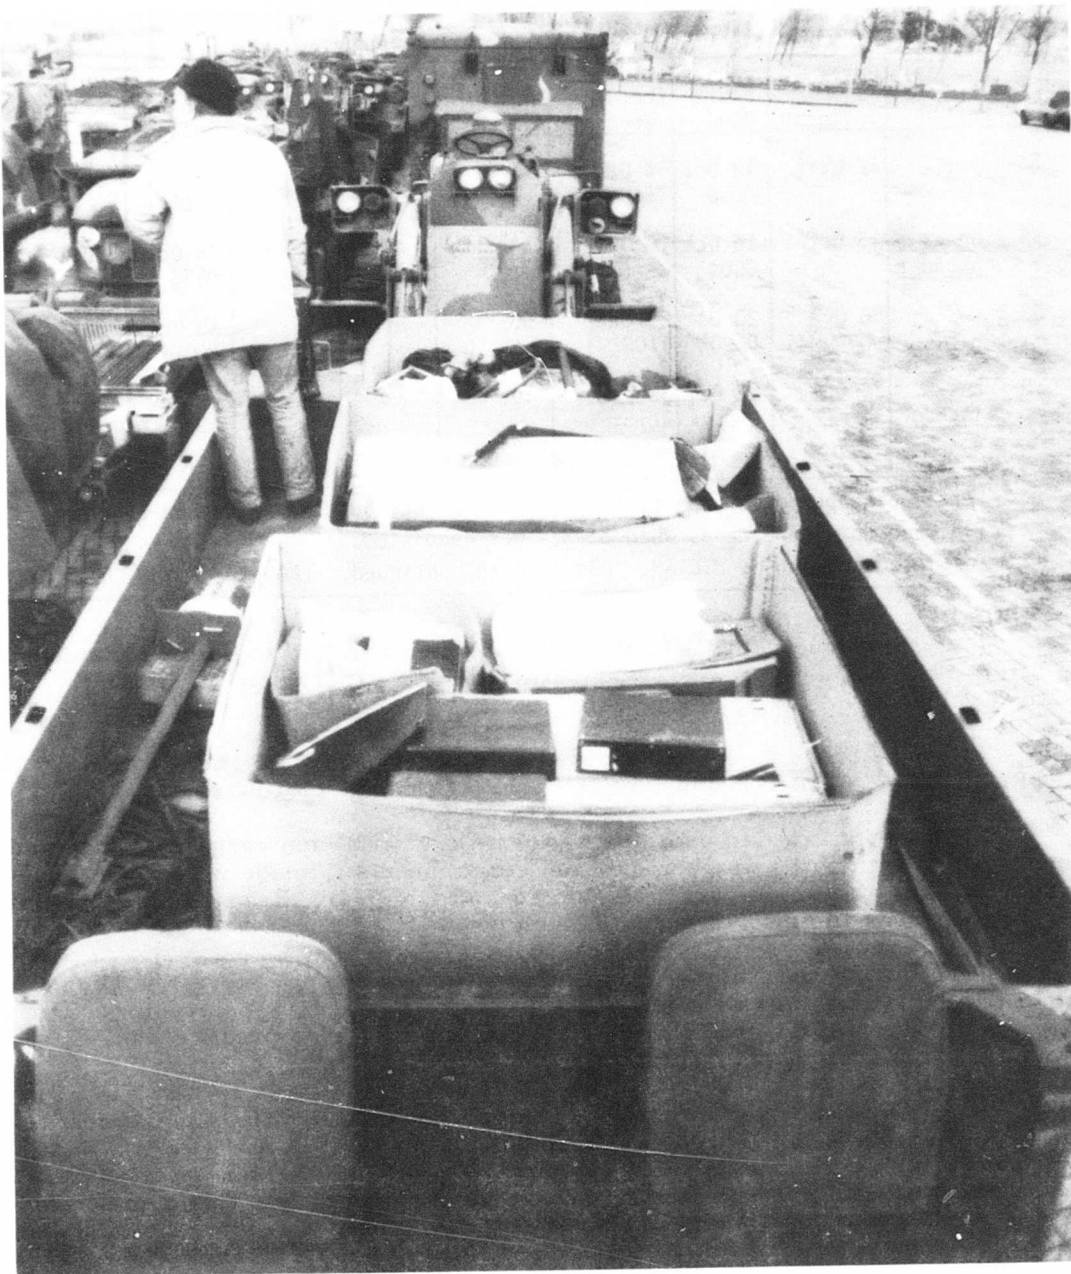
Figure 7-4. Cargo exposed to weather.

(1) Vehicles stored in staging areas over an extended period of time be started periodically to keep them in operating condition. Also, a plan be developed to check vehicles before being called forward from staging areas and to take corrective action there if needed.
