AFFDL-TM-73-136-FEE

**TEST EVALUATION OF THE
C-5A EMERGENCY OXYGEN
GENERATOR AS A POSSIBLE
CAUSATIVE AGENT OF FIRES**

EDWARD B. THOMPSON, JR

OCTOBER 1973

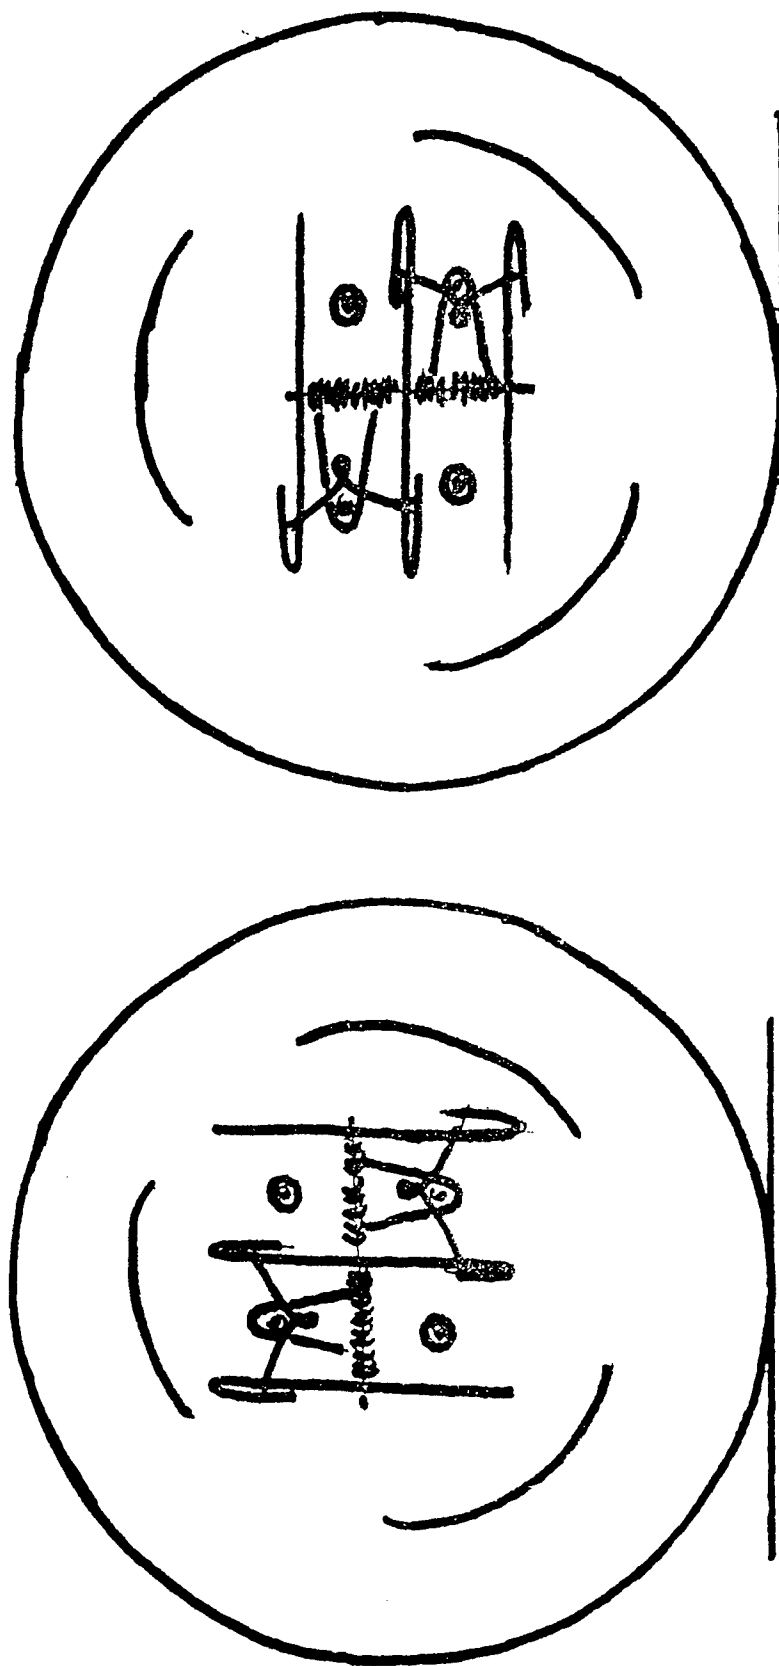
Test #1 - Two packaged generators were separately installed on a vibration table, each in a different plane as shown in the schematic in Figure 2. Vibration levels were simulated according to the following sequence:

FIGURE 2 - Generators Positioned for Vibration Test

Summarizing this test, the retaining springs which hold the Bouchon hammers in place and away from the ignition primers did not come loose regardless of the vibration load imposed. It was the qualitative opinion of the test monitor, Mr. Robert Sevy, that the generator(s) retaining springs could not accidentally dislodge when subjected to prolonged and random vibration levels.

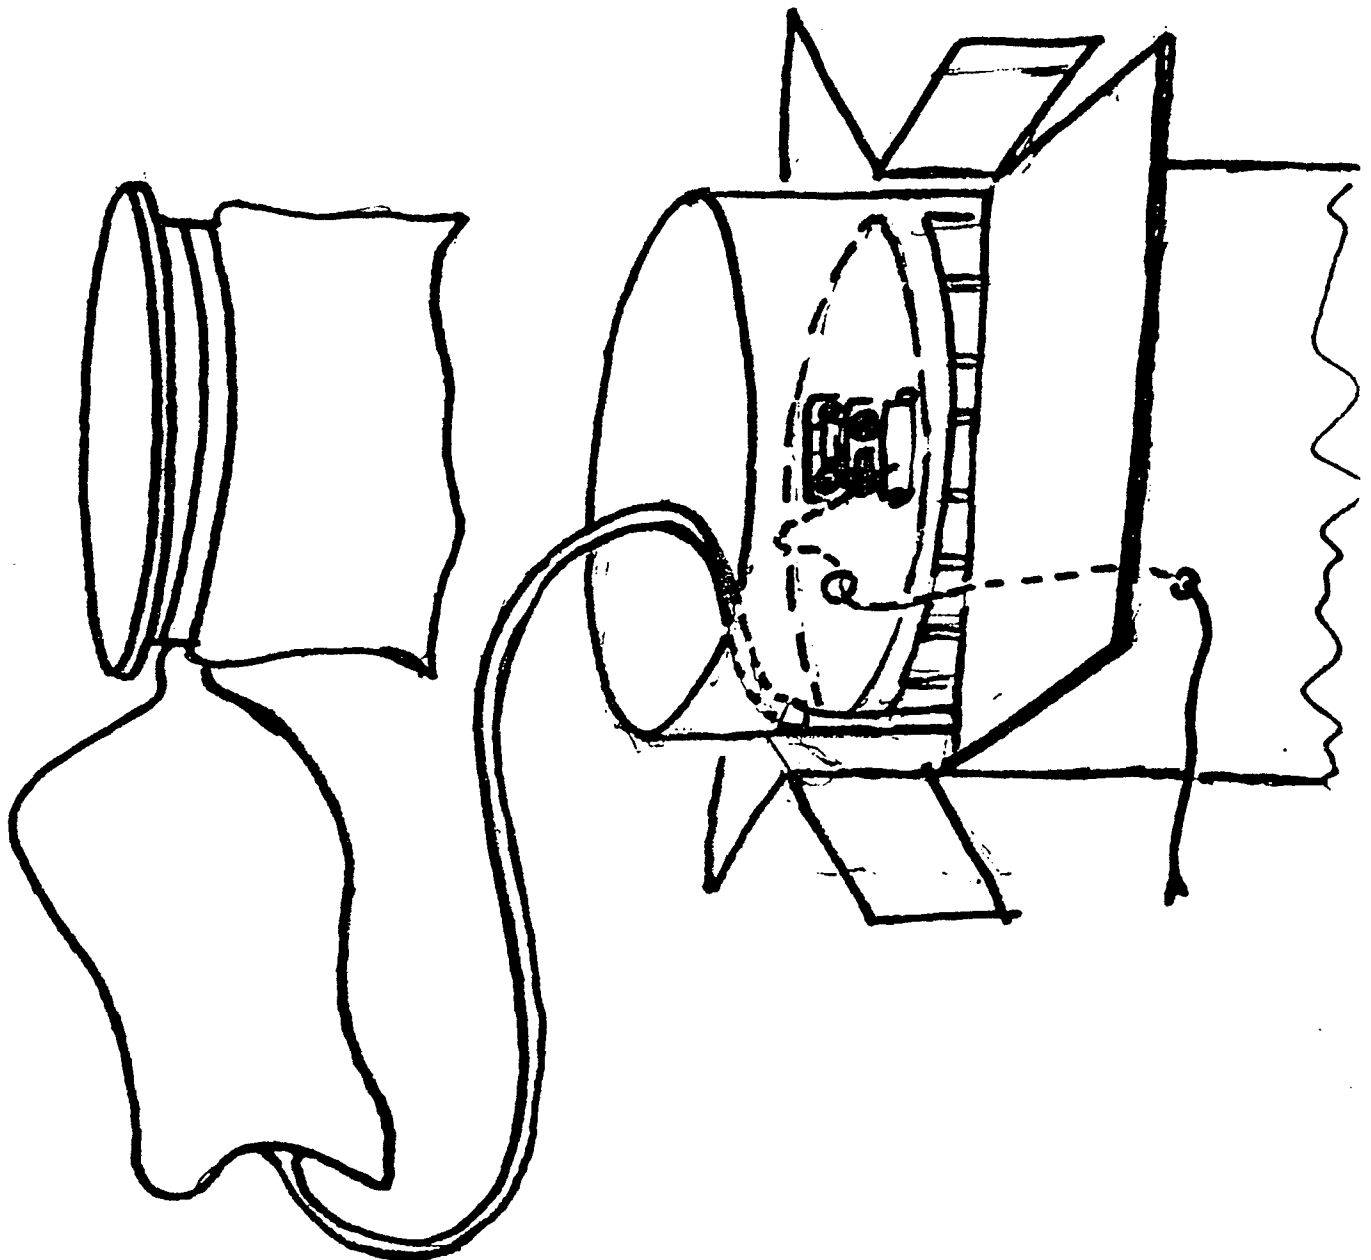
FIGURE 3 - "Malfunctioning" Generator Prepared for Test

Test #3 - A packaged generator was modified so that an igniter lanyard was drawn through the housing and packaging carton (Refer to Figure 3). The other primer was left undisturbed. The generator was then activated and allowed to operate thirty-four minutes until the candle was consumed. The carton did become warm to the touch throughout the test but did not burst into flames. Upon inspection afterwards, it was noted that part of the tygon hose leading from the housing to the mask had melted. (Figure 8).

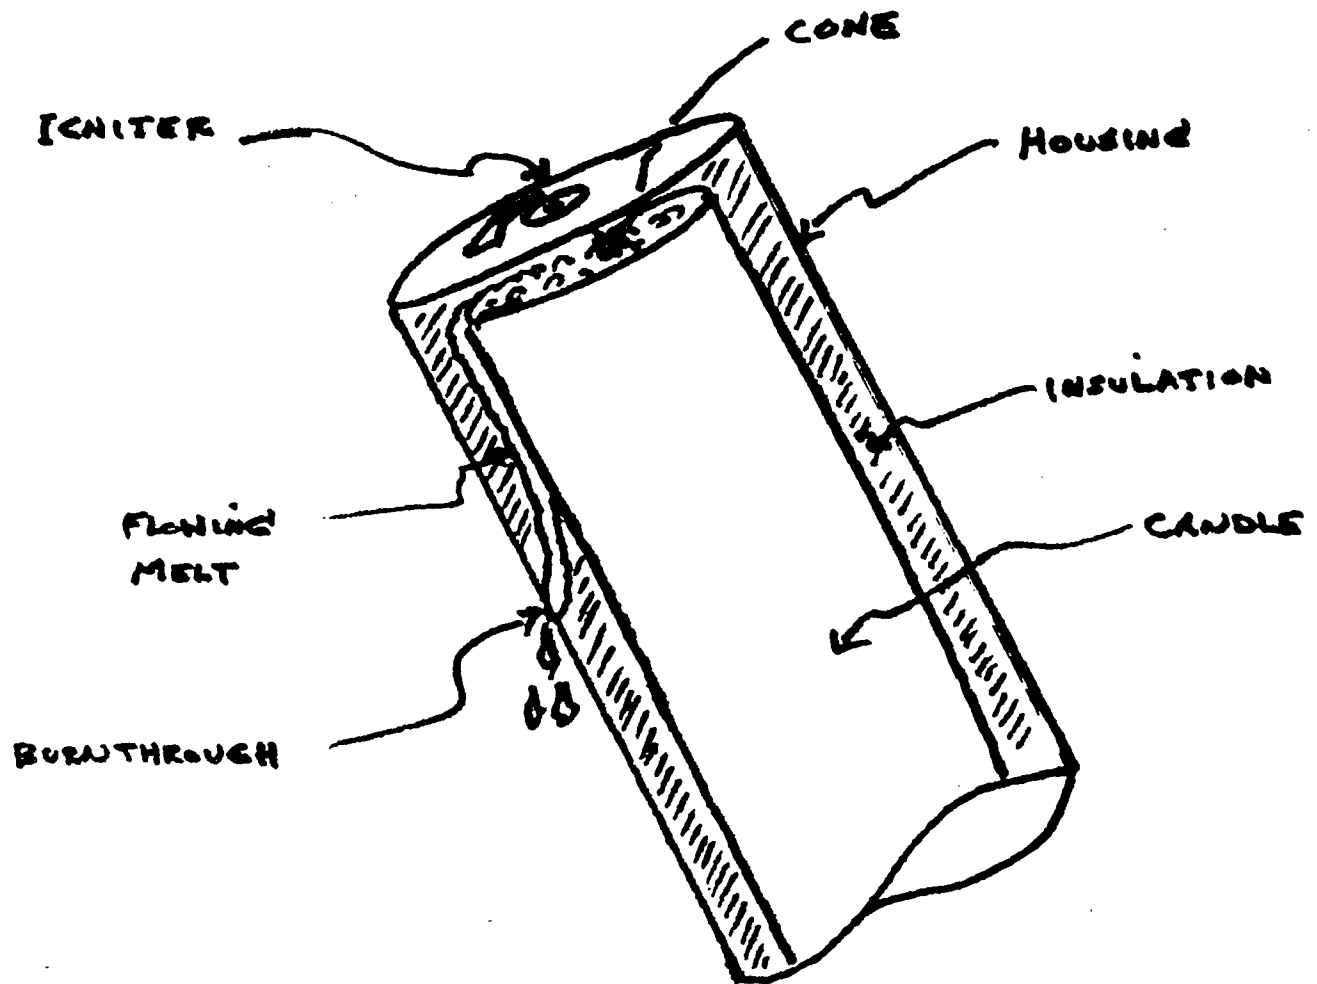
The second occurrence which would have had to happen would be a "burn-through" of the housing of the generator after it had accidentally ignited. A "burn-through" of the housing could (but not necessarily must) cause a fire in the generator or adjacent material. It is emphasized that a generator accidentally igniting under storage conditions and operating normally would not cause adjacent material to burn. Figure 19 is a cross-sectional schematic of a hypothetical chlorate candle which developed a burn-through at the housing. The drawing illustrates that it is possible for the molten candle material to flow out of the generator housing. While "burn-through" occurrences have developed in chlorate candle oxygen generators, there is no record of any such case with the C-5A unit. Furthermore, the internal configuration of the C-5A unit is so designed as to prevent a "burn-through" from occurring.

FIGURE 19 Chlorate Candle Housing "Burn-Through"
