TECHNICAL NOTES

No. 842

TIDEWATER AND WEATHER-EXPOSURE TESTS ON METALS

By Willard Hutchler and W. G. Galvin
National Bureau of Standards

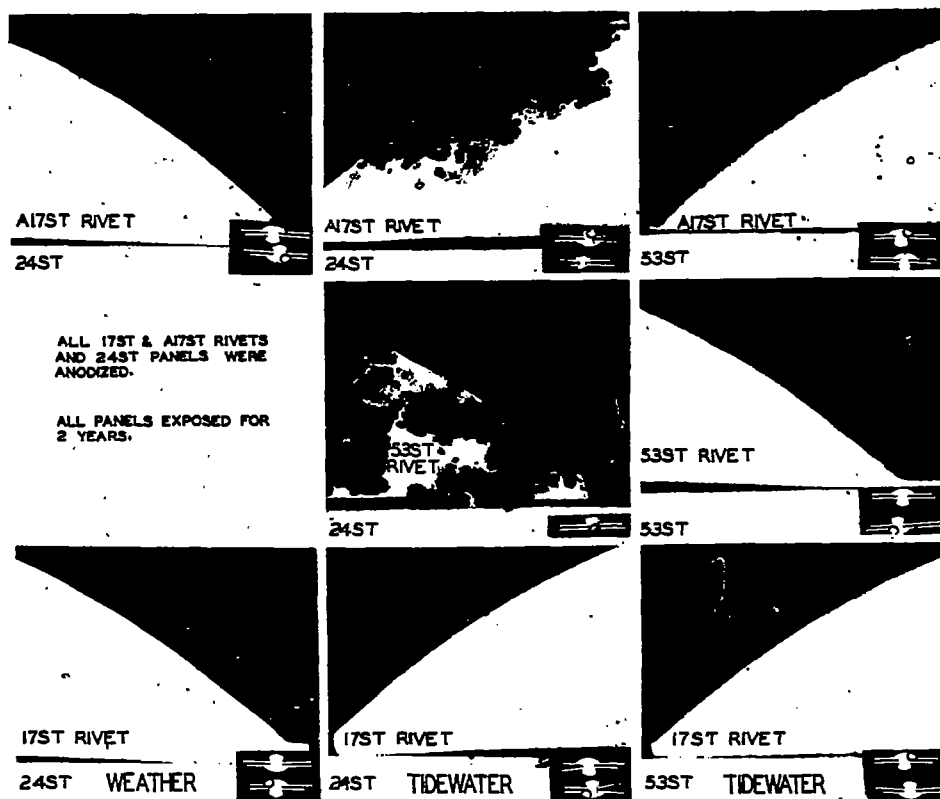
The microscopic examinations confirmed the practical absence of corrosive attack on either the rivets or the sheets where any of the three kinds of rivet were used to join Alclad 24ST, 52S- $\frac{1}{2}$ H, or 53ST (fig. 4) sheet. Such corrosion as occurred seldom exceeded 0.002 inch in depth and was of the pitting type on all the alloys.

Figure 4.- Corrosion on rivet heads and 53ST and anodized 24ST sheets. Attack was especially severe on 53ST and anodized Al7ST rivets joined to 24ST sheet and exposed to tidewater. Photomicrographs, x 25; cross sections (in black rectangles), x 1/2.

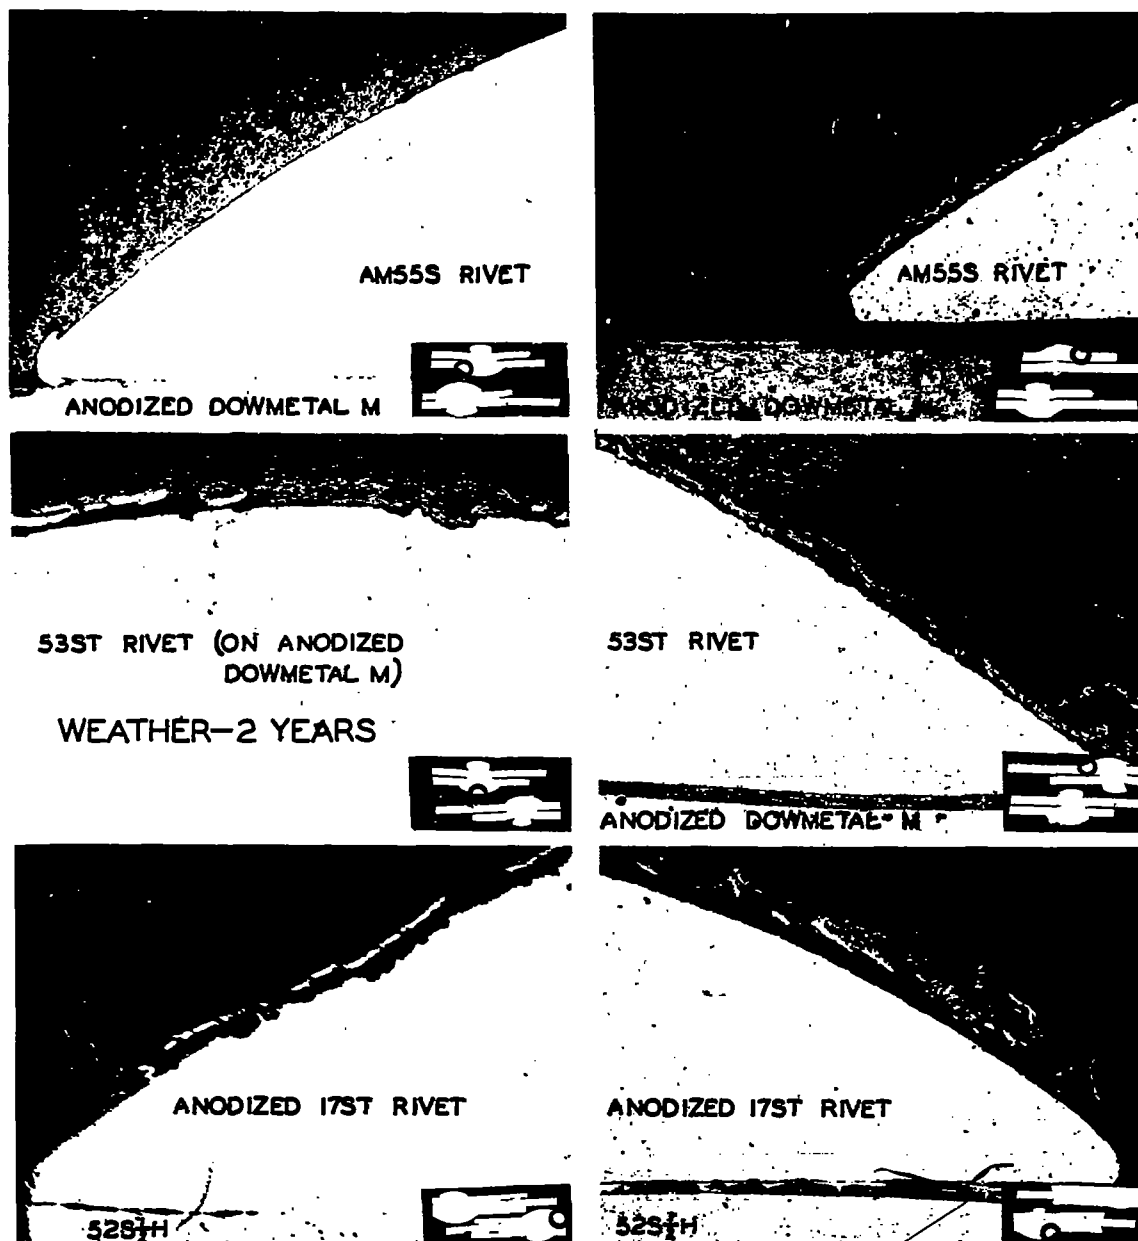
Figure 8.- Corrosion on rivets used for joining Dowmetal M sheets. Attack was least on the unanodized AM55S, intermediate on the 53ST, and most on the anodized 17ST rivets on unpainted panels. None of the rivets on painted panels were corroded. Micrographs, x 40; cross-sections, x 1.

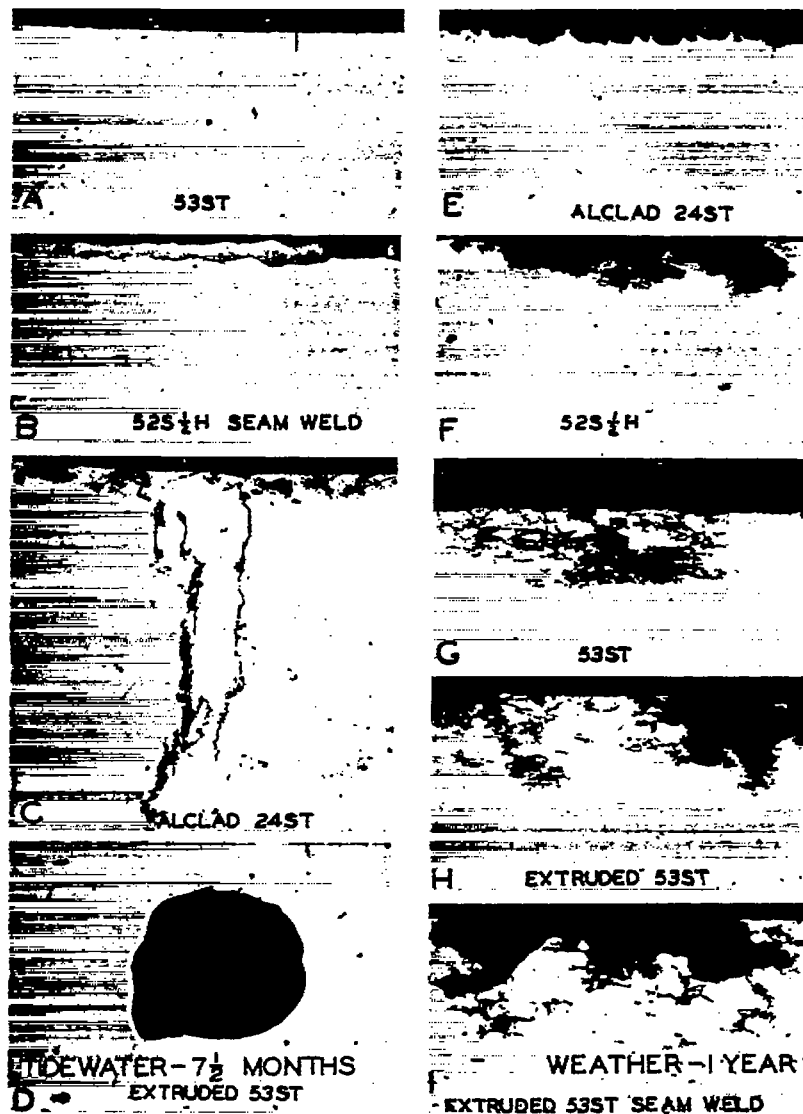
The seam welds were uniformly sound, but cracks occurred on some of the Alclad 24ST spot welds (fig. 13); whereas very small cavities, 0.001 inch in diameter, were present on a few of the 52S- $\frac{1}{2}$ H welds and cavities as wide as 0.010 inch were found in several of the welds on extruded 53ST panels. Numerous cavities, ranging from 0.005 to 0.010 inch in diameter, were found in the gas welds.

Figure 13.- Photomicrographs of welds on aluminum-alloy panels exposed to weather or to tidewater. Spot welds are pictured, unless otherwise noted. A - Formative stage of intercrystalline corrosion. B - Coating on weld, perhaps resulting from reaction with the electrode. C - Cracks present in some of the spot welds in this alloy. D - Cavity, representative of those of average size found in some spot or gas welds. E - Pitting, though general, had not penetrated the aluminum protective coating during the first year. F - Traces of intercrystalline attack were occasionally associated with pits on the 52S- $\frac{1}{2}$ H alloy. G - Intercrystalline corrosion on an area of the sheet remote from a weld. H and I - Intercrystalline corrosion on welds. x 60.

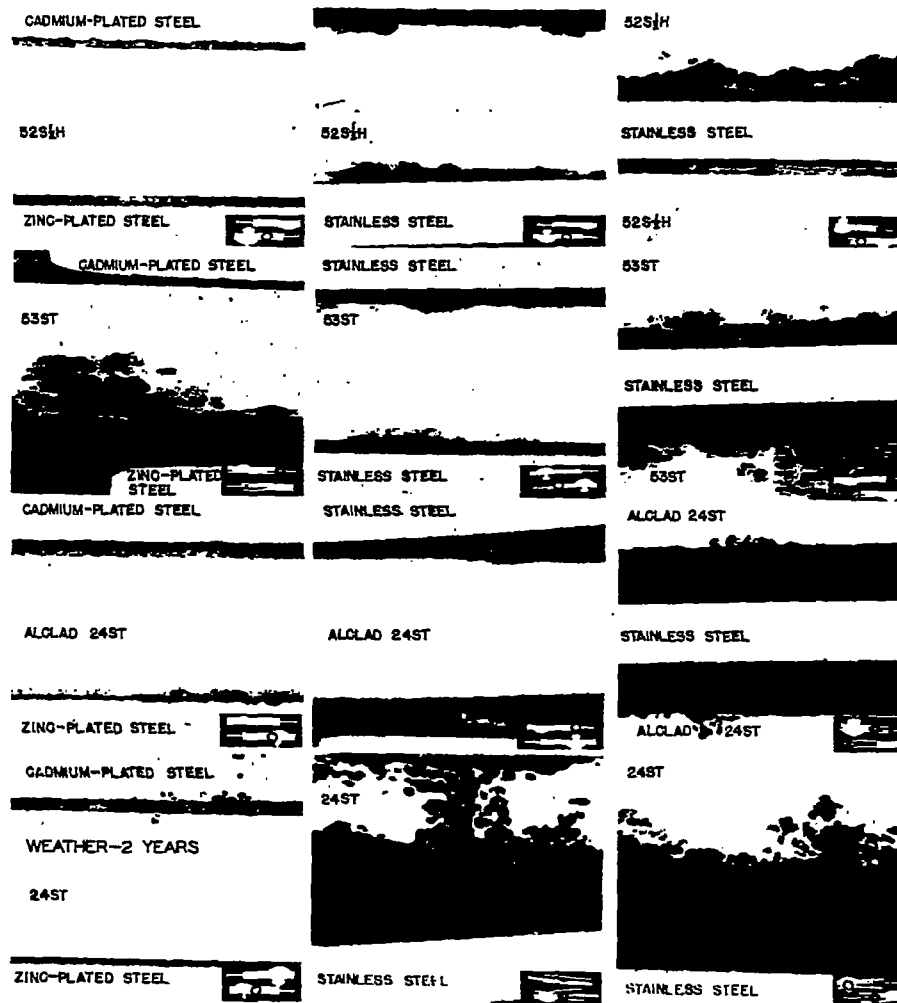
Figure 19.- Cross section showing aluminum alloys exposed to the weather in contact with electrodeposited coatings of cadmium and zinc or with stainless steel. Attack at the faying surfaces was usually deepest on the main panel at areas near the edges of the strips, especially when corrosion products were present in quantity. Photomicrographs, x 25; smaller cross sections, x 1/2.

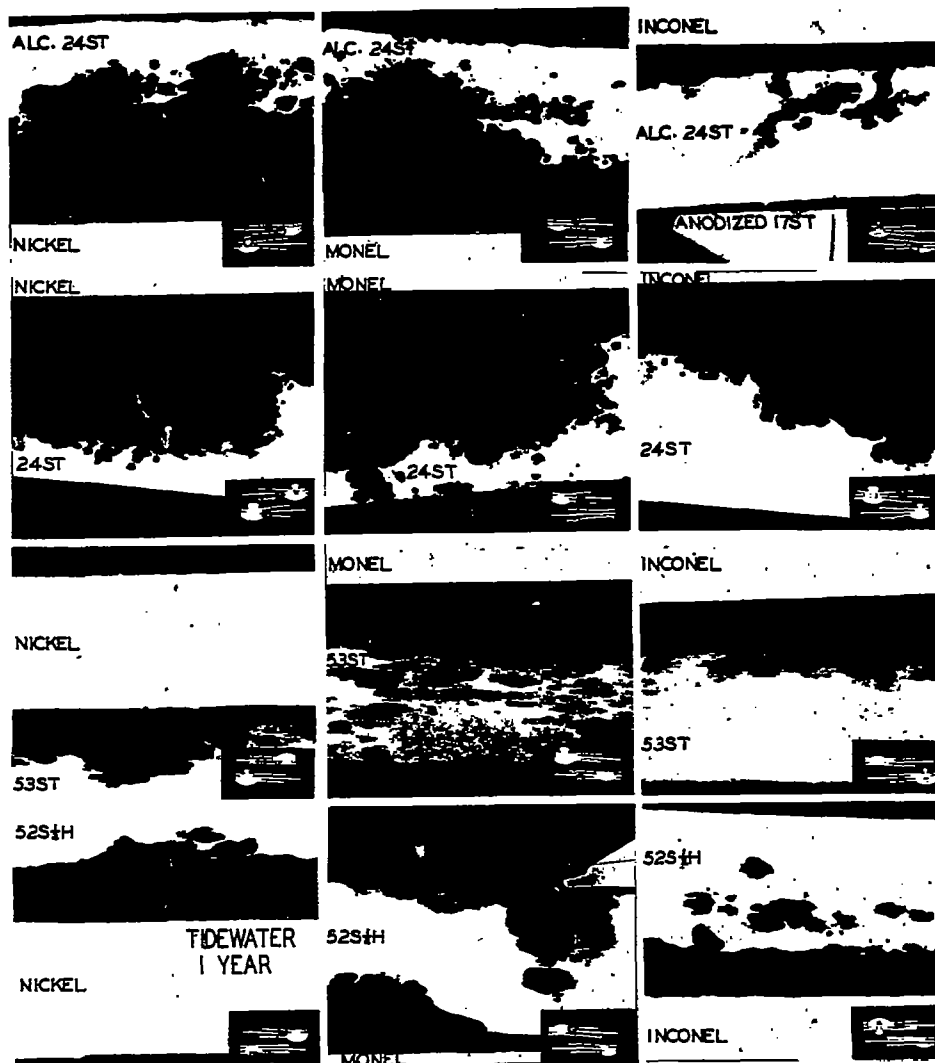
Contacts of aluminum alloys with nickel alloys.-- The aluminum alloys formed the 1- by 4-inch strips attached to main panels of nickel, monel metal, or Inconel. Microscopic examinations of the panels exposed for 1 year to tidewater (fig. 20 and table II) indicated that the aluminum alloys were probably more anodic to the nickel alloys than to the stainless steels. Monel-aluminum alloy couples resulted in the worst corrosion on aluminum, but the corrosion was sufficiently severe with all these combinations to indicate that coupling with these nickel alloys should be avoided. Cracks resulting from the combined action of stresses and corrosion were found on all strips of 24ST and Alclad 24ST in contact with these alloys.

Figure 20.- Cross sections showing nickel alloy panels exposed to tide-
water in contact with aluminum alloys. Attack on the alum-
inum alloys was very severe in every instance. Note the stress-corro-
sion cracking on the Alclad 24ST strips joined to Inconel (upper right
corner). Photomicrographs, x 25; smaller cross sections, x 1/2 (17).

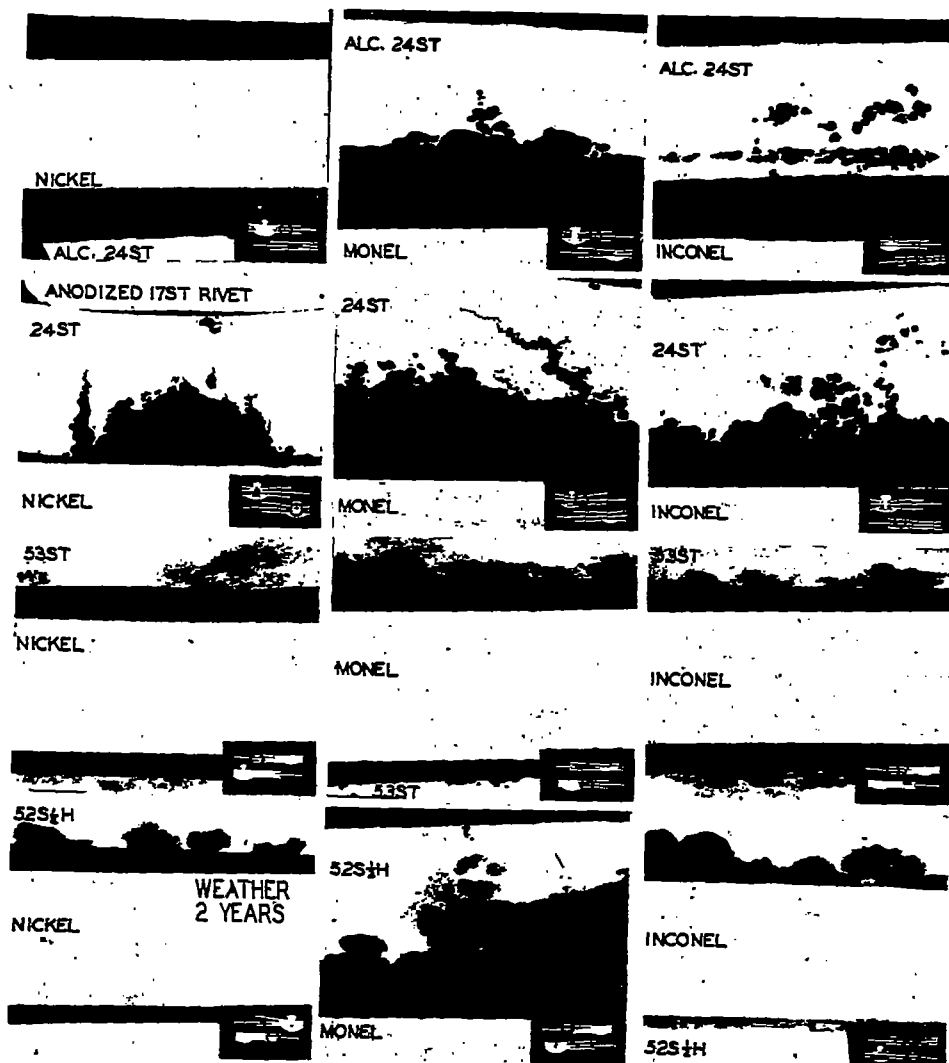
Figure 22.- Cross section showing nickel alloy panels exposed to the weather in contact with aluminum alloys. Compare with Figure 20. Note cracks on 24ST strips in contact with nickel and monel metal. Photomicrographs, x 25; small cross section, x 1/2.

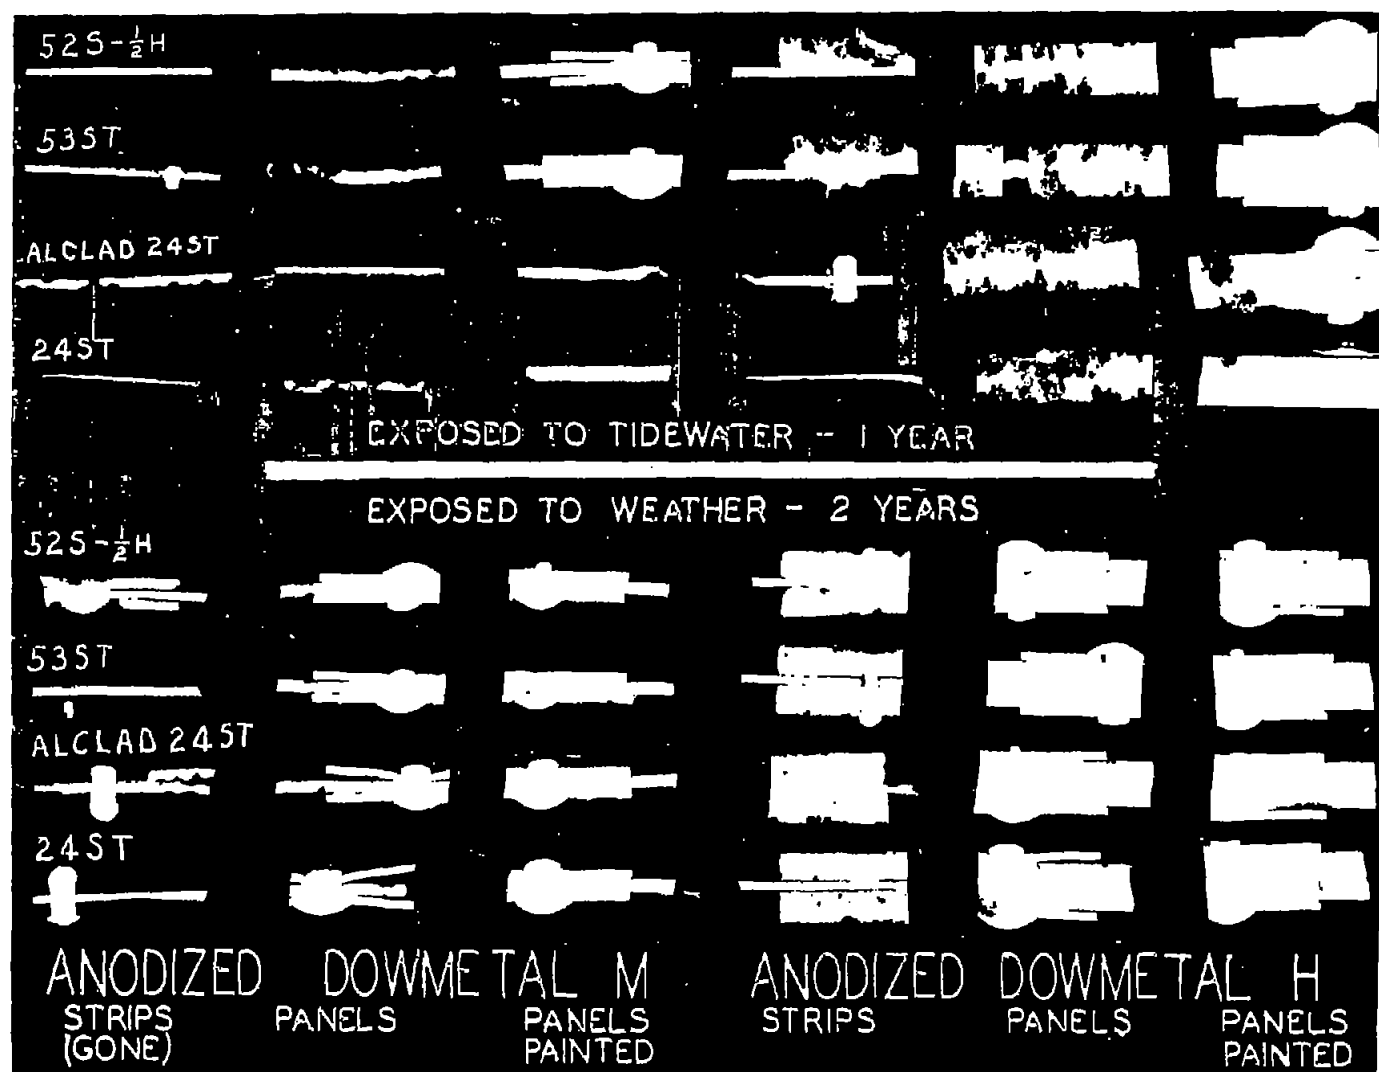
posed to the weather (fig. 23), but the painted panels were in relatively good condition after 2 years (figs. 23, 24, and 25). The panels were painted with 1 coat of Watson Standard Dowmetal Primer No. 1 plus 3 coats of Brooklyn Varnish No. 74 pigmented with $1\frac{1}{2}$ pounds of aluminum paste per gallon. The photographs illustrate that corrosion was much less severe where Dowmetal H, instead of Dowmetal N, was coupled with the aluminum alloys.

Figure 23.- Cross sections showing aluminum alloys exposed to tidewater and to the weather in contact with magnesium alloys. The magnesium alloys were the strips attached to larger areas of aluminum alloys in the first and fourth vertical columns; in the other vertical columns the aluminum alloys were the strips. Panels in the tidewater tests were in advanced stages of disintegration, except when painted. Unpainted panels with Dowmetal M strips were also severely attacked in the weather. x 1 (18).

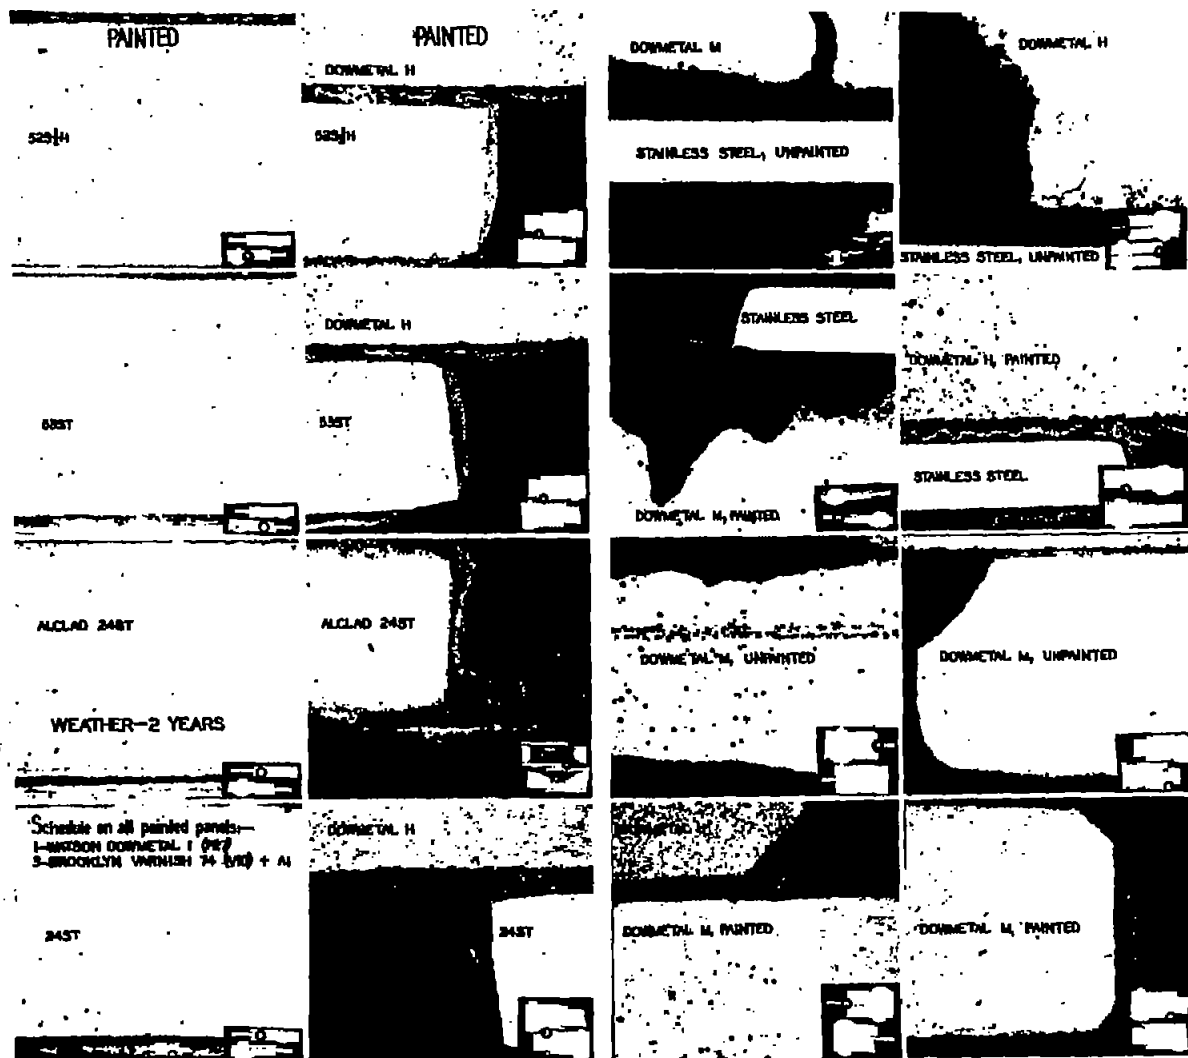
Figure 25.- Cross sections of panels exposed to the weather with magnesium alloys in contact with each other, with aluminum alloys, or with stainless steel. Painting was effective in preventing electrolytic reactions at the flaying surfaces except near the edges of Alclad 24ST, 24ST, and stainless-steel strips. Severe corrosion was present on corresponding unpainted panels. Photomicrographs, x 25; smaller cross sections, x 1/2.

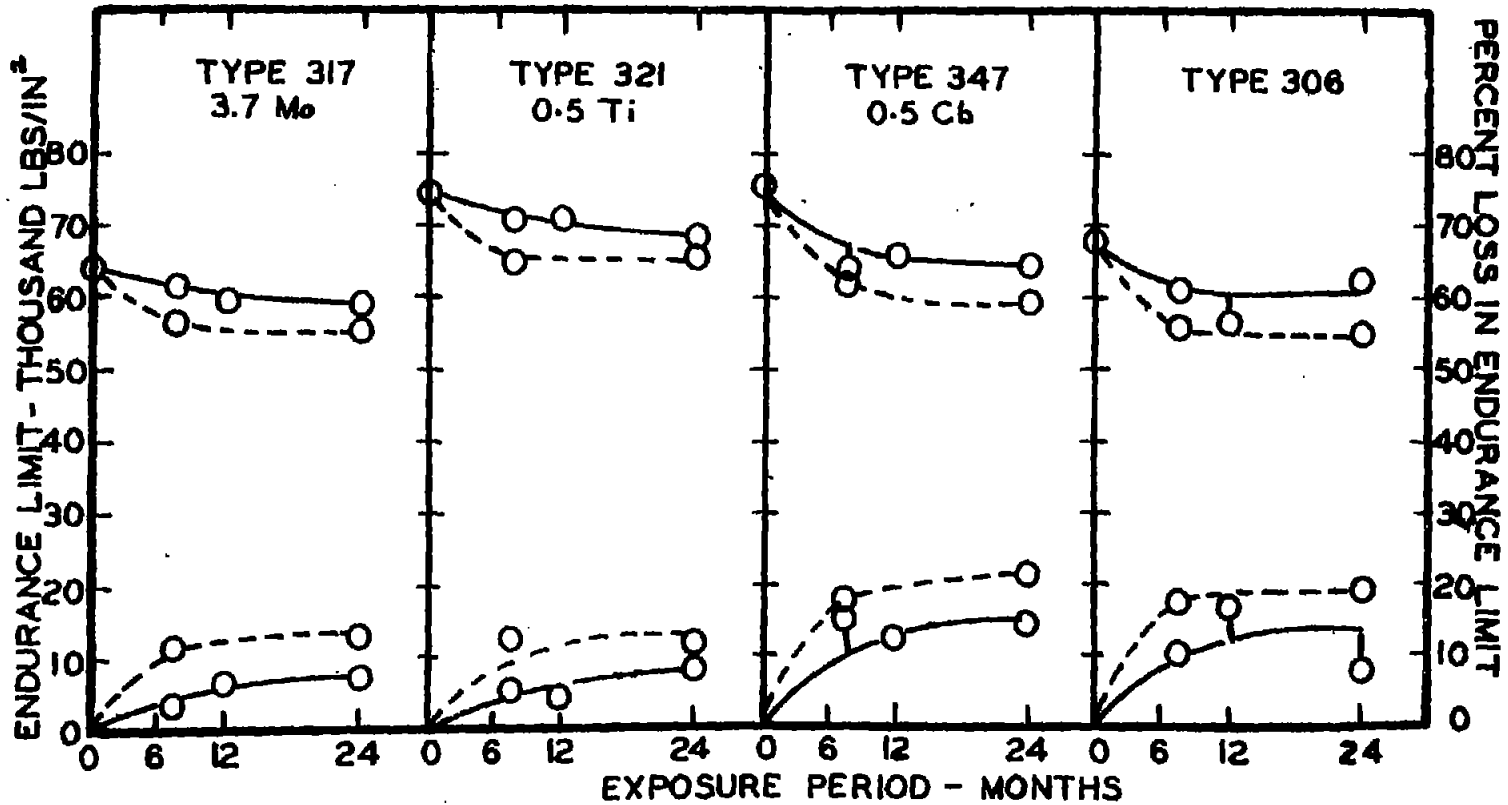
Figure 32.- Results of flexural fatigue tests on stainless steel. Solid line curves pertain to specimens exposed to tidewater; broken-line curves pertain to specimens exposed to the weather. The upper curves, in each instance, refer to values for endurance limits; the lower curves to percentage loss. Panels exposed to the weather consistently showed greater loss than those exposed to tidewater for equal periods. Steels containing molybdenum or titanium exhibited appreciably lower losses than those with columbium, or with no elements added to the typical 18 percent chromium, 8 percent nickel alloy (Type 306).
