# WARTIME REPORT

ORIGINALLY ISSUED  
February 1945 as  
Advance Restricted Report E5B07

EFFECT OF PROGRESSIVE RING FAILURE ON PISTON DESTRUCTION

By Max J. Tauschek and Lester C. Corrington

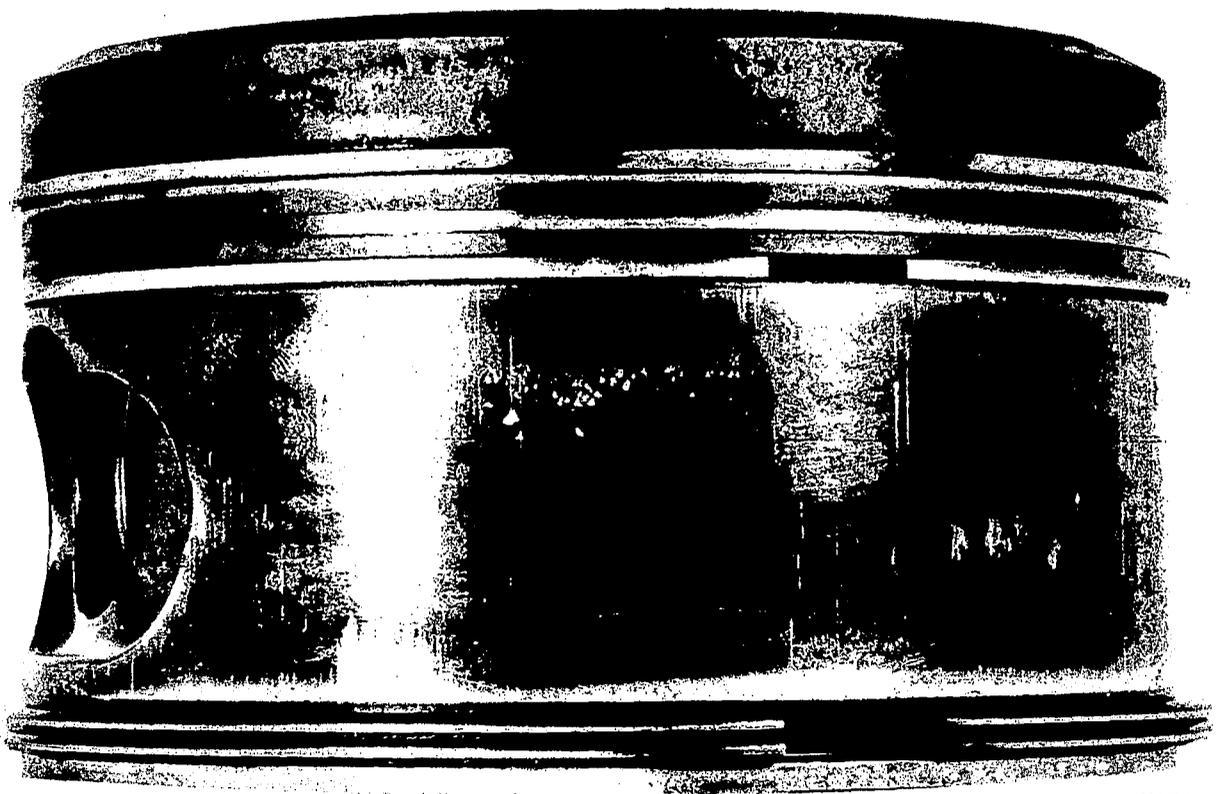
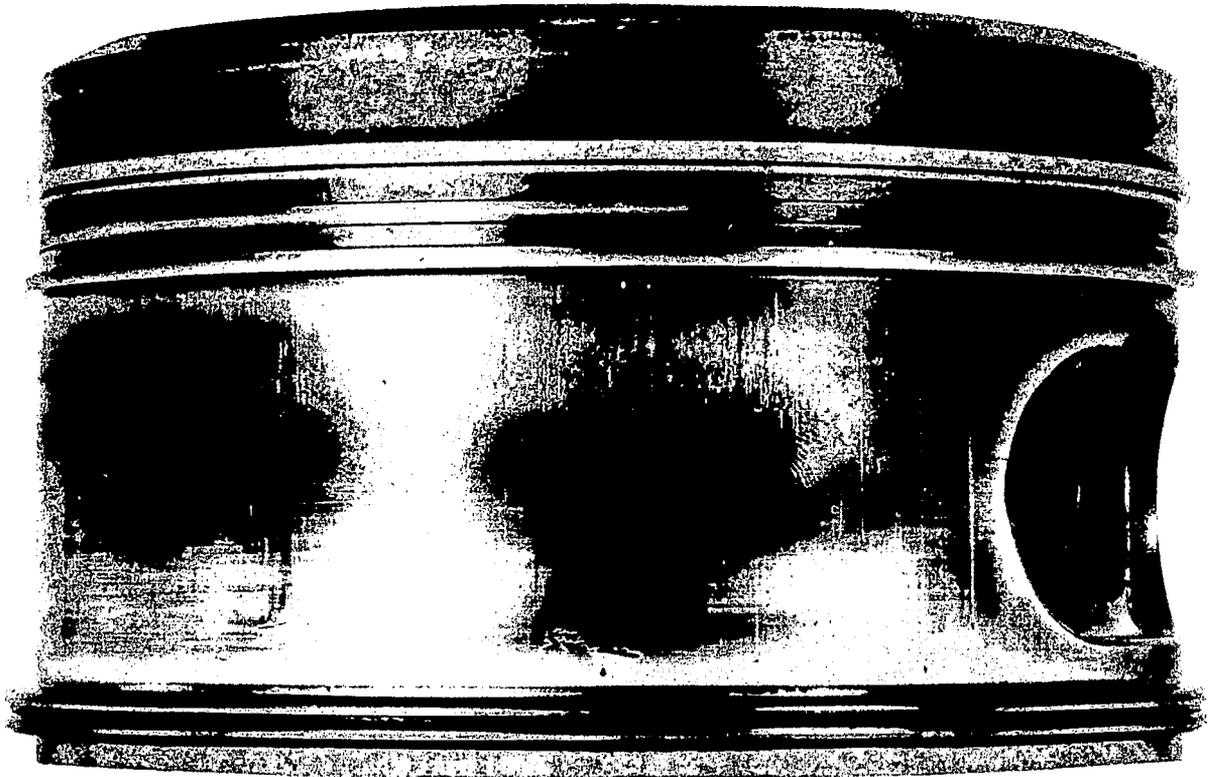
NACA  
C-2846

The piston used in the first test had previously been used to obtain preignition data in connection with another project. These tests comprised about 15 hours running time. The severe operating conditions encountered in the preignition tests resulted in breaking of the top ring and sticking of the second ring. Figure 1 shows the piston prior to installation in the cylinder at the beginning of the endurance test. A clean used piston equipped with new piston rings was used for the second test.

*Figure 1. - Piston and ring assembly just before the first endurance test. Failure of top and second rings has taken place.*

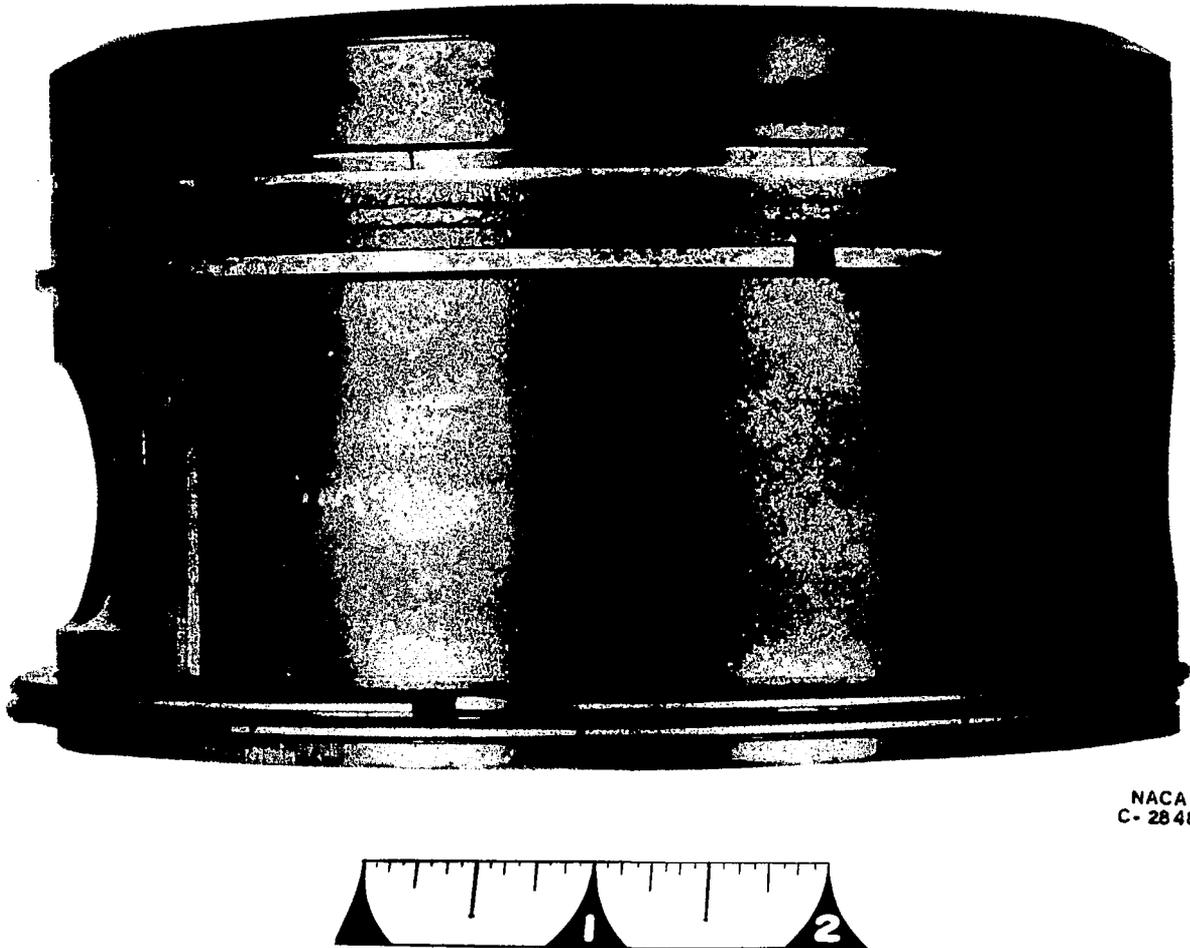
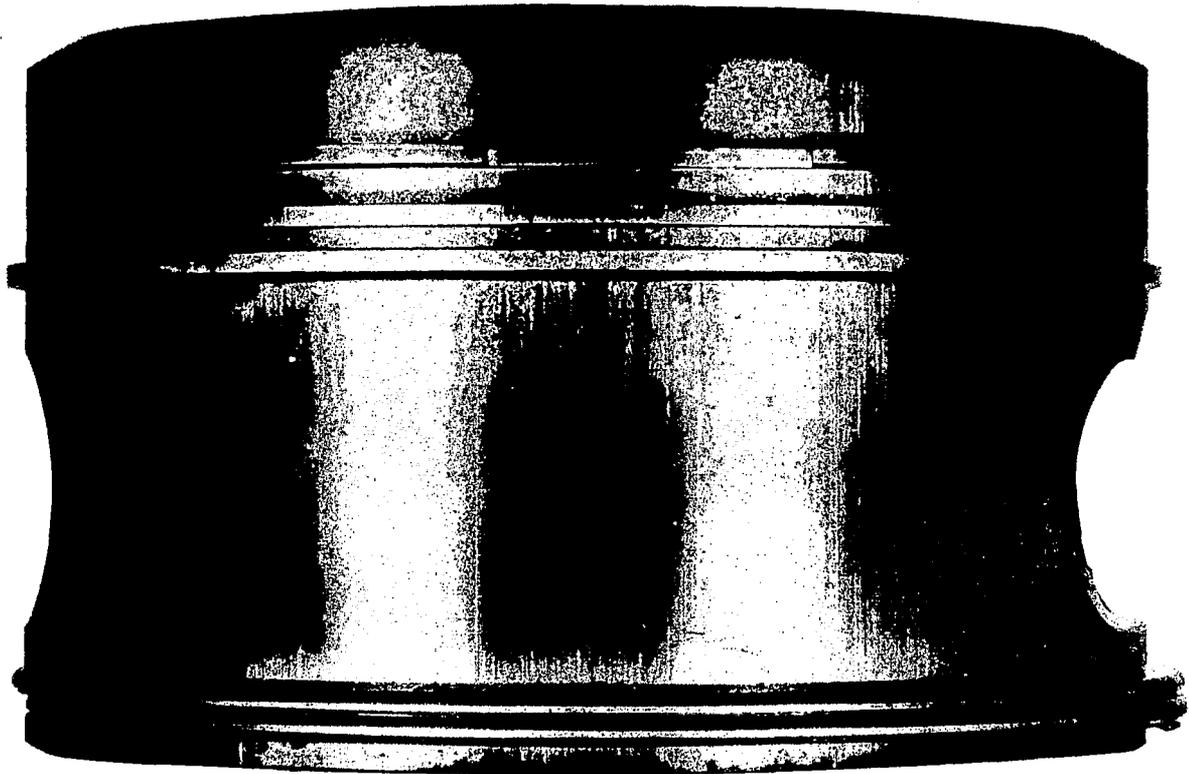
NACA  
C-2848

At the end of 7.5 hours the piston was removed for inspection. By this time complete failure of the compression rings had taken place but the oil rings were still in reasonably good condition (fig. 2). The piston and ring assembly was reinstalled and the test continued. After an additional 10.6 hours, the inlet-air pressure was increased to determine the power level at which immediate and complete piston failure would take place. This failure occurred at an inlet-air pressure of 68 inches of mercury absolute with the results shown in figure 3. The total test time was 33.1 hours including the preignition tests conducted previous to the endurance run.

time of the inspection when all the compression rings had failed (fig. 2), which suggests that the oil-control rings had a considerable effect in sealing the combustion chamber.

*Figure 2. - Piston and ring assembly after 7.5 hours of first endurance test. All compression rings have failed.*

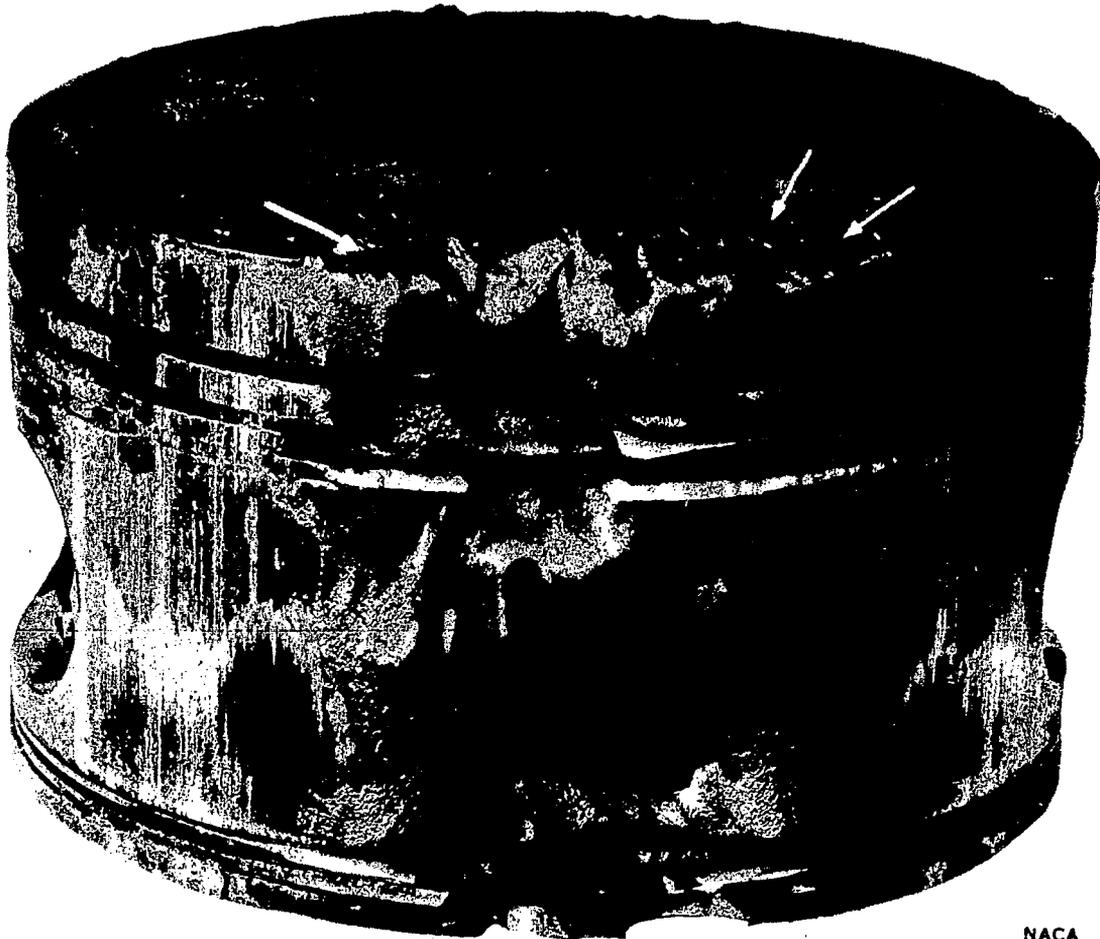
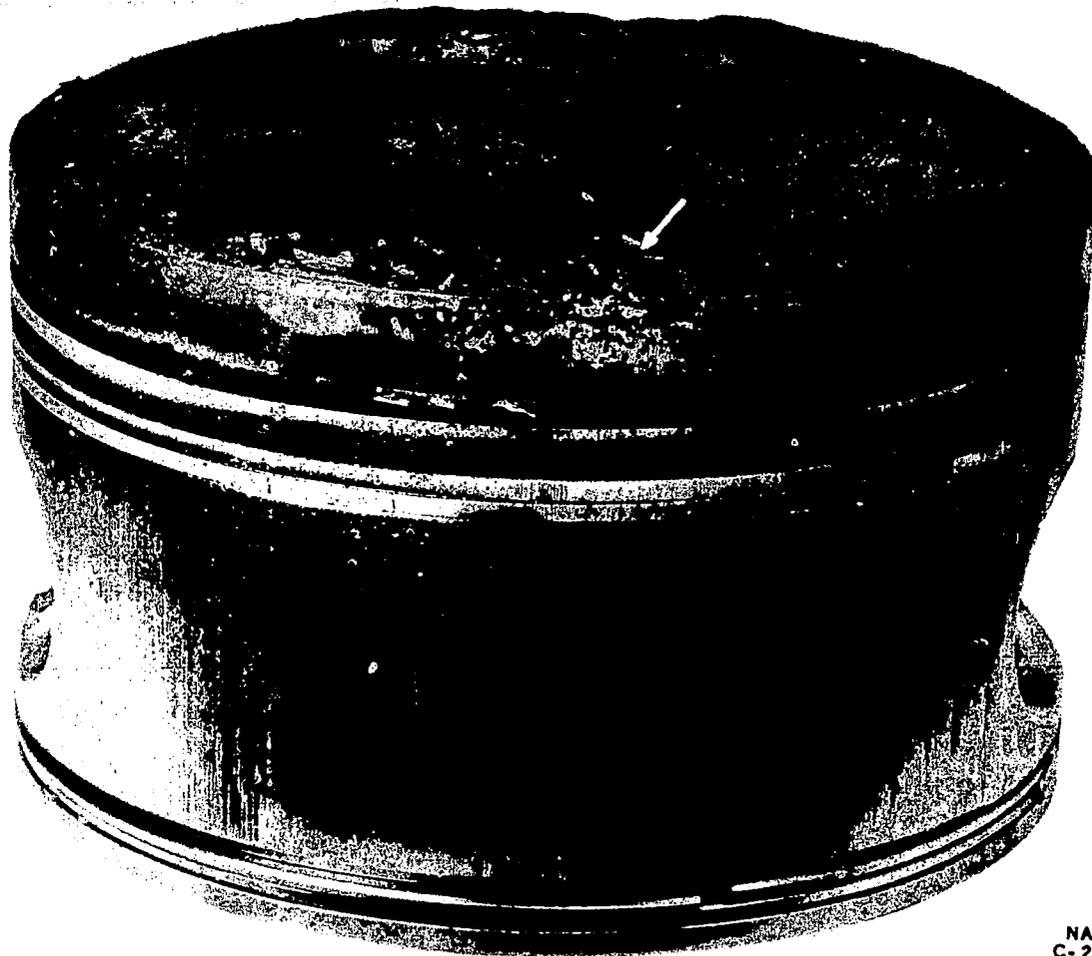
NACA  
C-2857

Analysis of failed piston. - Figure 3 shows the piston and ring assembly after the final failure of the first test. A wide deep channel has been burned down the entire length of the piston and a hole has been made through the piston skirt above the oil rings. This damage was confined to the minor thrust face of the piston; the major thrust face remained comparatively unharmed.

The ultimate failure was most likely caused by the action of high-temperature gases against the side of the piston, probably taking place over a relatively long period of time. Figure 7 shows the ring belt of a piston that had been operated under severe conditions in another test program. The large flow of high-temperature gases resulting from compression-ring failure has begun an erosion of one of the ring lands, which probably would have resulted in a large channel similar to figure 3 if operation had been continued long enough. These high-temperature gases are not necessarily all blow-by gases. A portion of these gases leaks by all the rings as blow-by gases, whereas part of them travel down and back up past the ineffective rings as the pressure in the combustion chamber is alternately increased and decreased. The net result is a scouring action, which in all probability causes the erosion shown in figures 3 and 7.

Further evidence that this channeling took place over a prolonged period of time is found in the fact that the entire top ring and parts of the second ring are missing from the piston in figure 3. The channel in the face of the piston provides the only escape path for these ring pieces. Because the broken rings were partly stuck in the grooves, the time required for them to work their way along the grooves to the channel would probably be quite appreciable. The pieces of rings imbedded in the top of the piston at the end of the test (shown by arrows in fig. 3) were covered with a coating of carbon, indicating their presence on the top of the piston for a considerable length of time. The preignition in the engine previously mentioned may have been caused by these ring pieces in the combustion chamber or by the ends of the compression rings left exposed by the formation of the channel down the side of the piston. The fact that particles of aluminum alloy were found lodged in the oil-ring groove, displaced as much as  $90^{\circ}$  from the channel in the face of the piston, lends further support to the supposition that the channeling of the piston took place over an extended period of time.

The final destruction of the piston occurred without any forewarning other than the high blow-by rates and did not extend beyond a few engine cycles. The piston skirt had been weakened by the channeling and by the increased temperature and the full pressure of the combustion chamber was acting on the sides of the channel.

The stresses in the aluminum became so great and the temperature so high that the skirt collapsed and permitted the free flow of burning gases into the crankcase.

*Figure 3. - Piston and ring assembly at end of first endurance test. Total test time 33.1 hours. Arrows indicate pieces of piston rings imbedded in piston.*

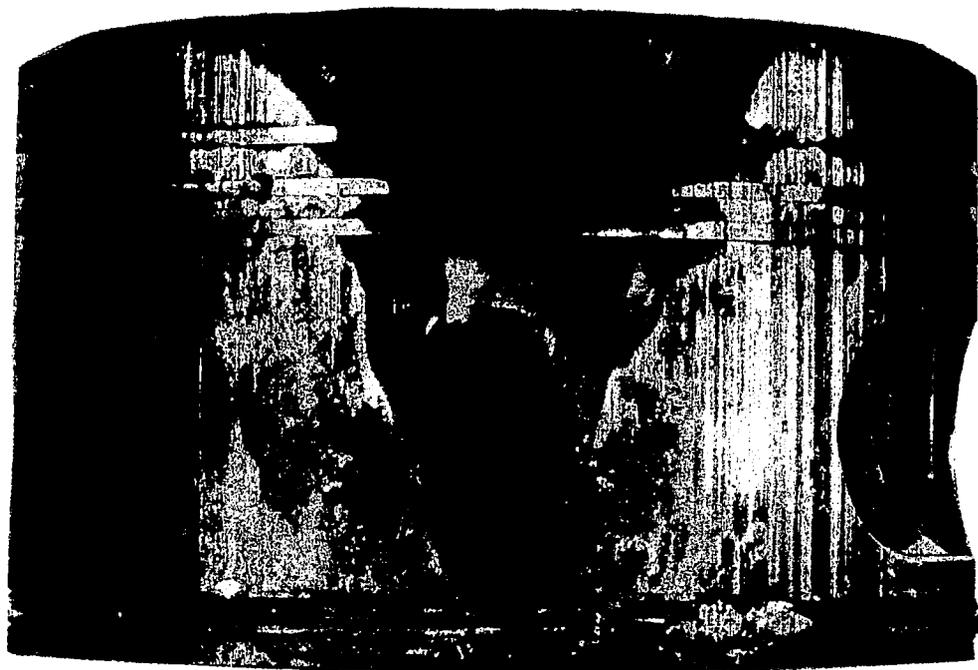
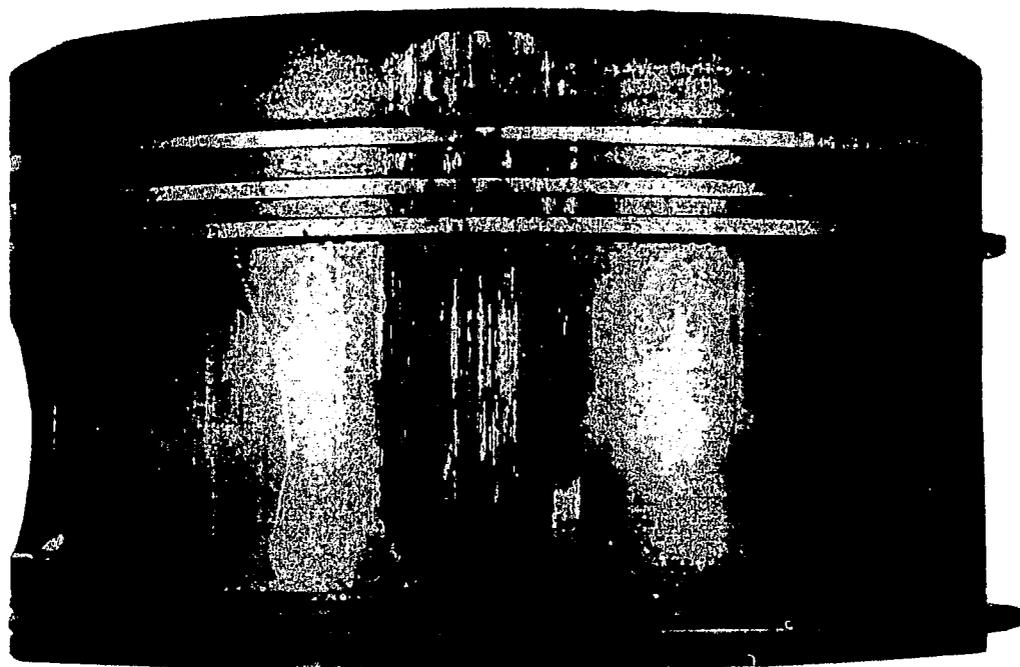
NACA  
C-3441

Analysis of failed piston. - Figure 9 shows the piston at the end of the second test. The failure was quite similar to that of the first test. In this case, however, much of the top two compression rings was still in the ring grooves, probably caused by the rings' being more severely stuck than in the first test and therefore not so free to rotate in the grooves.

Particles of aluminum alloy were found in the oil-ring groove displaced a considerable distance from the point of failure. Here again is evidence that the channeling of the piston took place over an appreciable period of time. It appears unlikely that these aluminum particles could have moved so far along the groove at the instant of final failure.

Figure 9. - Piston and ring assembly at end of second endurance test. Total test time, 84.25 hours.
