# WATERTOWN ARSENAL LABORATORY

NO. WAL 1371

Metallurgical Examination of Bayonets of Commercial and  
Springfield Armory Manufacture

To determine Method of Heat Treatment to Provide the Strongest  
and Most Durable Bayonets.

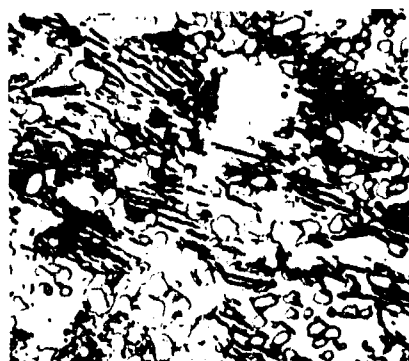
-J-

LOT I 1907 - CRITICAL  
SECTION.  
PEARLITE. SPHEROIDIZED  
CEMENTITE. SMALL FERRITE  
AREAS.

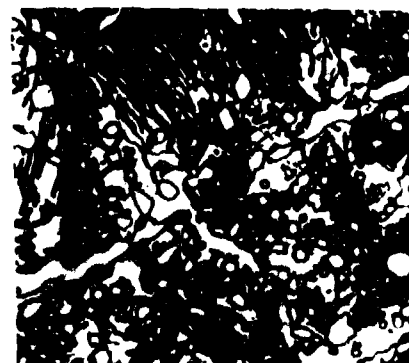
| BAYONETS | | | | | | | |
|---|---|---|---|---|---|---|---|
| I | 9 | Springfield<br>Armory | " | 1909 | Forged | 2 -L- | 23 |

LOT I 1909 - CRITICAL  
SECTION.  
PEARLITE. SPHEROIDIZED  
CEMENTITE. GRAIN BOUNDARY  
CEMENTITE.

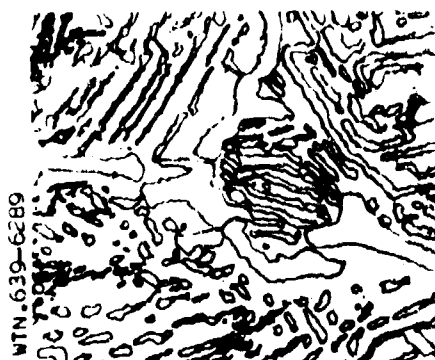
-S-

LOT I 1917 - CRITICAL  
SECTION.  
COARSE PEARLITE. GRAIN  
BOUNDARY CEMENTITE.

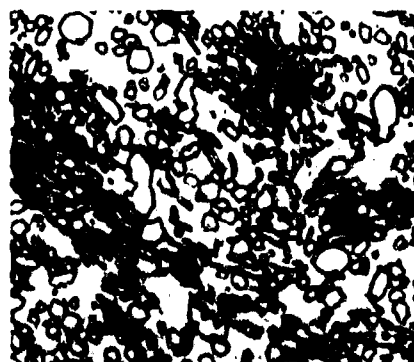
-T-

LOT I 1918 - CRITICAL  
SECTION.  
PEARLITE. SPHEROIDIZED  
CEMENTITE.

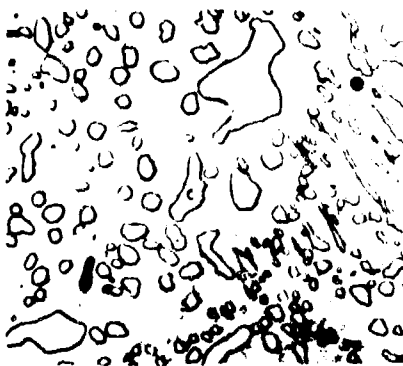
(4) Lot D - The structure at the critical section of Bayonet No. 2 of this lot consists of spheroidized cementite with traces of pearlite as shown in Figure 2 -Z-. The tang of this bayonet is in the unhardened condition whereas the tangs of the other three bayonets of this lot were hardened starting at a point about 1" from the front of the guard. This indicated that bayonets of this lot were not immersed to the same depth in the bath used for heating.

LOT D - CRITICAL SECTION  
SPHEROIDIZED CEMENTITE.  
TRACES OF PEARLITE.  
BAYONET NO. 2.

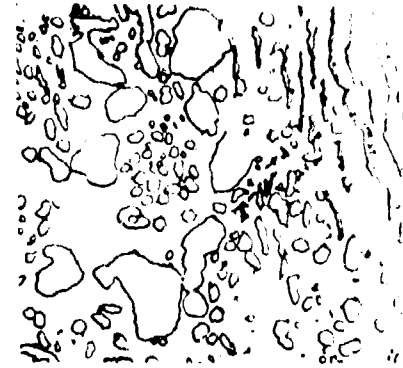
LOT I 1916 - CRITICAL SECTION  
SPHEROIDIZED CEMENTITE.  
MARKED TRACES OF PEARLITE.
