OPERATIONAL SUITABILITY TEST OF OPEN GUN PORTS FOR F-86  
AIRCRAFT

Project ADP 24913-5

DATE  
31 AUGUST 1949

FINAL REPORT

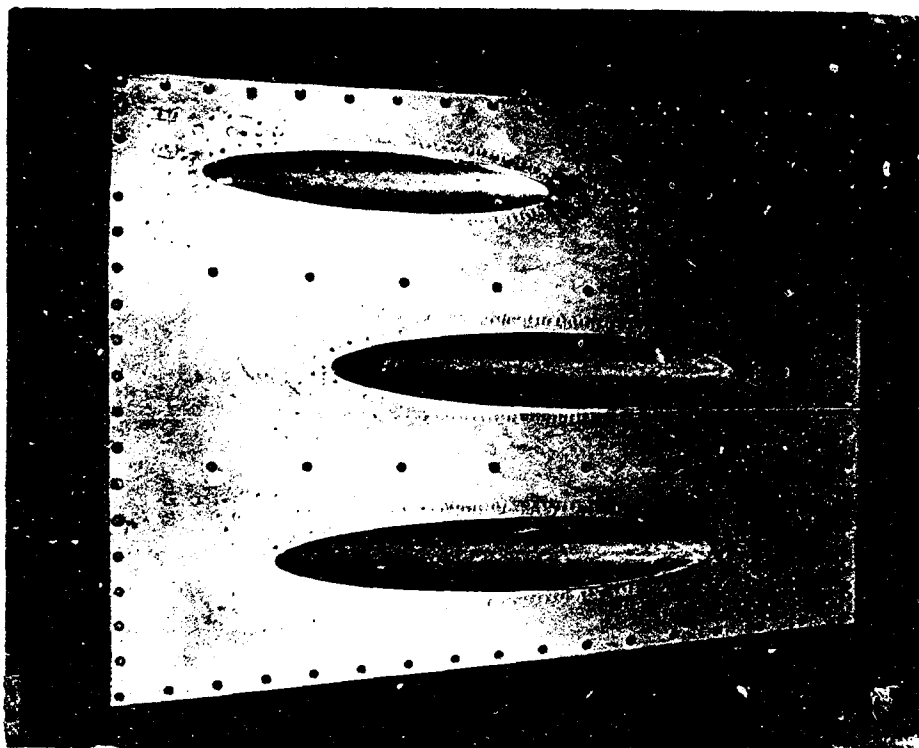
PHOTOGRAPH 1: Outside view of open gun port panel

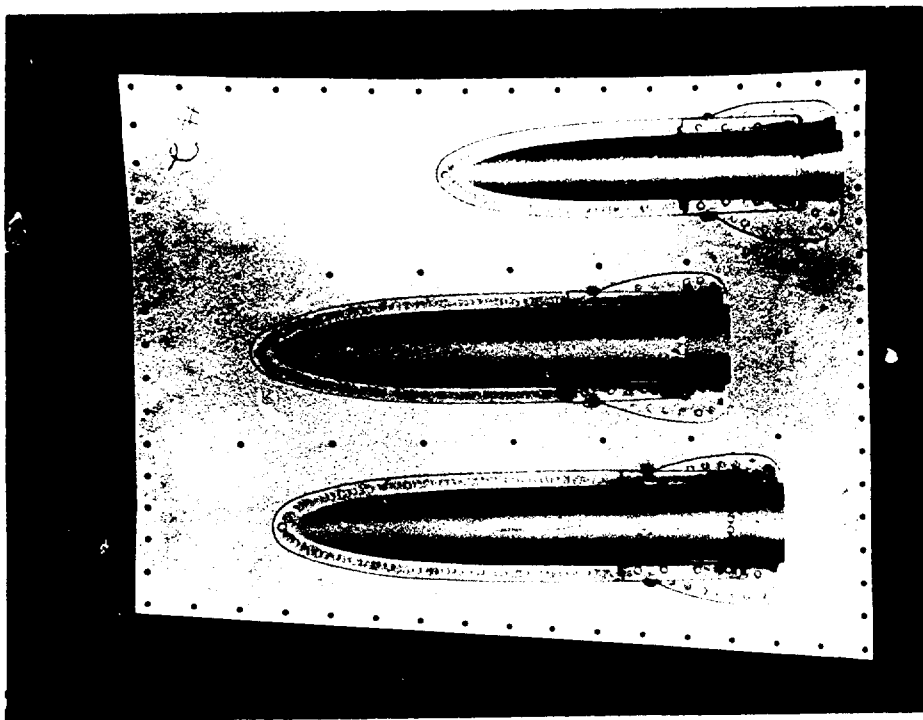
PHOTOGRAPH 2: Inside view of open gun port panel

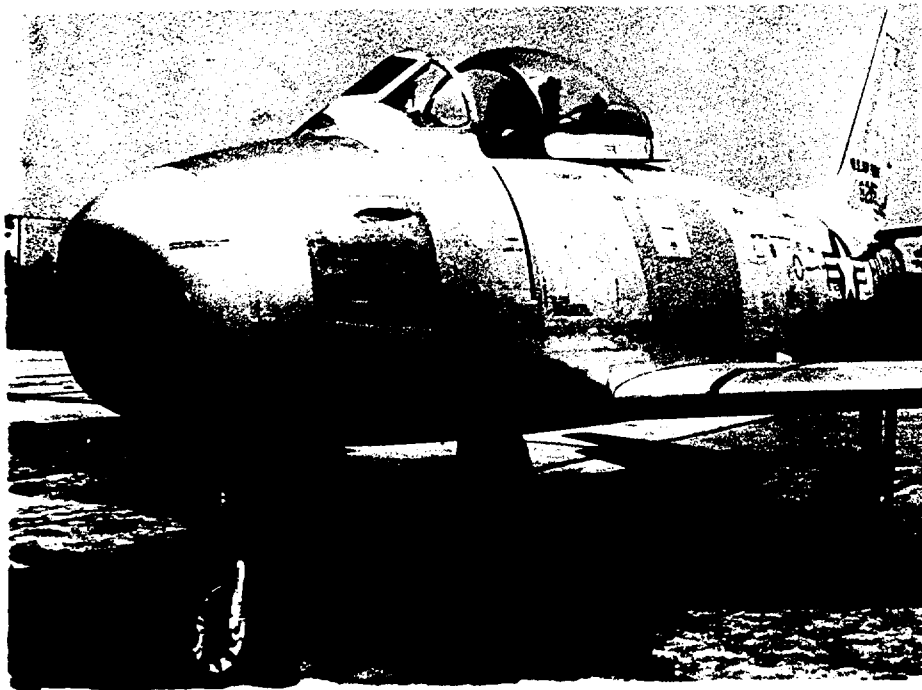
PHOTOGRAPH 3: Open gun port panel installed on F-86 airplane
