Technical Investigation of 11 January 1985  
PERSHING II Motor Fire

James A. Knaur  
US Army Missile Command  
Redstone Arsenal, Alabama

ABSTRACT

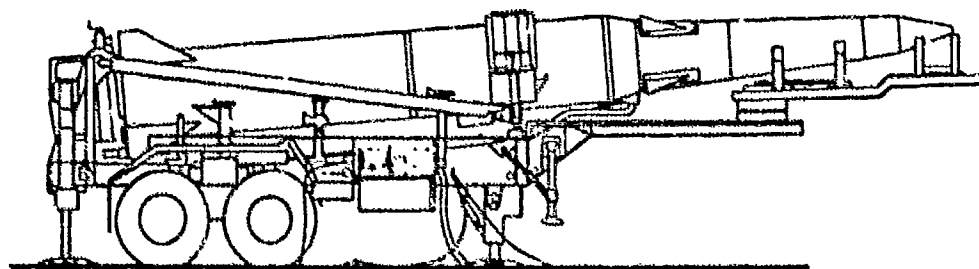
Figure 1. PERSHING II System fully assembled on the erector launcher.
