TITLE: Minutes of the Explosives Safety Seminar (22nd) Held in Anaheim,
California on 26-28 August 1986, Volume 1.

DEBRIS HAZARD AT A ROCKET
MOTOR TEST CELL FACILITY--
AN "ACCIDENTAL" STUDY

Patricia Moseley Bowles
and
Michael A. Polcyn

Southwest Research Institute
San Antonio, Texas

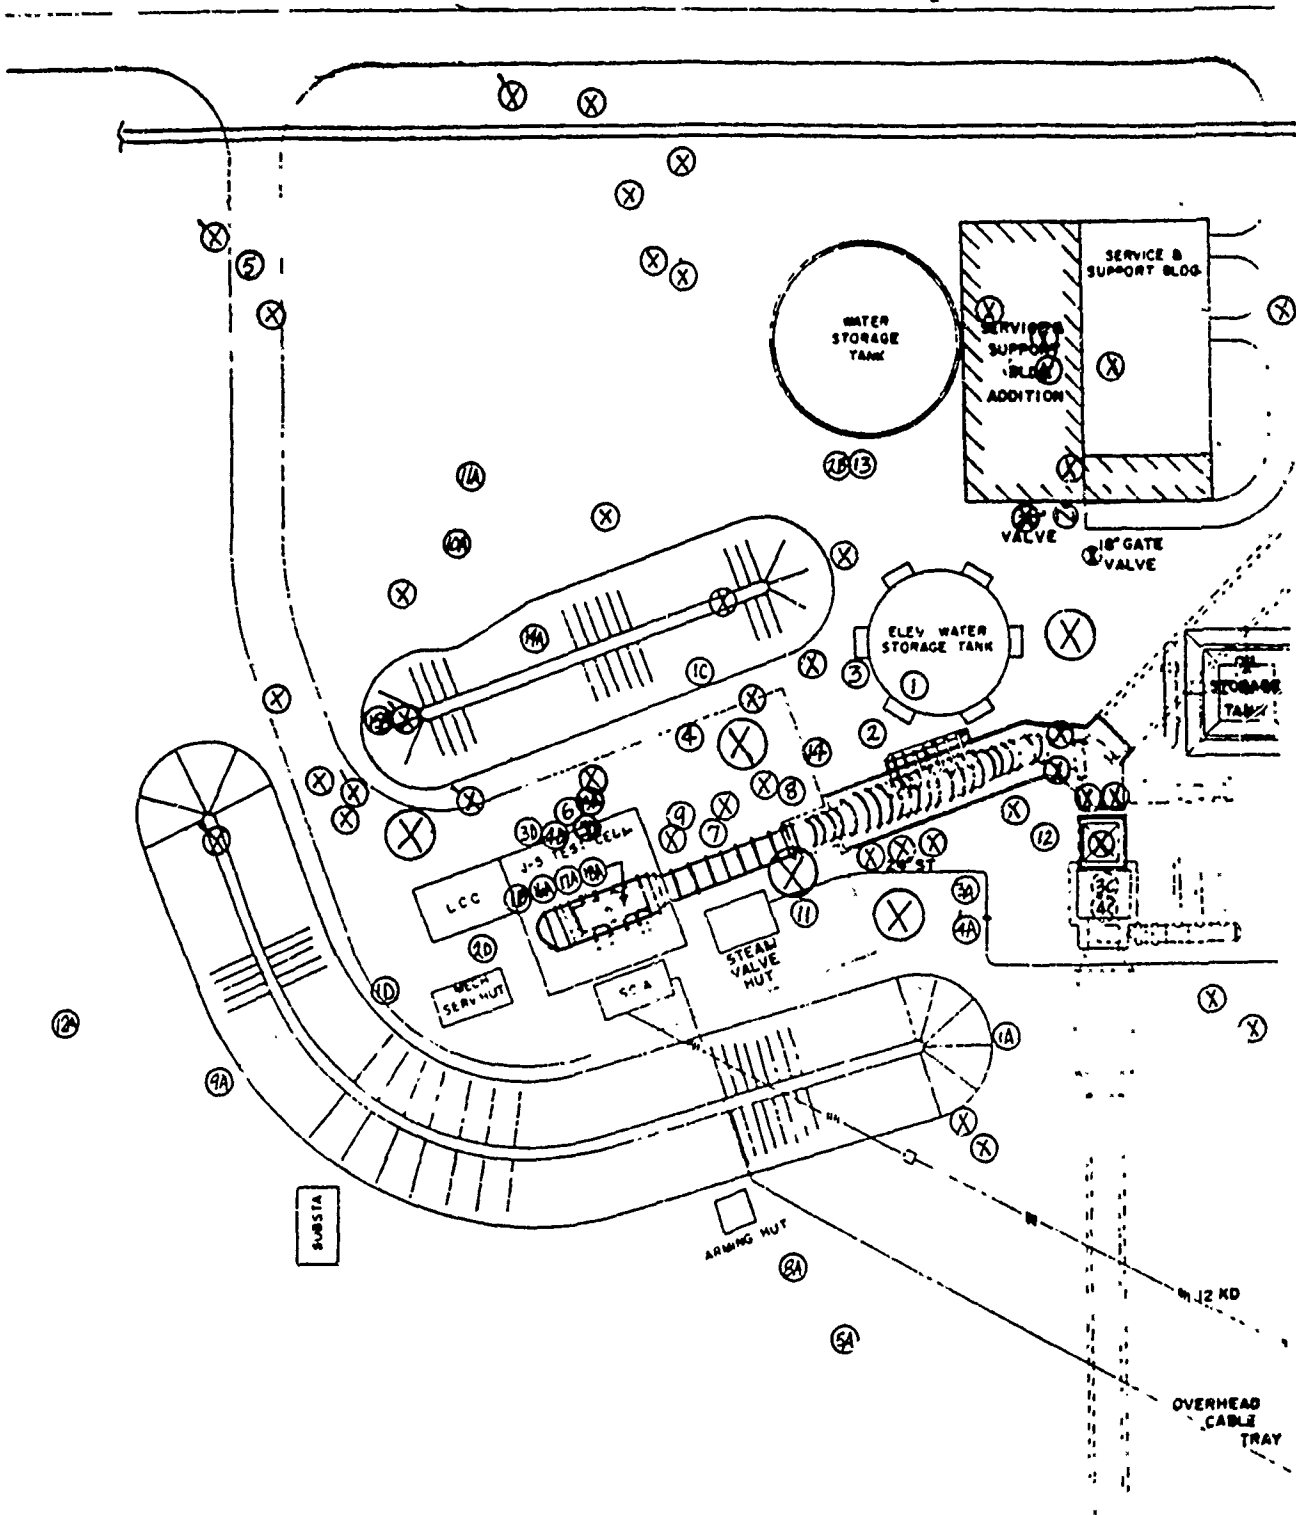
Figure 6. Missile Map Showing Motor Casing Fragments and Unburned Propellant

The test being conducted prior to the mishap involved a qualification test of a large rocket motor containing Class/Div. 1.1 propellant. The pressure inside the motor measured about 600 psi just before failure occurred. The peak pressure of 740 psi was measured about 10 seconds into the test. It was estimated that approximately 1100 lb of the original 16,000 lb of propellant remained in the motor when the failure occurred.

An AEDC mishap investigation team was immediately set to the task of determining the cause of the mishap. Their activities included review of manufacturing, shipping and test preparation records, a test procedures review, review and analysis of physical evidence at the site, and interviews of mishap witnesses. In addition to these activities, an SwRI team was allowed to study the site and collect data related to the distribution of debris caused by the mishap. Data collected included the type, size, and origin of debris, along with the impact characteristics and angles of debris throw. Although all identifiable motor casing parts were previously removed from the site, SwRI was provided with a missile map (shown in Figure 6) showing locations of retrieved motor casing fragments (numbered circles) and unburned propellant (circles with an "X" in them). SwRI also used post-mishap photographs (including aerial shots) to help summarize observations on debris and other physical evidence or damage indicators noted during the site investigation.

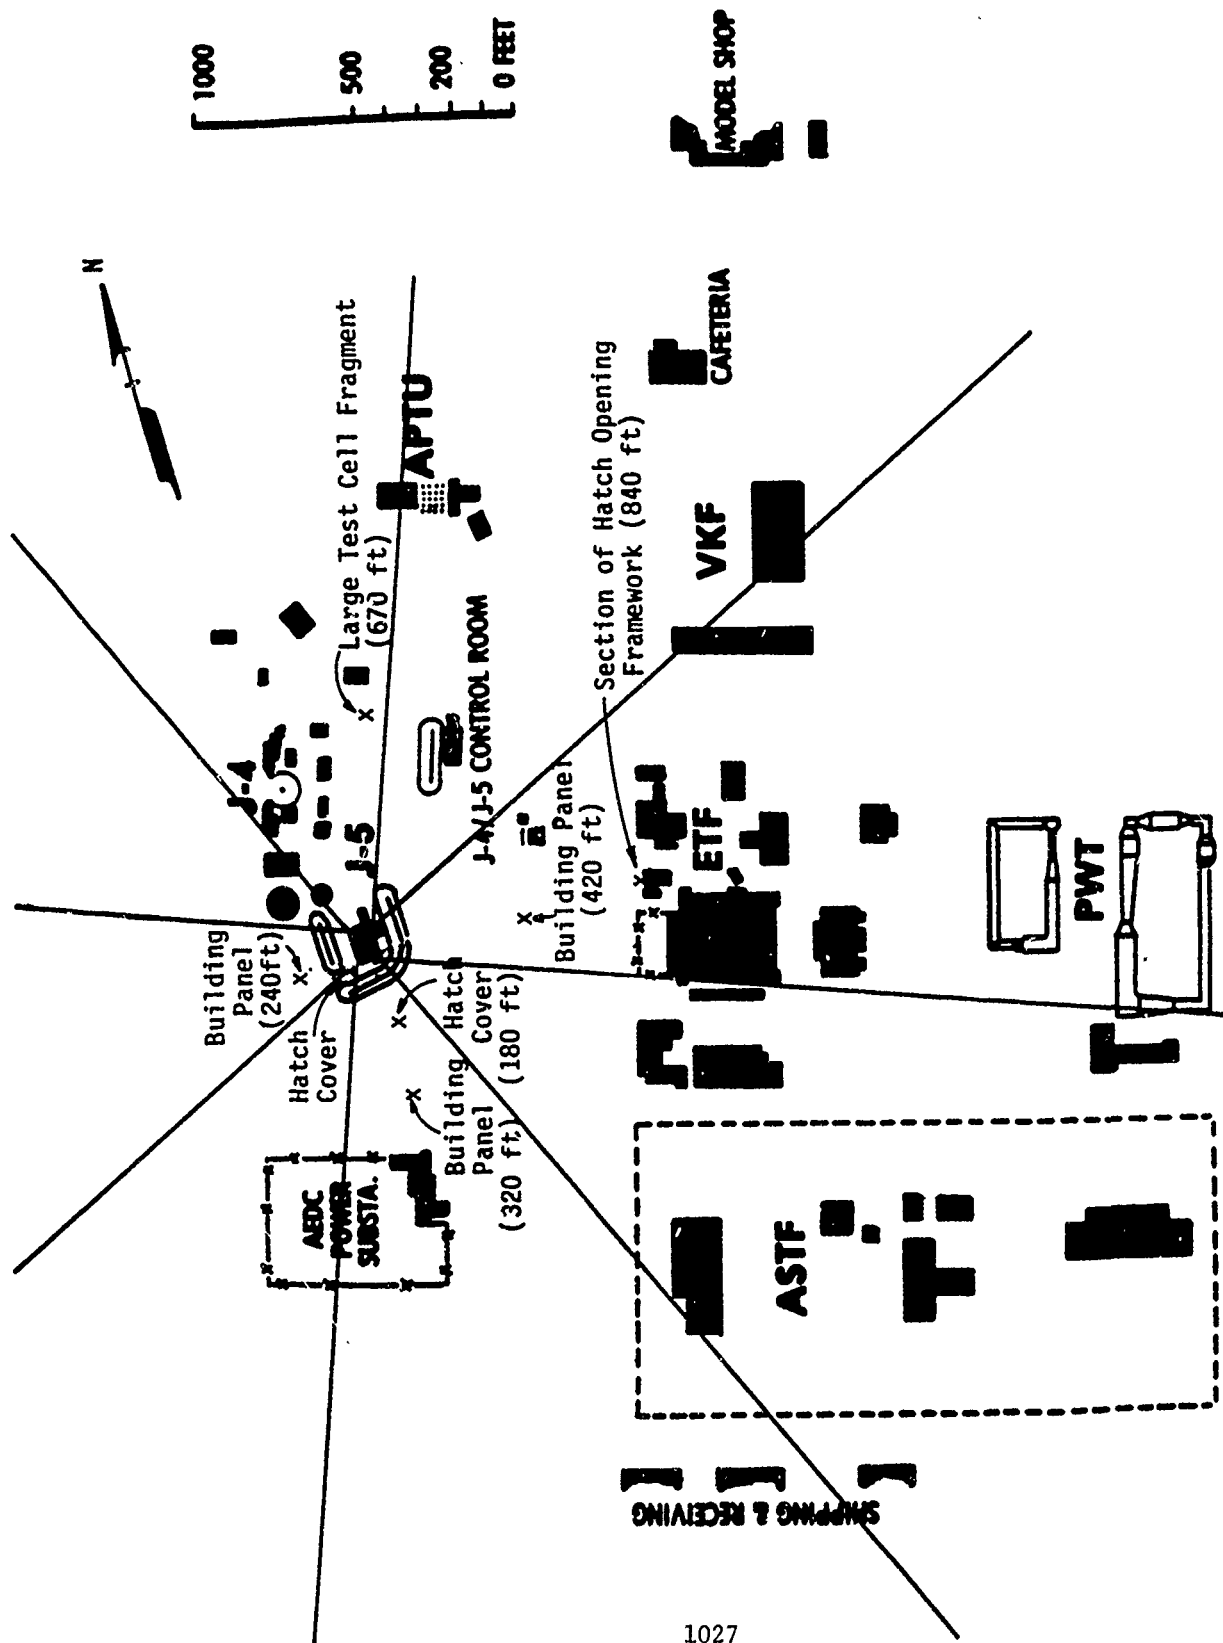
Figure 7B. Major Debris Impact Locations Following J-5 Mishap

The hazardous zones predicted for a 20,000 lb TNT equivalent propellant detonation are shown in Figure 7A. The limit distances indicate the threshold of hazardous fragment density, defined as more than one fragment with kinetic energy greater than 58 ft·lb per 600 square feet. Impact locations of a few of the larger cell and building debris from the mishap are shown in Figure 7B. The location of the impacts furthest from the test cell in each zone are indicated on the figure. Note that these are locations of single fragments and do not correspond to the limit distances for hazardous fragment density for the mishap. The hazardous density for the mishap was limited to the bermed J-5 area.
