TITLE: Minutes of the Explosives Safety Seminar (22nd) Held in Anaheim,  
California on 26-28 August 1986. Volume 2.

MULLER MIXER FIRE  
"LESSONS LEARNED"

MORTON THIOKOL, INC.

Longhorn Division

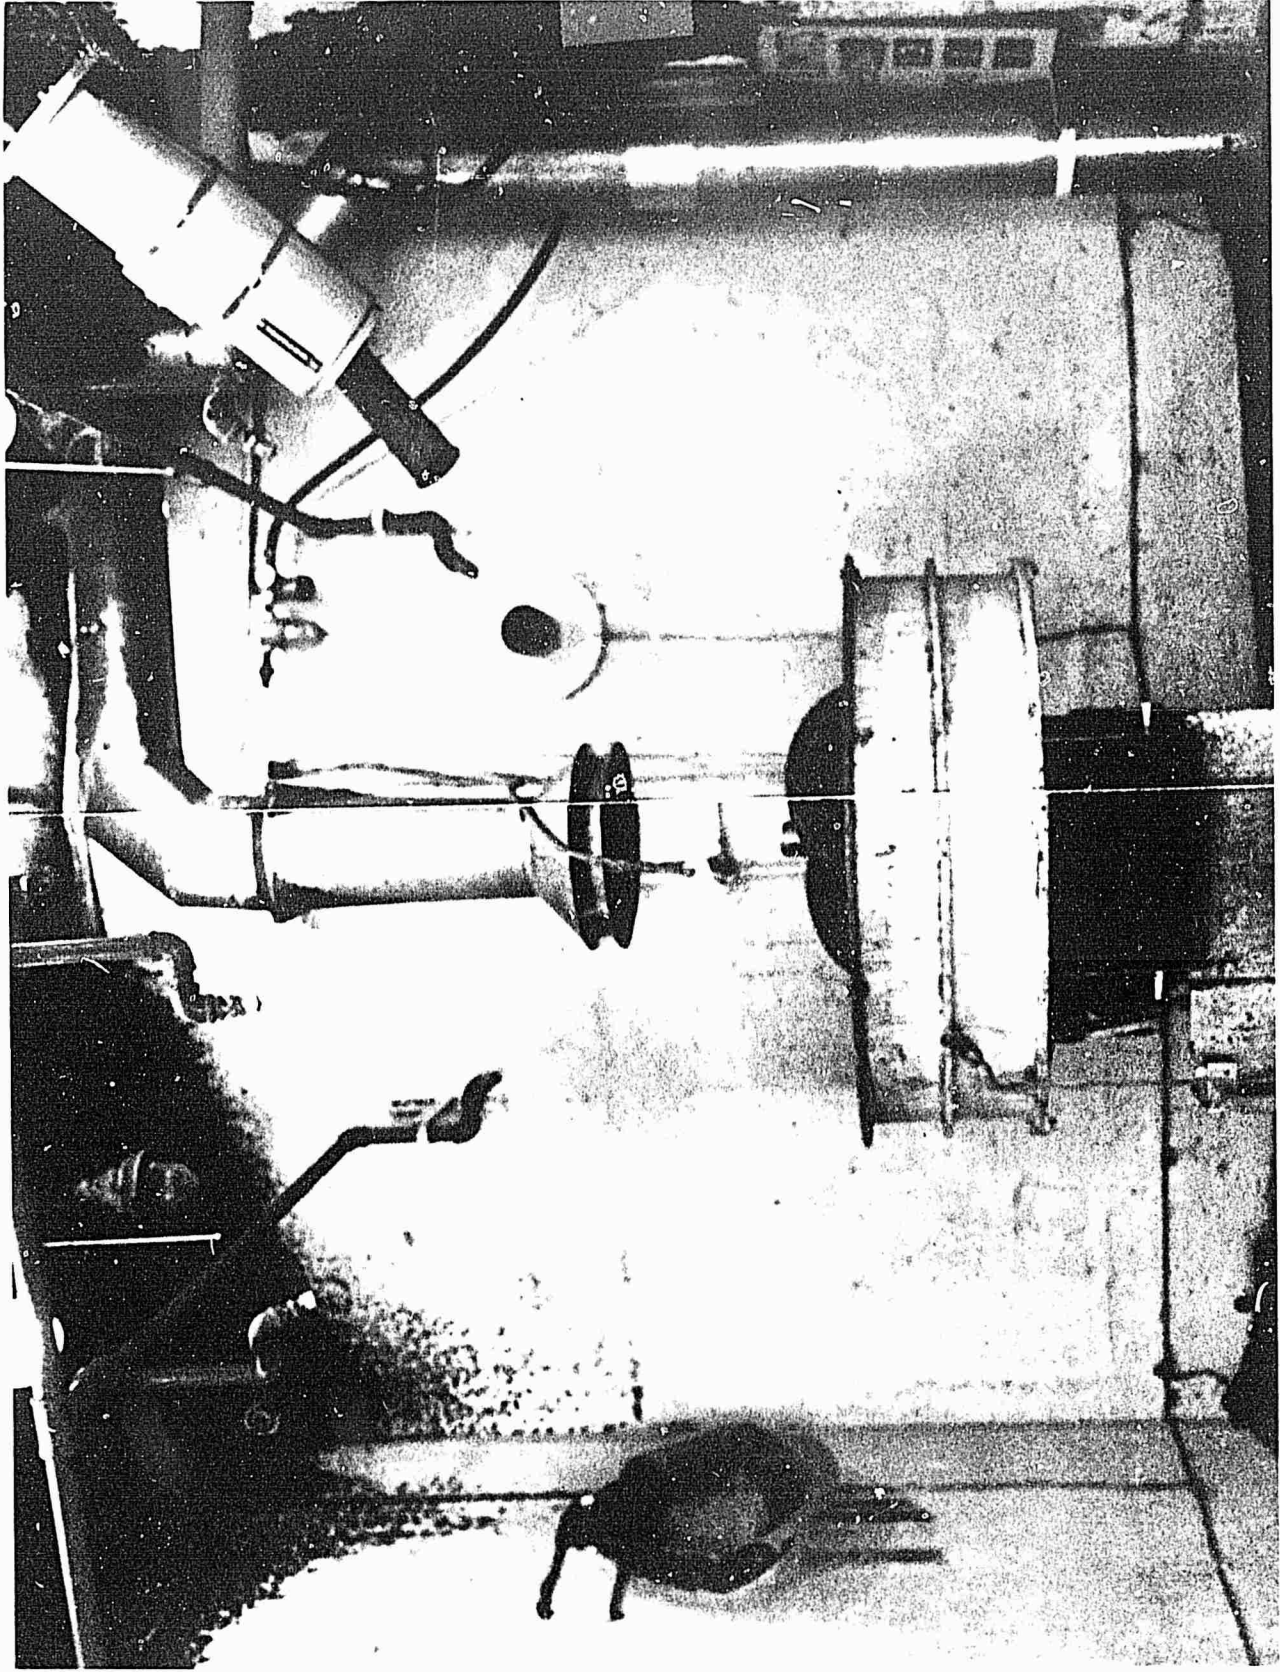
Figure 2

At the time of the incident, Bays A and B were inactive while Bay C was in same mix cycle as Bay D. The pyrotechnic being manufactured was a M22 flash composition mix which is composed of Magnesium (93.75 lbs.), Teflon (12.5 lbs.), and Viton Binder (18.76 lbs.) dissolved in Methyl Ethyl Ketone (44 lbs.). This was the first mix of the day with bowls in both Bays C and D being charged with only the Magnesium and the dissolved Binder. No Teflon had been added. The remote mix operation had run approximately 7 of the 10 minutes when the flash fire occurred. The fire caused superficial damage to Bay D and equipment with most of the production material either being consumed or tossed out of the bowl by deluge system. No personnel injuries were incurred. The fire ball did not propagate to Bay C due to the rapid acting deluge system but was

forced into the back corridor and out the emergency exit nearest Bay D. The fire ball also vented over the top edge of the sliding corridor fire door igniting contaminated surface along the fire door track and ceiling. In interviewing the operator who was supposed to have been watching the TV monitors, there was no indication of a problem before she heard a boom and looked up and to see Bay D engulfed in flames on the TV monitor. (Figure 2 shows damage in Bay D)

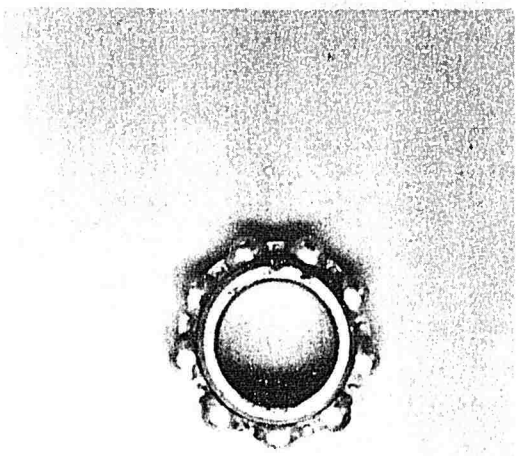
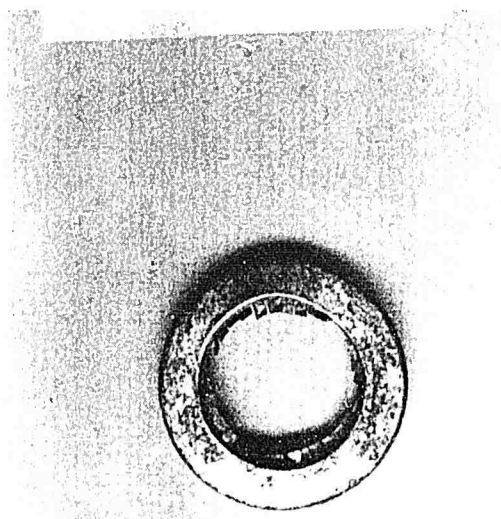
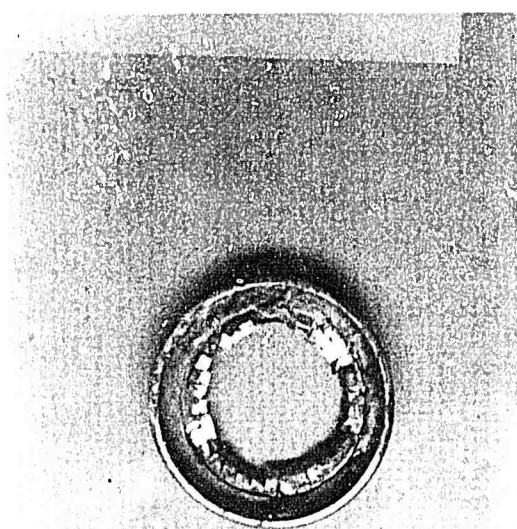
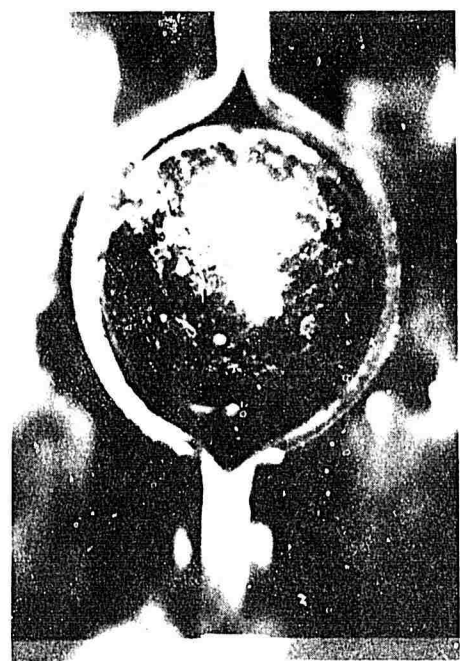
Figure 4

The above scenarios were selected as most probable since a man/machine interface was not evident at the time of the incident coupled with mechanical damage, contamination and fire being identified inside a muller wheel. This was also supported by no unusual observations noted prior to the incident or during post production material screening, chemical analysis, and sensitivity testing. Electro Static Discharge (ESD) was not indicated as all electrical continuity systems checked. The investigation of this incident centered primarily on friction/spark ignition, e.g., ignition temperature of MEK is 960°F with a flash point of 70°F while M22 composition is 752°F. The frictional heat levels indicated were considered achievable in the scenarios hypothesized.

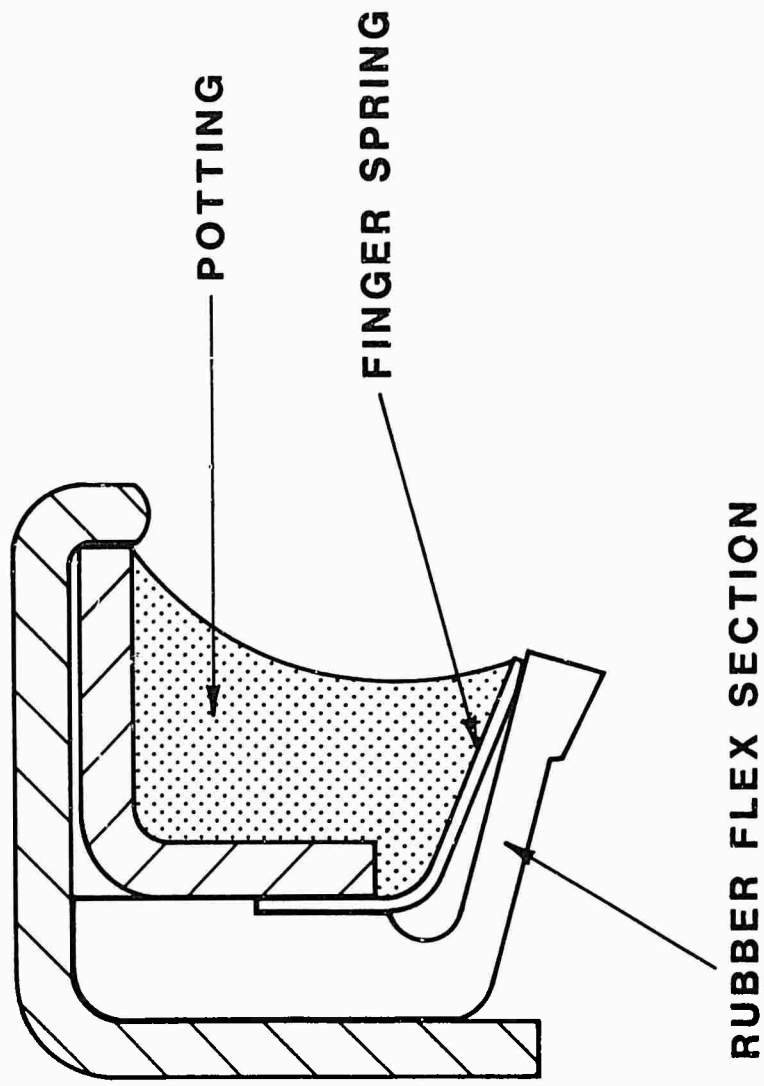
Figure 5

The most probable cause was identified during detailed disassembly of the muller wheels which found a damaged Garlock Klosure Lip Seal. Under microscopic examination it was apparent that the metal spring fingers in the lip seal had made metal to metal contact with the axle plus there was indication of fire in the area. Small amounts of explosive contamination were also found past the lip seals in bearings of both the muller wheel and center support post. To correct this deficiency the muller wheel assembly (Figures 3 and 4) has been redesigned with a redundant Ethylene Propylene "O" ring seal plus potting the void in lip seal with solvent resistant Epon 828 and Versamid 125 filler. The lip seal filler prevents explosive product entrapment and build up at the edge of the lip seal, protects finger springs, and aids in cleaning of center support post lip seal. The effectiveness of this lip seal configuration was tested in inert and live prove out mixes which established a twenty (20) shift replacement schedule of all lip seals and bearings. This preventive maintenance baseline may be extended as future experience warrants. Eight months of continuous operations has seen no migration of product past lip seals. (See Figure 5)

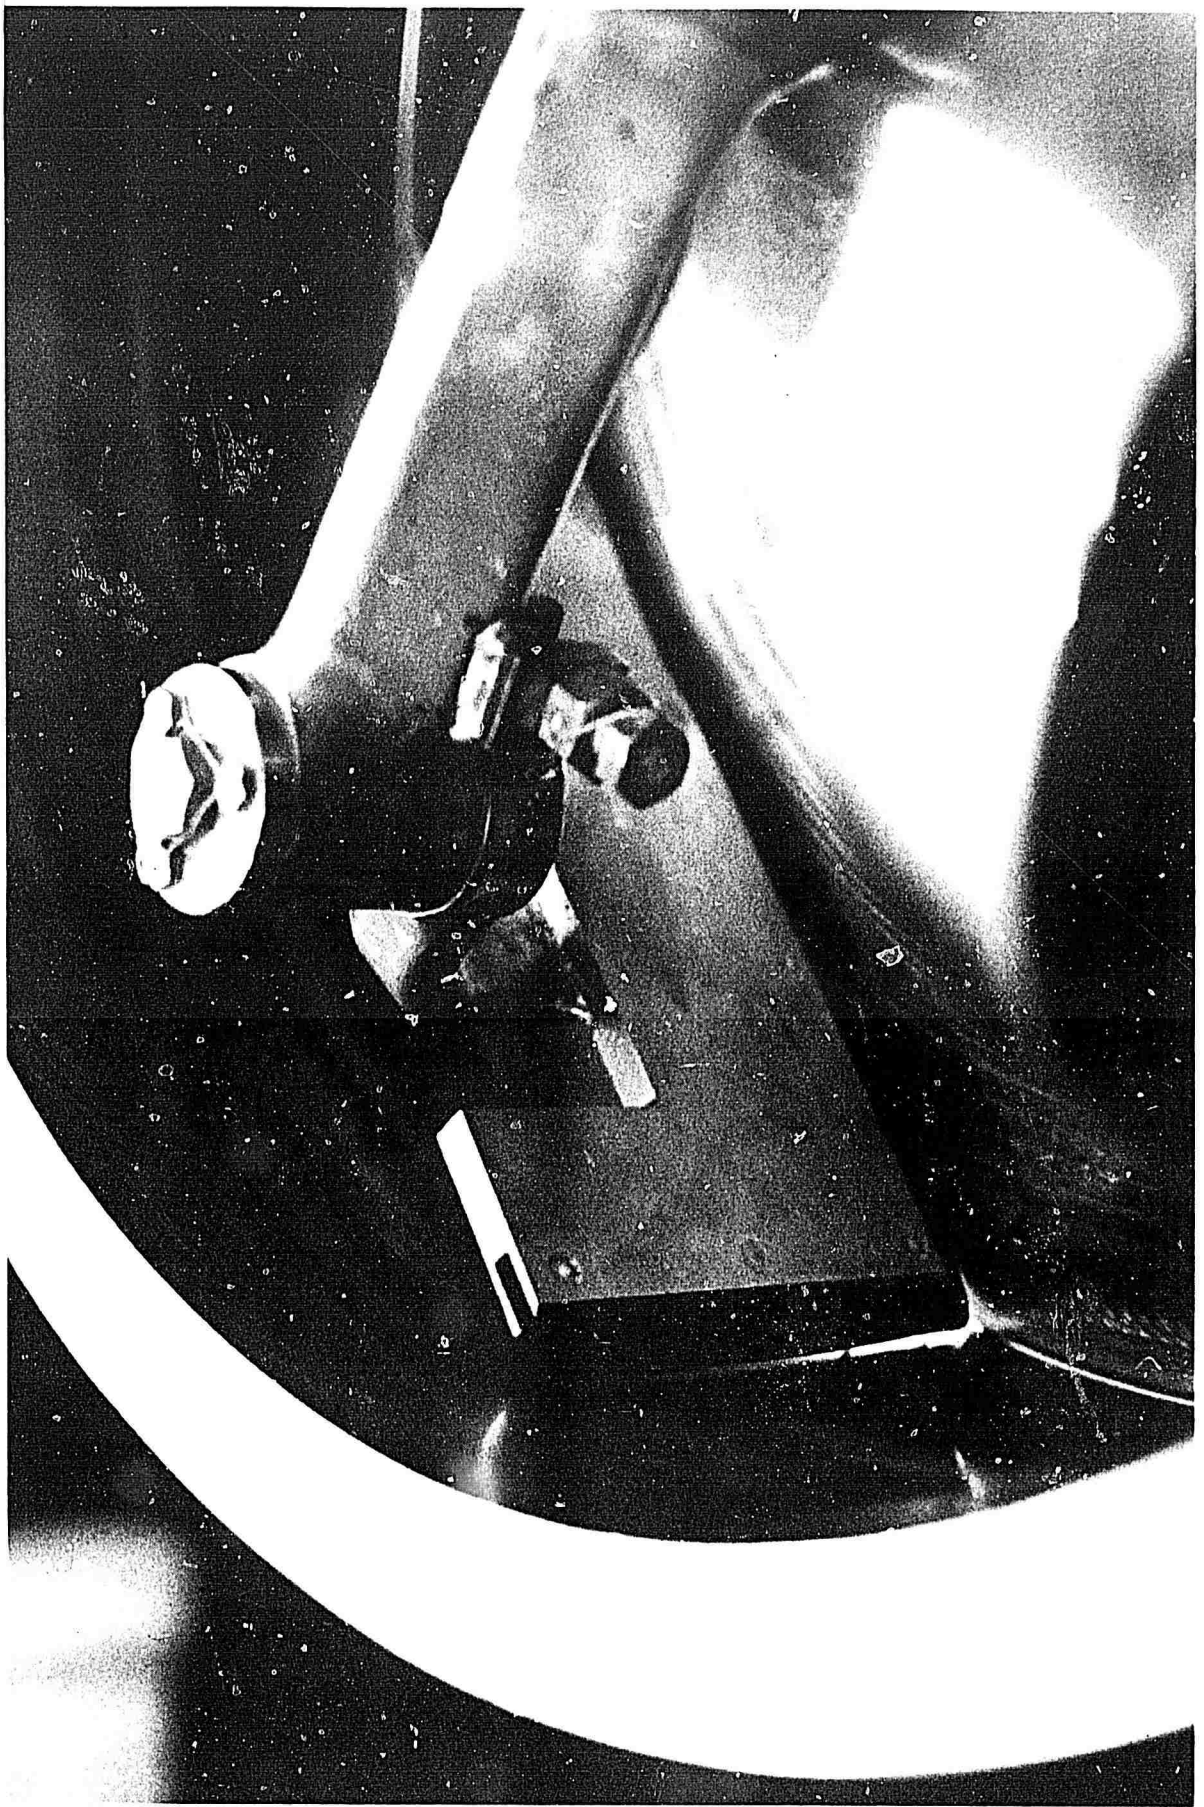
Figure 6

The third alternative focused on friction between pyrotechnic composition entrapped in the rough bowl surface and rubbed by direct contact wipers and plow blades causing hot spots. As indicated at the beginning of this paper, the

Longhorn Division has used nylon wiper/plow blades in "Zero" clearance with bowl surfaces for over ten (10) years without incident. The rough condition of bowl surface was due to years of continuous multi-product use without an adequate program to periodically reface bowl and wheel surfaces. The result was a badly worn bowl and muller wheel surface. In addition, it was also discovered that the Total Indicated Runout (TIR) of the bowl was excessive and that the bowl flexed when torque was applied from drive belts. To correct these deficiencies the bowl and wheels were refaced to remove all scratches, scores and gouges, the high points of the mixer wall and bottom were identified and marked on the bowl plus a drive belt tension stabilizer support was added to drive shaft. The muller wheels were also slightly crowned to push possible foreign material out from under wheel. The nylon blades were replaced with ultra high molecular weight conductive polyethylene blades which are installed with a minimum .030 clearance. This blade to bowl clearance is verified daily by production foreman. The last two initiatives were felt necessary to increase our safety margin by eliminating the possibility of static charge generation buildup on nylon blades. The .030 standoff also reduces the potential for blade/bowl friction points. In addition, a nylon bolt was added between rocker arm and crosshead to prevent metal to metal contact and pinching of material. (See Figure 6)
