TITLE: Workshop on Avionics Corrosion Control: Meeting of the Structures and
Materials Panel of AGARD (62nd) Held in Hovik (Norway) on 16-17 April 1986.

AVIONIC CORROSION

Irving S. Shaffer
Naval Air Development Center
Warminster, PA 18974-5000
USA

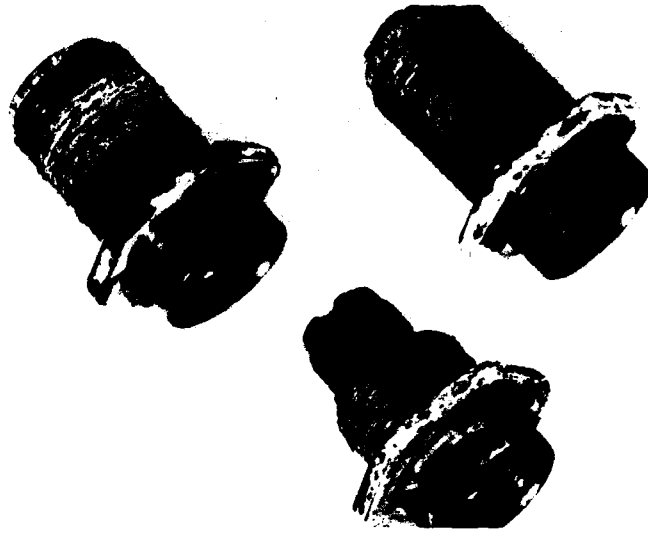
The use of a thin electroless nickel plating over 6061 aluminum on connector shells has caused serious corrosion problems as shown in Figure 5. Cracks develop in the nickel plating and when the surface is wet a galvanic cell is created with the aluminum corroding sacrificially. Figure 4 illustrates the effects of this galvanic corrosion on two coaxial connectors.

FIGURE 5. GALVANIC CORROSION OF NICKEL PLATED ALUMINUM COAXIAL CONNECTORS

In an attempt to correct this problem, Jankowski⁷ evaluated coatings for electrical connector shells. The effort led to the use of a duplex nickel-cadmium plating, which, while not preventing corrosion, does provide improved corrosion protection. The use of water displacing corrosion preventive compounds provides additional protection. The use of non-metallic connector shells, however, represents an approach which may completely eliminate this problem.
