TITLE: Workshop on Avionics Corrosion Control: Meeting of the Structures and
Materials Panel of AGARD (62nd) Held in Hovik (Norway) on 16-17 April 1986.

CORROSION OF ELECTRONIC COMPONENTS

Dr Bill Dobbs

Electronic Failure Analysis Group
Air Force Wright Aeronautical Laboratories/Materials Laboratory
Wright-Patterson AFB OH 45433-6533
USA

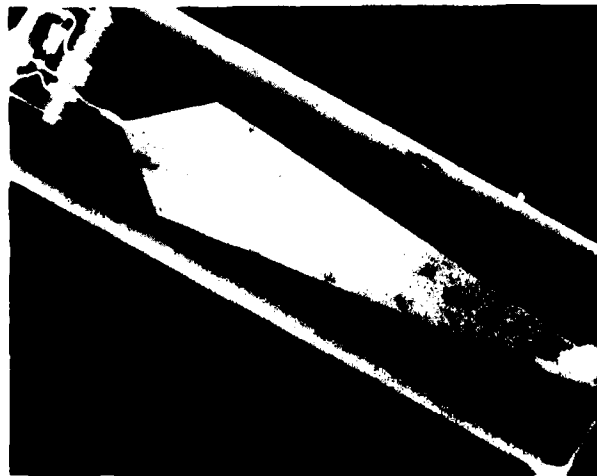
A corroded antenna marker beacon, Figure 6, was removed from an aircraft so that the source of corrosion could be determined. The beacon was x-rayed, Figure 7, and corrosion sites were visible in the radiograph. The antenna was opened and found to contain a polyamide foam, Figure 8. The antenna blade was removed from the foam, Figure 9, and found to be corroded too. Both the housing and blade were found to be aluminum. The housing was found to be plated with electroless nickel, Figure 10, and the blade was plated with a copper strike followed with a tin plate, Figure 11. It is believed that both the nickel plate and the copper/tin plate were porous. This permitted the penetration of moisture to the plating and aluminum interface. The presence of moisture and the anodic relationship of aluminum to nickel, or tin, resulted in a galvanic cell which caused pitting corrosion in the aluminum, Figures 12 and 13. These plating systems were used to maintain a high electrical surface conductance on the aluminum components. The corrosion has resulted in non-conductive surfaces which affect the electrical performance of the antenna. It was recommended that instead of plating the aluminum a chromate conversion coating be used.

Figure 7. X-ray radiograph shows areas of corrosion.

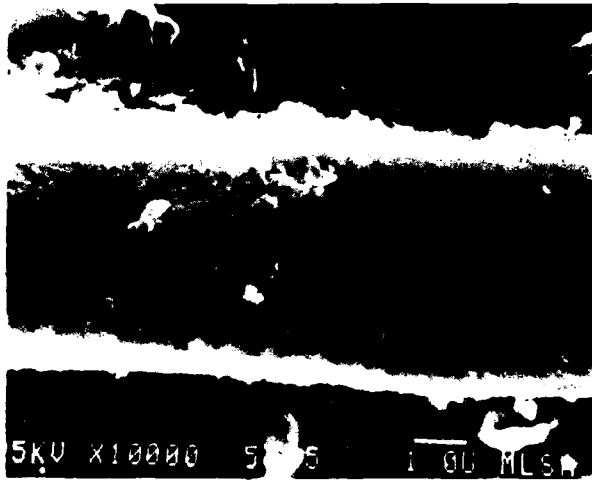
Figure 45. Cross-sectional area of failed connector.

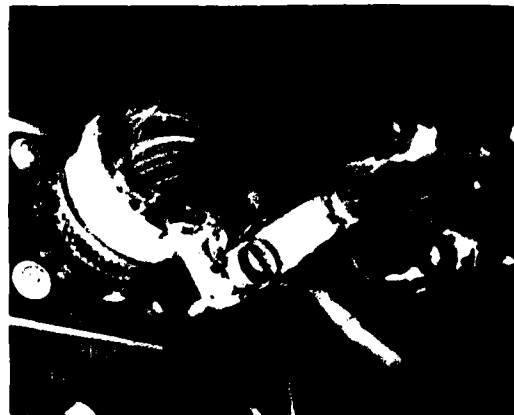
The corrosion of electrical connectors causes a large number of electrical failures. Figure 46 shows the corrosion on some aircraft connectors. These problems may be minimized when the connectors are installed in a horizontal position; when a loop is placed in the wire so water will not flow down the wire into the connector; when inhibitors are used on the connector pins and receptacle interior mating areas (MIL-C-81309, Type III); and when inhibitors are used on the external connector surfaces (AMLGUARD MIL-C-85054). It is

Figure 46. Corroded electrical connector on avionic equipment.

recommended that an aluminum connector with cadmium plate be used. The possibility of corrosion can be further minimized by using a chromate conversion coating over the cadmium plate.
