Ejection-Seat-Quick-Release-Fitting
Quantitative fractography and estimation of the local toughness using the
topography of the fracture surface

K.Wolf, Bundeswehr Research Institute for Materials, Explosives,
Fuels and Lubricants (WIWEB)
Landshuter Str. 70, 85435 Erding, Germany

ABSTRACT: A Quick-Release-Fitting of an Ejection Seat broke and investigations were made to estimate the fracture mechanism on the basis of fracture surface characteristics.

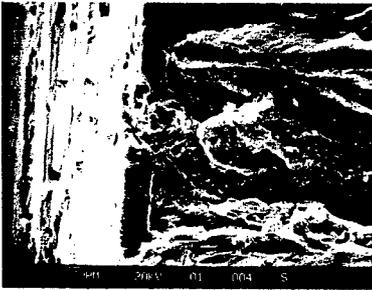
The fatigue fracture surface of the broken bell and the cracked bells were examined with respect to the striations at the origin area, the middle area and the crack tip area to quantify the crack propagation. Figure 11 shows the measured values (striations per mm) as a function of the crack length. These values were calculated by regression to get an average curve [1;2;3]. The integration of this curve lead to the crack propagation curve (Figure 12). The comparison of the derivated crack propagation (dl/dN) of the striation width with literature values shows that the crack propagation was uncritical at most investigated bells (Figure 13). This lead to the conclusion that for cracked bells even with relatively long cracks no critical stage can be expected during the time fixed life span,

Figure 9
SEM-micrograph of the crack area with striations – bell S

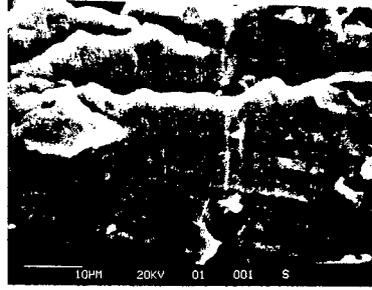
The bells „V1“ to „V8“ showed precrack extensions from 0.4 mm to 1.5 mm whereby the plate thickness was 1.5 mm. The circumference precrack extension runs from 4.5 mm up to 26 mm. Only „V4“ and „V8“ showed precracks on both sides (up to 0.3 mm). The longest precrack was found at „V7“ (26 mm). The results of the SEM-investigation showed that „S“ and „V1“ to „V8“ cracked due to fatigue fracture (Figure 9). The fatigue crack on „S“ was initiated by etch-pits and pittings underneath the 10 µm eloxal layer (Figure 10). The crack propagation took place from the outside of „S“. The crack propagation showed in addition to the operational load marks signs which points to the load of the bell during „put on-lock-take off“. Because of this operation the mass of the solid central part moves away from the mid part of the bell. Due to this loading the mid part is overcome by bending. The pits and pittings promoted the precracks in this area.

Figure 10
SEM-micrograph showing preinduced crack area with a crack origin underneath the eloxal layer – bell S

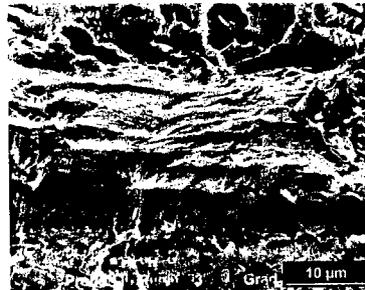
The stretched zone measurements were done on stereo image pairs by scanning electron microscopy on both corresponding fracture surfaces of the specimens „V1“ and „V2“ (Figure 14). Measurements along several base lines through the stretched zone achieved the stretched zone width (SZW) calculated by digital image processing [4;5;6;7]. Based on the ESIS P2-92 and DVM 002-Merkblatt the mechanical properties for the local crack initiation were calculated. The crack initiation toughness defined by the J-Integral is connected with the stretched zone and can be set as

By taking in the average SZW-values into this equation the bell V1 shows a J_i -value of 28 N mm/mm² and the bell V2 shows a J_i -value of 23 N mm/mm². On the other hand there exist a relation between J_i and K_{Ic} :

After calculation the value for bell V1 results in 47 MN/√m³ and the value for bell V2 results in 42 MN/√m³. Because of the little difference in local fracture toughness the results show that different materials by itself did not cause additional problems.

Figure 14
SEM-micrograph from the crack tip (SZW) - bell S1
