Industrial Case Histories

Kevin R. Guy

C J Analytical Engineering, Inc
R.R. #1 Box 353
Francisco, Indiana 47649
cjinc@cyanalytical.com

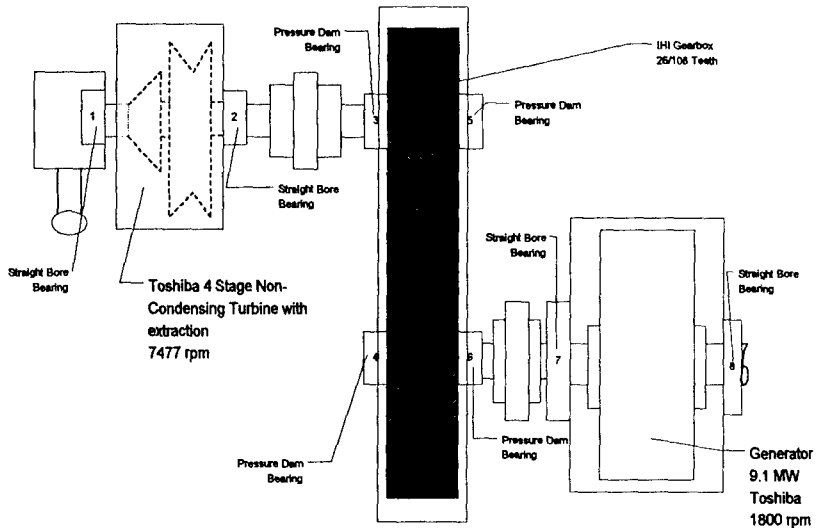
Figure #1

Problem: This unit was repaired after suffering catastrophic shut down during a hurricane. The turbine is owned by a government utility on a small island nation in the West Indies. The utility had utilized diesel generators until a far eastern country built their first steam plant. The utility ran into problems during Hurricane Hugo. Operations personnel not being experience with steam turbine failed to maintain the DC battery system. When the storm struck the island; the electric distribution system was destroyed causing the turbines to trip. The turbine generator train (Figure #1) went from operating speed to a dead stop in 45 seconds without lubricating oil. The turbine journals and bearings were destroyed. The bearings in the gearbox and generator were also completely wiped; however, there was no damage to the shaft journals.

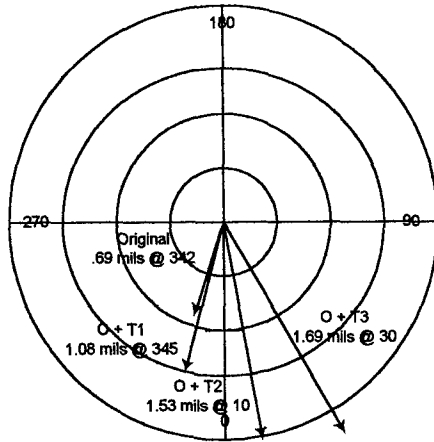
Figure #2

Test Data and Observations: Balance data was collected with a tracking filter and the analysis was performed with a Hewlett Packard Dual Channel FFT Analyzer. Velocity sensors were used throughout the balancing and analysis. Because no previous balance data was available; it was decided to perform a measured effect balance. This balance method was both ineffective and inclusive (figure #2).

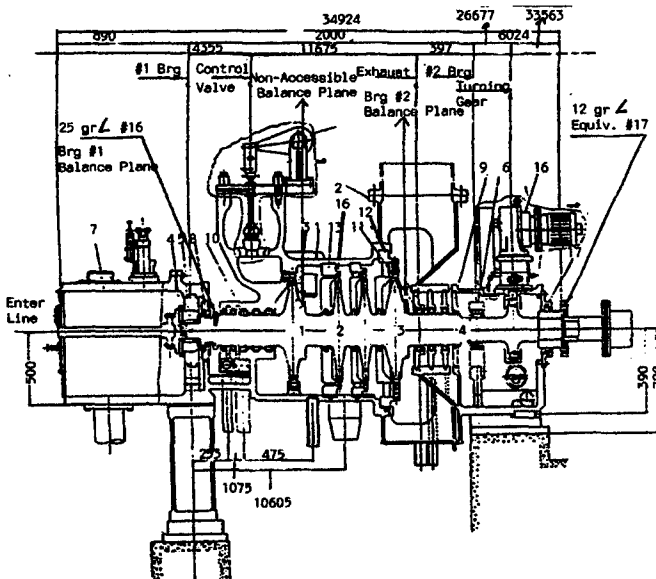
Figure #3

Since the effect was fairly decent, it was decided to again try a measured effect balance in conjunction with a four run no phase balance method. This proved to also be fruitless. Looking over the turbine schematic (figure #3) it was determined the #1 balance plane was too far from the center of the rotor (first mode) balancing on the #1 bearing balance ring.

Corrective Action: Since the second balance plane (exhaust end) was closer to the mid span and we were trying to balance a first mode it was decided to place weights in this ring. Also, since this ring was closer to bearing #2 and the highest vibration was on bearing #1 a two plane balance program was entered. The unit was successfully balanced below the first critical; however, the unit again tripped at the second critical. A second two plane balance program was started below the second critical. During the balancing at the second critical two other problems developed. The unit suffered a rub and a bow was detected in the coastdown data (figures #4 & #5). The rub was not initially detected and several balance runs were lost to the rubbing.

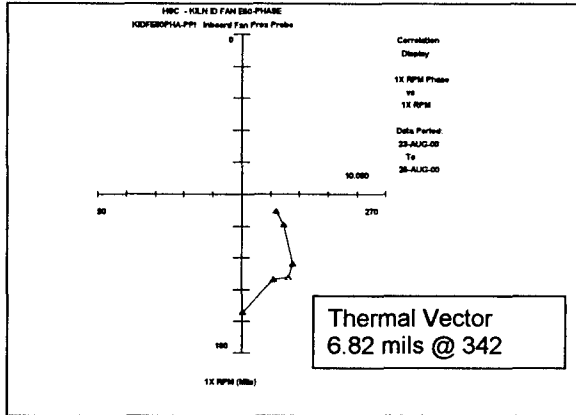
Figure #7

Phase and amplitude data showed thermal vectors as high as 6.8 mils (Figure #7). Coastdown data indicated the vibration dropped off almost immediately as the power was cut (Figure #8). This is a definite indication the fan is running very close to a natural frequency. In 52.5 cycles, the shaft vibration drops by over 76%

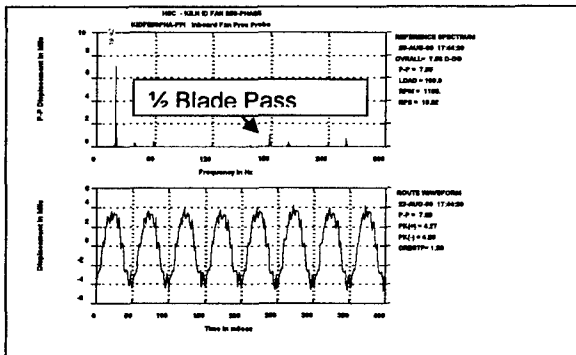
Figure #9

One other item that showed up in the vibration data collected during operation was the presence of a $\frac{1}{2}$ X of blade pass (figure #9). When an orbit analysis was performed this $\frac{1}{2}$ x of blade pass also was present.

Finally the 1/2 Blade Pass was caused by a force on the fan wheel generated by the turning vane.

Corrective Action: Due to the past history of balance problems with the turning vane, it was recommended to removed it. Also, recommended was to balance the fan with prox probes. The shaft vibration was 1.5X to 2X higher then the casing vibration. All previous balancing was only performed with seismic readings.

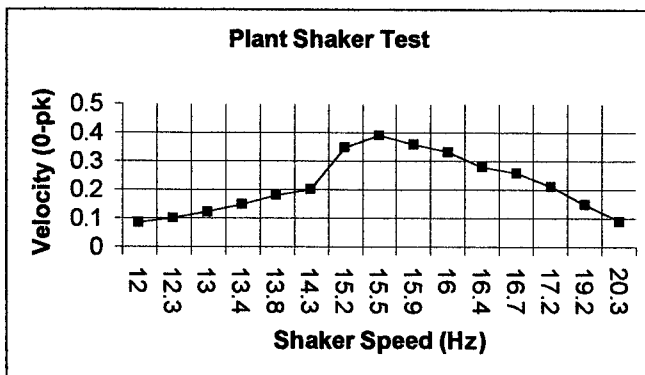
Figure #11

Symptoms: Plant personnel had performed a shaker test on the “A” cell and found vibration response was high in the 15 - 17 Hz range (Figure #11). The dominant vibration frequency from the data plots (motor to gearbox) is blade pass. This is found in the axial, horizontal and vertical directions. Once the review of the past data was completed a test plan was developed.

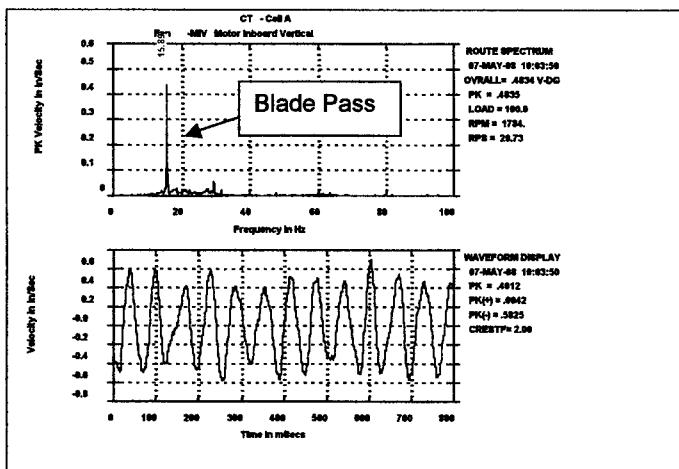
Figure #12

Test Data and Observations: A complete set of vibration data was collected with a dual channel data collector (Figure #12). Impact tests were performed with a dual channel FFT analyzer. A three (3.0) pound instrumented hammer was used for excitation. Along with the impact tests; another set of shaker tests were performed throughout the support structure of the motor, gearbox and fan system (Figure #13).

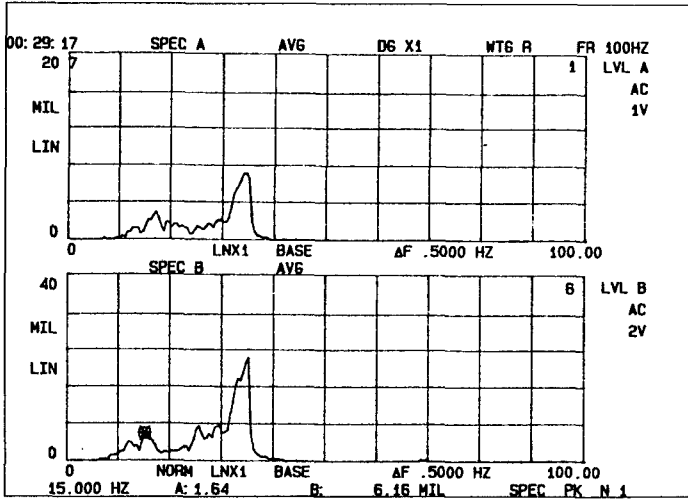
Figure #13

The Shaker tests indicated distinct natural frequencies around blade pass Figure #13). The amplification (Q Factor) from the tests were from 5.3 to 10.5 plus. Impact test (Figure # 14) and Shaker Test results can be found in Table III.

Corrective Action: The data definitely indicates a natural frequency excited by the blade pass frequency of the fan. The vibration problem being experienced is caused by the six blades on the fan exciting the natural frequencies.

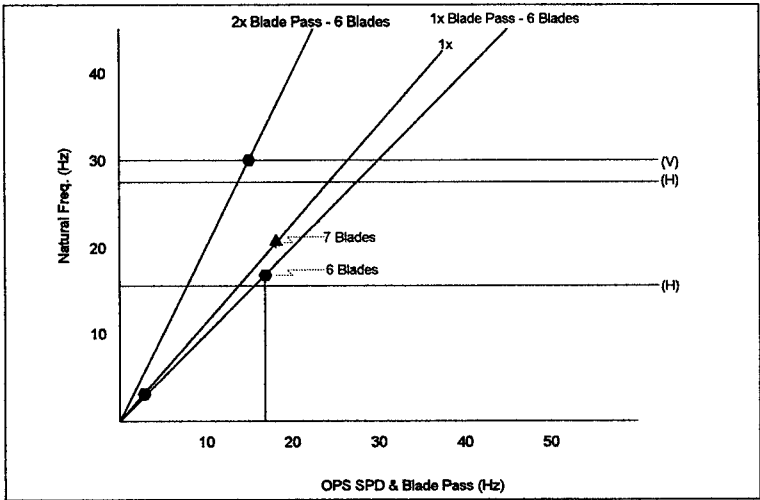
Because this is a natural frequency problem the solution is to remove the forcing function which is the blade pass. Figure #15 shows an interference diagram for the different pieces of the system tested by impact hammer and shaker. The plot clearly shows that a seven blade fan operating at 2.65 Hz will have a blade pass frequency that will fall between natural frequencies and will have little or no excitation from the blades.

Since the fan has operated for so long (over eighteen months) with high vibration and no significant problems have been experienced the best option maybe to run as is and not change anything in the system. Based on the fact that no serious problems have occurred in the present condition the recommendation was made to run the cooling tower without any modification. If problems arise in the future; Febreeca should be placed under the gearbox and motor to detune the system,

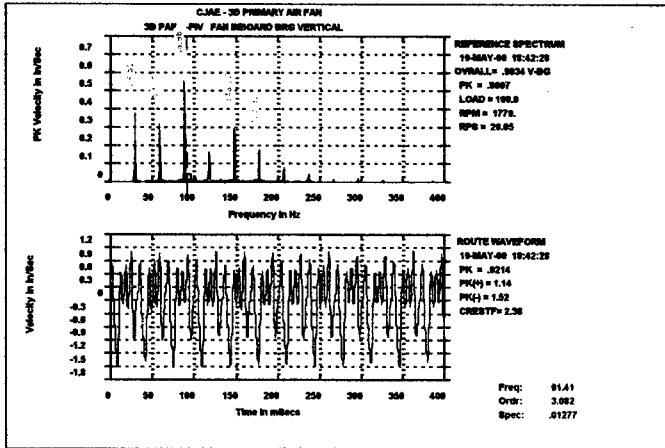
Figure #17

Symptoms: The symptoms remain consistent. The spectrum shows multiples of 1X and the timewave shows clipping (Figure #17).

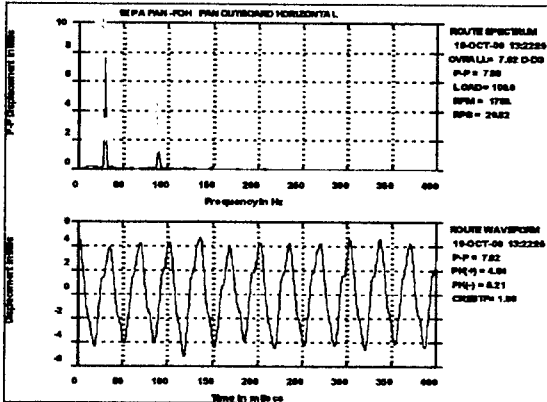
Figure #18

Test Data and Observations: This unit is on a monthly monitoring schedule; so it's easy to see when problems are developing. Once the looseness is apparent, the adjustment nut on top of the bearing has become loose. This nut is tightened down until the looseness is eliminated. This unit went through several cycles of the bearing nut becoming loose and having to be readjusted. The day after the last adjustment the bearing (outboard) closest to the fan failed. Failures of this nature have also occurred in the past. The failure required the bearing liner and bearing housing to be replaced. Data collected immediately after the fan was put back in service indicated the fan needed to be balanced (Figure #18).

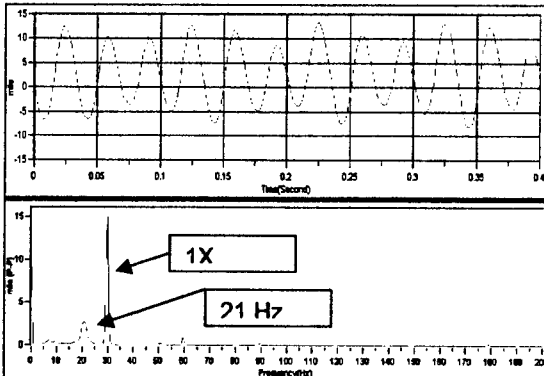
Figure #20

Prox probes were externally installed to read the shaft vibration between the bearings. Shaft vibration amplitudes (Figure #20) were still 15.0 mils (pk-pk) plus.

Corrective Action: Since this plant has six fans that behave this way, all the fans will be balanced using prox probe readings. It was recommended to perform an in-depth analysis of the fan bearing - pedestal system. A modal analysis of the fan movement in the axial, horizontal and vertical directions will be performed. Impact tests of the shaft and bearing caps will be done for validation of a rotor dynamic computer model of the shaft and bearing system.

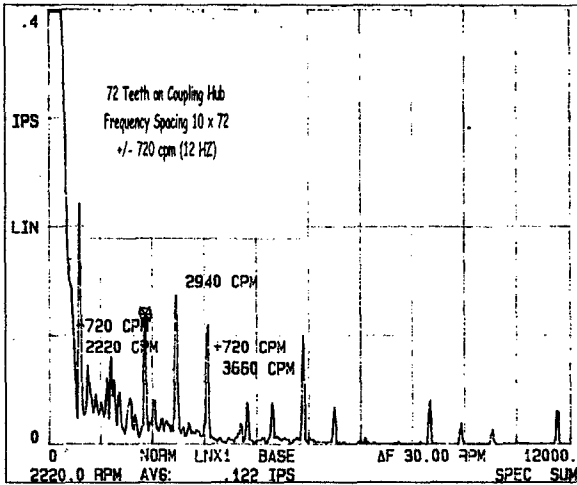
Next vibration data was analyzed from the turbine. Figure #23 is the outboard end of the turbine. The data is take off the shaft riders installed on the TSI system. The data shows ratty sub synchronous vibration. The peak amplitude at 2940 cpm has side bands at + and - 720 cpm. The 720 frequency is ten times

the number of teeth on the coupling hubs. It was concluded from this data that the pump and coupling both had serious problems.

Results: The coupling inspection found severe wear and it had to be replaced. The thrust check found the pump had severe wear and would have to be rebuilt. This pump had been in operation over eleven years and was the last original pump in the plant. The coupling had been in service for at least seven years and may have been the original.

Corrective Action: It was recommended that the unit be shutdown and the coupling be inspected for wear. The total thrust of the pump was also to be measured. This would indicate if the pump and coupling were the problem or if further analysis would be required.

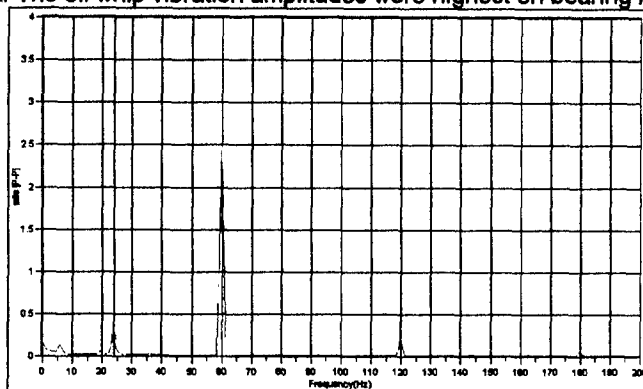
Figure #26

When this problem developed at 90 megawatts the oil temperature was at 105 degrees Fahrenheit. It was decided bring the unit back to 90 megawatts and raise the oil temperature from 105 degree F up to 110 degrees F. As the oil temperature was raised the subsynchronous vibration dropped. A three degree F temperature rise effected the subsynchronous vibration (Figure #26).

Conclusions: The oil whip problem was a combination of two factors. First the unit had not grown into alignment. This unit is aligned so that bearing #3 is loaded heavy during the start up. This is done because it is susceptible to whirl and whip conditions. The oil being cold and the unit not having grown into alignment allowed the whip to develop. Since this problem; questions have arisen about the alignment of this unit. Optical alignment data shows that bearing #3 may be unloaded. The alignment procedures used during the outage have also been brought into question.

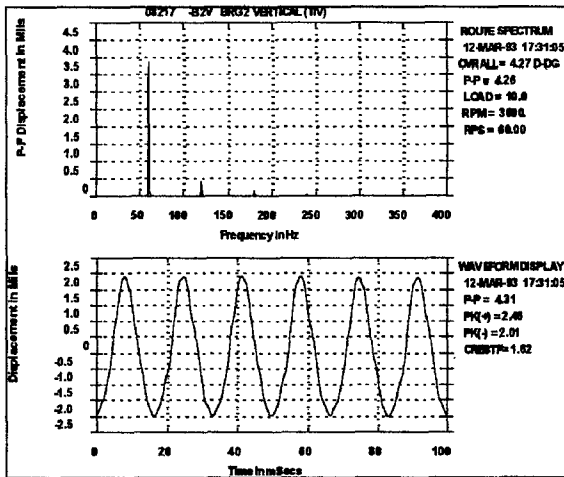
Figure #28

Test Data and Observations: Test data collected by the plant personnel indicated the vibration was at 1X (Figure #28).

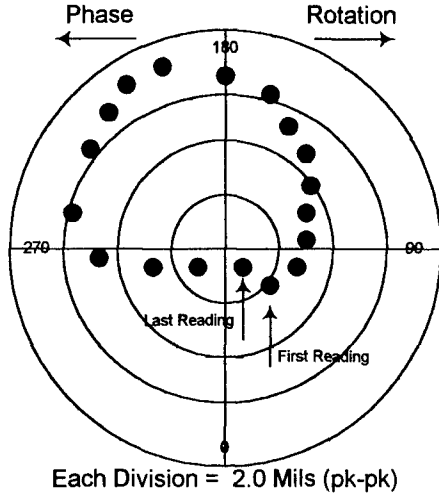
Figure #29

To get a better picture of the cycling of the vibration 1X amplitude and phase data was collected every five minutes for 90 minutes. This showed the vibration was moving opposite rotation over time (Figure #29).

Phase movement with 1X vibration is an indication of a rub. When the unit was at a low cycle of vibration an attempt was made at running the unit at full load. Vibration spectra data was collected on bearing #3 to see what the cause of the erratic vibration was. When the unit reached 20 megawatts a subsynchronous vibration appeared (Figure #30).

Corrective Action: It was recommended the alignment setting be verified and changed as necessary to relieve the situation. This needed to be done as soon as possible; because the plant generated its own power and could not run at full production without the turbine.

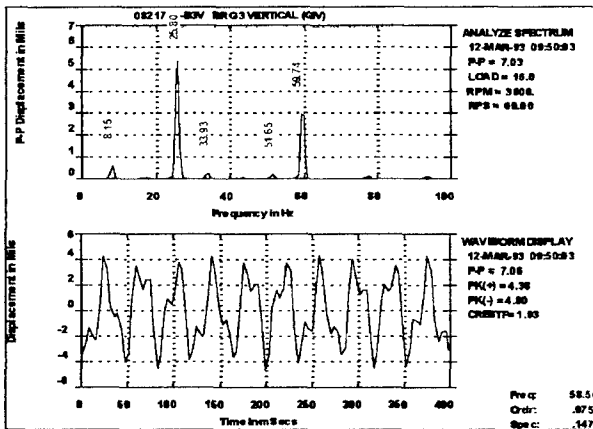
Figure #30

Results: It was found that during the calculation of alignment settings a dial indicator was read incorrectly. This resulted in the generator being set too low unloading the first generator bearing. In turn, bearing #2 was rubbing due to the seal clearances being closed up.

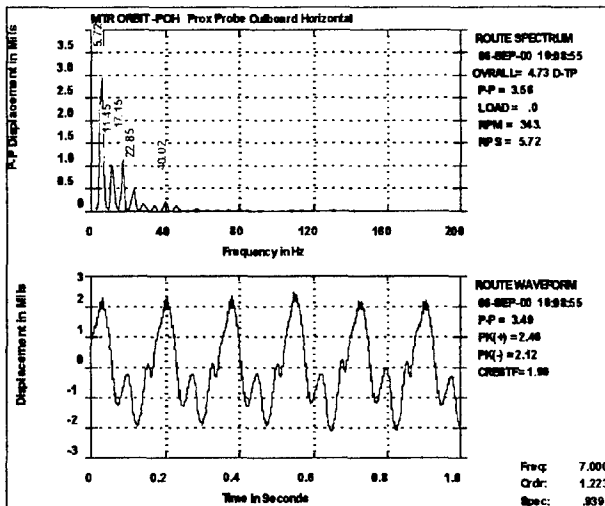
Figure #31

Test Data and Observations (1): All initial test data was collected with the motor uncoupled from the pump. Because of the sudden vibration trips when the excitation is at an excitation of 39 Hz to 40 Hz, data was recorded to determine the cause of the vibration. Data was collected from both the installed proximity probes and extra mounted seismic sensors. Trying to minimize the problem with tripping, vibration data was collected at 5 Hz to 10 Hz excitation intervals. Since the data was primarily 1X, Plant personnel and equipment vendors wanted the motor balanced (Figure #31).

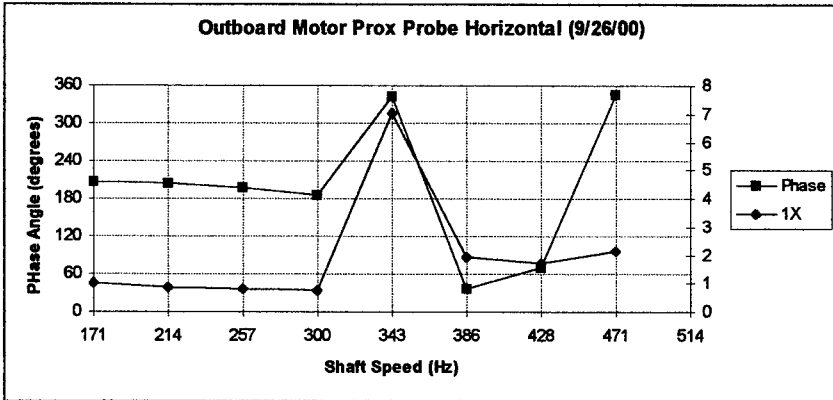
Figure #32

Balancing was able to somewhat lower the vibration in the uncoupled condition; however, when coupled up the vibration was still high at 40 Hz excitation and would trip the motor. There was also a thermal effect noted in the balancing process. During the step by step progression of collecting data at several points as the motor excitation was increased a poor mans bode plot was constructed (Figure #32). This data is from the outboard motor horizontal proximity probe.

The increase in vibration at 343 rpm (39 Hz excitation) with the associated phase shift is showing the shaft is going through a critical speed.

Corrective Action (1): Recommendations were made to replace the tilting pad bearings with an elliptical or straight bore bearing. It was additionally stressed that a rotor dynamic study be performed to determine the best bearing for the situation. This recommendation was met with stiff resistance by the motor manufacturer. A second consultant was contracted to look over the analysis and balancing data along with the "poor man bode plot." This consultant agreed with the first conclusions and recommendations.

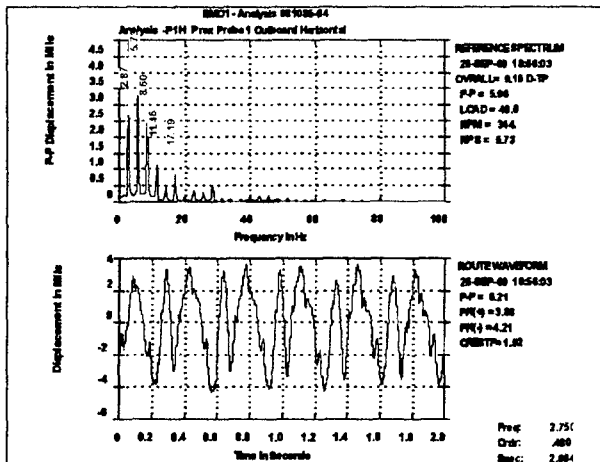
Figure #34

The subsynchronous vibration at 2.37 Hz is 47% of running speed (Figure #34). The subsynchronous vibration was only present on the outboard motor bearing. This vibration would only appear when the unit was at 40 Hz excitation and above. Below 40 Hz excitation this vibration was not present. It had been noted during the balance runs; a subsynchronous vibration was present; however, in amplitudes below .2 mils (pk-pk).

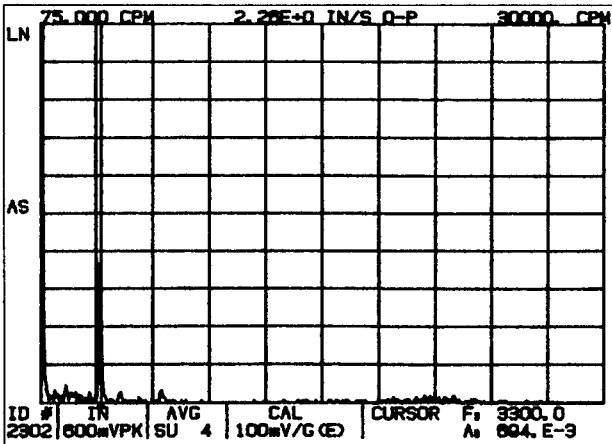
Figure #35

With the operating speed on the pump at 4350 rpm a subsynchronous vibration is present at 3225 rpm (Figure #35); the running speed vibration is non-existent. Only the sub-running speed vibration is present. The subsynchronous vibration at 74-78% of running speed indicates hard, continuous contact between the rotating and stationary parts of the pump.

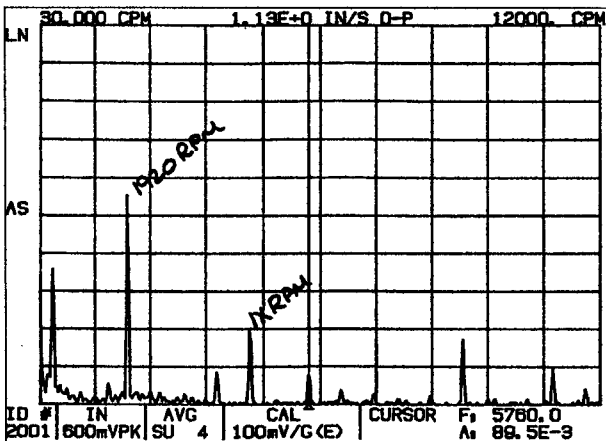
Figure #36

Test Data and Observations (2): Since the pump was just overhauled, our first thought was the turbine vibration was the result of some procedure done during the overhaul; even though the vibration was in the turbine and not the pump. Because this is a capability related piece of equipment, it was recommended that we go into a two part analysis program. First, a decision was needed to determine, if the pump could be used for operational needs; second, find the cause and solution to the problem. Before any decisions were made, a full set of data was collected to determine if the unit could be run without severe damage. Spectrum data shows approximately 7.9 mils of subsynchronous vibrations present at 1920 rpm and 3840 rpm (Figure #36).

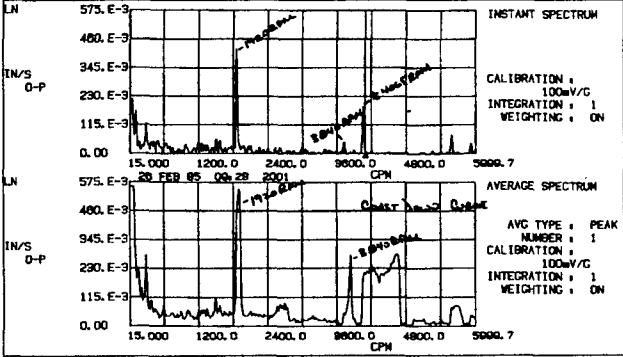
Figure #37

Next, the turbine was brought up to 4700 rpm. Coast down curves (Figure #37) in peak average (Bottom Plot) were going to be plotted vs. instantaneous spectrums (Top Plot) to determine the speed this whirl develops. This data plots the vibration with the turbine running 4065 rpm. Note the subsynchronous vibration is present at 1920 rpm and at 3840 rpm.

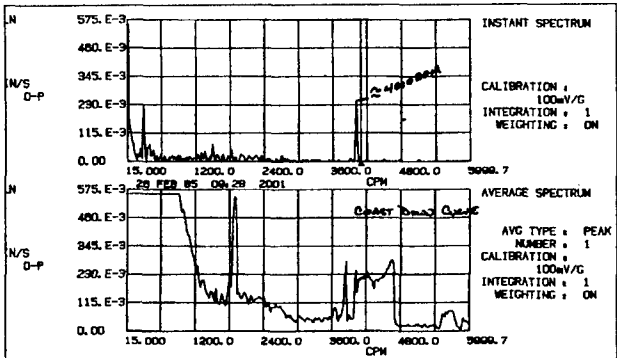
Figure #38 shows the vibration with the turbine running at 4010 rpm with no subsynchronous vibration. This indicates that the factor causing this vibration is not present until the turbine is in the last 20% of its speed range, the point at which steam flow is the highest.

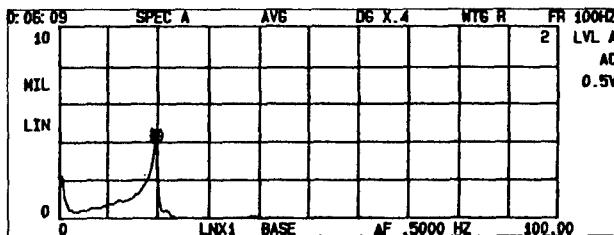
Figure #41

Operating data showed the majority of the vibration to be in the horizontal direction and a drastic drop in vibration as the motor speed lowered from full speed operation (Figure #41). The vibration amplitude drops 3.0 mils in 2.0 Hz.

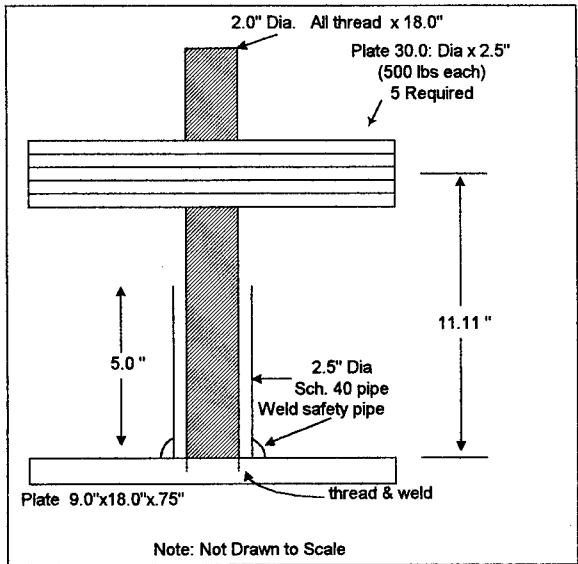
Figure #42

The design of the DVA dictates that it must be at least 10% of the total weight of the machine. The west motor, frame and pedestal weighted roughly 25,000 pounds. This means the absorber must have at least 2500 pounds of weight. To design an absorber one has to determine the length of the vertical support based on the weight to be supported (Figure #42).

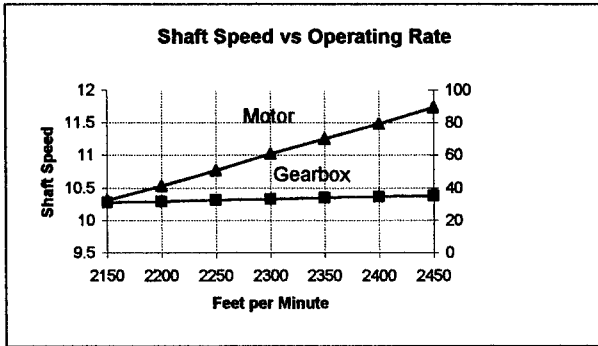
Figure #44

Production personnel noticed floor vibration when the mill was operating at 2350 feet per minute (fpm). A plot of motor speed versus mill operating speed is in figure #44.

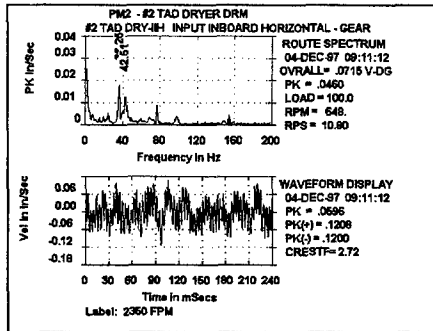
Results: The equipment supplier designed isolators and snubbers on the gearbox to help relieve the vibration caused by the natural frequency. Figure #48 shows data after the isolators and snubbers were installed.

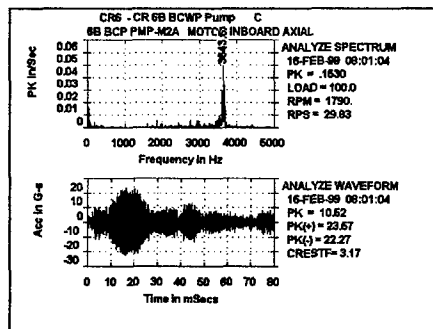
Figure #49

Symptoms: Vibration trend data showed a high frequency vibration at 3643.6 Hz (Figure #49). The overall amplitude of vibration had been trending up over the past several months.

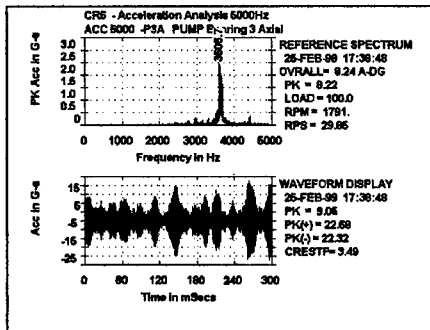
Figure #52

The new plots with the longer time data shows the bursts of energy are at 1X (Figure #52). Looking at the same point in Velocity (Figure #53) shows essentially the same information as figure #2; 1X and a subsynchronous vibration between 5.0 and 6.0 hertz. None of the velocity or Acceleration plots indicate any bearing frequencies. The time data is typical of bearing frequencies; however, no distinct frequencies can be identified. Since the goal of this analysis was to identify if the problem was a pump or motor bearing it was decided to try peak view analysis. The peak view data plots showed two distinct bearing problems on the thrust bearing in the pump (Figure #54).
