WADC TECHNICAL REPORT 55-107

"PROJECT BIG EVA"

**Accelerated Service Test
of Radio Sets AN/ARC-21**

MARCH 1955

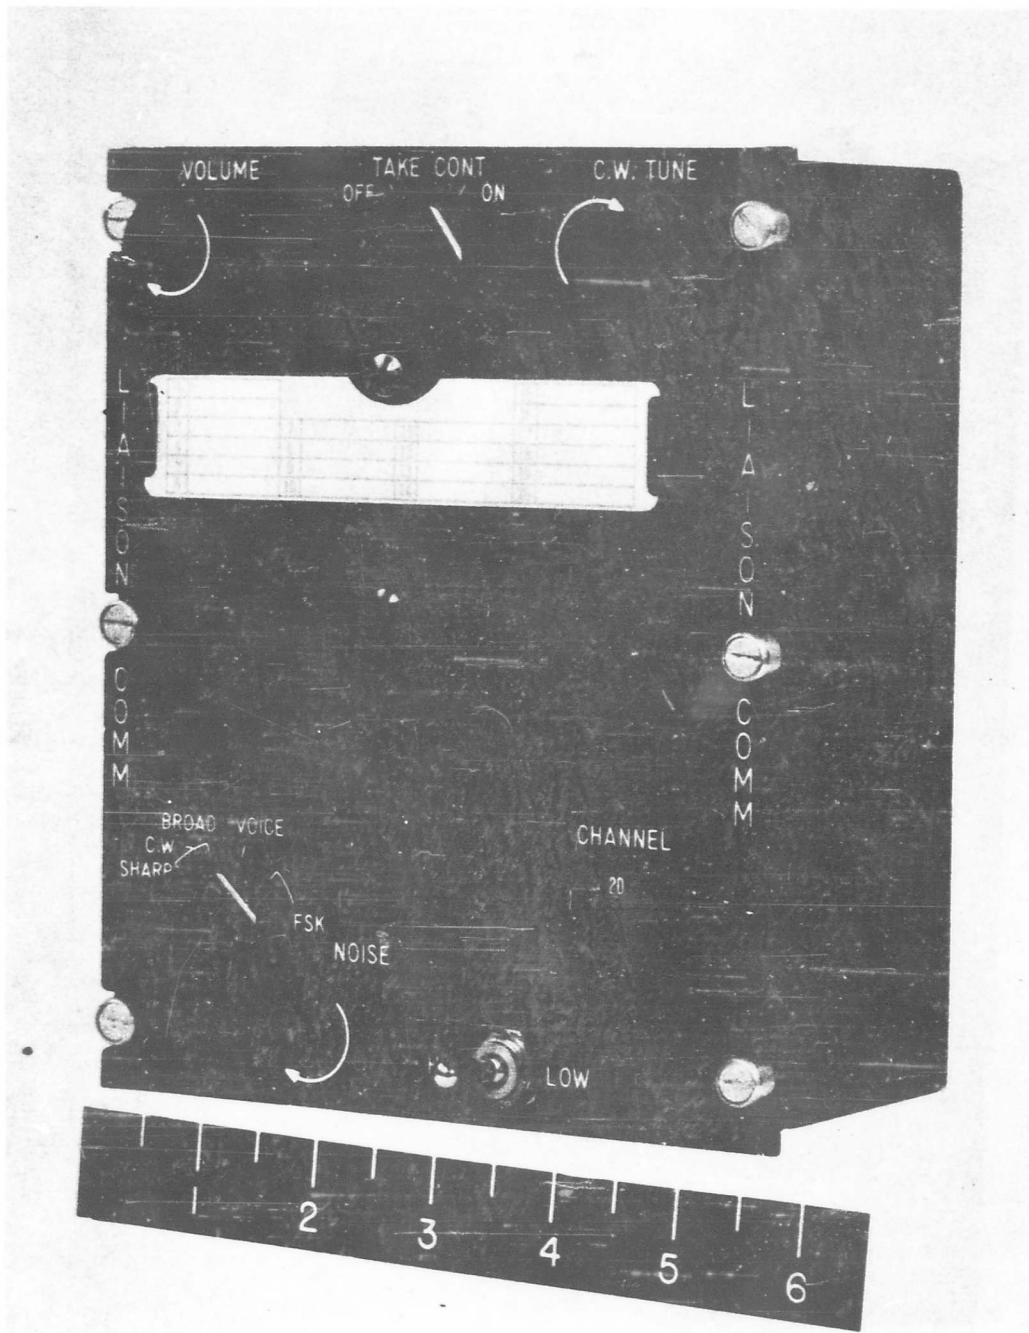
FIGURE 3
RADIO SET CONTROL C-451/ARC-21

Control Panel C-451A/ARC-21. On Control Panel C-451A/ARC-21, it was found that the channel detent mechanism was not always positive enough and that it was possible to stop between channels. This condition was corrected in an improved design and the nomenclature changed by the addition of an "A." This control panel is in production.

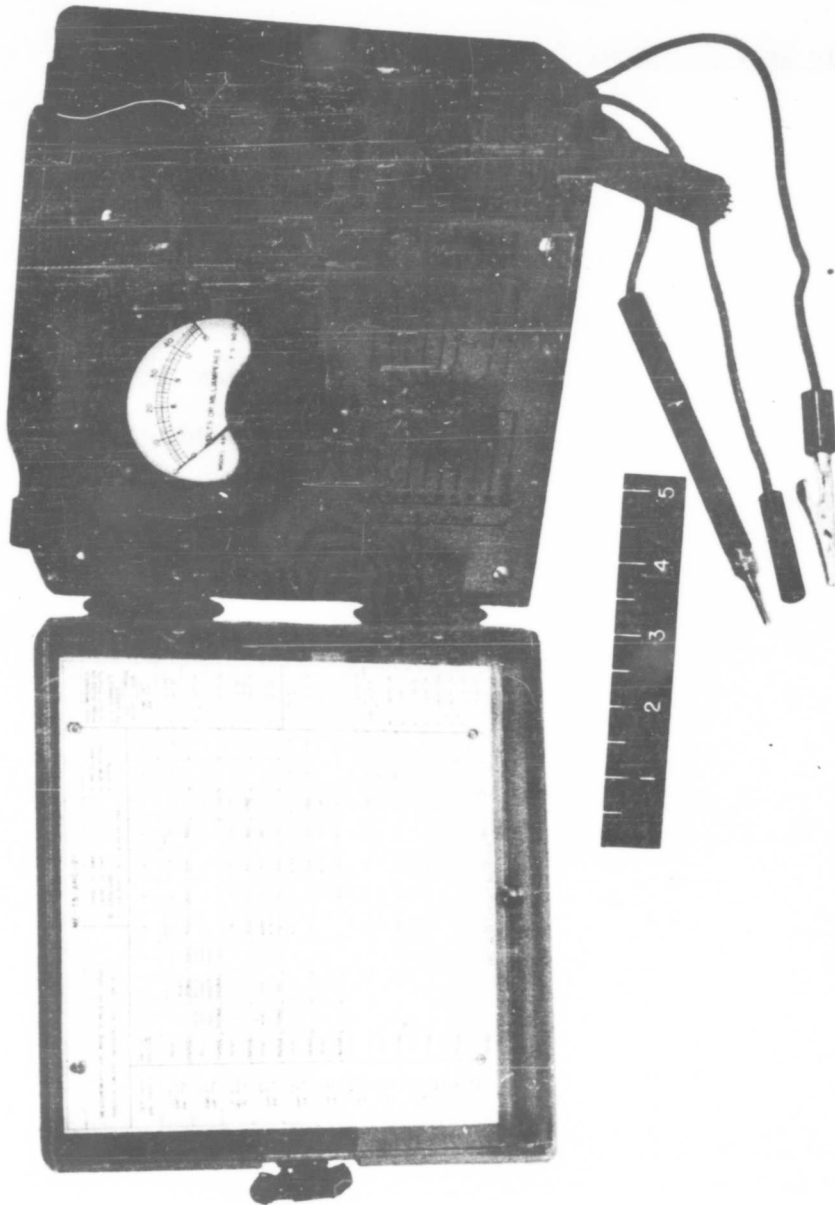
FIGURE 6
TEST METER ME-75/ARC-21

Multimeter ME-75/ARC-21. Use of the "go, no-go" meter at Scott AFB in training operations resulted in the discovery of a potential personnel shock hazard. Wearing of insulation within the instrument could connect the metallic case to the potential of the high-voltage lead (1000 v) from the radio set. The contractor determined a fix which prevented such an occurrence. The fix was accomplished by grounding the case of the instrument to the frame of the R-T Unit through a separate lead, after which the instrument case cannot be above ground potential.

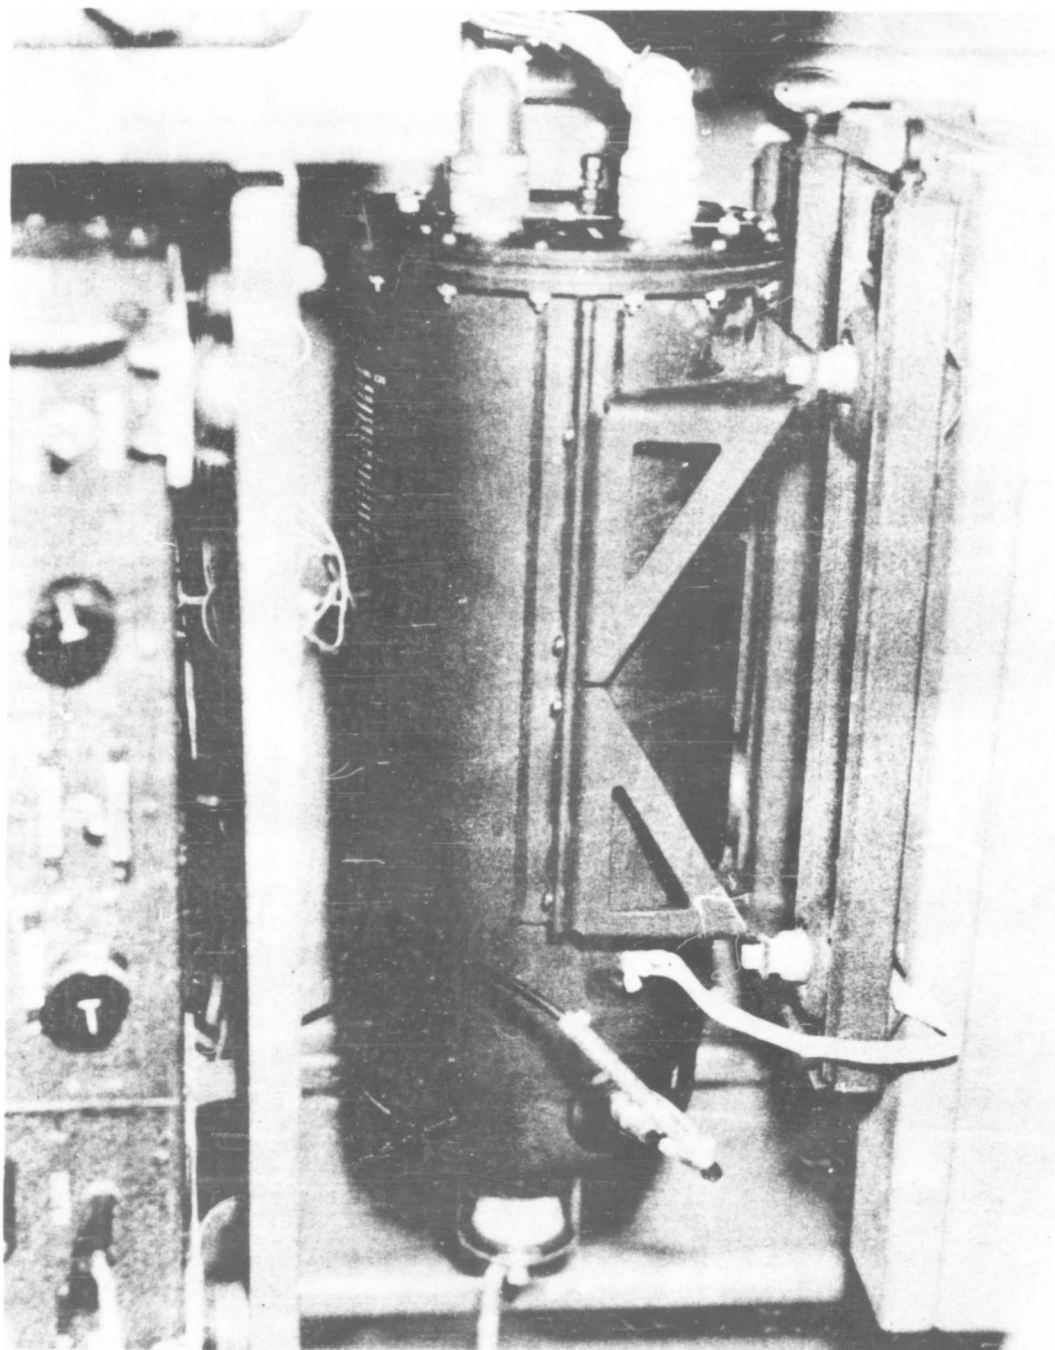
FIGURE 25

E.R.A. Coupler. At one frequency it was found that the transmitter and coupler would not come to a stable tuning point, due to the fact that a pure resistive load was presented to the coupler. The fix consisted in a small modification to the coupler itself of changing wiring and adding resistors.

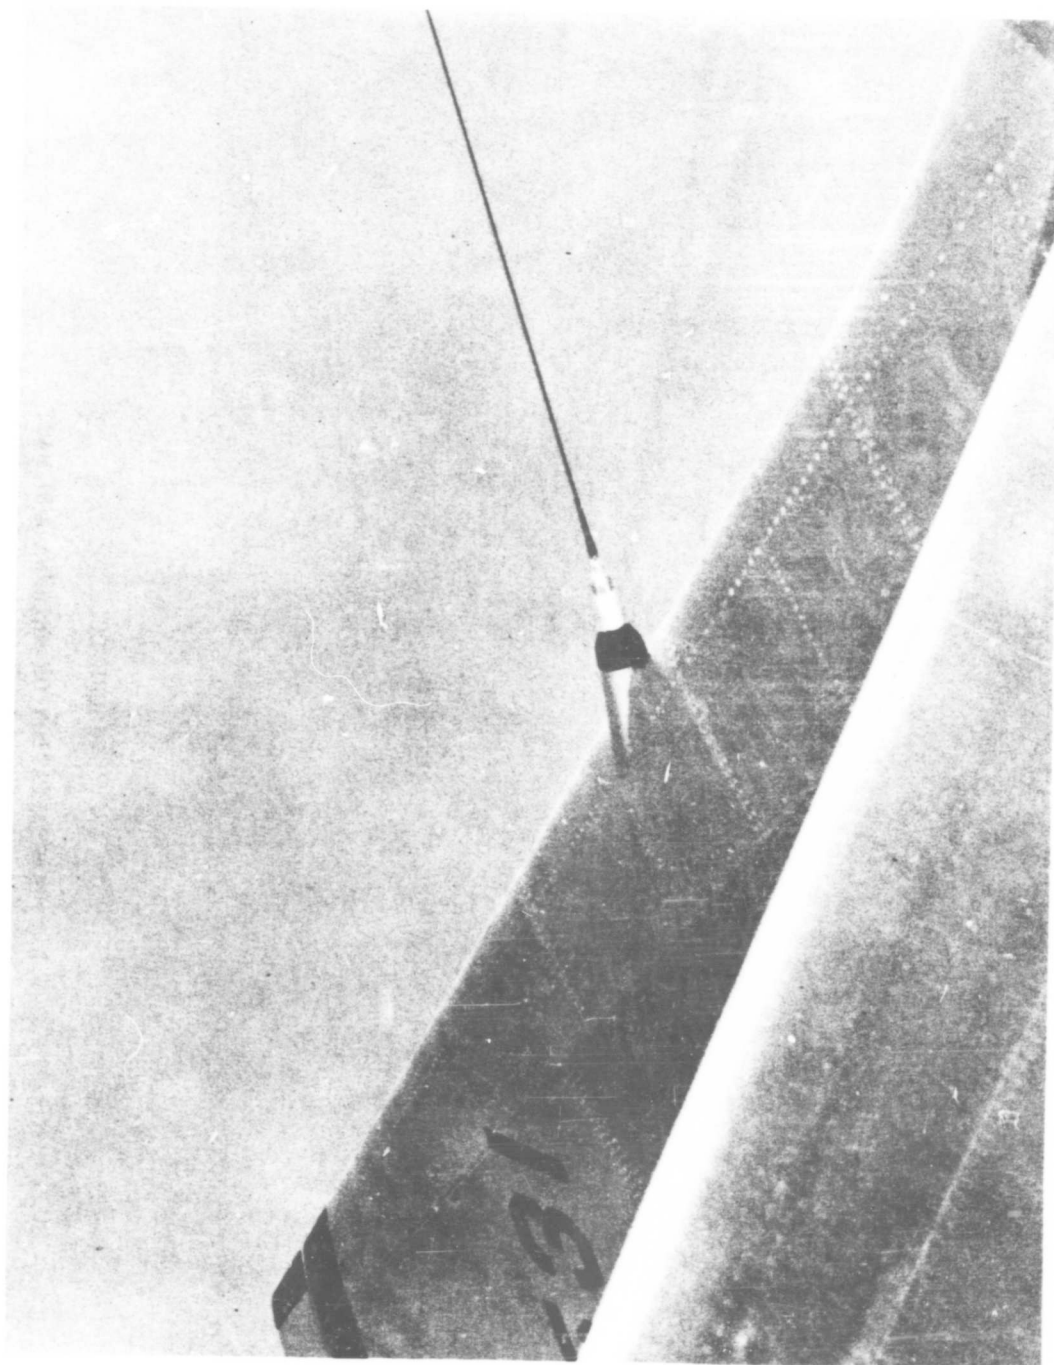
FIGURE 27
B-47 INSTALLATION OF ANTENNA SHORTING RELAY

Relay RE-132/ARC. Some difficulty was experienced at MacDill AFB due to transients caused by operation of the antenna shorting relay affecting the proper operation of the ERA Coupler. The fix consisted of an addition of a filter in the Coupler.
