M.A.E.E. Report No. F/187
(Saunders-Roe Report No. FT/15/0/24, Part 3)

June 1955

SAUNDERS-ROE PRINCESS FLYING BOAT G-ALUN

ENGINEERING APPRAISAL

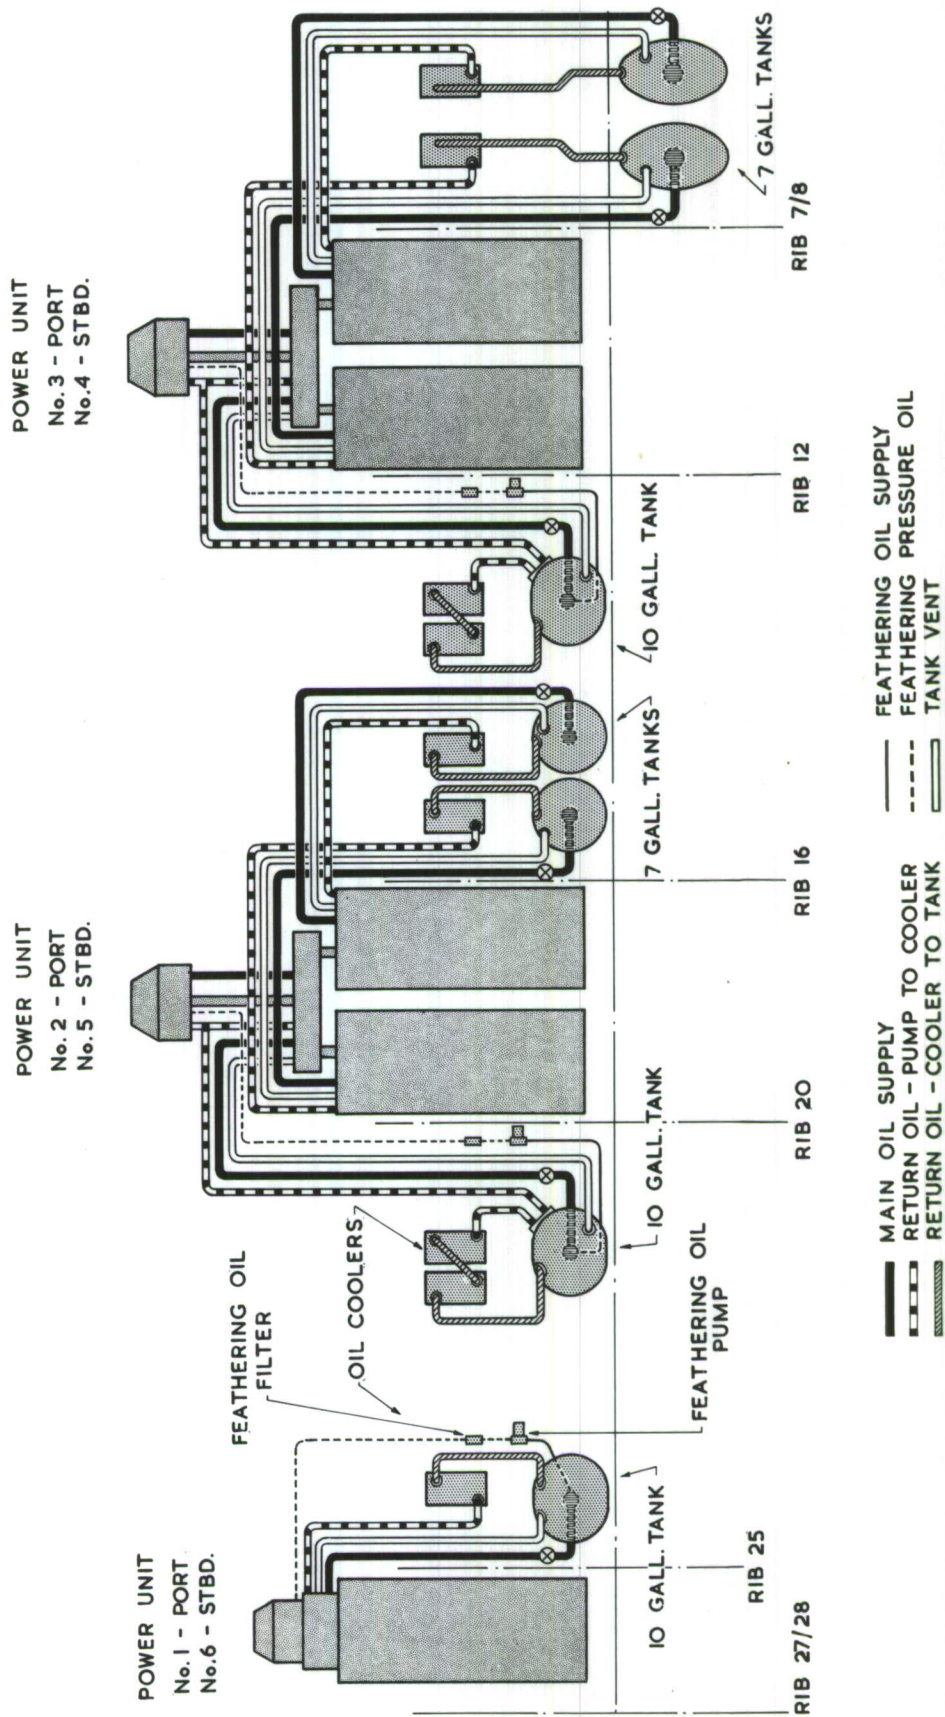
DIAGRAM OF OIL SYSTEM

Each coupled power unit had its own oil system and also a separate transmission oil system. A single unit installation had one common system for both engine and transmission. The layout of the oil systems for two coupled and one single engine is shown schematically in Figure 5 and a full description may be found in Section 4, Chapter 3 of Reference 4.

The four coupled engine transmission systems and the combined single engine systems were satisfactory. The oil systems for the coupled units were not satisfactory. Even under temperate summer conditions it was not possible to warm the oil up to a desirable operating temperature, or to maintain it at a figure above the minimum limit in flight. This over-cooling was mainly due to the low oil circulating rate through the engine, and was aggravated to some extent by air leaks around the cooler shutters. Temporary sealing was fitted to the shutters, and part of the cooler matrix blanked off; this enable flying to continue, but was only a temporary arrangement.

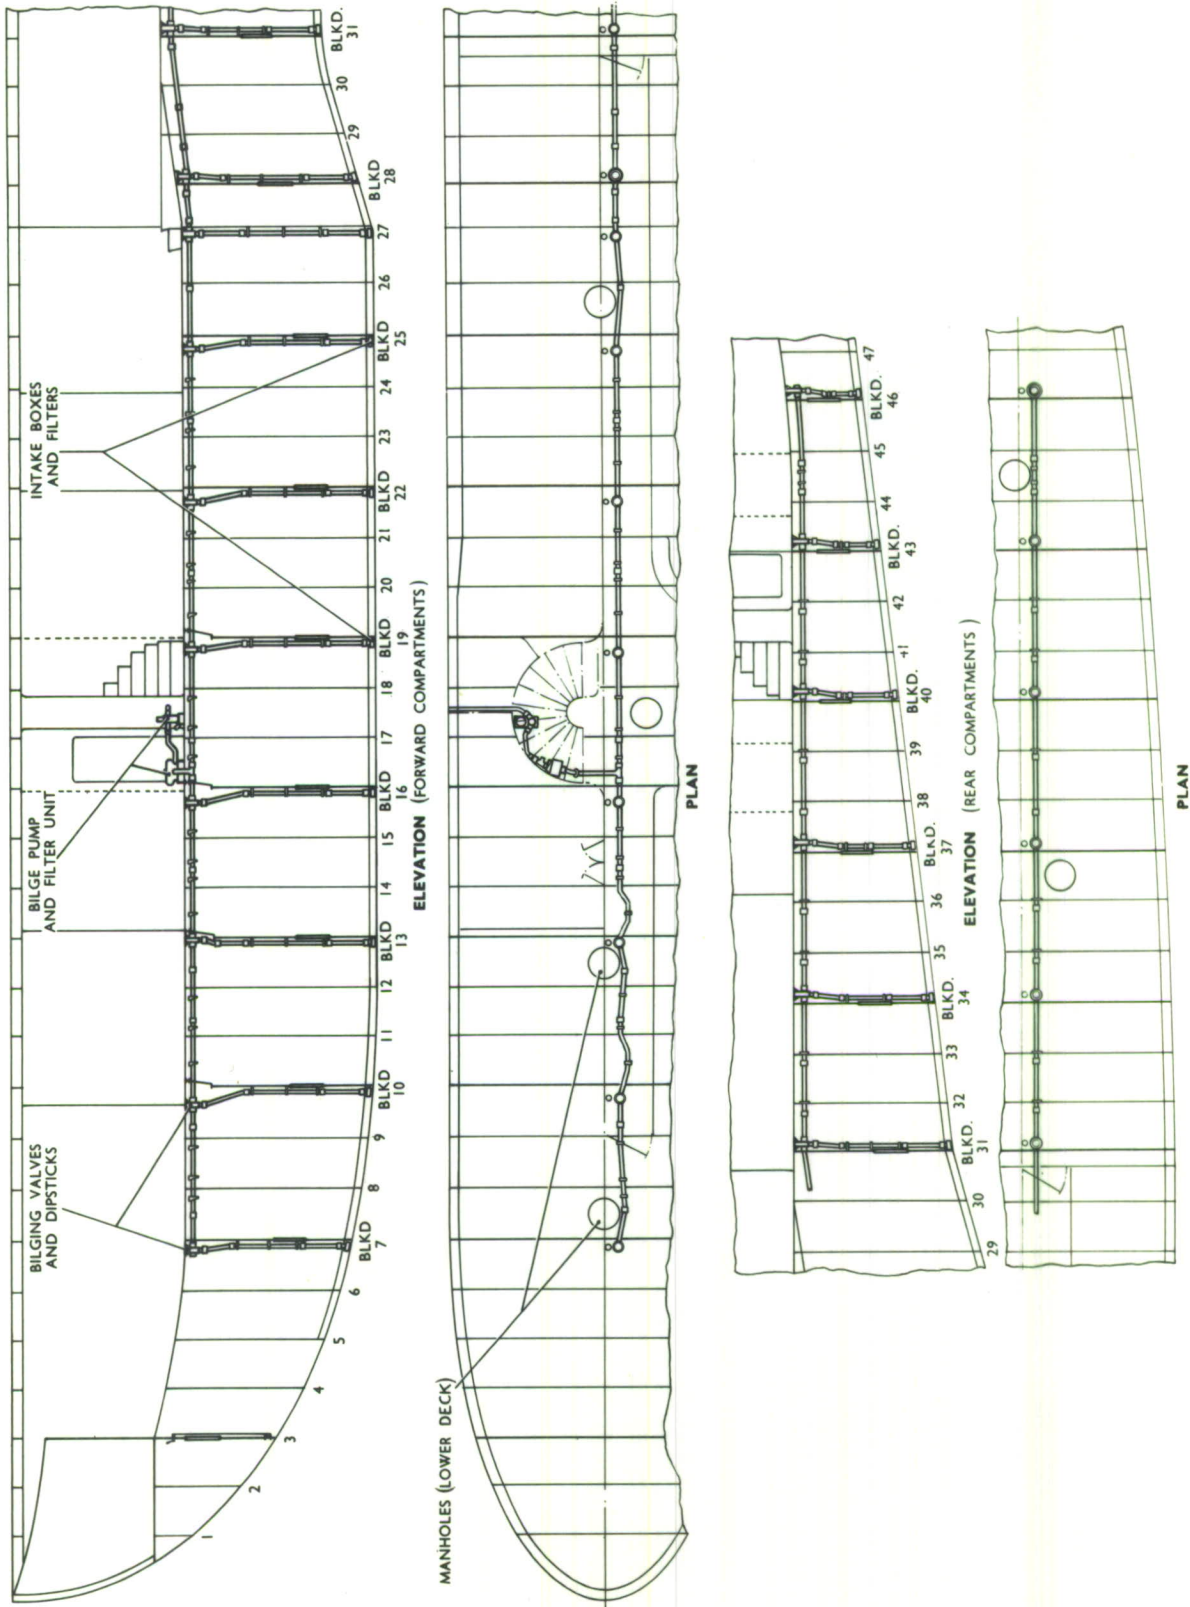
DIAGRAM OF BILGING SYSTEM

The troubles encountered on the main bilge pump were the result of corrosion in the units due to the dissimilar metals in the pump, which was aggravated by the effects of salt water. Fresh water was pumped through the unit, but this did not overcome the electrolytic action of the dissimilar metals.

The rubber sealing rings in the disc valves had to be changed on several occasions. These rings were generally damaged whilst sliding past the main gallery unions. The rings expanded into the gallery as the valve was being opened or closed, and were cut away by the continual action of the valve. This process was aggravated by the effects of salt water on the seats, which perished the rubber. A leak in one valve could render the system unserviceable.

The hose piping used for connections at various points in the system was affected by sea water and replacement was necessary on several occasions.

Improvements should be made to prevent the corrosion which occurred of several components, and hence reduce the amount of maintenance necessary on the installation.
